Design and Operational Issues While Tunneling in Firm at the South Pole Station

September 2003

Design and Operational Issues While Tunneling in Firn at the South Pole Station

*Cold Regions Research and Engineering Laboratory
72 Lyme Road
Hanover, New Hampshire 03755*

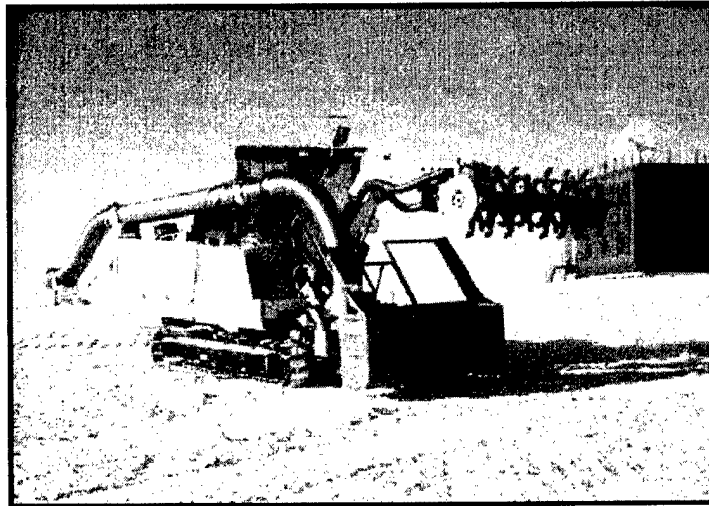
Figure 3. Tunneling machine (photo, M.R. Walsh).

The tunneler proved to be underdesigned for the conditions initially encountered at the South Pole. The biggest factor was the higher than expected snow strength attributable to the increased tunneling depth specified upon our arrival. The snow strength that was used in the tunneler design calculations was 0.5 MPa. This was based on an anticipated depth of 9 m and undisturbed snow compacted through natural mechanisms (Gow and Ramseier 1964, Mellor 1964). However, the actual depth of the tunnel was up to 16 m and the area into which the tunnels were driven was highly disturbed and thus more compacted and stronger than anticipated. The difference in strength for these conditions is substantial, over twice that for undisturbed snow. The power required to meet the production goal

(3 m/h) thus went from 8 to about 25 kW. Concurrent with the power, higher torque is necessary to machine the snow and maintain the production rate. The available torque at the drum with the system as originally designed limited the possible depth of cut. In very hard material, approaching the consistency of ice in places (density greater than 800 kg/m^3), the depth of cut was limited to 0.05 m instead of the 0.24 m used under the original design conditions. In 1997, following the analysis of the South Pole tunneling operations in 1996, a 19-kW hydraulic pump was specified to replace the original 10-kW pump. This pump is the maximum size compatible with the original drum drive system. However, a 23-kW pump was shipped by the supplier and installed for testing and training in 1999. This pump was inadvertently left on the unit, overdriving the drum and causing premature failure of the drum drive components in subsequent tunneling operations.

The tunneler will be discussed first. The drum drive problem was caused by a lack of power. The snapped pump shafts experienced during the 1996 deployment were resolved with the installation of the larger pump with a larger input shaft in 1999 (15.87-mm \varnothing to 31.75-mm \varnothing input shafts). When the original drum pump was replaced with the more robust unit, it was discovered that the supplier had not shipped the unit specified. The output (with inefficiencies) of the pump supplied was 22.8 kW at 1.32 L/s, 21% higher than the 18.8 kW, 1.1 L/s, unit specified. The pump was slated for replacement prior to the commencement of the 1999–2000 tunneling effort but the task was not carried out. The result was the failure of several hydraulic components, including several drum drive motors. The maximum continuous flow the motor is designed to accommodate is just over 1.02 L/s. The pump was delivering a minimum of approximately 1.3 L/s. The result was overspeeding of the unit and eventual failure. In 2002, the correct pump was installed and hydraulic failures (with the exception of blown hoses) ceased.

Problems with the hydraulics in general and the drum drive in particular have been examined to a great extent. It is obvious the drum drive was underpowered for the conditions encountered during the tunneling operations. Both a larger hydraulic drive and an electric drive have been considered to power the drum. As the system currently sits, the final chain drive is rated at 16 kW continuous duty. Using a 15% intermittent duty factor, the largest system drive that can be considered is around 18 kW, 23 kW before inefficiencies. Although still undersized (a 23-kW final drive is more suitable), this is a workable system that will not require a major redesign. Going to a larger hydraulic drive system will require the redesign of both the hydraulic and mechanical aspects of the drum drive. An electric drive would weigh in excess of 250 kg and require a major redesign of not only the drive but the supporting mechanism of the drum. The most workable solution for the current system therefore is to reinstall the 23-kW drum drive pump and replace the current drum drive motor with a larger displacement, higher torque model that will directly output the desired speed. Care needs to be exercised prior to cold start to reduce damage attributable to high oil viscosity. Pre-warming the hydraulics with a heater or leaving the hydraulics circulating between shifts will help alleviate the problem.

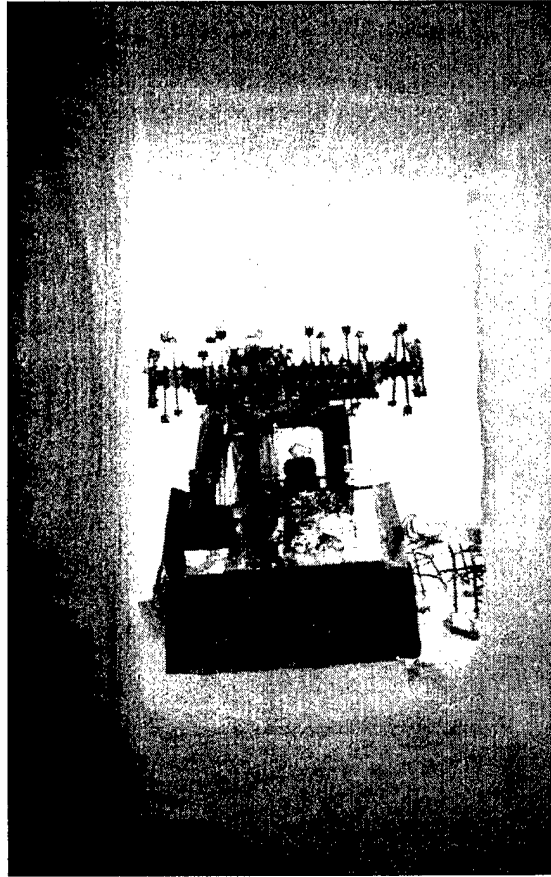
Figure 4. Front of tunneling machine showing snowblower (photo, M.R. Walsh).

A second problem associated with the center-impeller snowblower is the stress on the joint where the ejector tube meets the snowblower. The ejector tube is unsupported from the snowblower to the end of the tunneler (up to 7 m), with a sliding joint and a large-radius 100° elbow between. When the snowblower is

lifted or lowered, extended or retracted, high stresses are experienced at the snowblower joint. In addition, the uneven distribution of weight adds stress to the lift/extension frame for the snowblower. Both assemblies failed several times and were modified. Some problems still persisted, although they may be attributable to overuse of the system.

The speed and torque of the snowblower impeller are too low. Because of the configuration of the throat, an attempt was originally made to meter the snow into the airstream through the throat to avoid clogging. This did not prove successful. Higher rotational speed and more torque will be necessary to give the debris enough momentum to fully engage the airstream. This should improve the efficiency of the disposal system.

The snowblower frame failures were primarily attributable to tight tolerances on machined parts and stresses from almost constant use. Some of the stress problems were reduced when the frame was redesigned in 1997. The lift cylinder raised the frame in compression rather than in tension as on the original design. Recurrent problems with the frame lift mechanism were traced to two factors: loss of retaining rings on clevis pins and tight pivot bushings. Both these items were addressed successfully in the field.

The ejector tube connection point failure at the snowblower was a recurrent problem that was addressed but never fully resolved. The stresses at that point are quite large, and the joint is stressed often during operation. It was redesigned and rebuilt twice, resulting in increased reliability, but the joint will have to be reexamined if the system is to be used again.

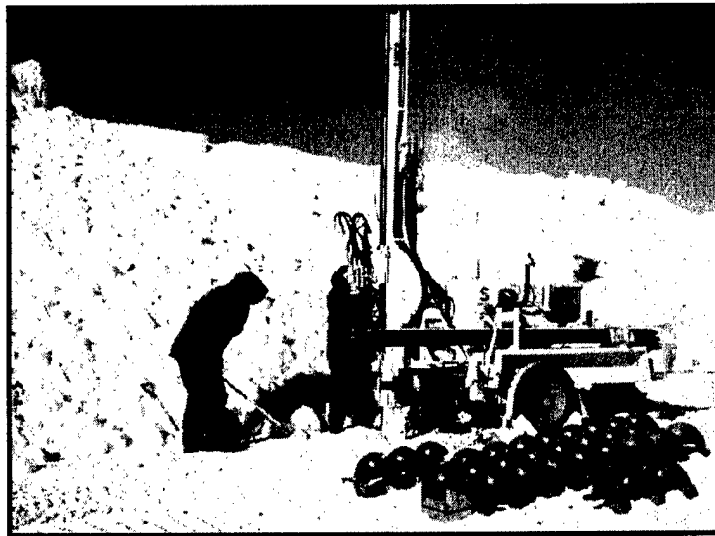
Figure 5. Drill rig used at pole (photo, M.R. Walsh).

The drill rig (Fig. 5) did not operate in the cold as well as expected. Starting the unit was very difficult, even with a block heater and hydraulic oil heater. When back boring the 1-m diameter escape shafts, the drill string tends to whip violently as the bit approaches the surface. This becomes especially dangerous when the bit breaks through. Varying the drilling parameters had little effect on this behavior. A means of stiffening or stabilizing the rod needs to be found and implemented.

Starting problems with the mobile drill in the cold were resolved by warming the unit for longer periods with a mobile heating unit. This did not fix the problem of cold starting but it was a work-around. The hydraulic reservoir is equipped with heaters, but the oil temperature was too low for efficient operation. Adding an insulated cover to the tank resolved this problem.

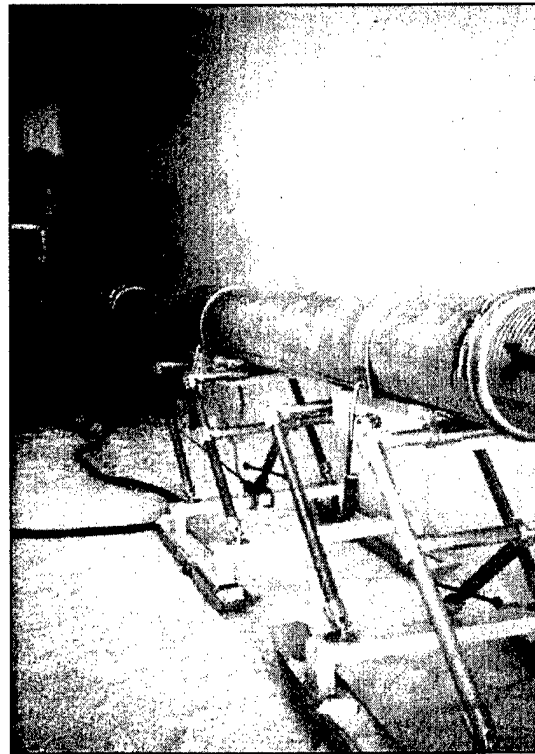
Figure 6. Single-expansion duct unit mounted to tunneler (photo, M.R. Walsh).

The problems associated with the remainder of the debris transport system were successfully addressed. Stressing of the horizontal ducting during the frequent positioning of the tunneler were resolved with the fabrication of a short single expansion duct unit that was mounted directly behind the tunneler (Fig. 6).

This unit is much lighter than the regular double expansion units and runs much smoother. The hard stops used on the horizontal ducts to prevent tube separation were removed and expansion limits maintained with cables. This eliminated the pull-out problems experienced earlier when advancing the tunneler. Polyethylene sleeves were inserted in the ducts to facilitate sliding. Hard stops were installed on the opposite ends to limit tube contraction. The separation of the flow at the fan inlet was eliminated by the addition of a 2-m straight expanding duct between the fan and the elbow where the vertical tubing exits the surface (Fig. 7). This had the added benefit of simplifying the positioning of the fan assembly, as its placement at the access hole in the surface was no longer as critical, resulting in reduced setup times.
