The Evaluation of Aluminum Foil-Interlayered High-Modulus K13CU Pitch Fiber-Siloxane- Modified Resin Composite Panels

15 July 2003

R. J. ZALDIVAR and R. CASTENEDA
Space Materials Laboratory
Laboratory Operations

6. AUTHOR(S) R. J. Zaldivar and R. Casteneda				5d. PROJECT NUMBER	
				5e. TASK NUMBER	
				5f. WORK UNIT NUMBER	
7. PERFORMING ORGANIZATION NAME(S) AND ADDRESS(ES) The Aerospace Corporation Laboratory Operations El Segundo, CA 90245-4691				8. PERFORMING ORGANIZATION REPORT NUMBER TR-2003(8565)-5

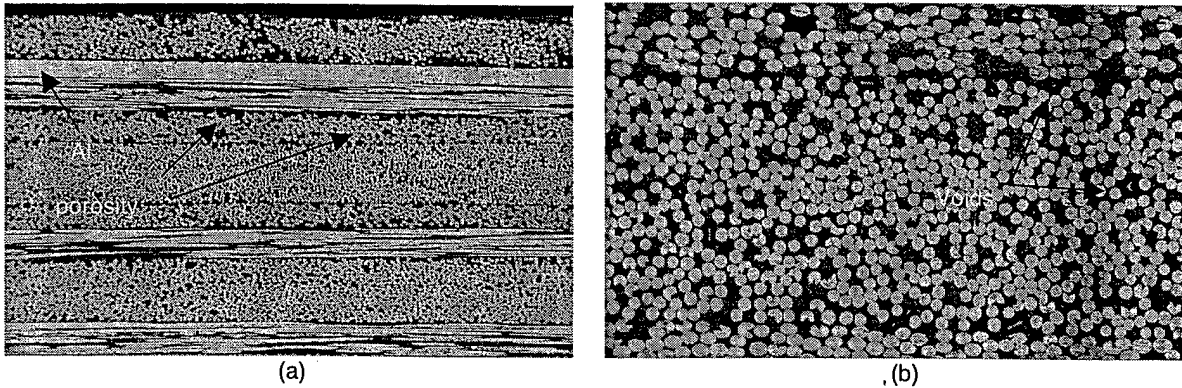
The aluminum-foil layer can be seen one ply in from the outer surface. Figure 4a shows this layer. The foil appears well bonded to both sides of neighboring laminate plies. Figure 5a shows a higher magnification photo of the aluminum foil within the structure of sample 1. No areas of debonding or excessive fiber-to-metal contact were

Figure 4. Cross-sectional optical micrograph of composite sample 1. The composite appears fairly well consolidated with some porosity observed within plies.

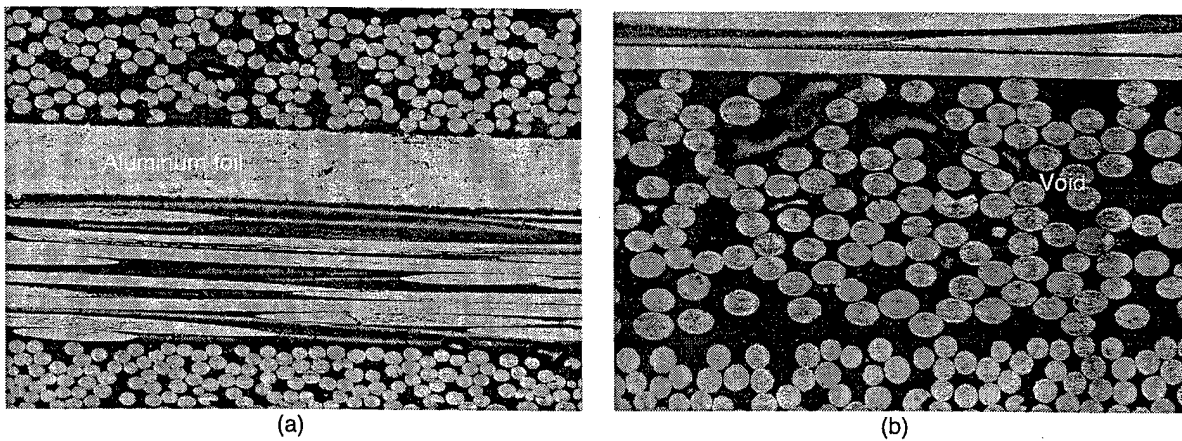
Figure 5. Cross-sectional optical micrograph of composite sample 1. (a) Shows good bonding on aluminum foil in the structure; (b) shows porosity within plies.

observed. Resin-lean areas would account for decreases in interlaminar shear strength; however, the sample appeared fairly resin rich on both sides. Figure 5b shows a higher magnification micrograph of the porosity observed within plies. The porosity appeared fairly well distributed throughout. Image analysis indicated a void volume of less than 2%.

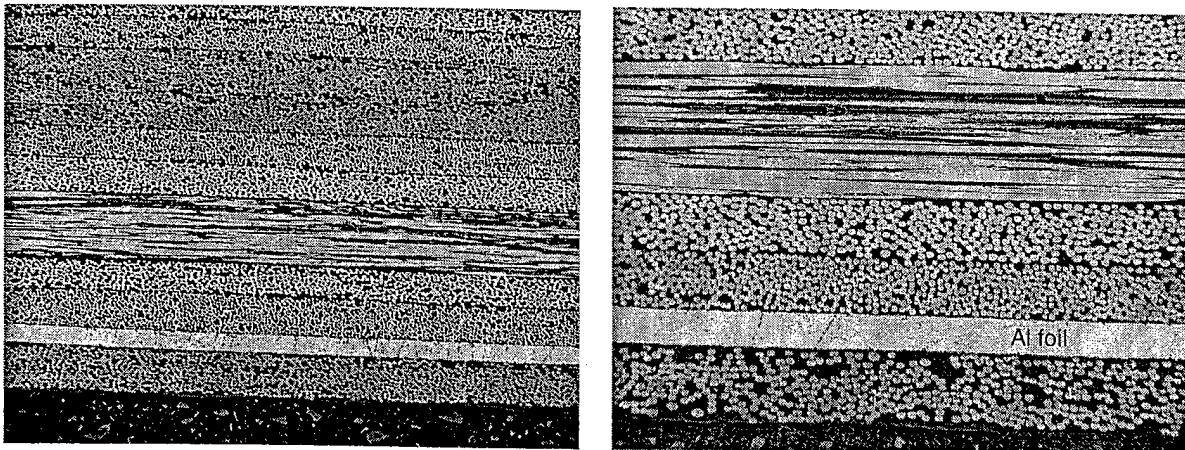
Figures 6 and 7 show cross-sections of sample 2. As shown, there appears to be consolidation and minimal porosity within the plies of this composite also. The aluminum-foil interface appears to be well bonded to the adjacent plies by the matrix material. No indications that would result in decreased mechanical properties were identified.

Figure 6. Cross-sectional optical micrograph of composite sample 2. (a) Shows good consolidation to aluminum foil in the structure; (b) shows low fiber content on outer ply.

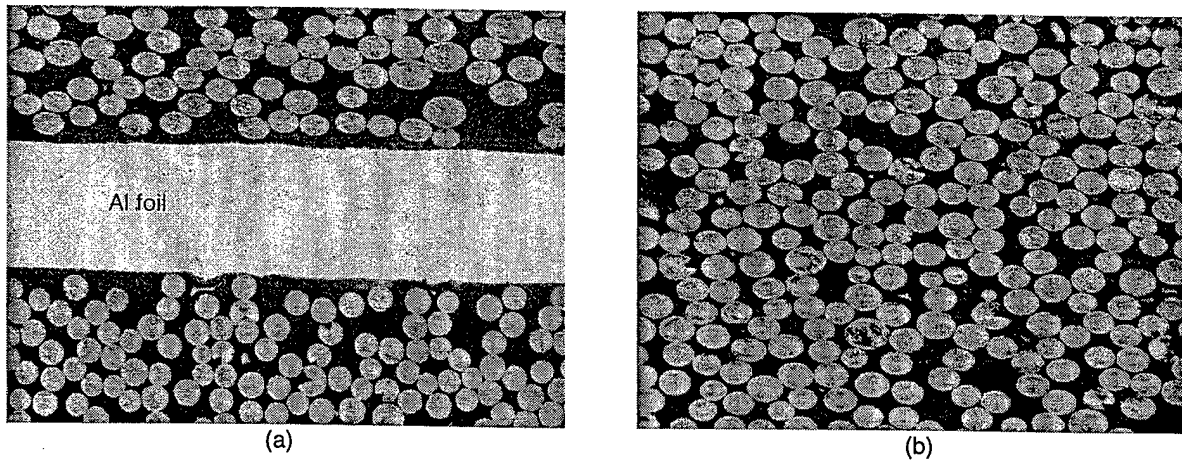
Figure 7. Cross-sectional optical micrograph of composite sample 2. (a) shows good bonding on aluminum foil in structure; (b) shows minimal porosity within plies.

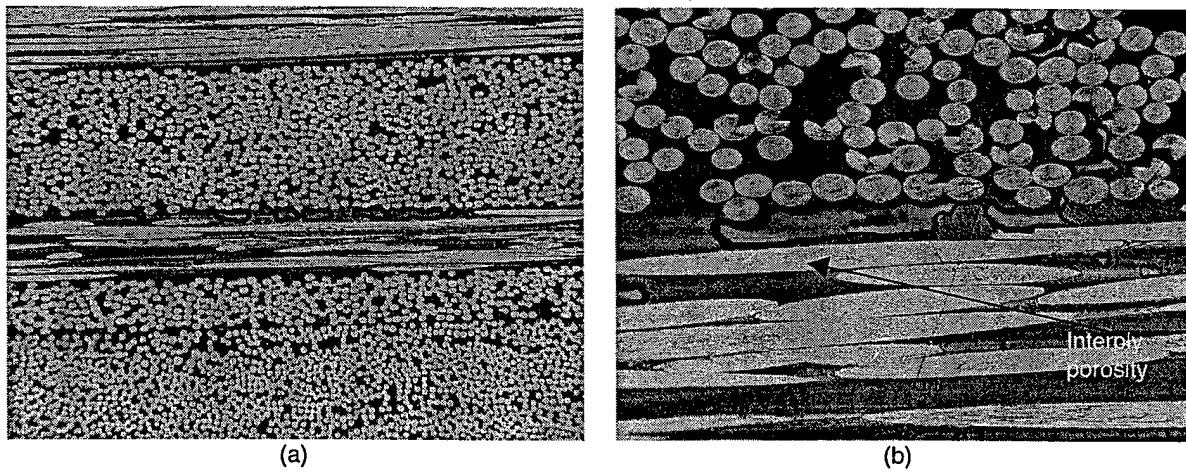
Optical micrographs of microstructural cross-sections of samples 3 and 4 are shown in Figures 8 and 9. Composite sample 3 appeared to have some pronounced porosity between the second and third ply. However, the porosity was limited to a fraction of the entire length of the sample. There were no indications of debonding between the foil layer and the adjacent prepreg. Composite sample 4 was notably different from the other specimens. Two aluminum layers were positioned in the mid-plane of the sample, in addition to the two foil layers closer to the sample surface. Sample 4 exhibited no other differences, which would raise cause for concern. Mechanical tests were then performed on the tag specimens to evaluate the failure mode.

Figure 8. Cross-sectional optical micrograph of composite sample 3. (a) shows good bonding on aluminum foil in the structure; (b) shows porosity within plies.

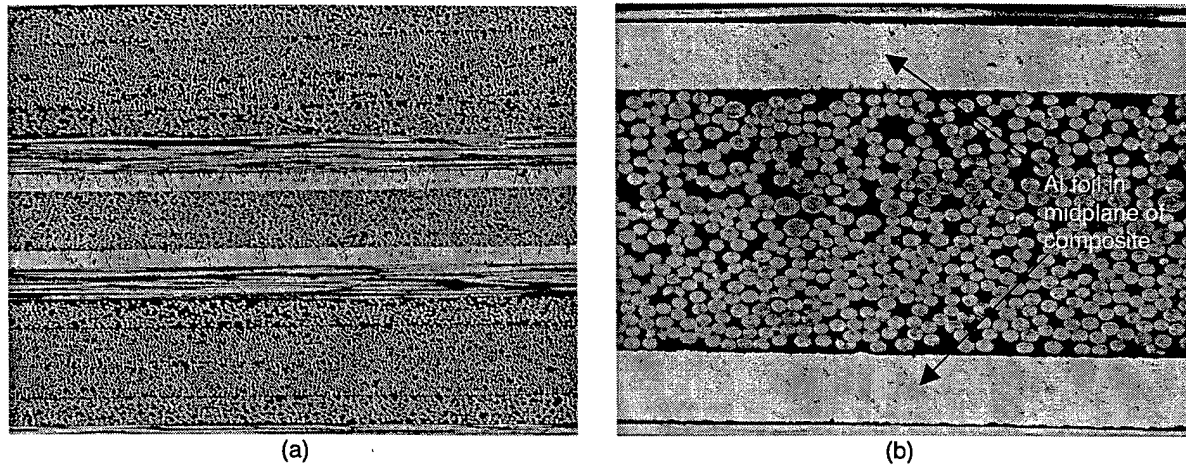
Figure 9. Micrograph of composite sample 4. (a) shows good bonding on aluminum foil in the structure; (b) shows minimal porosity within plies.

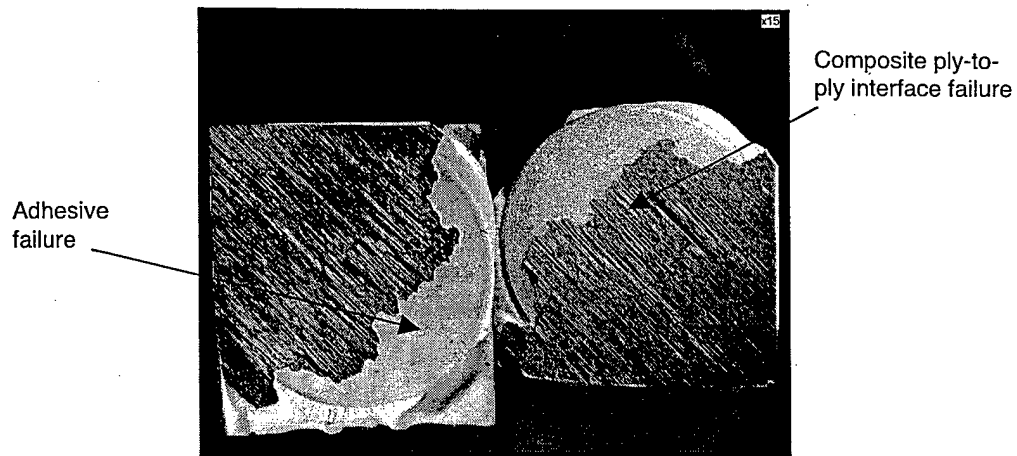
interply performance. The main reason for this testing was not to acquire mechanical strengths, but rather to determine where the failure was occurring. Figure 10 shows the fracture face for a typical flatwise tension specimen. This sample shows a mixed mode. Over 60% of the sample has failed within the composite, exhibiting a ply-to-ply separation. The majority of the failures occur within the first 3 outer plies. In this case, there appears to be some exposed metal from the aluminum plug. This indicates that some of the failure occurred at the interface between the aluminum plug and the bonding epoxy. An ideal sample failure would exhibit no such separation or adhesive failure. The failure load for this sample was somewhat decreased due to this separation. The other 3 specimens exhibited complete ply-to-ply separation.

All of the materials and processing issues appeared to be fine; therefore, the focus of the lower-than-expected strengths was placed on the test laboratory subcontractors specimen preparation procedure. The contractor was notified of our results, and we asked about the failure mode being experienced by the majority of the samples. Only one of our samples out of all of the lots exhibited an aluminum foil to composite separation. The subcontractor analyzed the failed samples and observed that the majority of the failures were actually occurring on the outer surface between the bonding adhesive and the composite face. This failure mode is usually indicative of poor sample preparation. Lower-than-expected strengths would be expected from this type of behavior. In order to improve the bond and get the correct type of failure mode, the composite sample needs to be roughened considerably to ensure a strong mechanical bond with the bonding adhesive. In addition, the type of high-modulus, pitch-based carbon fiber used in this composite is prone to weaker bonding than lower modulus PAN-based fiber typically used. The contractor instructed the testing laboratory in correct sample preparation, and, thus far, all of the composite test specimens appear to be failing within allowable ranges and within the composite.

Figure 10. Fracture surface of sample 1, 2, 3, and 4 all appeared to fail within the composite.

- There appeared to be no issues dealing with the composite material investigated that would cause degradation in flatwise tension strengths. We suggest that the contractor investigate the sample preparation process that the laboratory testing subcontractor is using as well as verify the failure mode of all tested samples.
