# Cure Evaluation of Two Critical Composite Hybrid Flat Panels for use in a High-Dimensional Stability Satellite Application

20 July 2003

R. J. ZALDIVAR and R. CASTENEDA  
Space Materials Laboratory  
Laboratory Operations

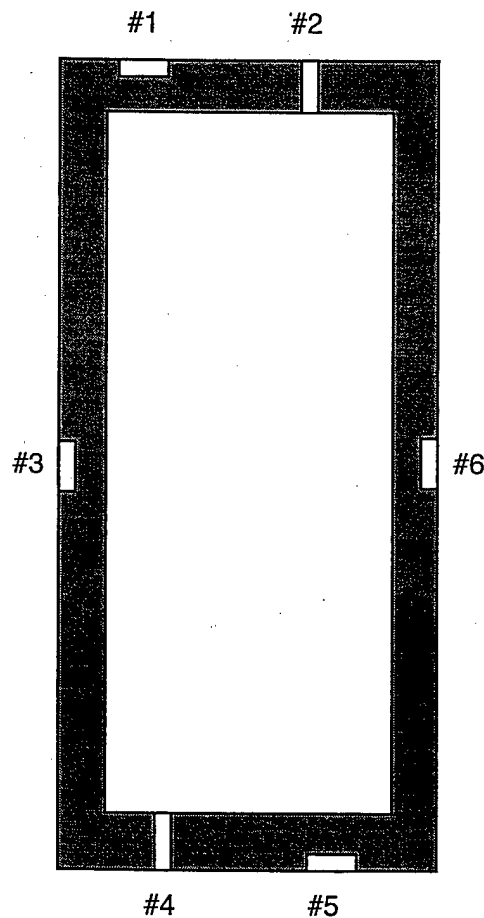
Figure 1. Schematic of composite panel tested in our investigation along with location of tag ends used for dynamic mechanical analysis testing. Gray area denotes problematic portion of laminate (window frame area) as evidenced by solvent wipe test.

The tag end samples were cut from the actual panels, as shown in Figure 1. The residue is believed to be concentrated on the outer 2 in. of the sample, similar to a window pane trace. Each of the tag end samples was tested using dynamic mechanical analysis (DMA). Each of the samples designated 1-6 was tested in two different modes. The entire thickness of the sample was tested, and only the outer few plies of specimens were also tested. Our previous studies have shown that contamination may be localized in the few outer plies, and measurements of Tg on the entire samples may be misleading unless severe degradation has occurred. Either way, if it is a surface effect or the entire sample has been affected, bonding onto this panel will make it prone to premature mechanical failure.

At this time, we don't know whether both panels were fabricated using the same lots of material. Flatwise tension tests should still be performed to ensure that good consolidation of the panel has occurred; however, the cure state is satisfactory, and we see no reason to discard Panel 2. To assure highest reliability, Panel 2 should be machined 1.0 in. from the outer perimeter to remove any contaminated material.

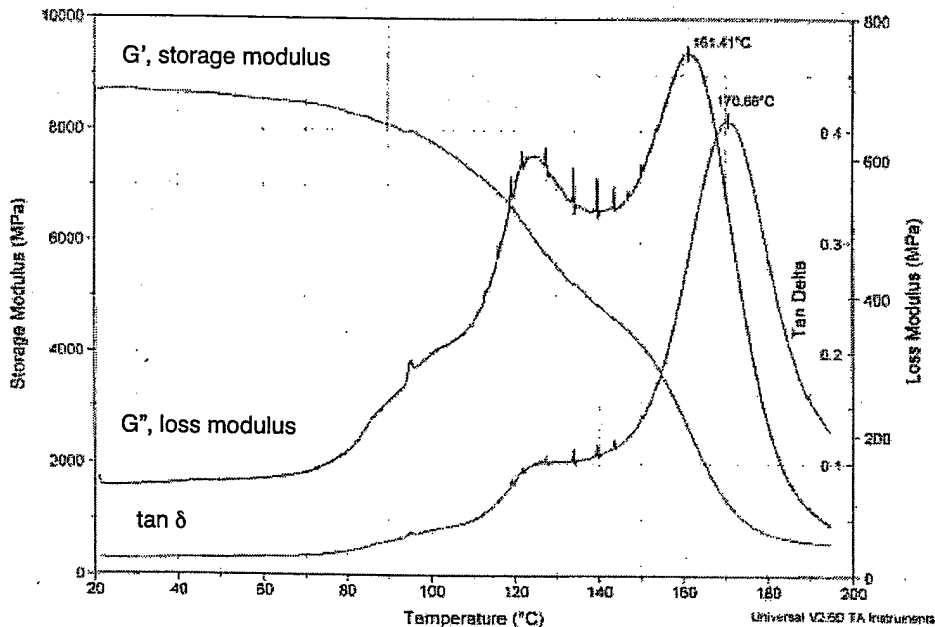
Figure 3 shows a DMA scan for panel 1. This scan shows the loss modulus as a function of temperature. Typically, the peak value for the loss modulus indicates the T<sub>g</sub>. This material should produce a single loss modulus peak centered at about 170–175°C. As shown, the loss curve appears to be a combination of a number of peaks. This is usually an indication of severe hydrolysis contamination. As shown, there is a shoulder at 100, a peak at 125, and one at 165°C. This scan describes a resin system that is not only undercured but has regions cured to varying degrees. In other words, portions of the network have cured significantly while others are only slightly branched. Upon heat-treatment exposure, the lower crosslinked areas of the polymer are easily softened and cannot resist thermal degradation. Not only is this polymer system only partially cured, the hydrolysis of the system creates a more linear, less compliant matrix material that is different in chemical structure than what was intended. This DMA scan indicates serious moisture contamination. Additional heat treatments would have no effect on advancing the resin further or improving crosslinking density. Samples from this panel were placed in a solvent batch for a specific length of time as described in a previous publication.<sup>2</sup> The system was observed to completely dissolve within 5 min. Well-cured systems will not dissolve, even after exposure up to 5 h.

Figure 3. Typical DMA scan of Panel 1 on the outside edges.

Table 1 shows a compiled list describing the measured Tg values for the many tag end samples from Panel 1. As shown and described previously, there are a number of multiple Tg values for each tag end. This indicates severe moisture contamination. Samples 2 and 4 represent areas of the panel 0.05, 1.0, and 2.0 in. from the outer edge. The Tg values increase as the samples move in a few inches from the outer edges. However, even at a 2.0-in. depth, the resin still appears compromised. A Tg value of 165°C for this resin has been shown in previous publications to be both mechanically and thermally affected. Tag-end samples 3, 5, and 6 indicate changes in Tg values from the edge of the sample to 1.0 in. from the edge into the panel. Again, the values indicate an increase in Tg, showing improvement, but significantly lower than a well-cured material. The samples (1, 3, 5, and 6) tested laterally around the perimeter of panel 1 were shown to be quite consistent. The entire panel appeared to be hydrolyzed to the same degree on the outer sections. The Tg data for this panel shows that this composite was severely affected during cure. Mechanical flatwise tension tests are currently being performed, and the contractor has stated that preliminary data shows a higher-than-expected degree of scatter and low strengths. Once the resin becomes hydrolyzed during cure there is no remedy to obtain full cure. The by-products created during hydrolysis prevent a well-crosslinked, fully cured end product. Multiple peaks in the Tg curves for most tag ends led us to recommend scrapping the panel. Other issues, such as severe microcracking, thermal expansion coefficients, moisture absorption and thermal capabilities, will be affected.

- We do not recommend using Panel 1 due to the severe degree of contamination that has occurred to the composite. Bonding to the surface of the composite may greatly affect mechanical performance. However, Panel 2 appears to be fairly well cured, especially 1.0 in. in from the outer perimeter. Panel 2 appears satisfactory for use with respect to its degree of cure. Additional, flatwise tension tests should be performed to evaluate variability and strength.

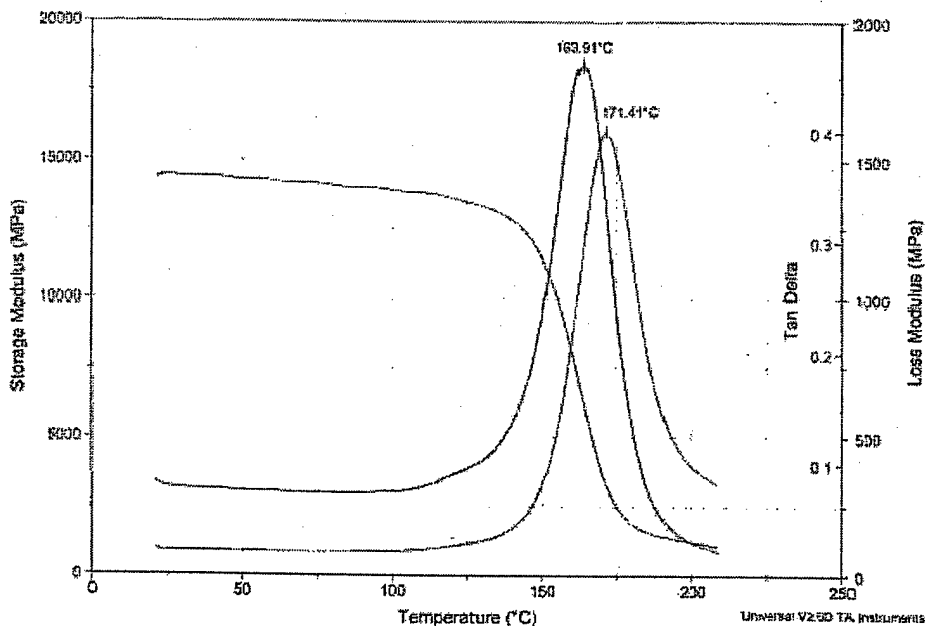
Table 2 shows a compiled list describing the Tg values for the tag end samples from Panel 2. As shown and in contrast to panel 1, all of the samples for panel 2 had only one single sharp peak for the loss modulus. The DMA scan shown in Figure 3 shows this loss modulus peak, which represents the glass-transition temperature of the material. Samples 2 and 4 represent areas of the panel moving in from the outer edge. As shown, the Tg values show a slight increase in Tg as we move into the bulk of the panel. The slightly lower Tg on the outer perimeter may be due to some hydrolysis of the polymer. However, the Tg values are all quite high and above the values that

Figure 4. Typical DMA scan of Panel 2 on the outside edges.

are indicative of a well-cured system. The other Tg values taken from the tag ends around the perimeter of the panel indicate minimal changes and that full cure has occurred. The overall cure state of Panel 2 appears to be sound. It is quite surprising that the state of Panel 1 is so degraded in comparison to Panel 2 since both panels were processed simultaneously.

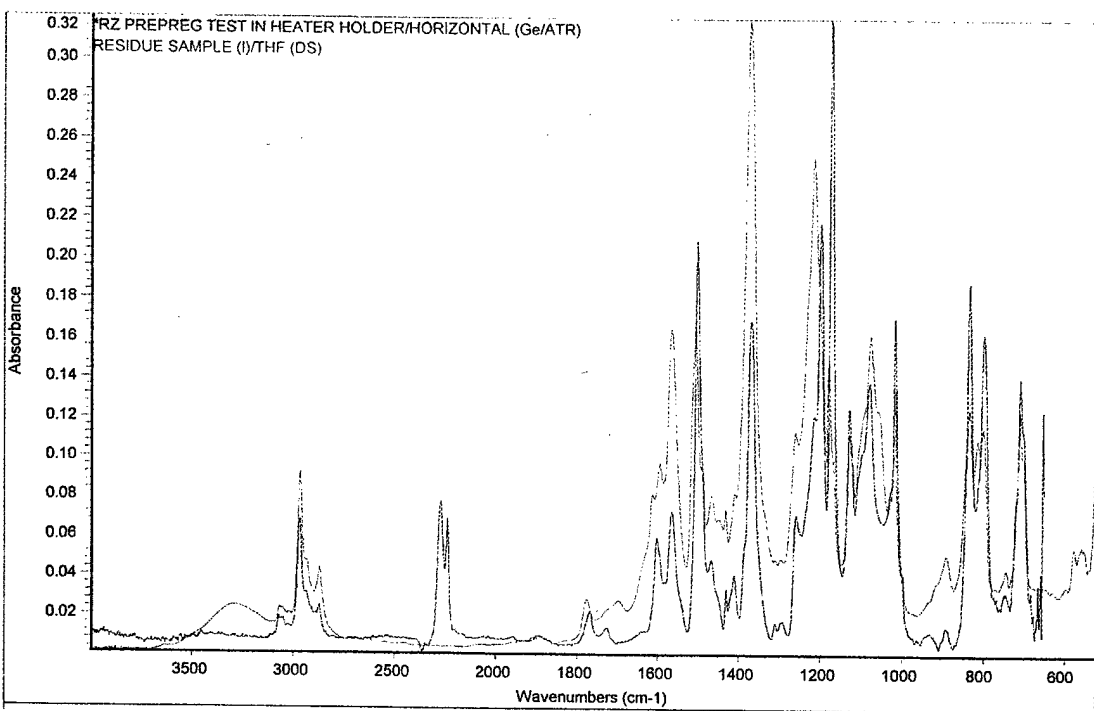
The third peak to focus on is located at approximately  $1750\text{ cm}^{-1}$ . This is a carbonyl peak that is usually indicative of hydrolysis of the cyanate ester occurring during the polymerization process. This type of carbamate contamination is the primary cause for large variations or decreases in the glass-transition temperature of the resin, even after heat treatment to high temperature. Figure 7 shows a typical FTIR with limited contamination.

Figure 7. FTIR spectra showing indications of limited moisture contamination during cure. Blue spectra shows uncured system to emphasize differences in spectra.
