NRL/MR/7130--03-8685

## **Preliminary Observations Regarding LDV Scans of Panels Excited by Broadband Actuators at the U.S. Capitol**

November 7, 2003

The following represents a short synopsis of several observations we have made regarding measurements made at the U.S. Capitol using a scanning LDV to map normal velocity of two panels when each was excited at one point by a broadband force actuator. The panels are identified as 6W1S (panel 1) and 6S1W (panel 2), the latter being what is called a pilaster. Regarding panel integrity, Panel 1 is

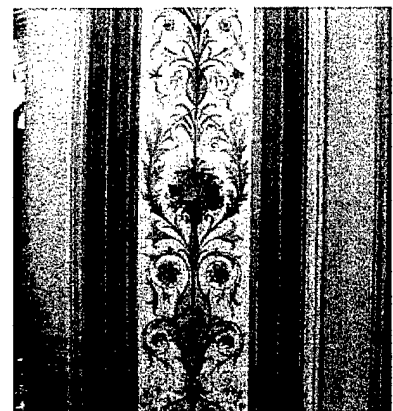
Figure 1 – “Pineapple” Panel

characterized as simple in the sense that tapping tests indicate defect areas that involve less than 10% of the total panel area. Panel 2, on the other hand, is more complex in that at least 50% of the panel area appears to have some defects. The scan density was every three cm for panel 1 and every one cm for panel 2.

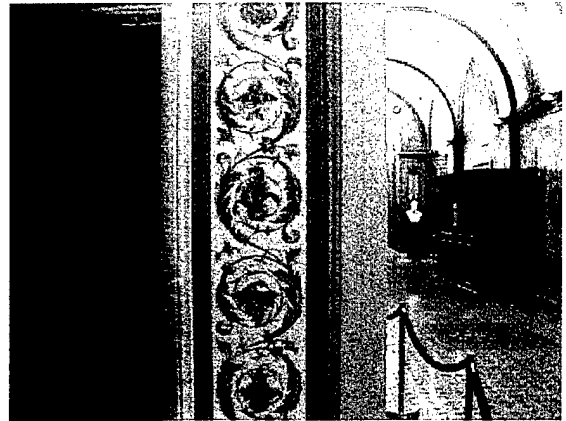
Figure 5 - "Eagle" Panel

Panel 2 (Fig. 5) is on what is known as a pilaster, a segment of the wall that protrudes rectangularly from the wall. Observation of the velocity phase plots (see Figs. 6a - 6l) indicates that we have obtained meaningful data on this panel 2 from about 500Hz to 6KHz. Generally, what appeared as simple wave motion (shear) in panel 1 can be seen again in the panel 2 data up to about 1KHz. However, the higher frequency panel 2 data which is available beyond 1 KHz begins to look more modal in character. However, the spatial mode structure still seems to be related to shear wavenumbers. As in panel 1, at the lower frequencies (below about 1KHz) a local patch with high mobility is readily seen against the long wavelength wave motion. However, as frequency is increased, it becomes more difficult to notice such regions because of the modal-like structure of the base panel motion. However, at some frequencies it is still possible to do so when the local patch motion reaches high enough velocity levels. This is the case, for example, at around 800Hz and 980Hz where a high mobility patch can be observed just in from the left panel edge at the vertical midline; between about 860Hz and 930Hz where both this patch and another below and just to the left of it can be seen; at about 1070 Hz, 1200 Hz, and 1290 Hz where in addition a second patch near the top can be seen; at about 1400Hz, 1500Hz, 1800Hz where this upper patch becomes isolated; and at five or so frequencies above 5 kHz where only a new, highly localized patch (about 2cm in extent) can be seen in the lower quadrant just right of the panel center. It may be fortuitous, but we can make a simple comparison between this result and that for the mobile patch seen in panel 1. In particular, the panel 1 patch is about 20cm in extent and first appears (resonates) at 420Hz whereas the panel 2 high frequency patch first appears at about 5.2 KHz and is about 2cm in extent. The ratio of the two frequencies is 12 which is close to the inverse ratio of their spatial sizes (10). This relationship would be expected for the resonance of two patches having identical thicknesses but different lateral extent.

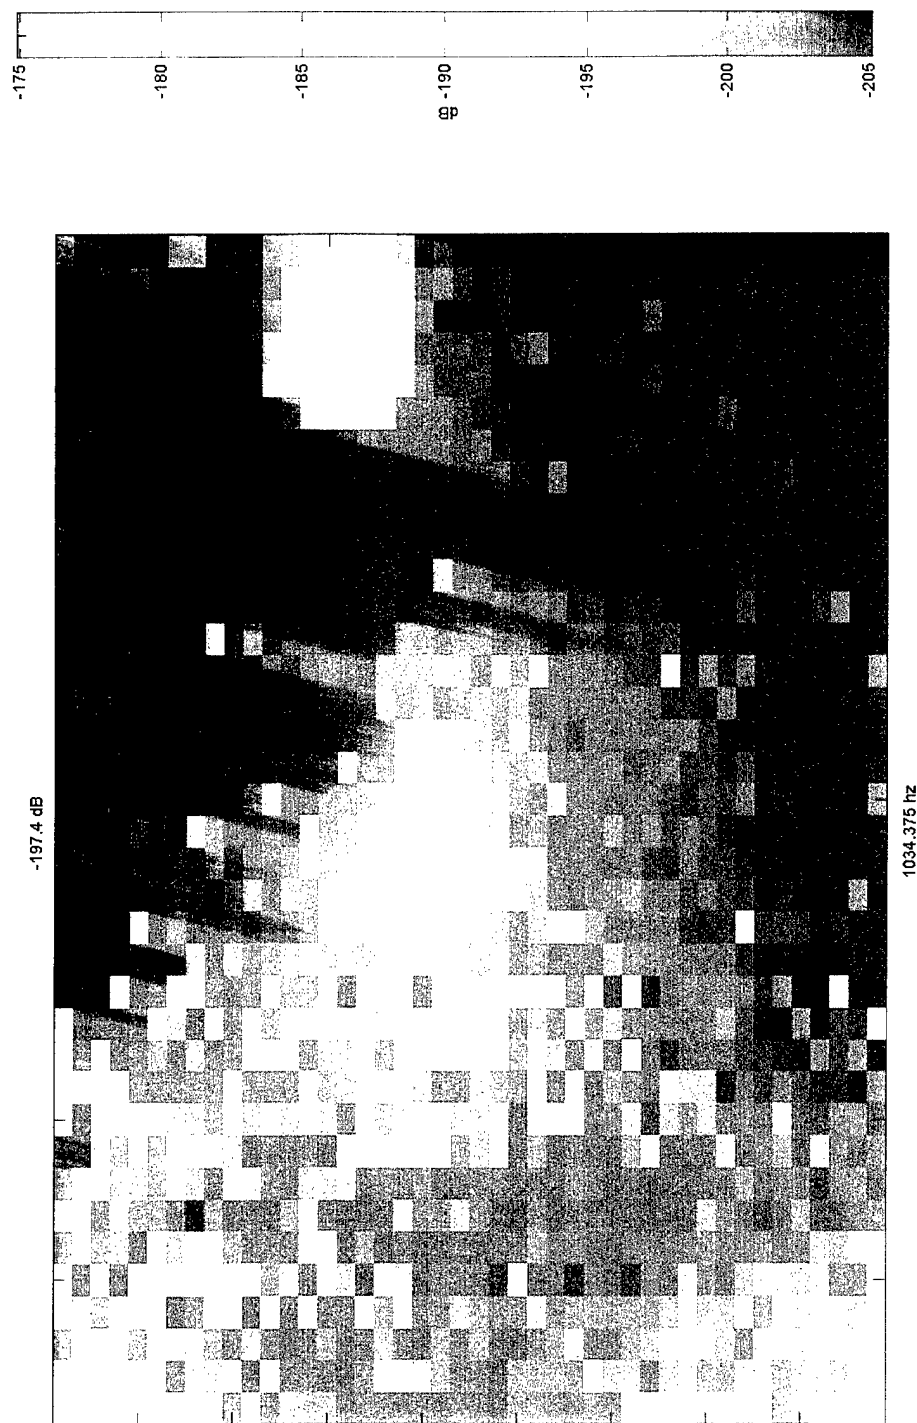
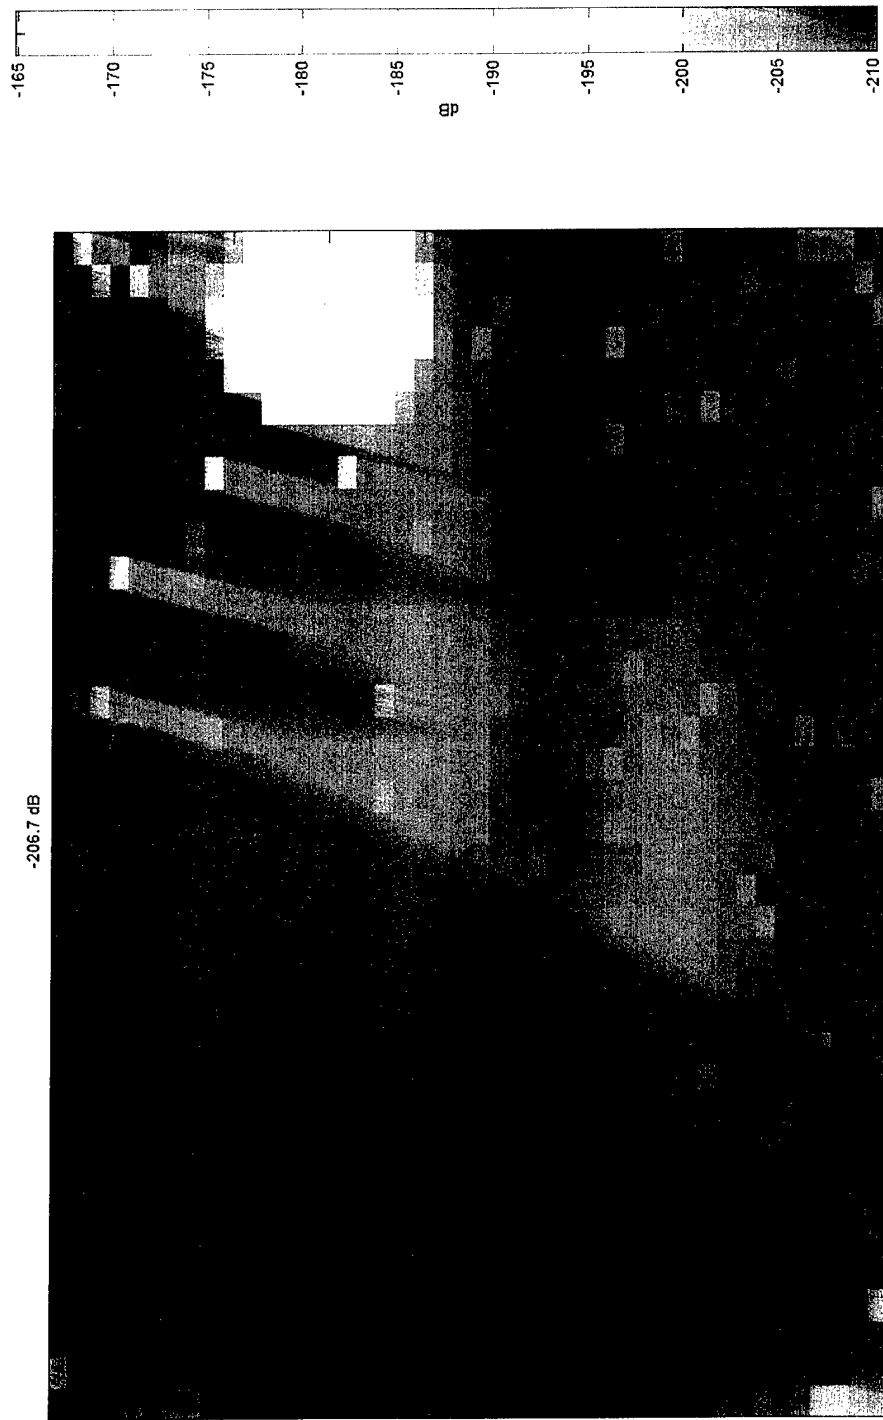
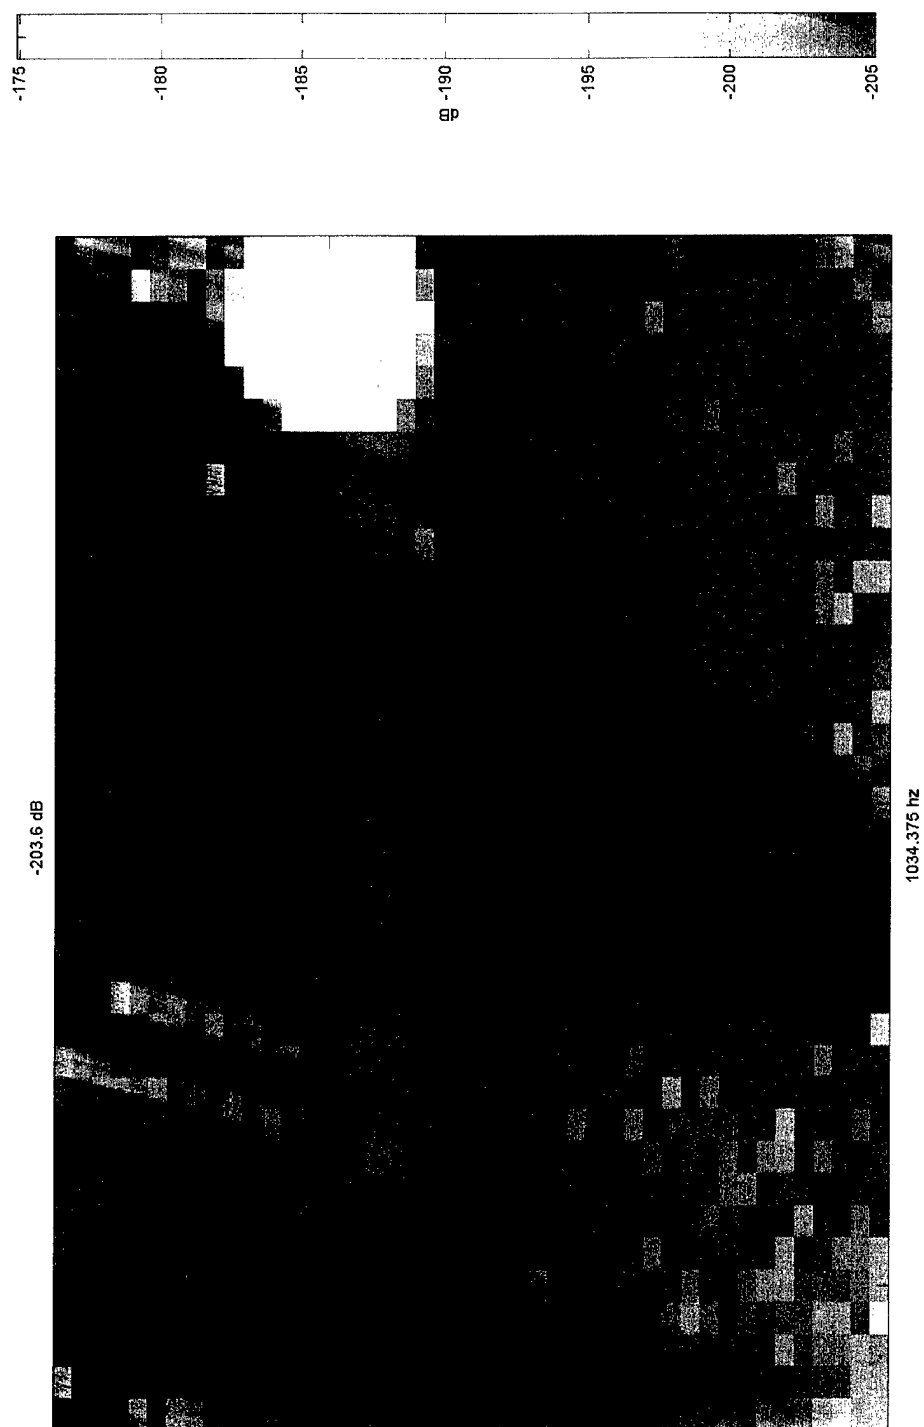
An attempt was made to combine the individual narrow-band scans into a broadband map. We did this by forming the sum over the frequency bands of the properly normalized quantity  $|VV^*|$  at each spatial point. The resulting maps are shown in Figs. 4a - 4c for the full band and two partial bands, respectively. In addition to the dominant mobile patch in the upper right previously discussed, there appears to be additional larger areas with levels lower by some 30dB. As can be seen in Figs. 4b and 4c, these seem to be dependent on frequency. At this point, we are not certain whether these broader features are actually related to increased mobility of the structure or a signal to noise related artifact.

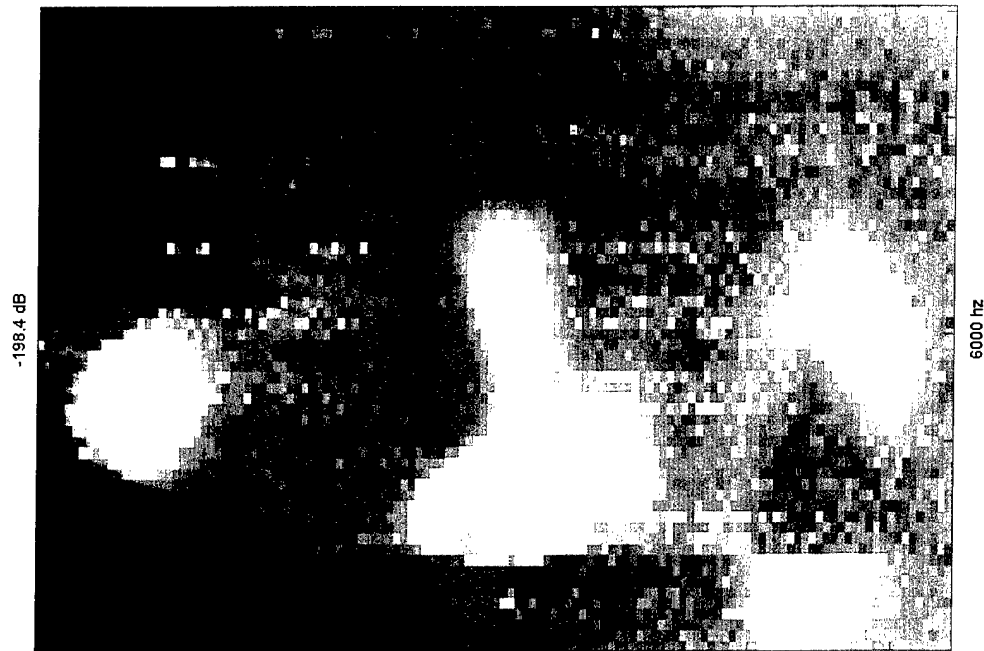
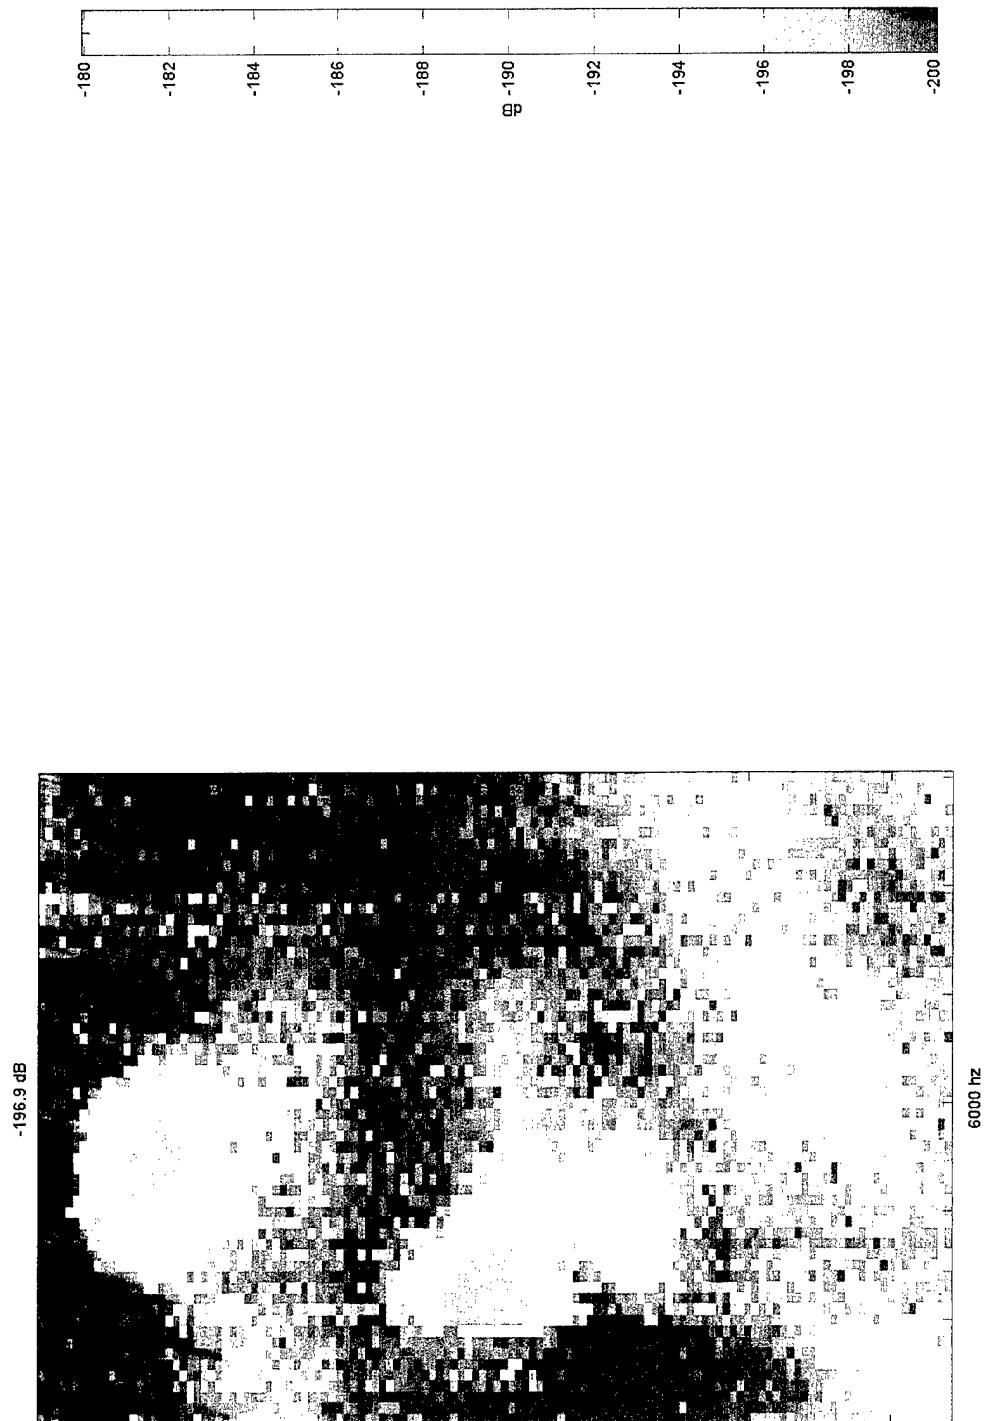
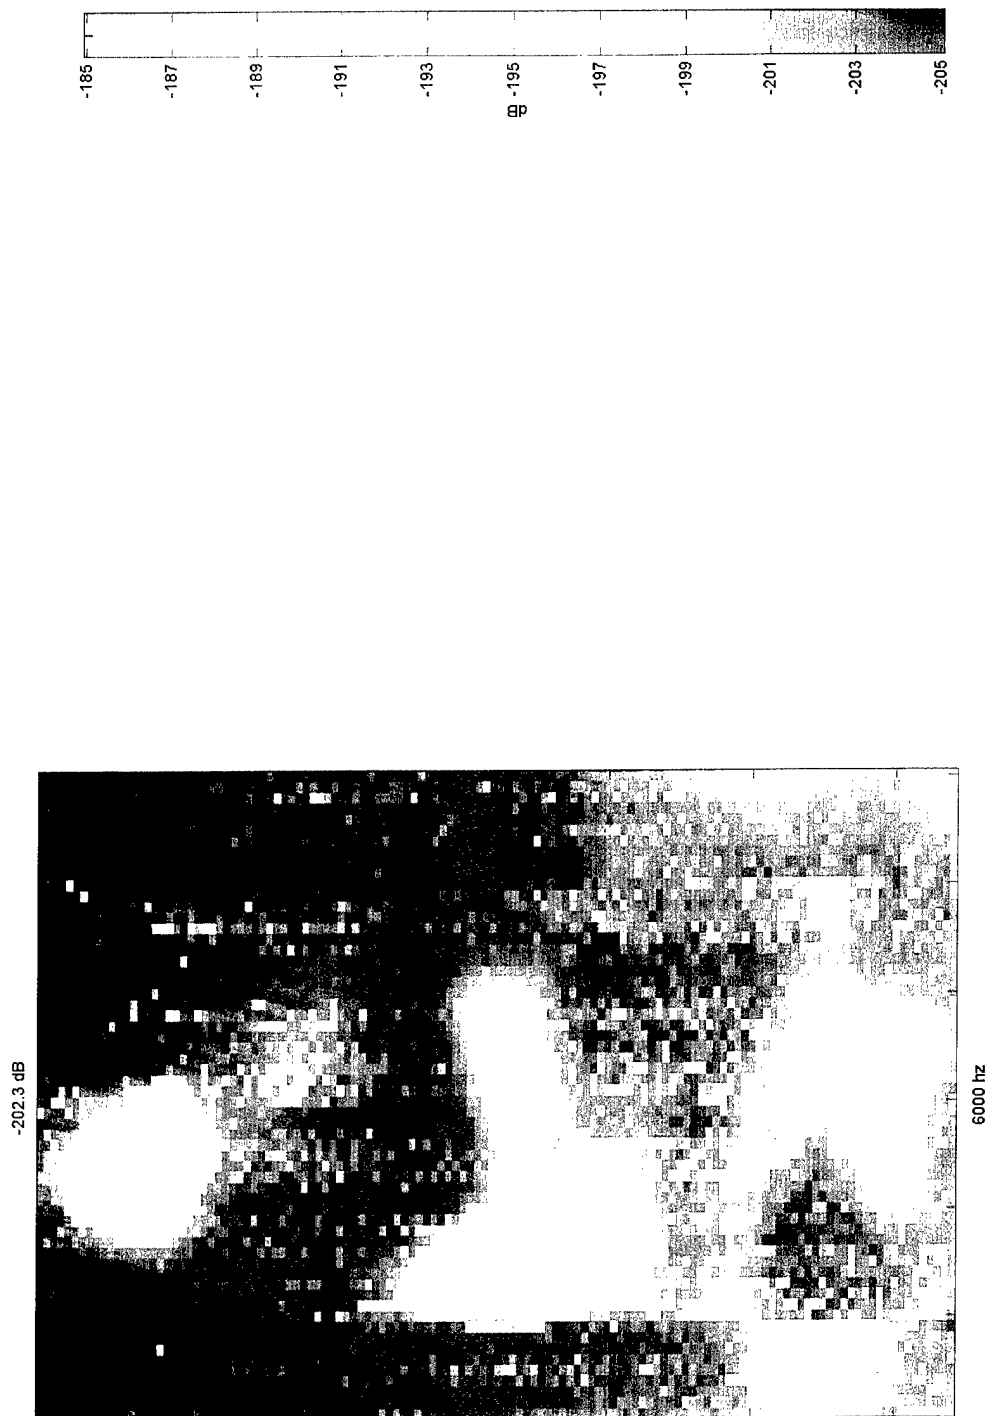
In Figs. 7a - 7c is shown the normalized  $|VV^*|$  quantity for three different bands at frequencies below 2KHz. The above mentioned features for these frequencies now appear even more pronounced, presumably due to the frequency

averaging (and thus smearing) of the background modal structure of the panel. There also now appear three other mobile patches, one at the panel center, one below that point near the bottom, and one just below and to the right of the second patch from the left. Finally in Fig. 8 is shown the normalized  $|VV^*|$  quantity for the entire band, 770Hz to 5KHz. Here all of the above features can be seen. This figure seems to indicate a total defect area of about 30-40%, a number consistent with the 50% level estimated with the tap tests. In addition, the broadband motion now clearly reveals two vertical discontinuities, the sharpness of which suggests they are connected to the structural design of the panel.
