ERDC/GSL TR-03-24

## E-Krete™ Polymer Composite Micro-Overlay for Airfields: Laboratory Results and Field Demonstrations

November 2003

Final report

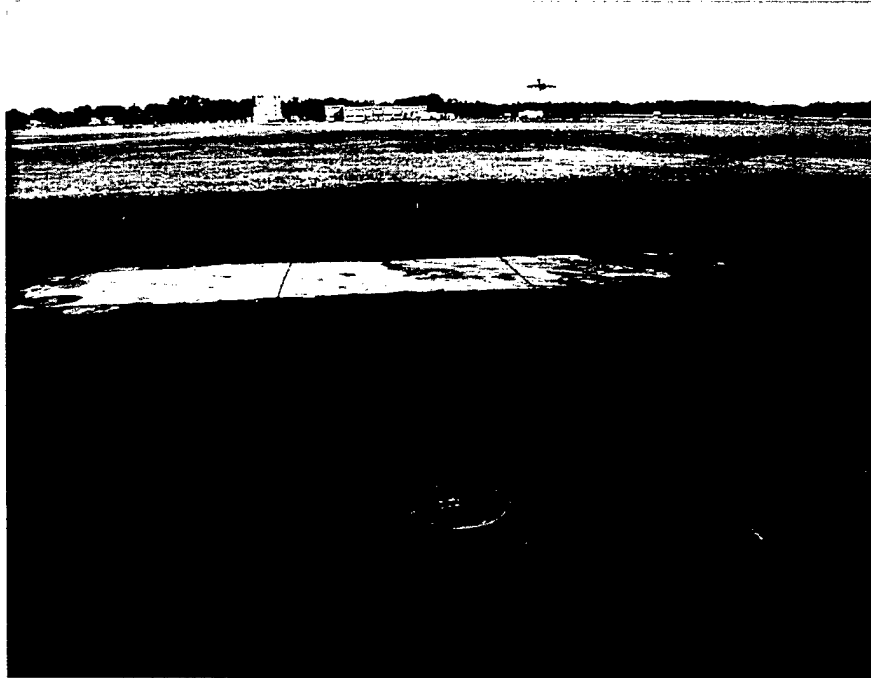
Figure 12. E-Krete and PermaStripe at Norfolk Naval Station. Note the severe hydraulic fluid staining around the concrete island. This area has been used repeatedly for servicing aircraft

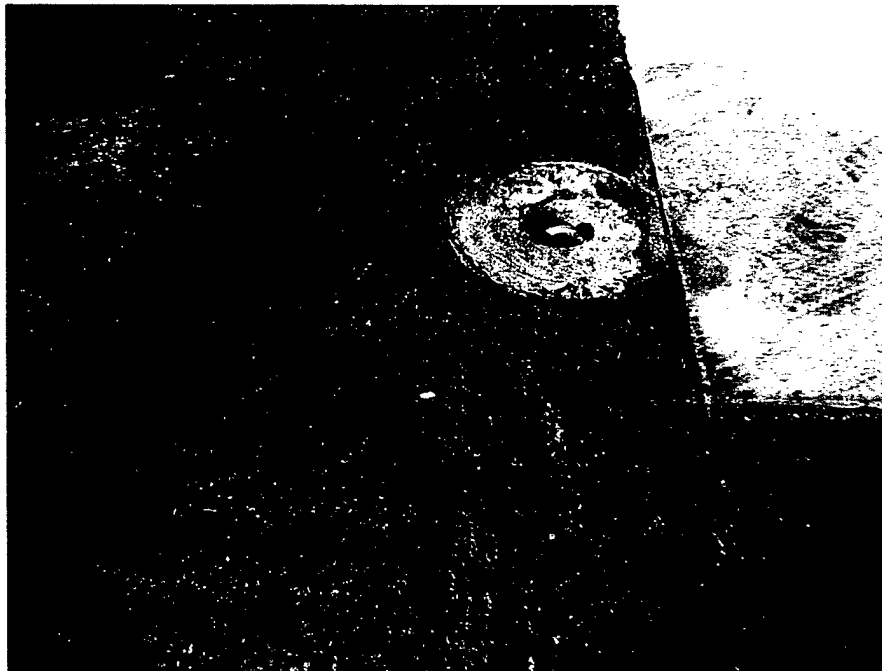
Figure 13. Closeup view of the E-Krete and PermaStripe at Norfolk Naval Station. The hydraulic fluid is literally pooled around the PermaStripe tie-down. Some delamination of the PermaStripe has occurred because of the ingress of hydraulic fluid under the surface of the PermaStripe where the asphalt and concrete meet

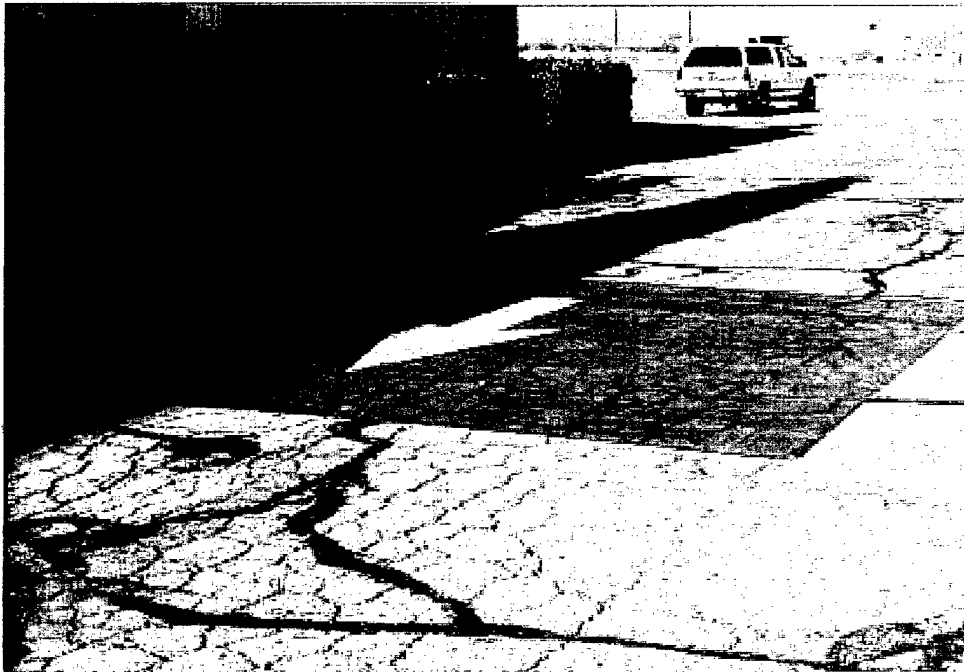
Figure 14. E-Krete and PermaStripe at Edwards AFB. Note the severely cracked asphalt surface upon which the E-Krete was placed. Although many of the cracks have reflected back up through the E-Krete, it is in much better condition than the asphalt with virtually no raveling, unlike the surrounding pavement

The condition of the E-Krete™ was excellent aside from the reflective cracks from the underlying asphalt. The reflective cracking is excessive but no distresses related to the E-Krete™ were noted. Some minor raveling from the crack faces had occurred where there is noticeable unevenness in the substrate and in areas where the underlying asphalt cracks were about ½ in. wide. Some cracks have also reflected through the white arrow. The color of the E-Krete™ is darker than the surrounding pavement and is holding the color well. There is a white arrow of PermaStripe™ in the middle of this section that was placed directly on top of the E-Krete™. This section receives car and light truck traffic only. Frictional resistance was not measured since traffic was present during the inspection. Adhesion tests conducted on the E-Krete™ section pulled up the underlying asphalt.

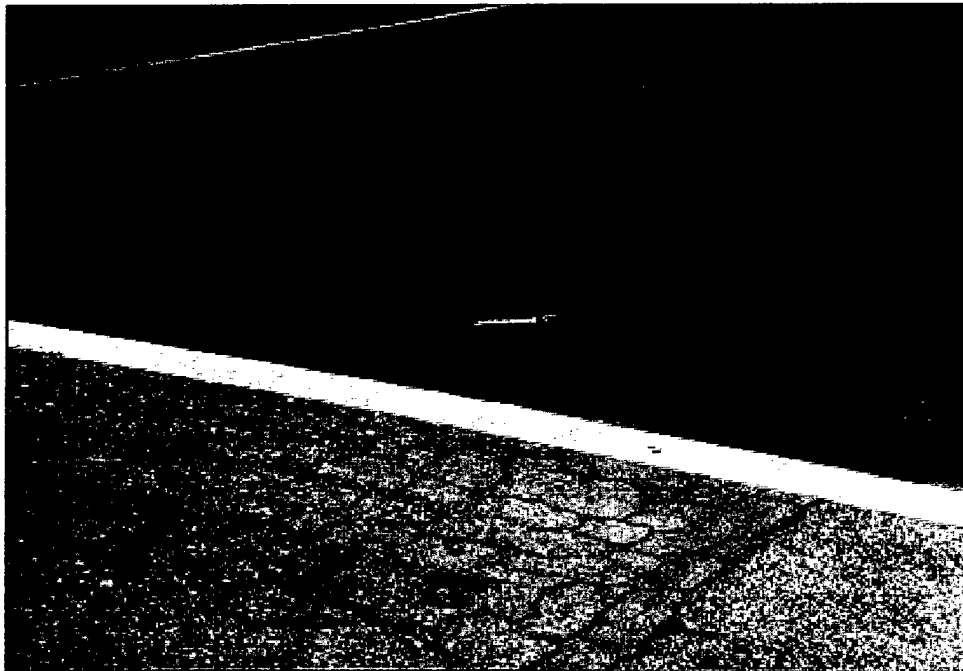
The overall condition of the pad is better than the surrounding pavement. A white discoloration is noticeable on the E-Krete™, in areas adjacent to hairline cracking. A similar condition was noted on one of the E-Krete™ sections at Forbes Field. There were only a few areas where raveling had occurred from the crack faces and these were in areas with large underlying cracks. Generally, most of the cracks vary from hairline up to 3 mm (1/8 in.). The largest cracks are up to 6 mm (1/4 in.) wide. These types of cracks, while widespread, did not cover the entire pad. The yellow center strip did not appear to have cracks and is holding color well with little apparent fading. All of the cracks were reflecting up from the underlying asphalt.

Figure 16. E-Krete and PermaStripe at North Island NAS. Note the severely cracked asphalt surface upon which the E-Krete was placed. Although many of the cracks have reflected back up through the E-Krete, it is in much better condition than the asphalt with virtually no raveling, unlike the surrounding pavement

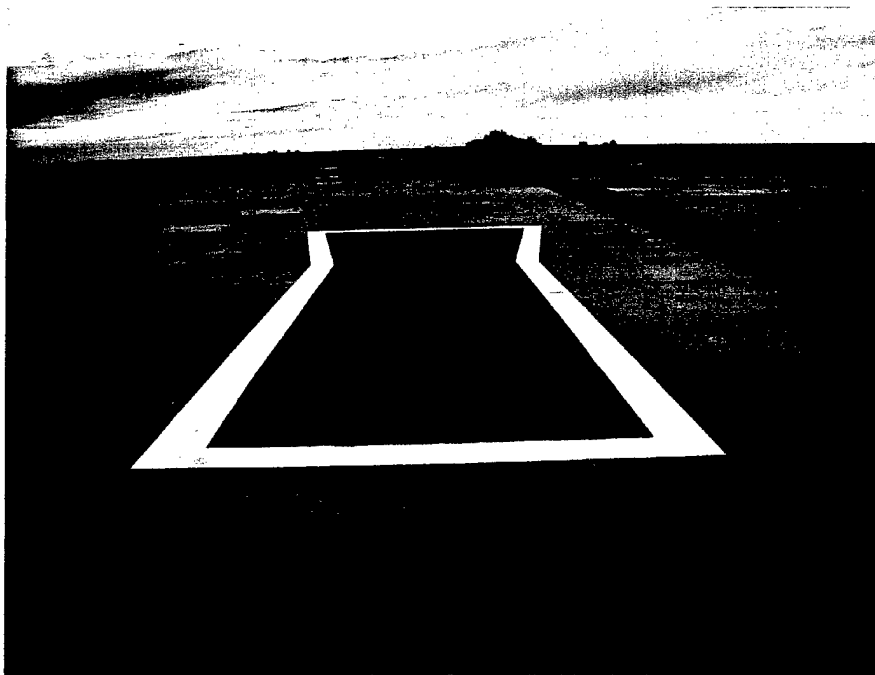
Figure 19. "Red Carpet" area in November 2000. Some fading of the red has occurred and reflective cracks are present, but overall, this section is in excellent condition

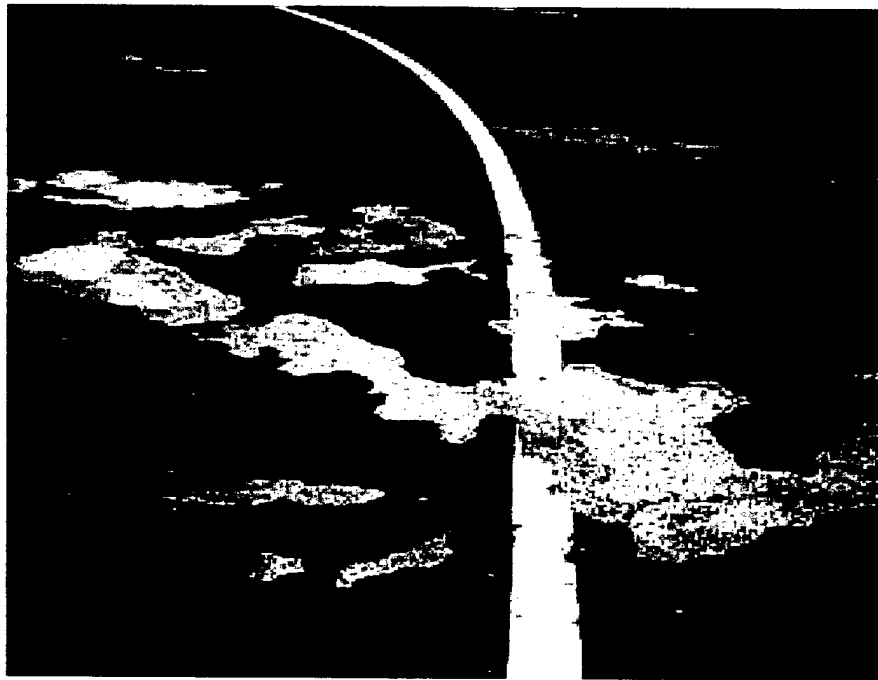
Figure 21. Severe delamination of existing coal tar surface (prior to E-Krete application)

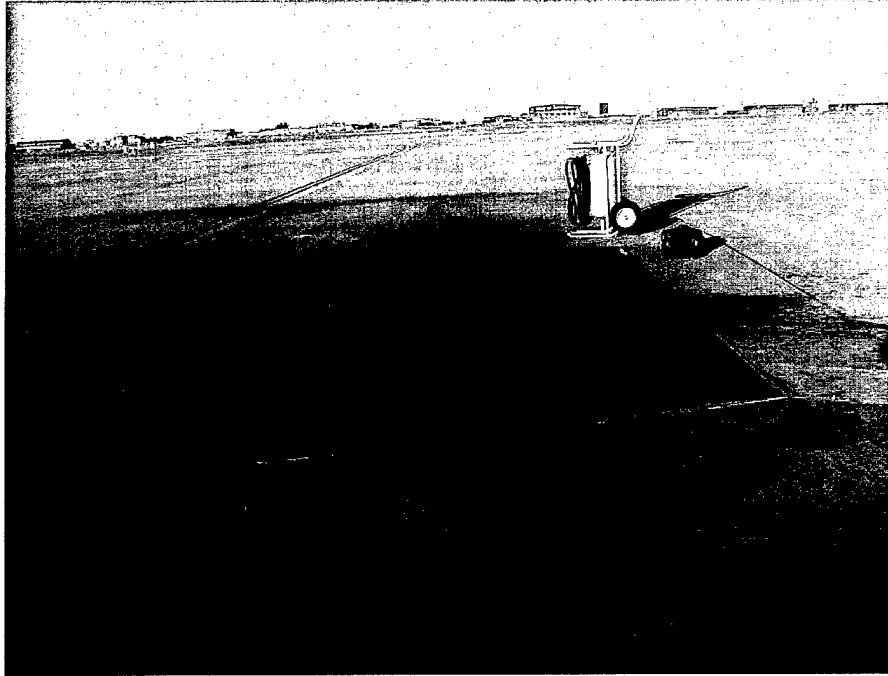
In November 2000, a detailed inspection of the B-1B pads was conducted. The overall condition of the E-Krete™ was described as good. Approximately 10 percent of the E-Krete™ surface has delaminated, with severe staining from hydraulic fluid. In pads B10 and B12 the E-Krete™ had turned rubbery. This rubbery condition is resulting from swelling of the polymer within E-Krete™ by synthetic jet turbine fluid. The condition of the E-Krete™ on pad B11 (Figure 23) was better than B10 (Figure 24) and B12, but some rubbery areas were noted. Despite this condition, the E-Krete™ has prevented the aircraft fluids from causing serious damage to the underlying concrete substrate. Given that concrete replacement under the B1B aircraft generally occurred every 2 years, the performance of the E-Krete™ coating was considered highly successful. Delamination of the E-Krete™ occurred from poor adhesion resulting from existing aircraft fluids already present on the concrete and proceeded from the joints towards the center of the concrete slab (Figure 25). It is apparent that using E-Krete™ with a fuel-resistant top coating to prevent aircraft fluid ingress into the concrete is a viable and economical solution to prevent concrete damage under B-1B aircraft. Further use of the E-Krete™ product is planned at McConnell AFB in the fall of 2001.

Figure 23. Overall view of B1B aircraft pad B11 in November 2000. The E-Krete is completely soaked with hydraulic and turbine fluid and is in good condition

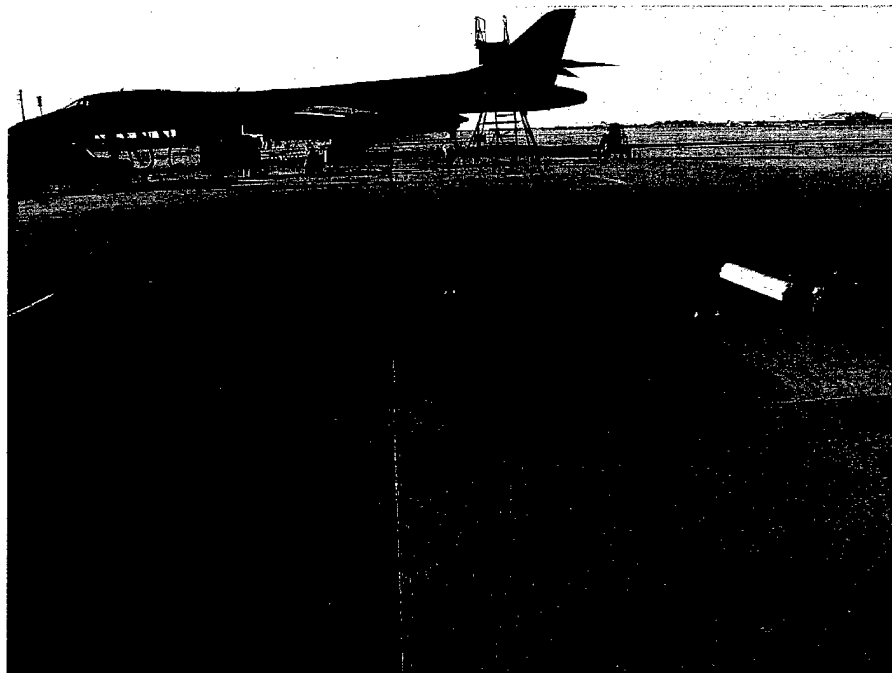
Figure 24. Overall view of B1B aircraft pad B10 in November 2000. As with B11, the E-Krete is completely soaked with aircraft hydraulic and turbine fluid and is in good condition.
