**Failure Analysis of an AH-64 Main Rotor Damper  
Blade Rod End, P/N 7-211411186-5**

**by Scott M. Grendahl and Marc S. Pepi**

**ARL-TR-3100**

**December 2003**

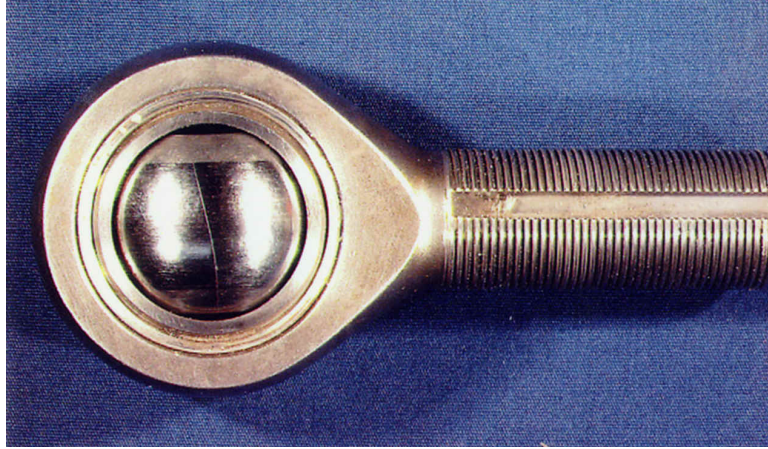
The failed part is shown in figure 2 in the as-received condition (approximately 1x magnification). The ball component of the assembly contained a “through” (i.e., complete) crack that was observed along the exterior as well as the interior (see figure 3). The body and the outer ring were sectioned by ARL in order to extract the cracked ball. Special care was taken not to damage the crack. Figures 4 and 5 show both halves of the cracked ball. One half of the ball, subsequently labeled “A” (see figure 4), was cleaned in an Alconox solution to remove the

**Figure 2. Failed component in the as-received condition (mag ~1x).**

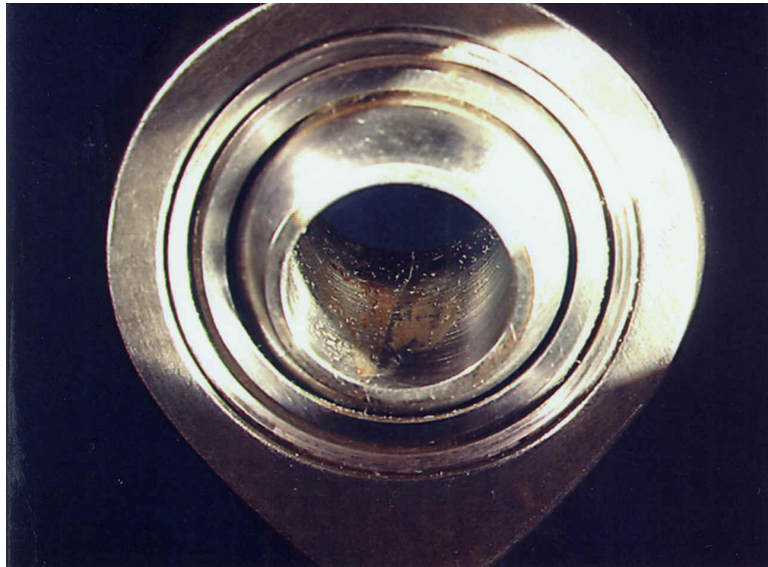
**Figure 3. Through crack visible along the interior bore (mag ~2x).**

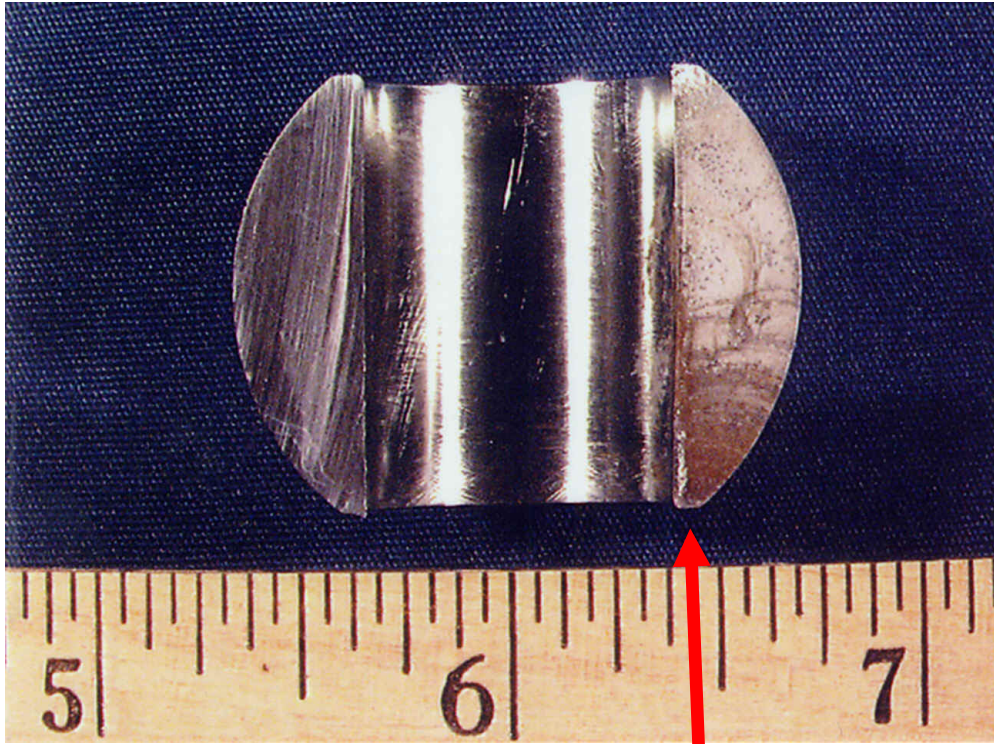
coarse corrosion products. After cleaning, evidence of beach marks (i.e., groups of fatigue striations) became apparent, as well as the fracture origin indicated by the arrow.

Figure 4. Fracture half "A" cleaned in an Alconox solution (scale in inches).

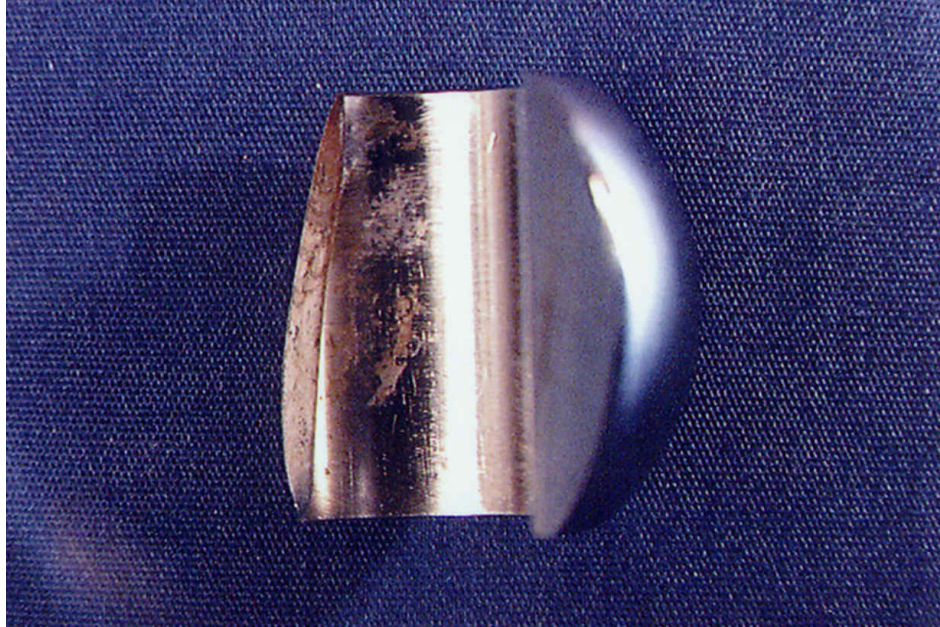
Off-axis views of the ball halves are presented in figures 6 and 7 to detail the corrosion observed along the internal bore of the ball near the through crack. This corrosion may have formed after the crack propagated entirely through the ball.

**Figure 6. Fracture half “A” showing corrosion along the inside bore (mag ~2x).**

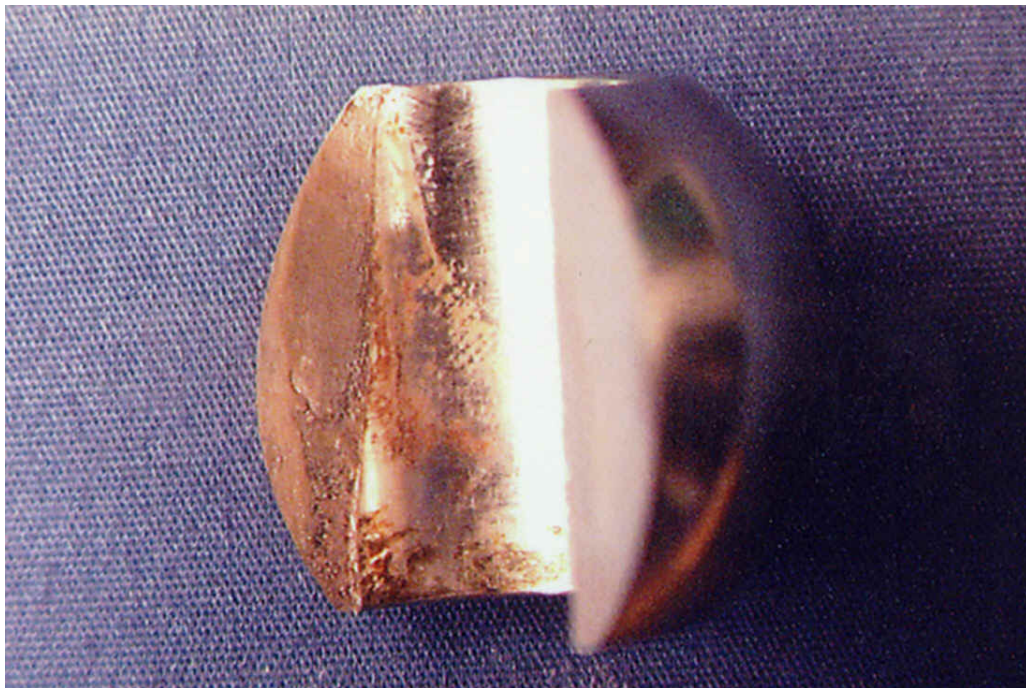
**Figure 7. Fracture half “B” depicting corrosion along the inside bore (mag ~2x).**

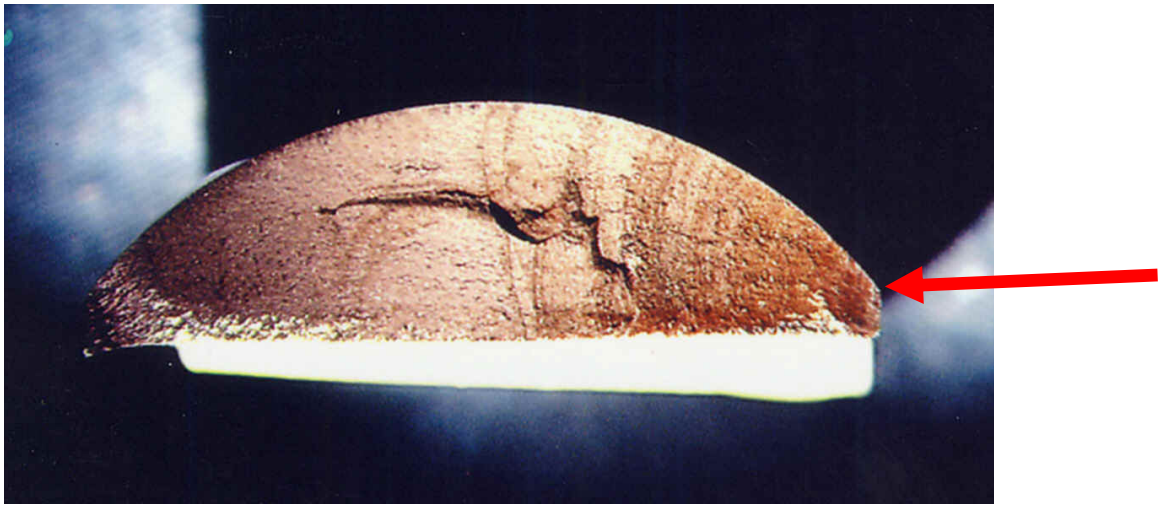
Figure 8 depicts the fracture origin from half “A”. Note the progressive, distinct beach marks emanating outward from the origin, which indicate fatigue crack propagation. The fracture propagated on a relatively flat plane until approximately one-quarter into the cross-sectional area

of the ball; thereafter cracking occurred on different planes. Separate distinct beach marks can be observed at the halfway point and again at the three-quarters position.

**Figure 8. Fracture half “A” detail, two distinct fracture planes (mag ~2x).**

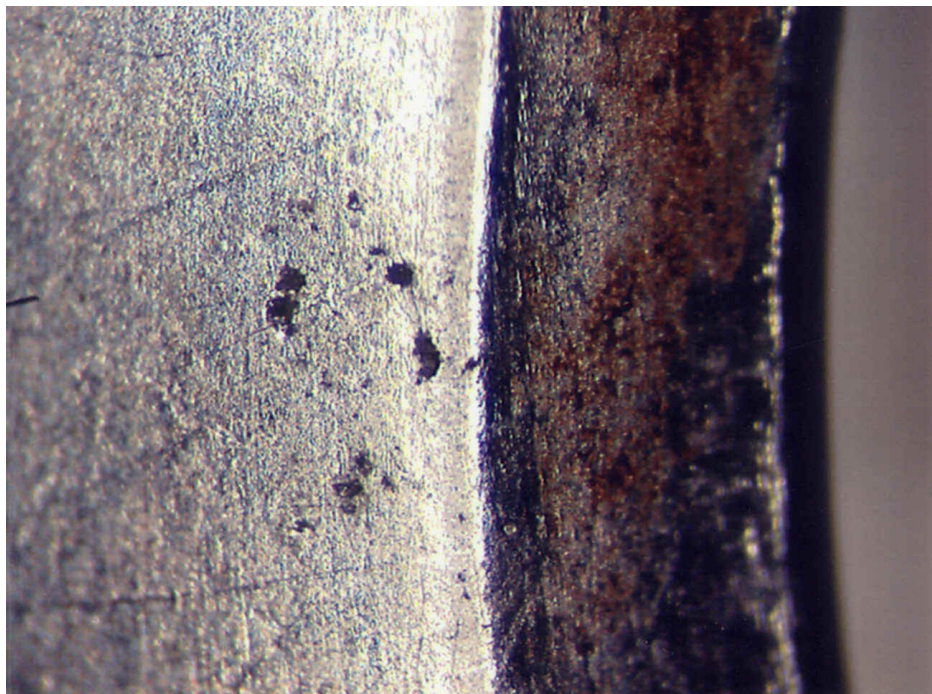
Further examination of fracture half “A” revealed numerous corroded areas, as shown in figures 9 through 11. The areas of attack were approximately 0.19, 0.04, and 0.01 inch from the origin. Figure 12 depicts the sites in figure 11 at higher magnification to show detail more clearly.

**Figure 9. Corroded areas near fracture origin (mag ~30x).**

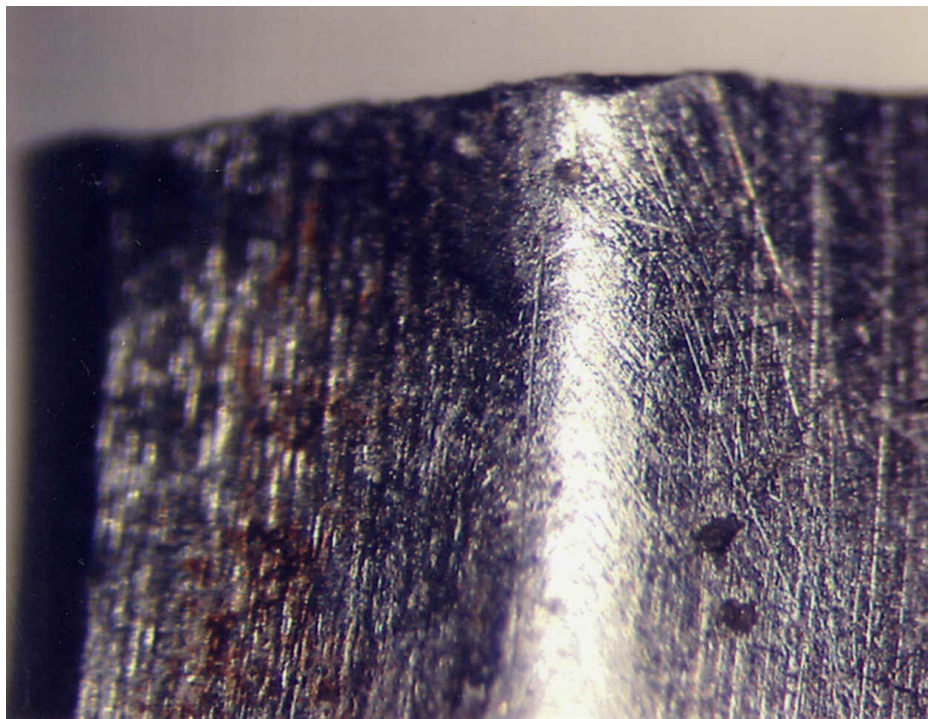
**Figure 10. Attacked areas near origin of fracture (mag ~50x).**

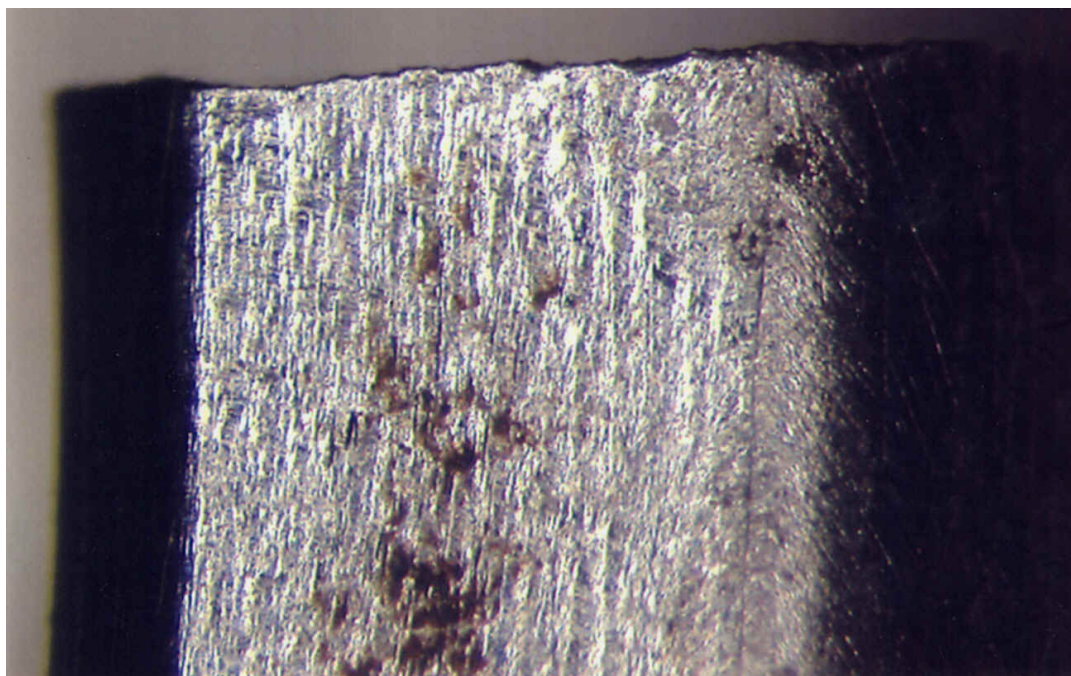
**Figure 11. Corrosion on chamfered edge adjacent to fracture plane (mag ~40x).**

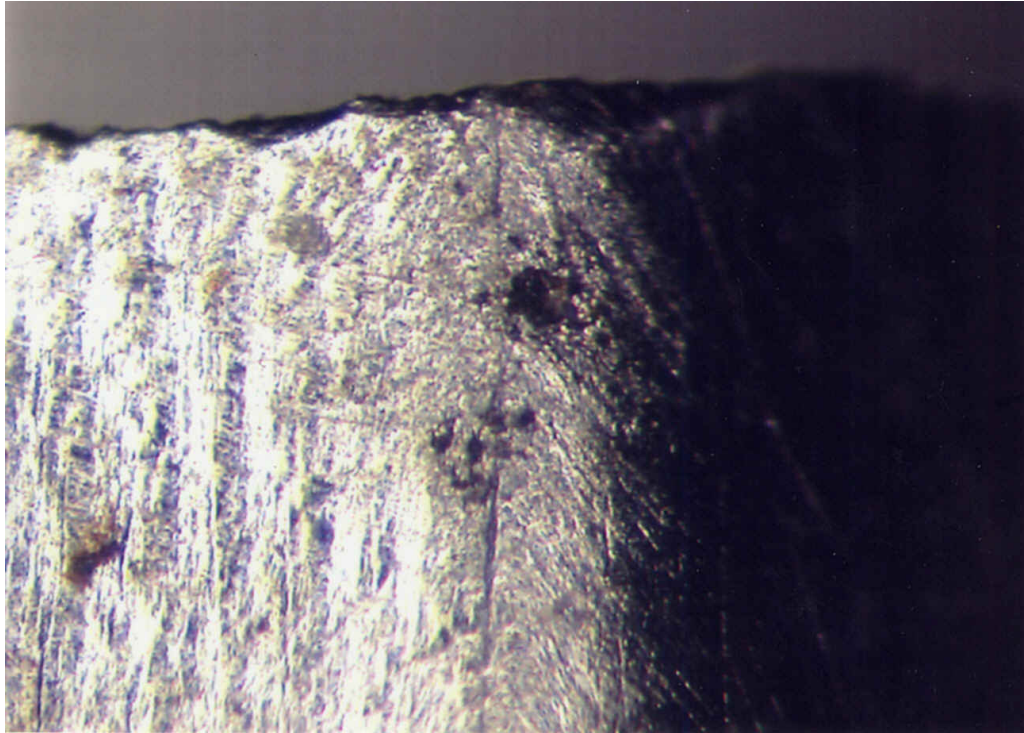
**Figure 12. Detail of Figure 11 showing localized corrosion near origin (mag ~100x).**

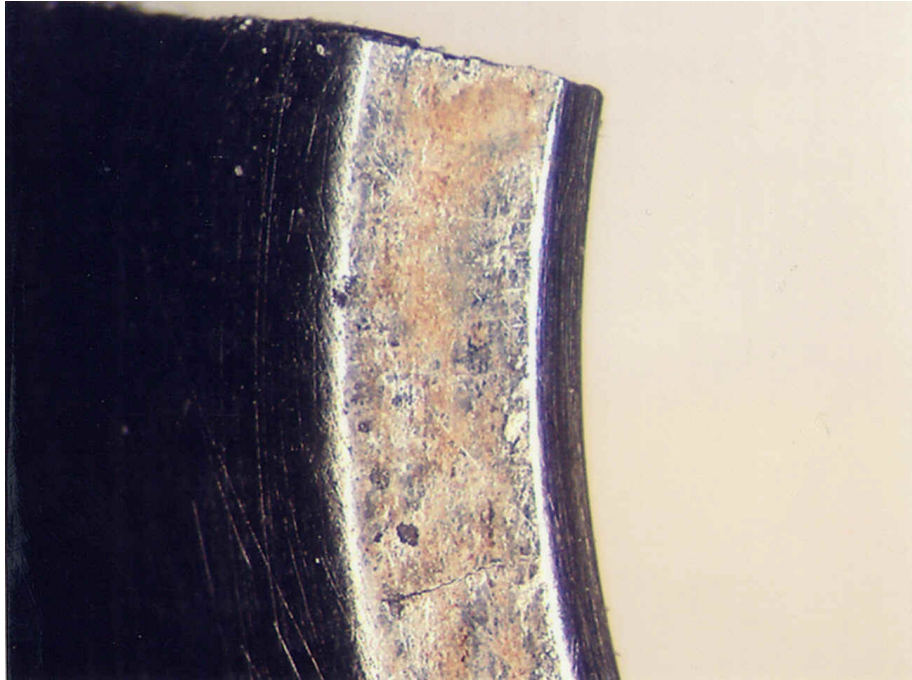
The corroded regions were uniform in neither size nor frequency. Light optical examination only revealed this condition on the exterior surface of the ball. The interior bored hole through the ball was noticeably void of these areas of corrosion. Less than 5% of the exterior surface of the ball contained corrosion. Examination of the “B” fracture half revealed similar features as those noted on half “A”. In addition, significant secondary cracking was observed, which ran parallel to the fracture plane. One crack was 0.21 inch from the fracture plane and was more than 0.125 inch long, as shown in figure 13. Figure 14 shows the presence of a slightly smaller crack adjacent to the crack shown in figure 13.

**Figure 13. Secondary crack noted adjacent to the fracture plane (mag ~20x).**

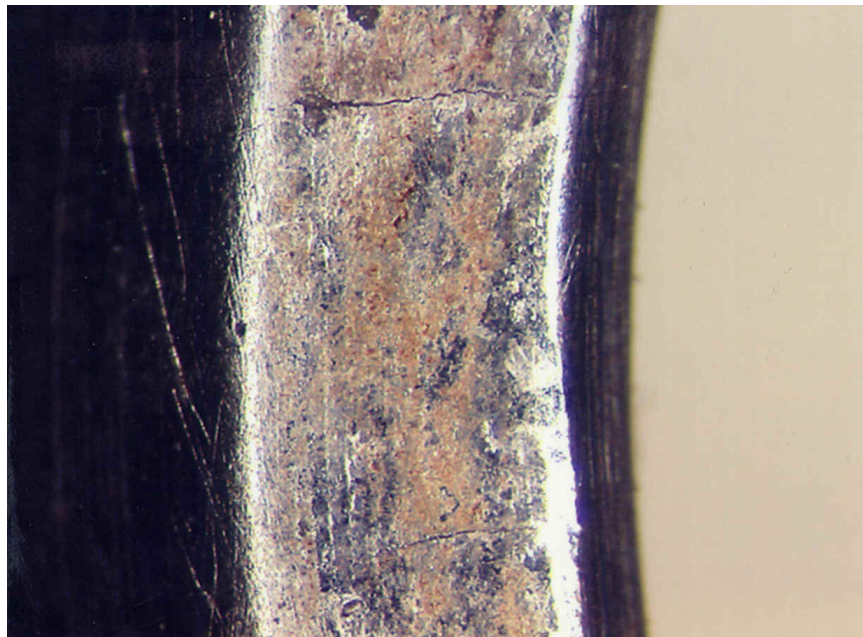
**Figure 14. Small secondary crack adjacent to fracture plane (mag ~30x).**

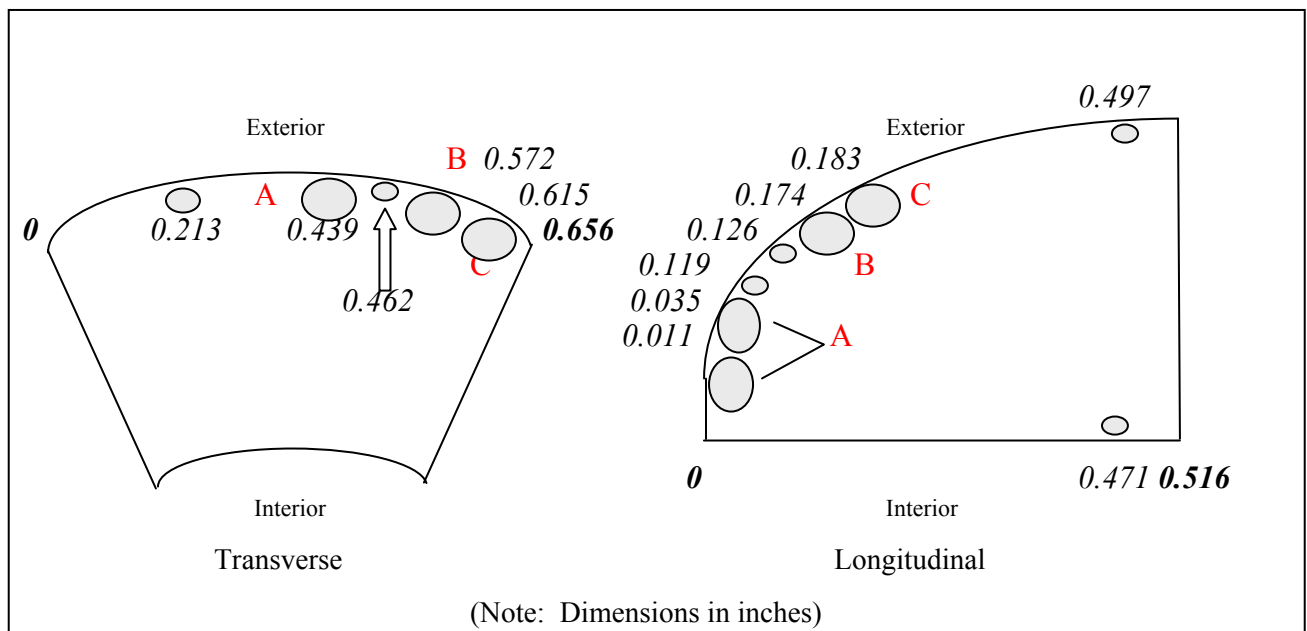
The specimens were examined in the as-polished condition. Localized regions of surface intergranular attack were noted in the areas shown in figure 16. The corresponding measurements were approximated with simple geometry. Except for one very small region on the interior of the longitudinal sample (see figure 16), each region of attack was noted on the exterior surface of the part. It was interesting to note that the bulk of the inter-granular regions observed on the longitudinal sample corresponded to the general location of the fracture origin.

Figure 16. Schematic of localized inter-granular attacked locations.

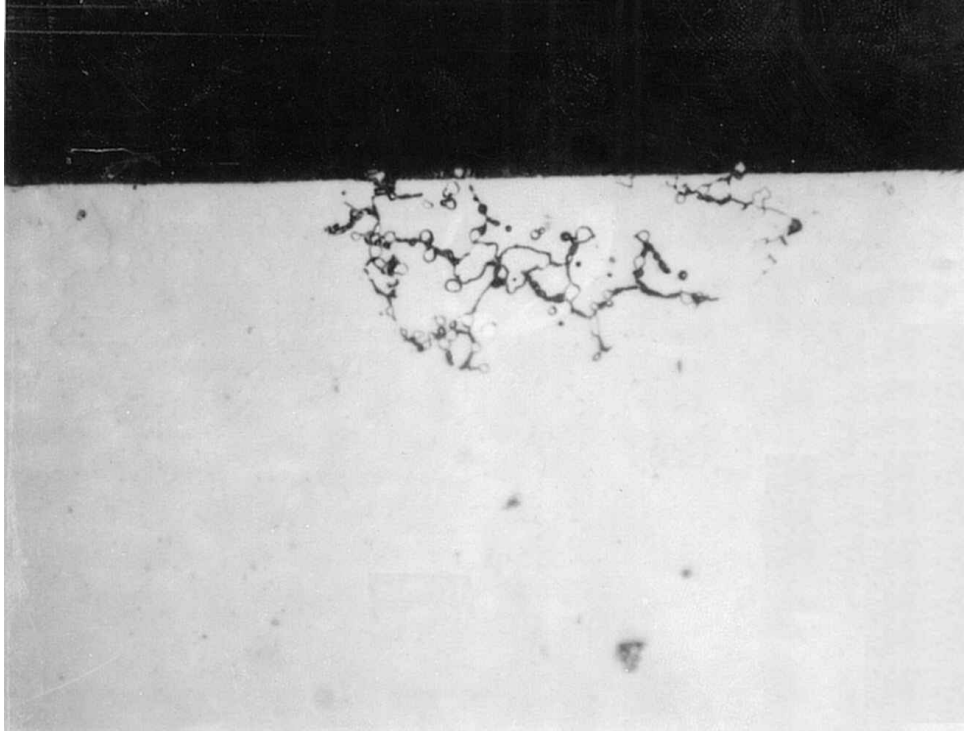
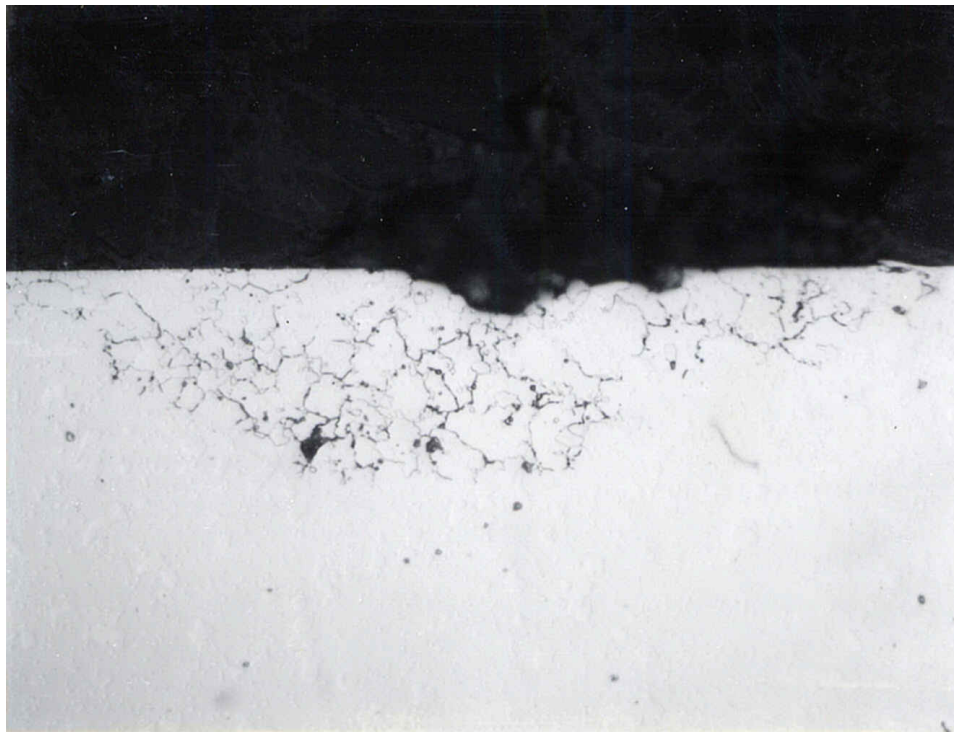
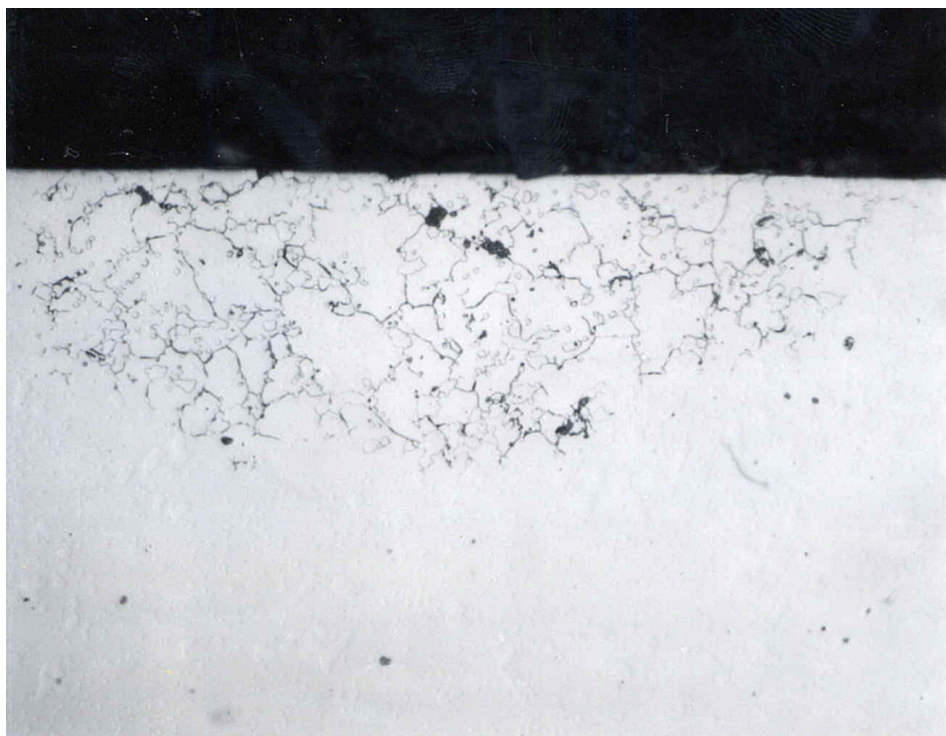
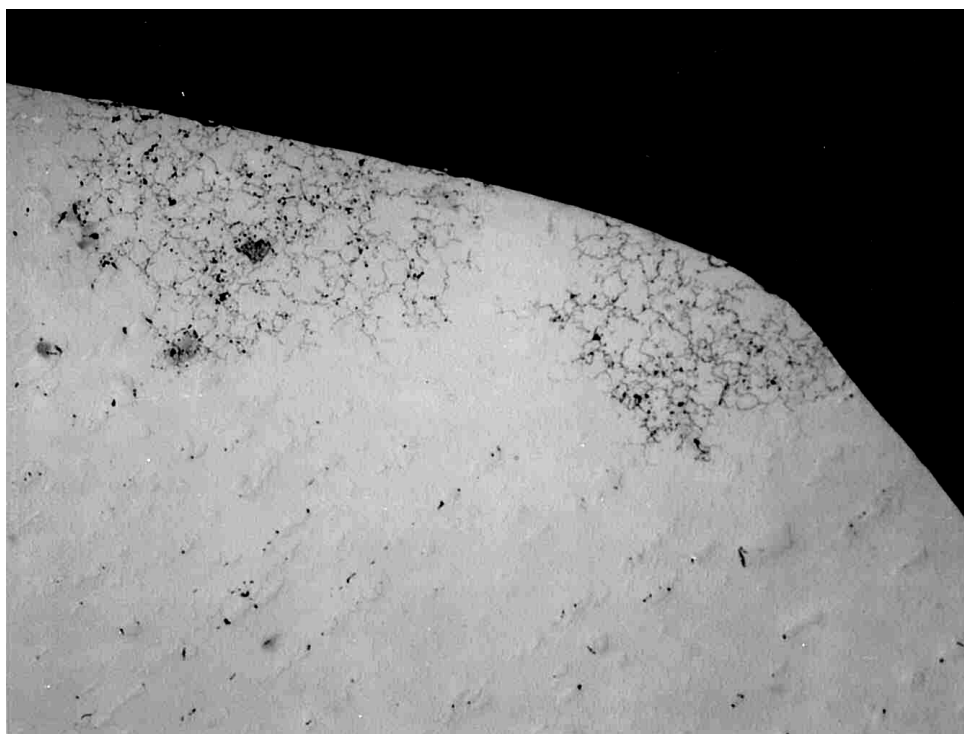
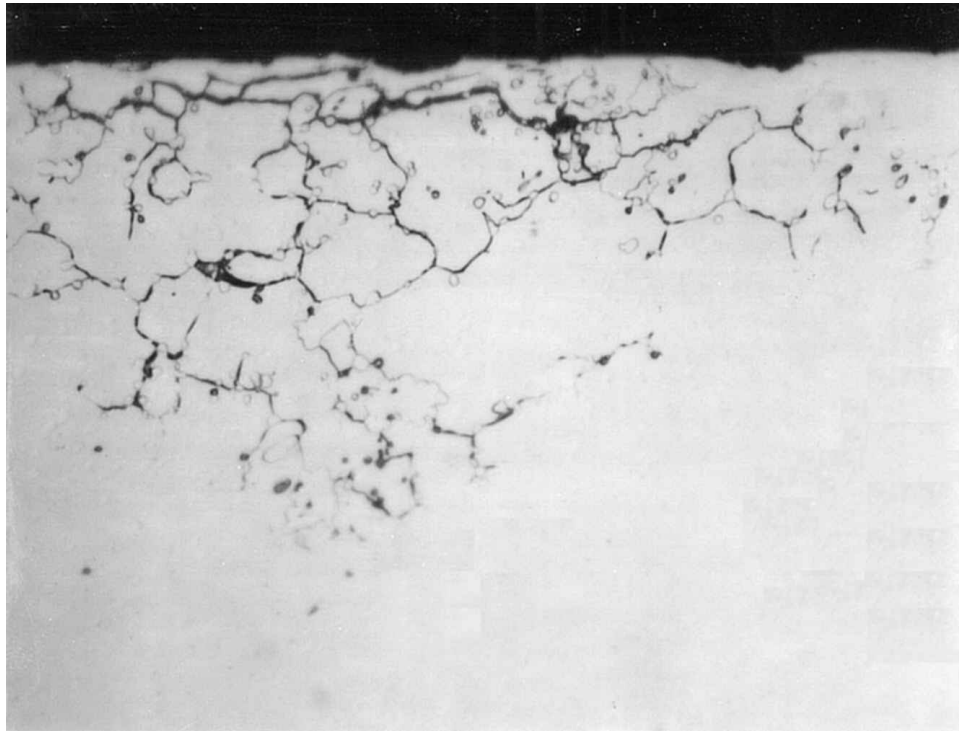
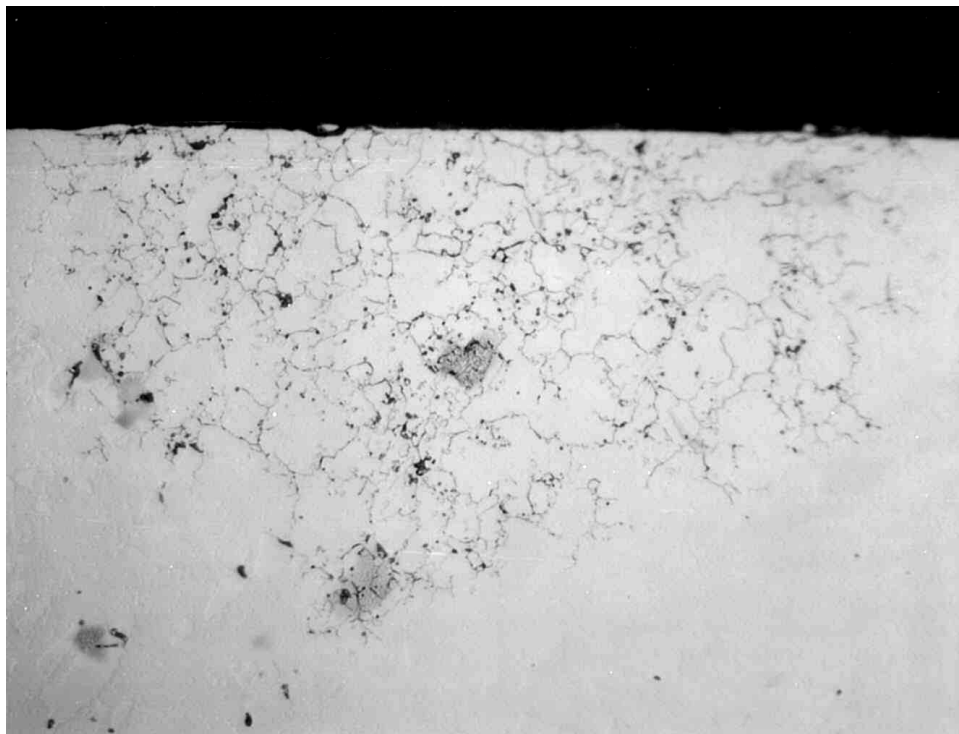
The regions of attack labeled “A,” “B,” and “C” in figure 16 are shown in figures 17, 18, and 19 for the transverse section and in figures 20, 21, and 22 for the longitudinal section, respectively. In these photomicrographs, it is apparent that inter-granular cracks progressed to and around the precipitates (figures 17 and 21, especially). This fact is intuitive when it is realized that the matrix is inherently depleted of chromium in these areas. Figure 18 shows that individual grains of metal have actually been dislodged from the network of inter-granular attack, forming a cavity or pit at the surface of the part.

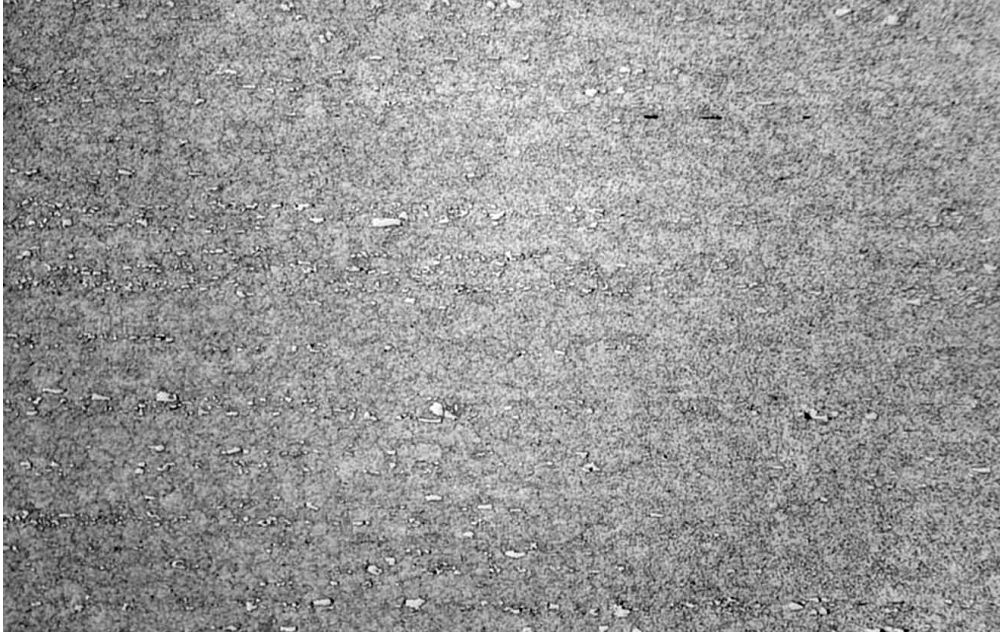
The samples were subsequently etched with Vilella's reagent to reveal the microstructural features. At low magnification, some banding was noted, indicative of the prior flow direction (see figure 23) in the material.

**Figure 23. Etched microstructure of the ball material showing the presence of banding (mag 100x).**

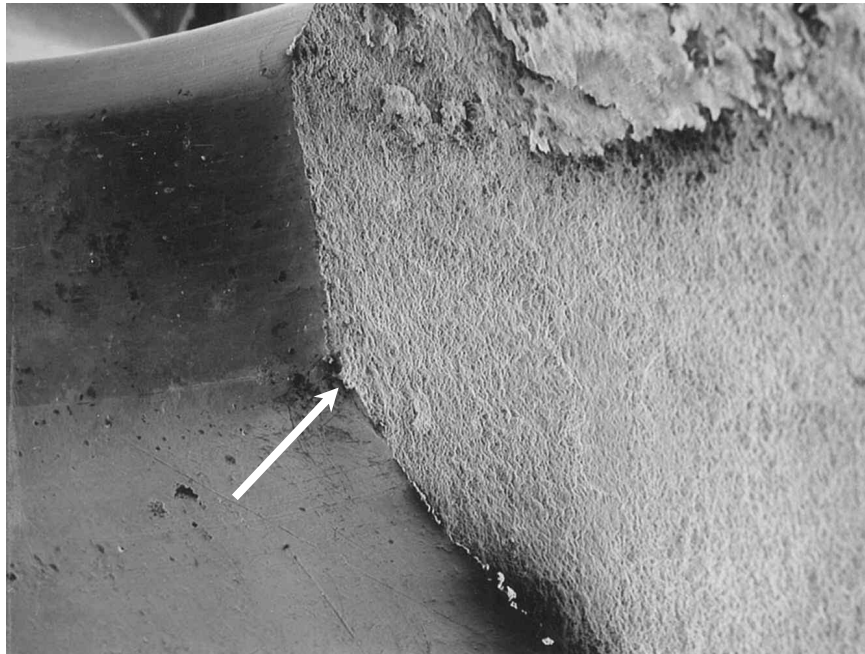
One half of the sectioned component was thoroughly cleaned and prepared for examination. The fracture half of the ball was examined with a Japan Electron Optics Laboratory JSM<sup>4</sup>-840A scanning electron microscope (SEM) and a Kevex SIGMA series energy dispersive spectroscopy (EDS) system. The failure origin (indicated by the white arrow) and surrounding area can be observed in figure 34.

**Figure 34. Failure origin area of the 440C ball (mag. 30x).**

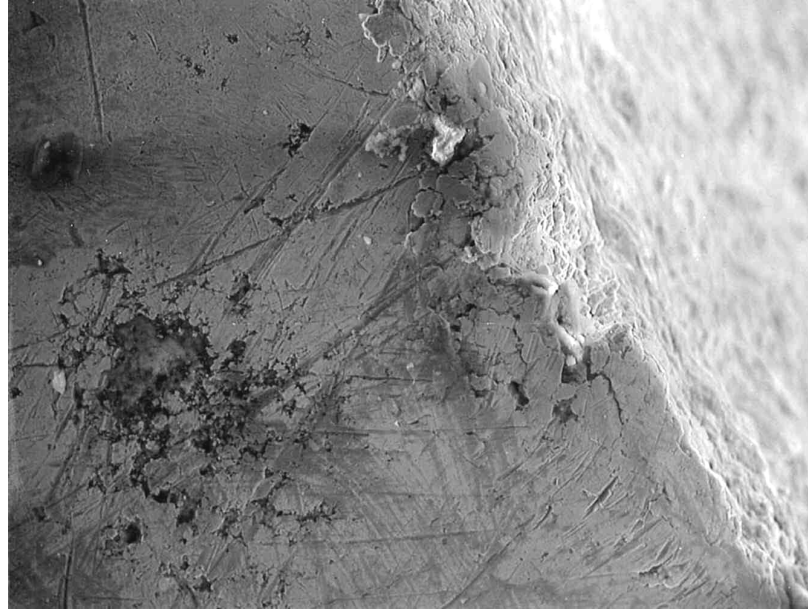
Closer inspection revealed inter-granular attack within and near the origin. Figure 35 depicts the likely fracture origin and the surrounding area at higher magnification at a 45-degree tilt angle with respect to the fracture surface. The large area of attack near the origin in figure 35 can be observed in figure 36.

**Figure 35. Fracture origin at high magnification and 45° tilt (mag. 250x).**

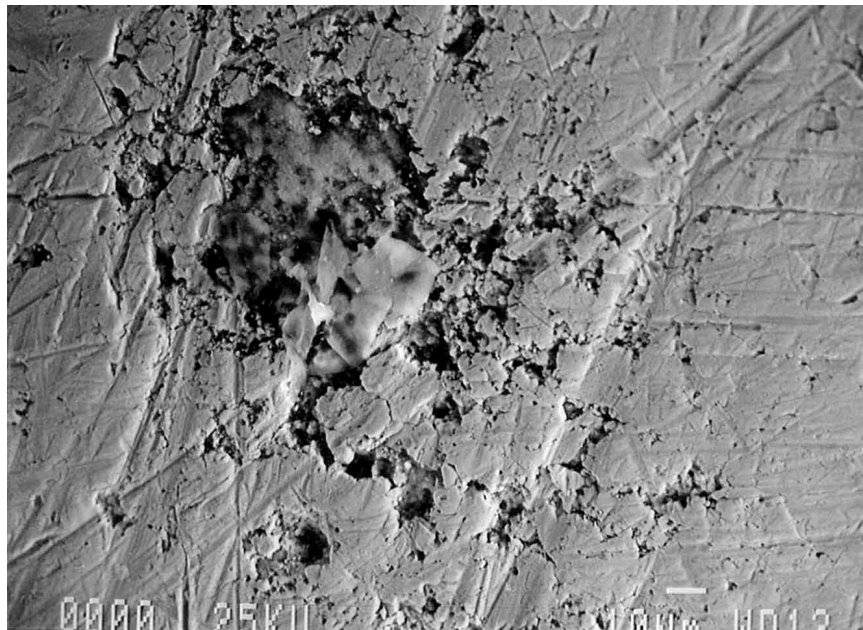
**Figure 36. Area of inter-granular attack near the origin (mag. 500x).**

The attacked area was filled with corrosion product. This product was analyzed with EDS. The EDS spectrum produced from this product can be observed in figure 37. It was similar in chemistry and composition to the other attacked areas on the ball. However, it was slightly different from the corrosion product on the fracture surface that is presented later.

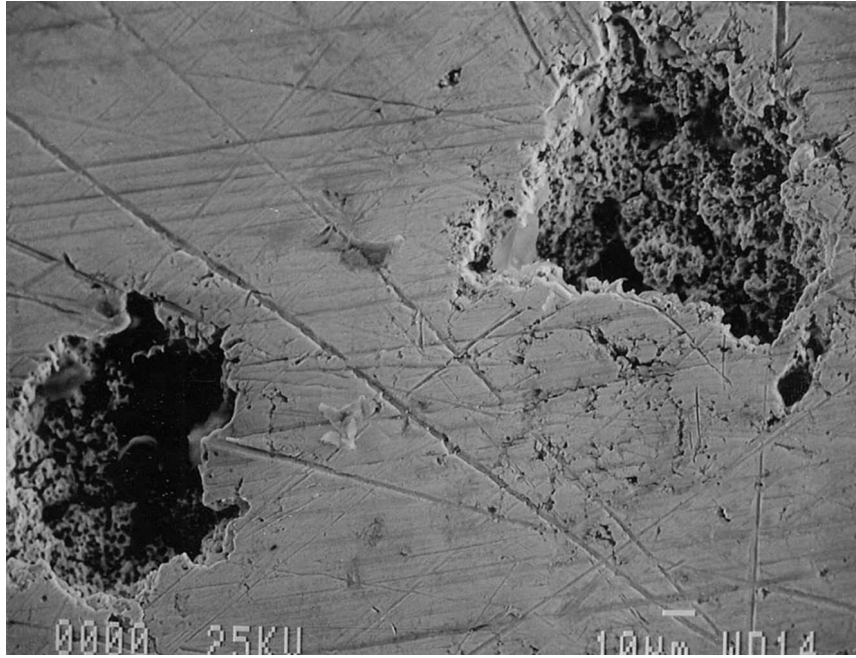
The inter-granular attack at the origin was neither the only nor the largest site of its kind on the ball. Several localized inter-granular attacked sites existed along the exterior surface. Overall, it was estimated that less than 5% of the exterior surface contained corrosion. The hole bored through the ball, however, was noticeably void of inter-granular attack. This would provide evidence that either the attack took place before the hole was made or the hole was somehow shielded from the attack. It is suspected that the combination of the inter-granular attack occurring at a concentrated stress site, the edge of the component, was likely the cause of failure even though much larger attacked areas existed. Two relatively large areas of the attack are observable in figure 35. These areas are depicted at higher magnification in figure 39. The corrosion sites measured approximately 0.0015 inch deep.

Both sites contained some corrosion product, and a noticeable distinction was discernible. The inter-granular attack was preferential to the precipitates at or near the grain boundaries. Closer examination of the region on the left in figure 39 revealed that the precipitates themselves are not

**Figure 39. Two large areas of inter-granular attack near the origin (mag. 400x).**

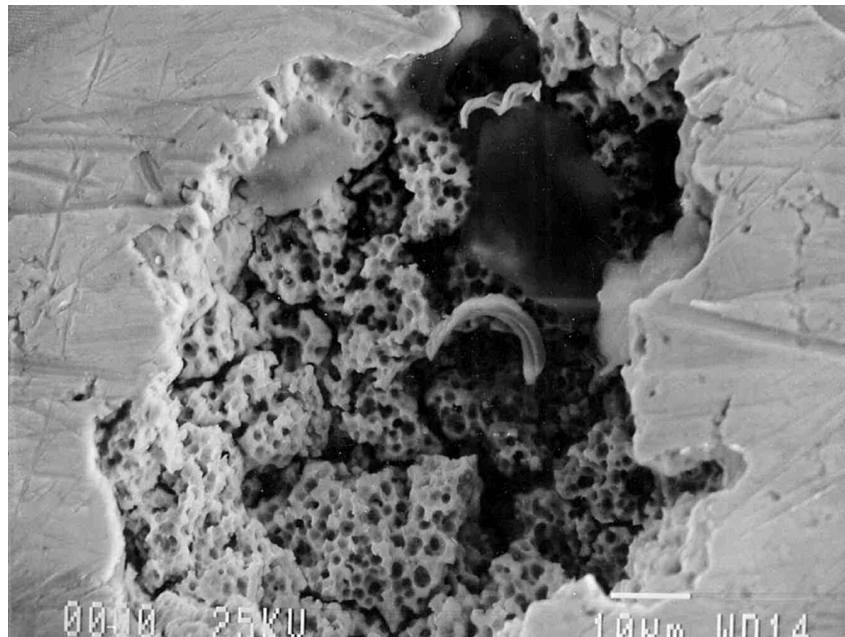
attacked. Conversely, they are dislodged by the attack. Figure 40 depicts this region. The depletion of chromium in the regions surrounding the precipitates makes this occurrence intuitive. The white arrows indicate the precipitates in advancing stages of dislodgment. Figure 41 presents the precipitates shown in figure 40 at higher magnification. Other inter-granular attacked areas demonstrated evidence leading to this conclusion.

**Figure 40. Inter-granular attack site with dislodged precipitate (mag. 1kx).**

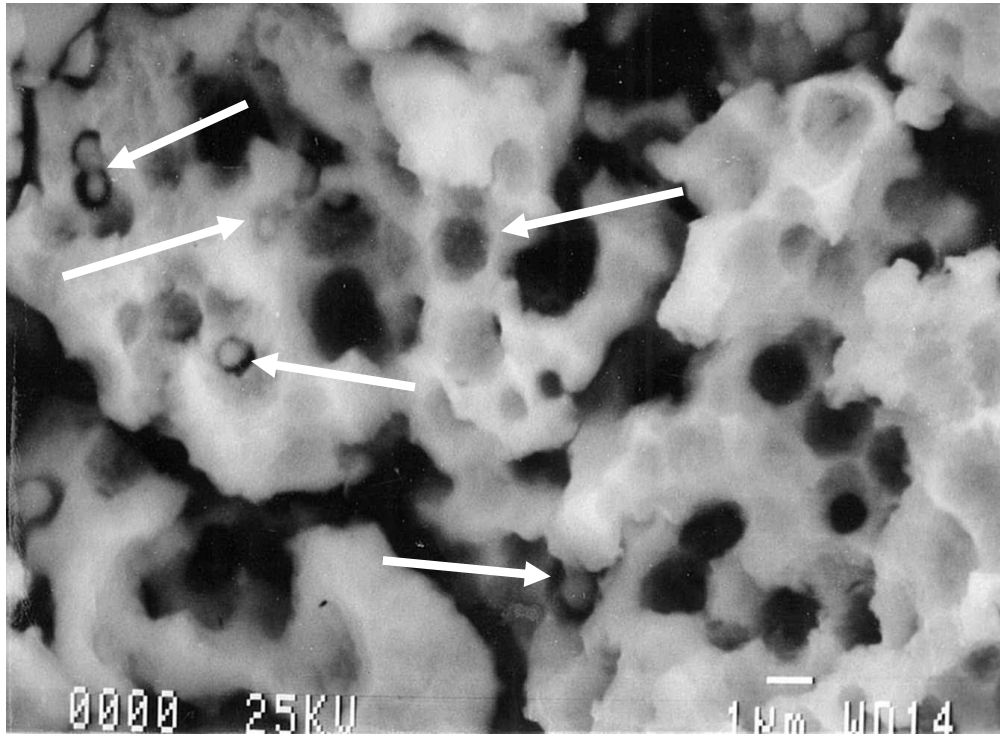
**Figure 41. High magnification showing detail of figure 40 (mag. 5kx).**

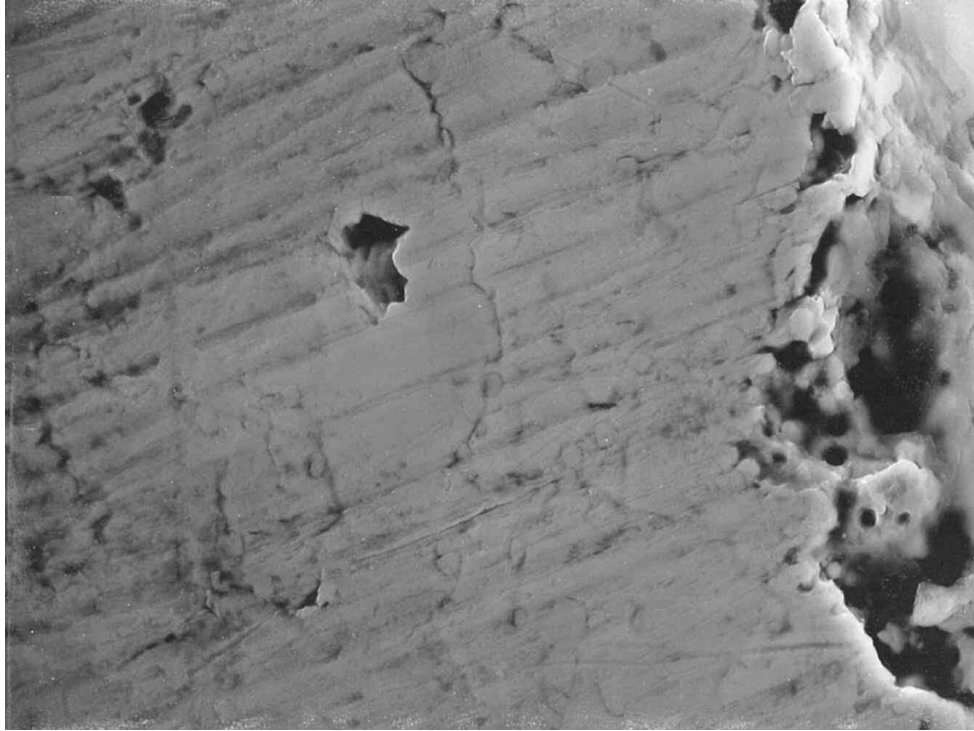
Figure 42 was situated approximately 1 mm from the origin along the fracture surface. Intergranular attack around precipitates near the surface is indicated by the arrows. Another region adjacent to the fracture surface, figure 43, depicts attack around precipitates as well as dislodged precipitates embedded within the corrosion product on the fracture surface. High magnification of another attacked area away from the fracture surface shows four distinct precipitates clearly dislodged from the matrix material. These precipitates are shown in figure 44. The EDS spectrum of the precipitates displayed increased levels of chromium and carbon compared with the matrix base material as might be expected with the formation of iron-chromium carbides of this material (see Metallography section). Figure 45 displays this spectrum and the corresponding increases in chromium and carbon compared with the base material. Note that no carbon was detectable by EDS within the base material. Table 16 shows the qualitative and quantitative results generated from the spectrum.

**Figure 42. Inter-granular attack preferentially around precipitates (mag. 2kx).**

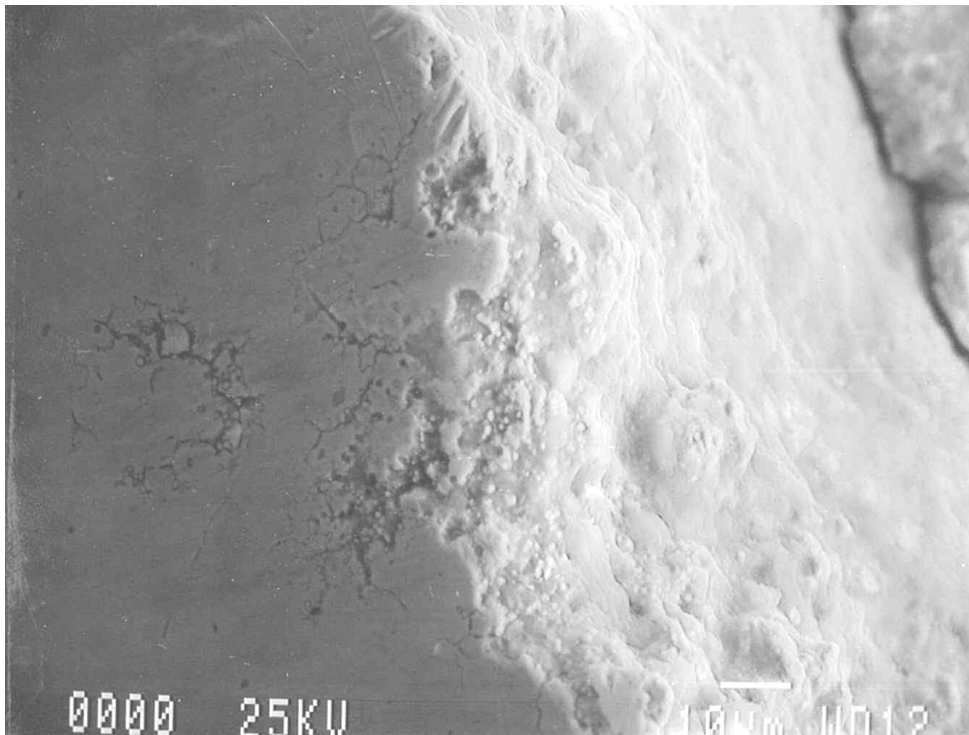
**Figure 43. Attack around precipitates and dislodged precipitates (mag. 750x).**

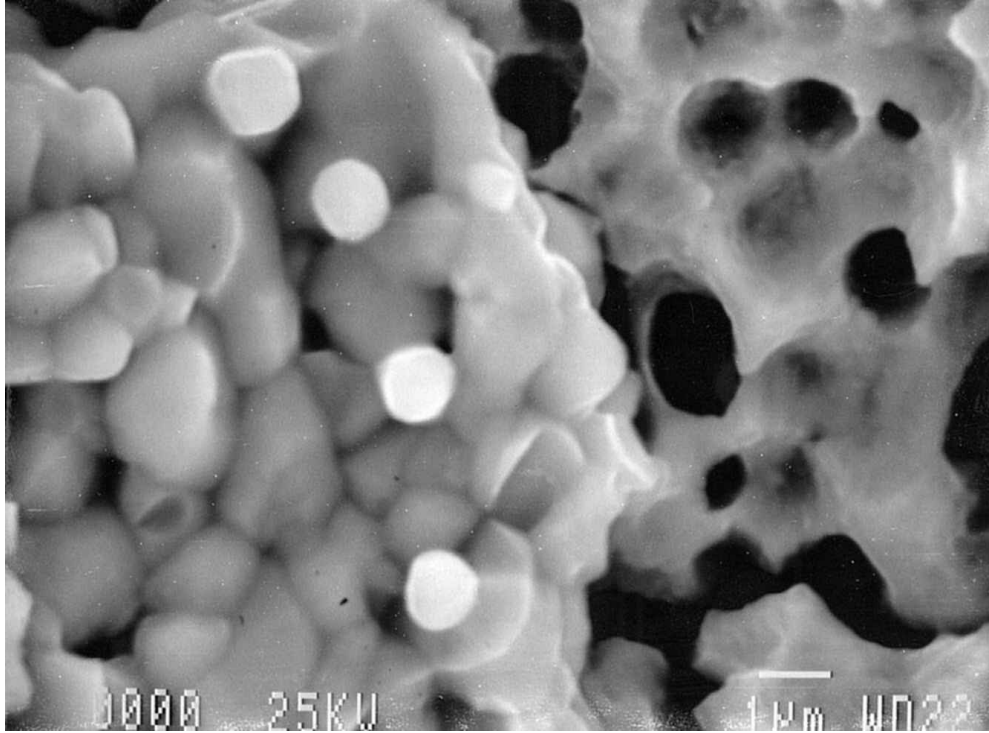
Figure 44. Four distinct dislodged precipitates (mag. 7500x).

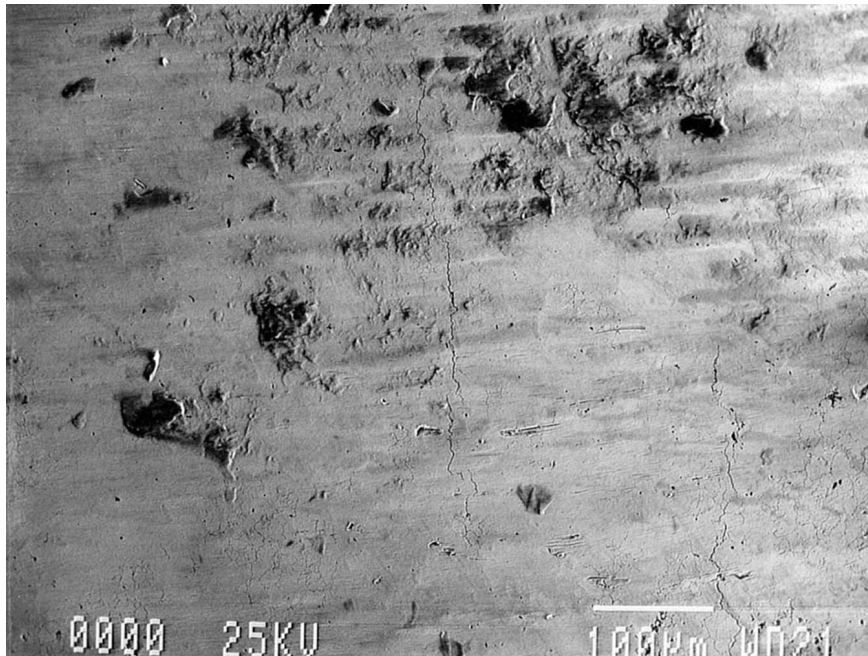
Secondary inter-granular cracks that propagated parallel to the fracture plane were observed within 2 mm of the fracture. These cracks were observed along the flat surface adjacent to the bored hole. Figure 46 depicts the multitude of these cracks highlighted with arrows. At higher magnification (see figure 47), an excellent example of inter-granular cracking preferentially around surface precipitates was observed.

**Figure 46. Secondary cracks near and parallel to the fracture surface (mag. 150x).**

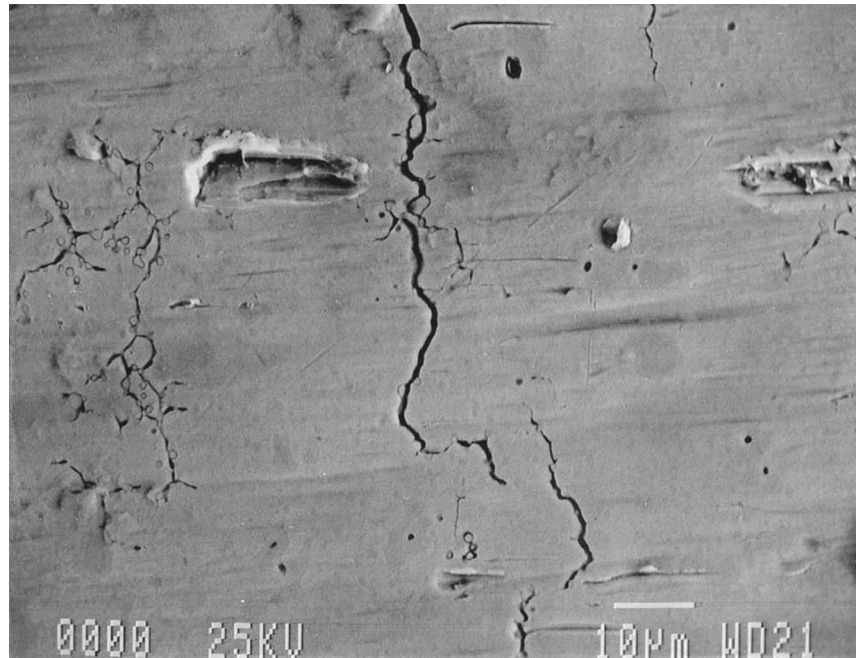
**Figure 47. Preferential inter-granular cracking around precipitates (mag. 1kx).**

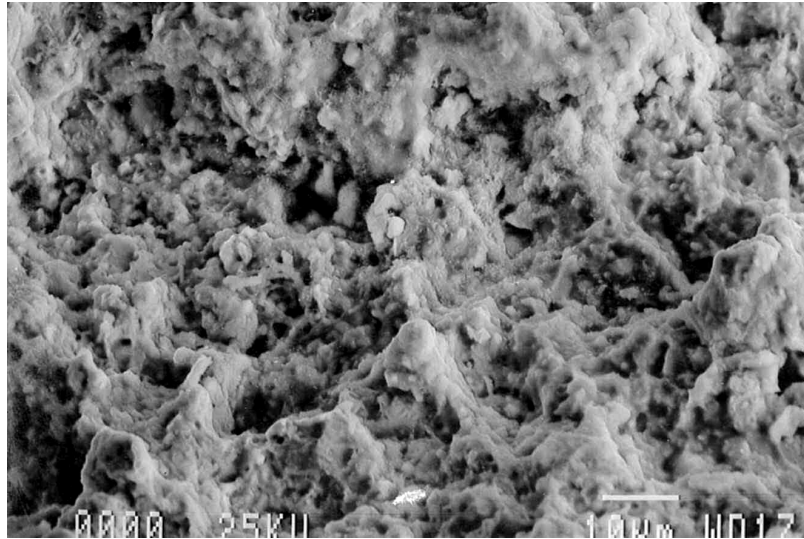
**Figure 49. Fractograph 2 of 5, heavily corroded (mag. 1kx).**
