**Failure Analysis of an AH-64 Main Rotor Damper  
Blade Rod End, P/N 7-211411186-5**

**by Scott M. Grendahl and Marc S. Pepi**

**ARL-TR-3100**

**December 2003**

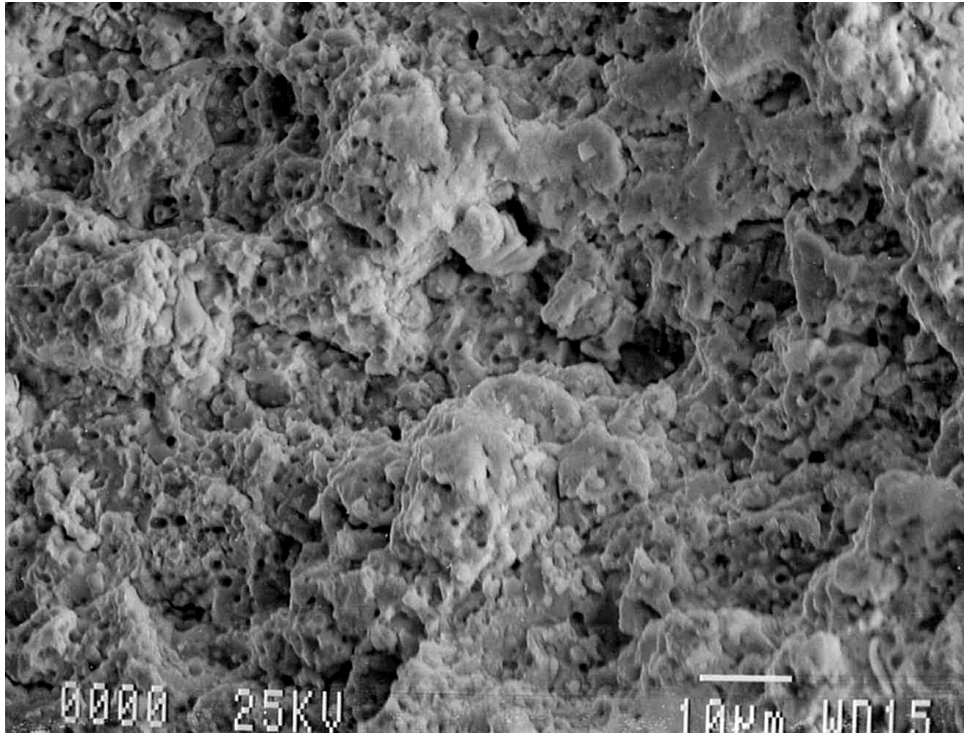
Figure 51. Fractograph 4 of 5, showing only light corrosion (mag. 1kx).
