NSWCCD-65-TR-2003/37 September 2003

## SIDER Testing of Royal Navy Vessel P292 HMS *Trumpeter*

SUBJ: STRUCTURAL IRREGULARITY AND DAMAGE EVALUATION ROUTINE  
(SIDER) INSPECTION OF SHIP STRUCTURES

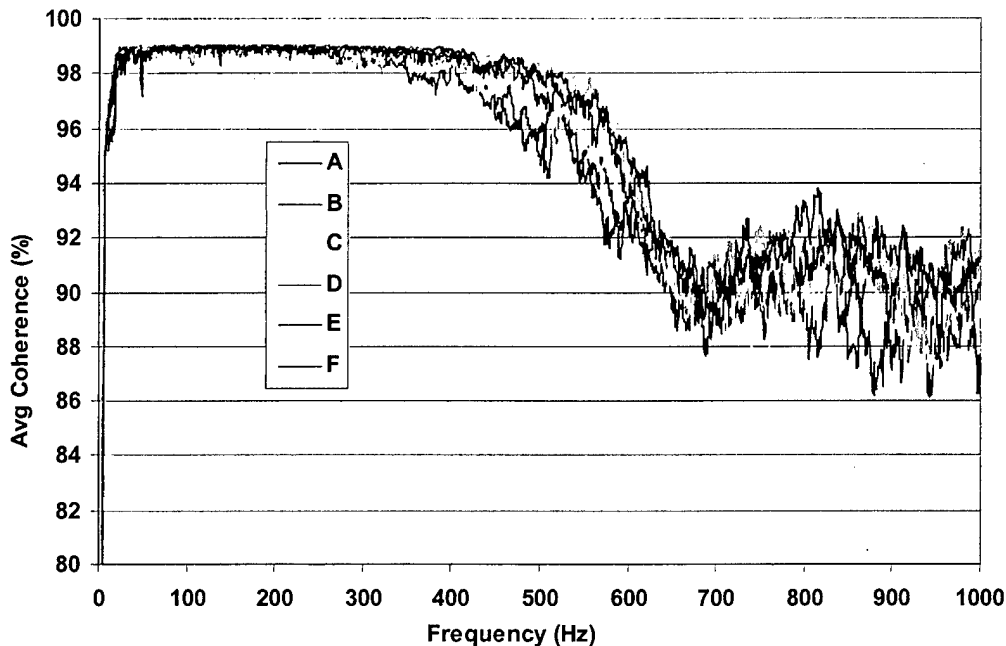
**Figure 6. Average Coherence**

average coherence is shown separately for each transducer. In this way, instrumentation or local structural problems can sometimes be identified. Note that the coherence axis for each graph is expanded, and only shows the range 80-100%. We would normally consider a high quality data set to have an average coherence in excess of 95%, and preferably more than 98%. We have very high quality data from about 15 to 450 Hz.

The conclusion drawn is that all the accelerometers recorded data of a high quality, although, as is normally expected, the data at the highest frequencies have reduced quality. This is because the hammer impact did not put sufficient energy into the structure at these high frequencies to get the response signals sufficiently out of the noise threshold.

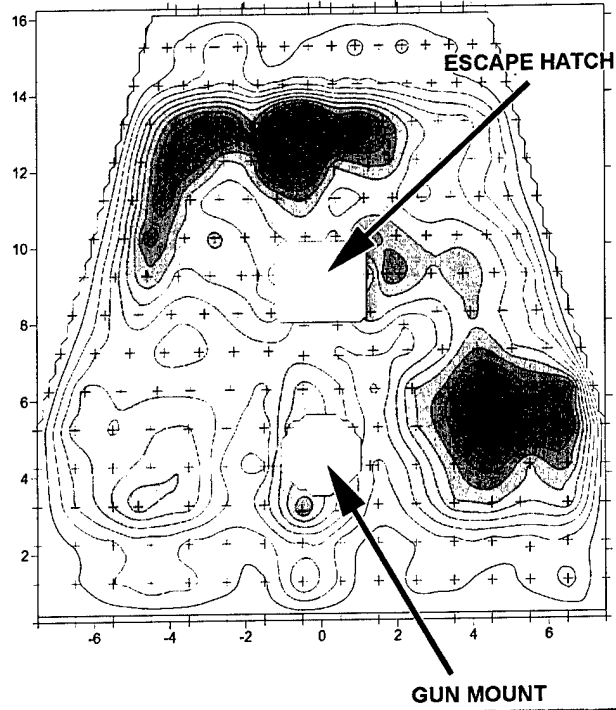
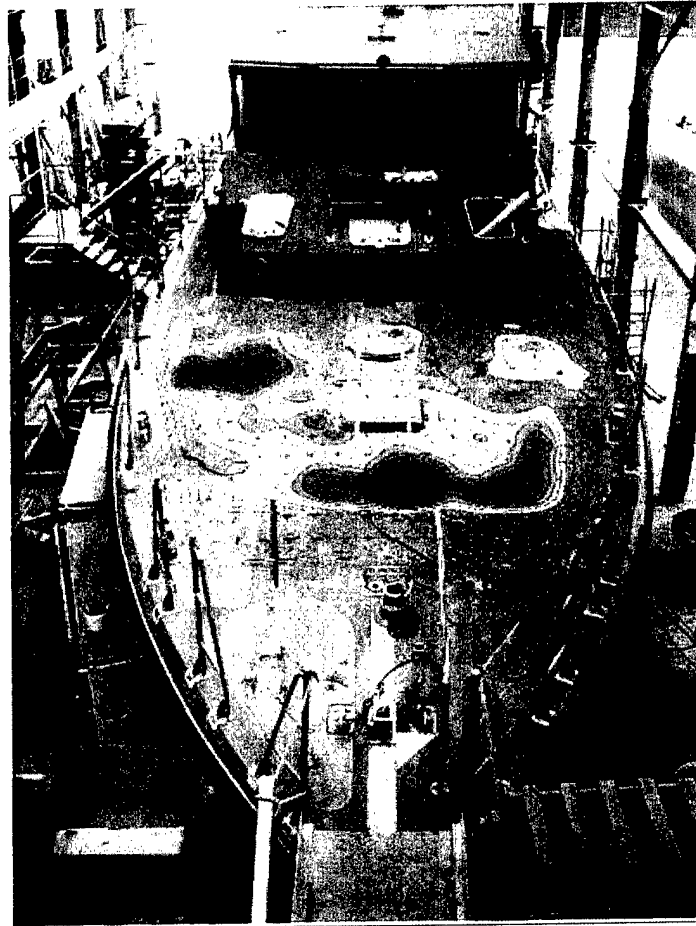
Figure 7. SIDER Fore-Aft Analysis

Figure 7 and Figure 8 show the SIDER contour plots. On these plots the small crosses show the test grid and the axes legends show the distance in feet from the global origin. The SIDER is a directional test. Thus there are two results, one for the fore/aft analysis and one for the port/starboard analysis. Each result is shown as a contour plot, and separately overlaid on a photograph of the foredeck. Note that the contour plots can be used to accurately locate features, whereas the foreshortening of the photographs means that features can be shown up to a foot or more from their actual position on the photographs.

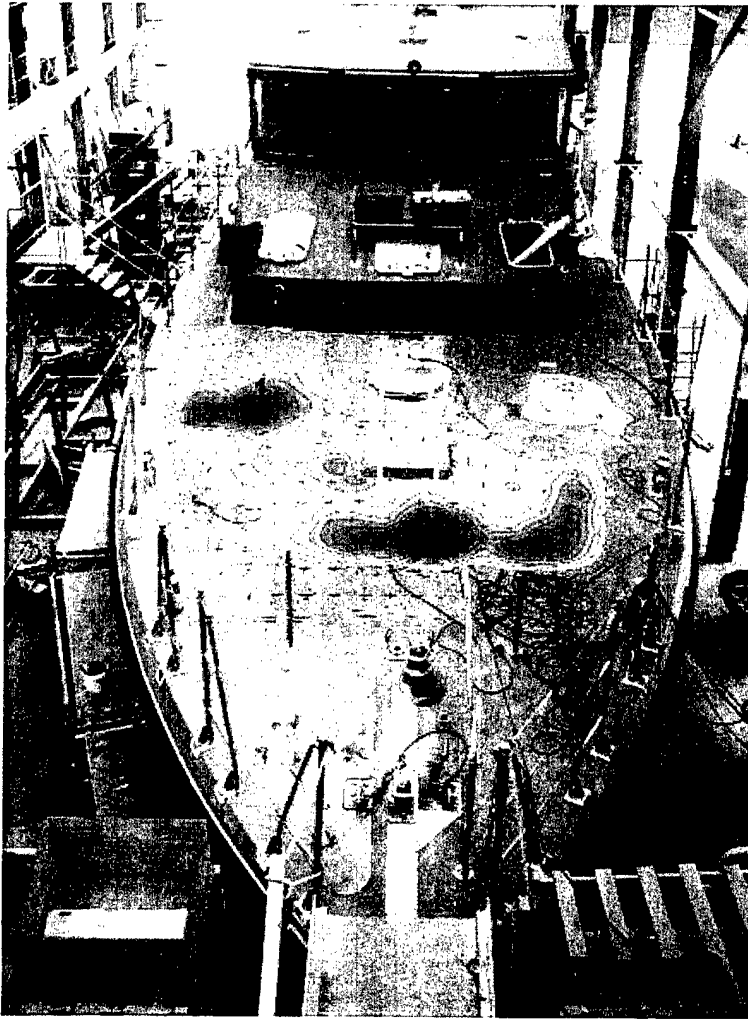
**Figure 9. Fore-Aft Analysis with Identified Features**

Figure 9 repeats Figure 7, but with two features highlighted. Feature 1 is coincident with a structural bulkhead that runs from the starboard side to the gun mount. The bulkhead does not continue to the port side. SIDER has located the stiffness change caused by this bulkhead.

Feature 2 has a maximum at the marked position, but it also extends along a port-starboard line. Just forward of this feature is a significant structural bulkhead that is almost coincident with the forward edge of the test mesh. SIDER has located the stiffness change (reduction) caused by the transition from the stiff area to the main foredeck.

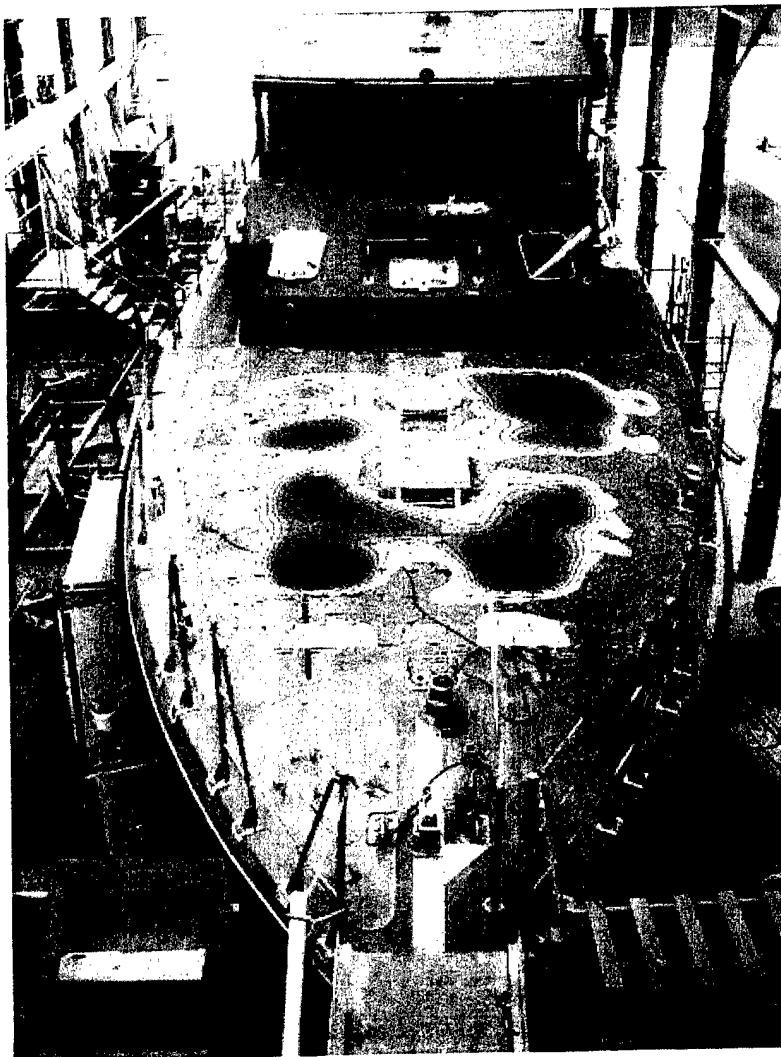
**Figure 10. Port-Starboard Analysis with Identified Features**

Figure 10 repeats Figure 8, but with several features highlighted. Symmetry can be a powerful assistant in the interpretation of single SIDER results. For example, features marked "3" show symmetry. These features are coincident with deck penetrations (deck prisms). Features 4 and 5 appear to be almost symmetric, but they are not quite symmetric. Feature 4 maps to a deck prism that only exists on the port side. Feature 5 maps to a deck vent that is only on the starboard side.

Feature 6 is a major non-symmetric feature. This feature maps exactly to the lack of bulkhead mentioned in the fore-aft analysis (feature 1). Feature 1 is also coincident with a section where the nonskid surface was not bonded to the substrate, as shown in Figure 11. It is surprising to the authors that SIDER was able to locate this type of problem. The technique typically identifies regions where there are stiffness variations. The reduction in stiffness that the debonded nonskid would result in is assumed to be less than the sensitivity of the detection technique. Physical manipulation of the area, however, did reveal the soft spot that corresponded to the debonded region.

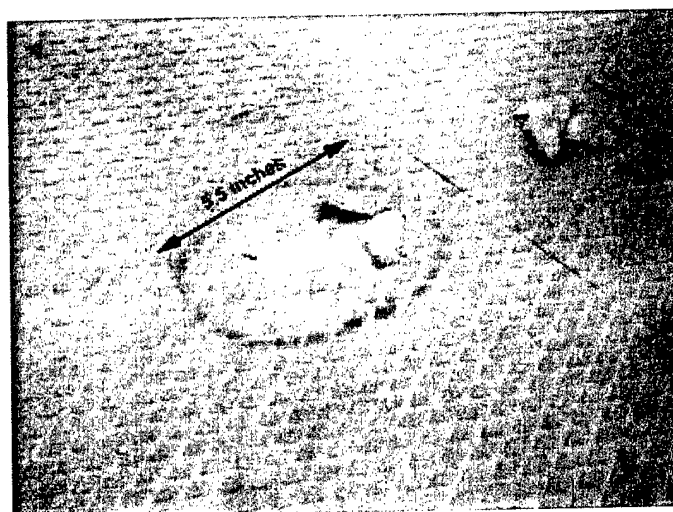
**Figure 11. Damage to Nonskid Surface**
