POST-FIRE DAMAGE ASSESSMENT OF A COMPOSITE WINGBOX

May 2004

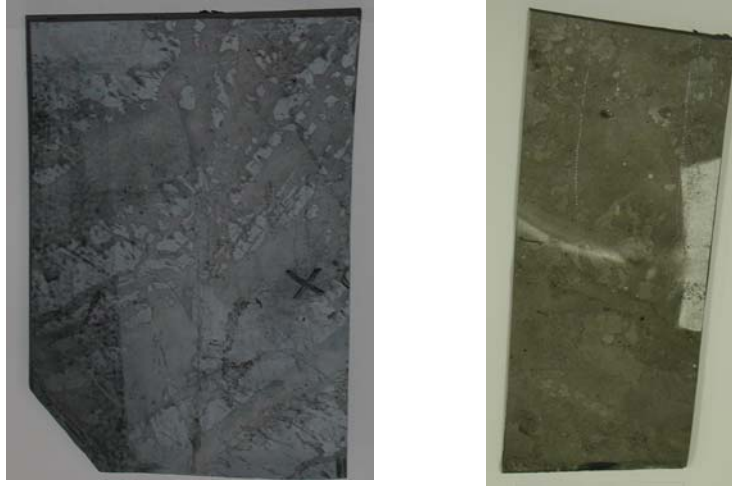
Photographs of some of the samples are shown below. One minute exposure samples show varying degrees of damage ranging from surface discoloration to scorching and pitting. This may be due to the coating on the composite material (paint or others) burning away. All the 5 minute exposure samples (top and bottom of wing box) show significantly more damage than the 1 minute samples, as expected. In most cases, the 5 minute samples were essentially completely

Figure 1 Photographs of two samples (1W-T-6, 1W-T-1) from top-side of Wing Box 1 (1 minute exposure)

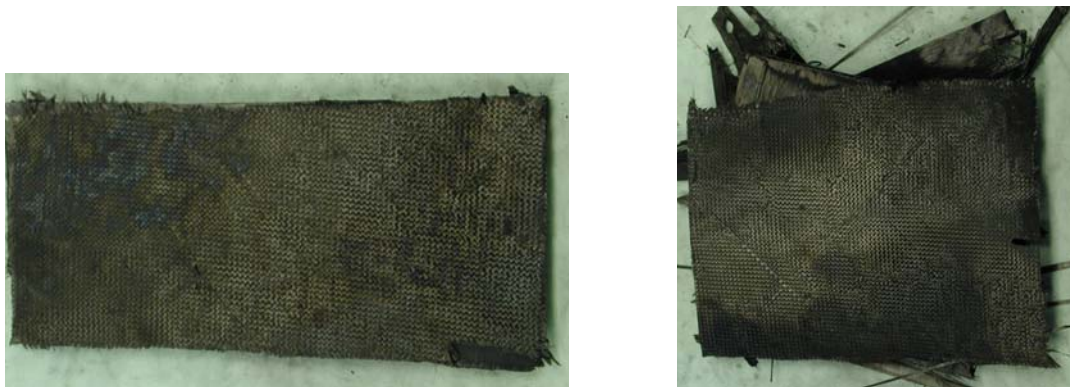
damaged to the point where property measurements would be impossible. These samples showed very visible resin loss, fiber damage and layer separation (Figures 3 and 4). We can also expect some fiber oxidation and burn damage due to the temperatures measured during the 5 minute burn test.

Figure 3 Photographs of two samples (2W-T-6, 2W-T-1) from bottom-side of Wing Box 2 (5 minute exposure)

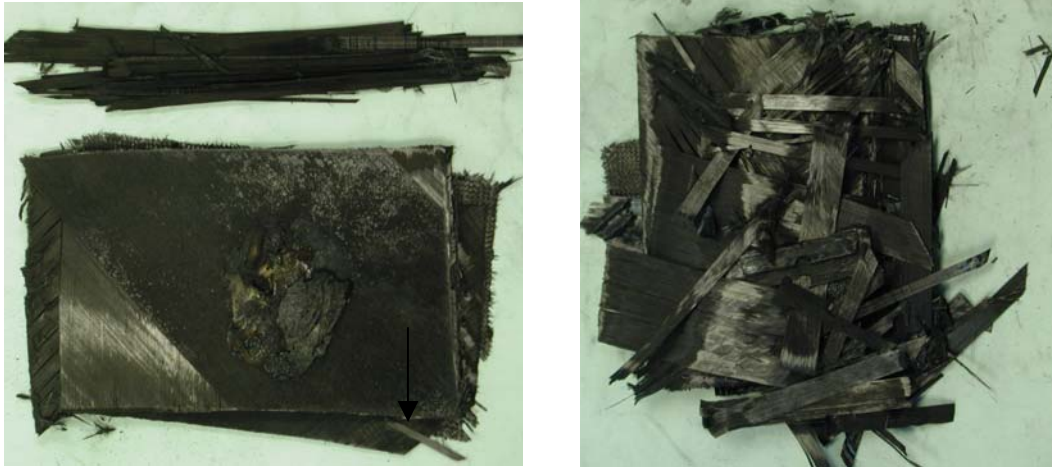
Figure 4 Photographs of two samples (2W-B-1, 2W-B-2) from bottom-side of Wing Box 2 (5 minute exposure)
