**SACRAMENTO RIVER FLOOD CONTROL PROJECT,  
CALIFORNIA  
MID-VALLEY AREA, PHASE III**

**DESIGN MEMORANDUM  
VOLUME I OF II**

**US Army Corps  
of Engineers**

**August 1995**

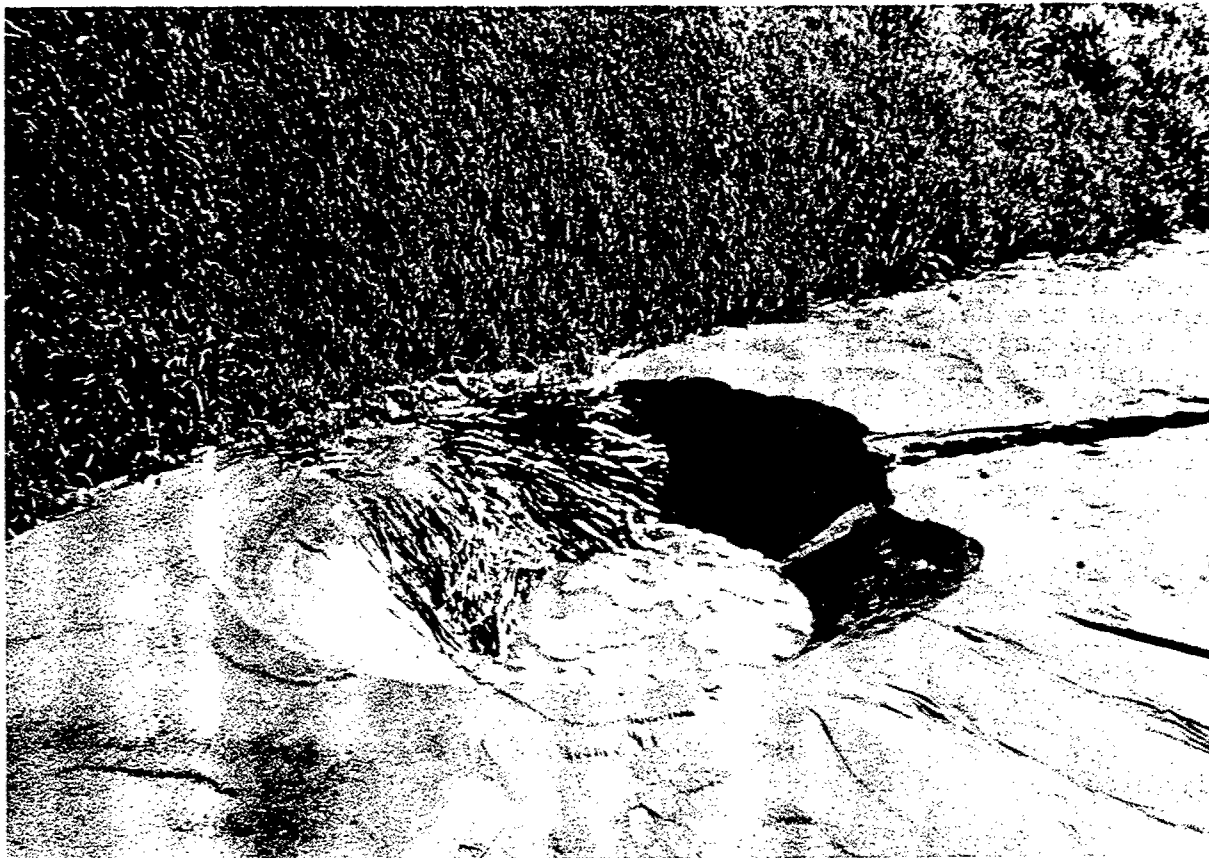
Sutter Bypass. - The west levee of Sutter Bypass just east of Robbins was the site of significant seepage and settlement in February 1986 (see front cover and Figures 1, 2, and 3). The problem began suddenly as a blowout of levee embankment toe material. Erosion of the landside levee toe continued until the levee embankment subsided at the site. Seepage water then appeared immediately downstream, eroding levee material until this too was stopped by settlement of the levee. The process continued downstream for about 200 feet. Emergency flood fight efforts (see Figure 2) were initiated by the Corps of Engineers to stabilize the levee embankment. A temporary waterside berm about 50 feet wide and 300 feet long was constructed of sand and gravel at a cost of about \$290,000. Upstream from this site (in the vicinity of Highway 113), numerous clear water boils have occurred along about 1 mile of levee during past high flows. Two of these boils, identified as boil numbers 12 and 16, have occurred regularly enough to have acquired numbers

LEVEE EMBANKMENT PROBLEM AREAS ON WEST LEVEE SUTTER BYPASS  
DURING FEBRUARY 1986 FLOOD.

(numbered staffs at each boil). One of these boils has a permanently installed corrugated metal standpipe to control flow. On the east side of Sutter Bypass, seepage waters appear landward of the levee during high flood stages from the Natomas Cross Canal upstream along about 8 miles of levee. Significant seepage and small boils have occurred along this levee just upstream from the cross canal. The levee embankment also failed in this same area (see Plate 3 for location) in the past.

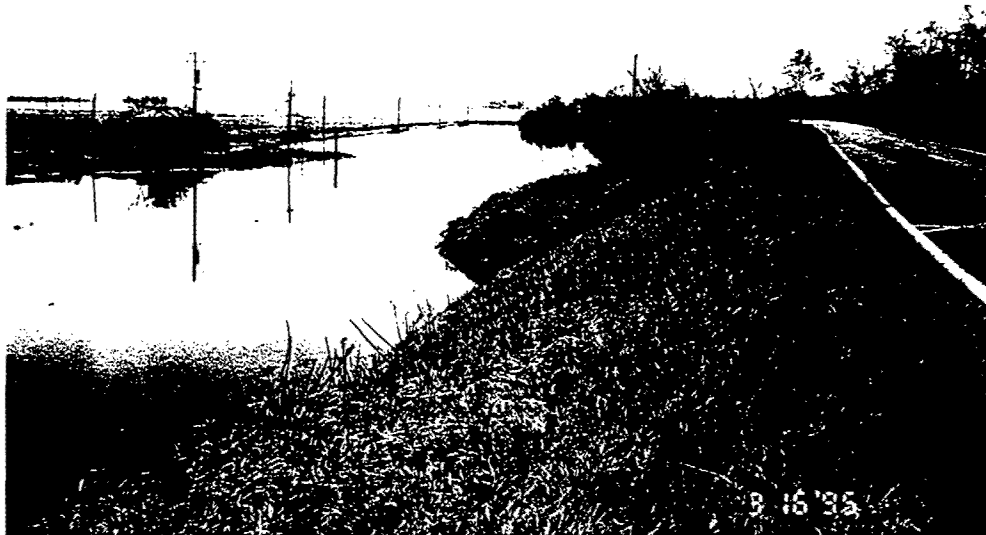
Feather River. - The south levee of Feather River, about 1 mile downstream from Nicolaus, failed during the 1955 flood event. The 1955 peak flood stage for this levee reach was at or near the design water surface. In spring 1995, a pond was created from extensive seepage along the landside toe of the east levee of the Feather River at levee mile 11.5 (river mile 0.93).

IN 1995, POND CREATED FROM EXTENSIVE SEEPAGE ALONG  
LEVEE TOE AT SITE 18, FEATHER RIVER/YOLO BYPASS.  
LAST TIME WATER PONDED HERE WAS IN 1986.

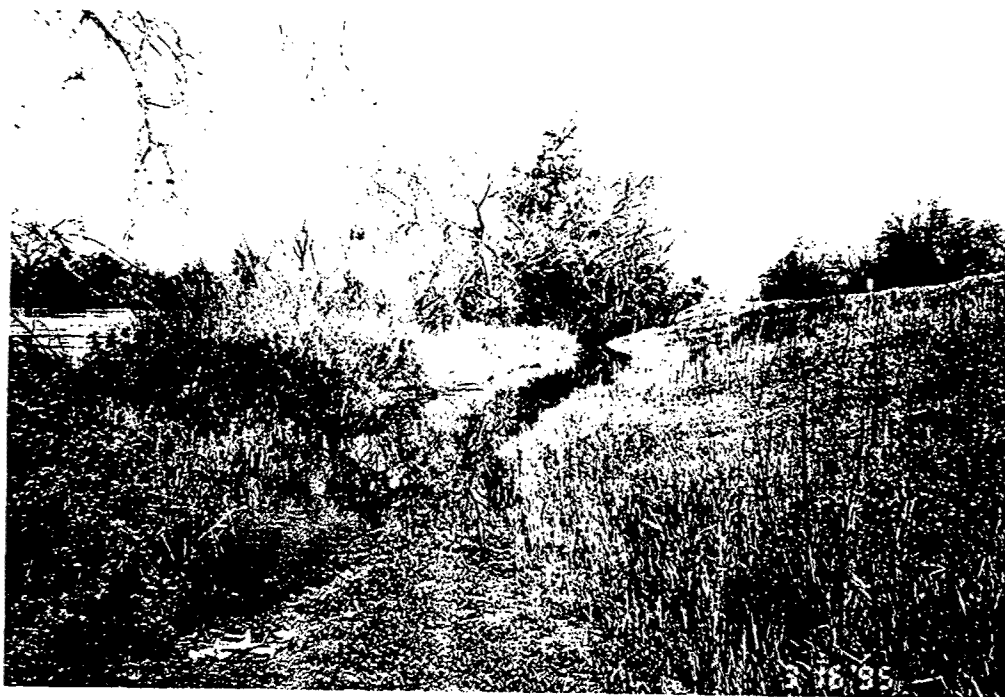
SITE 17 WATERSIDE VIEW MARCH 16, 1995  
OPPOSITE OLD LEVEE BREAK POND.

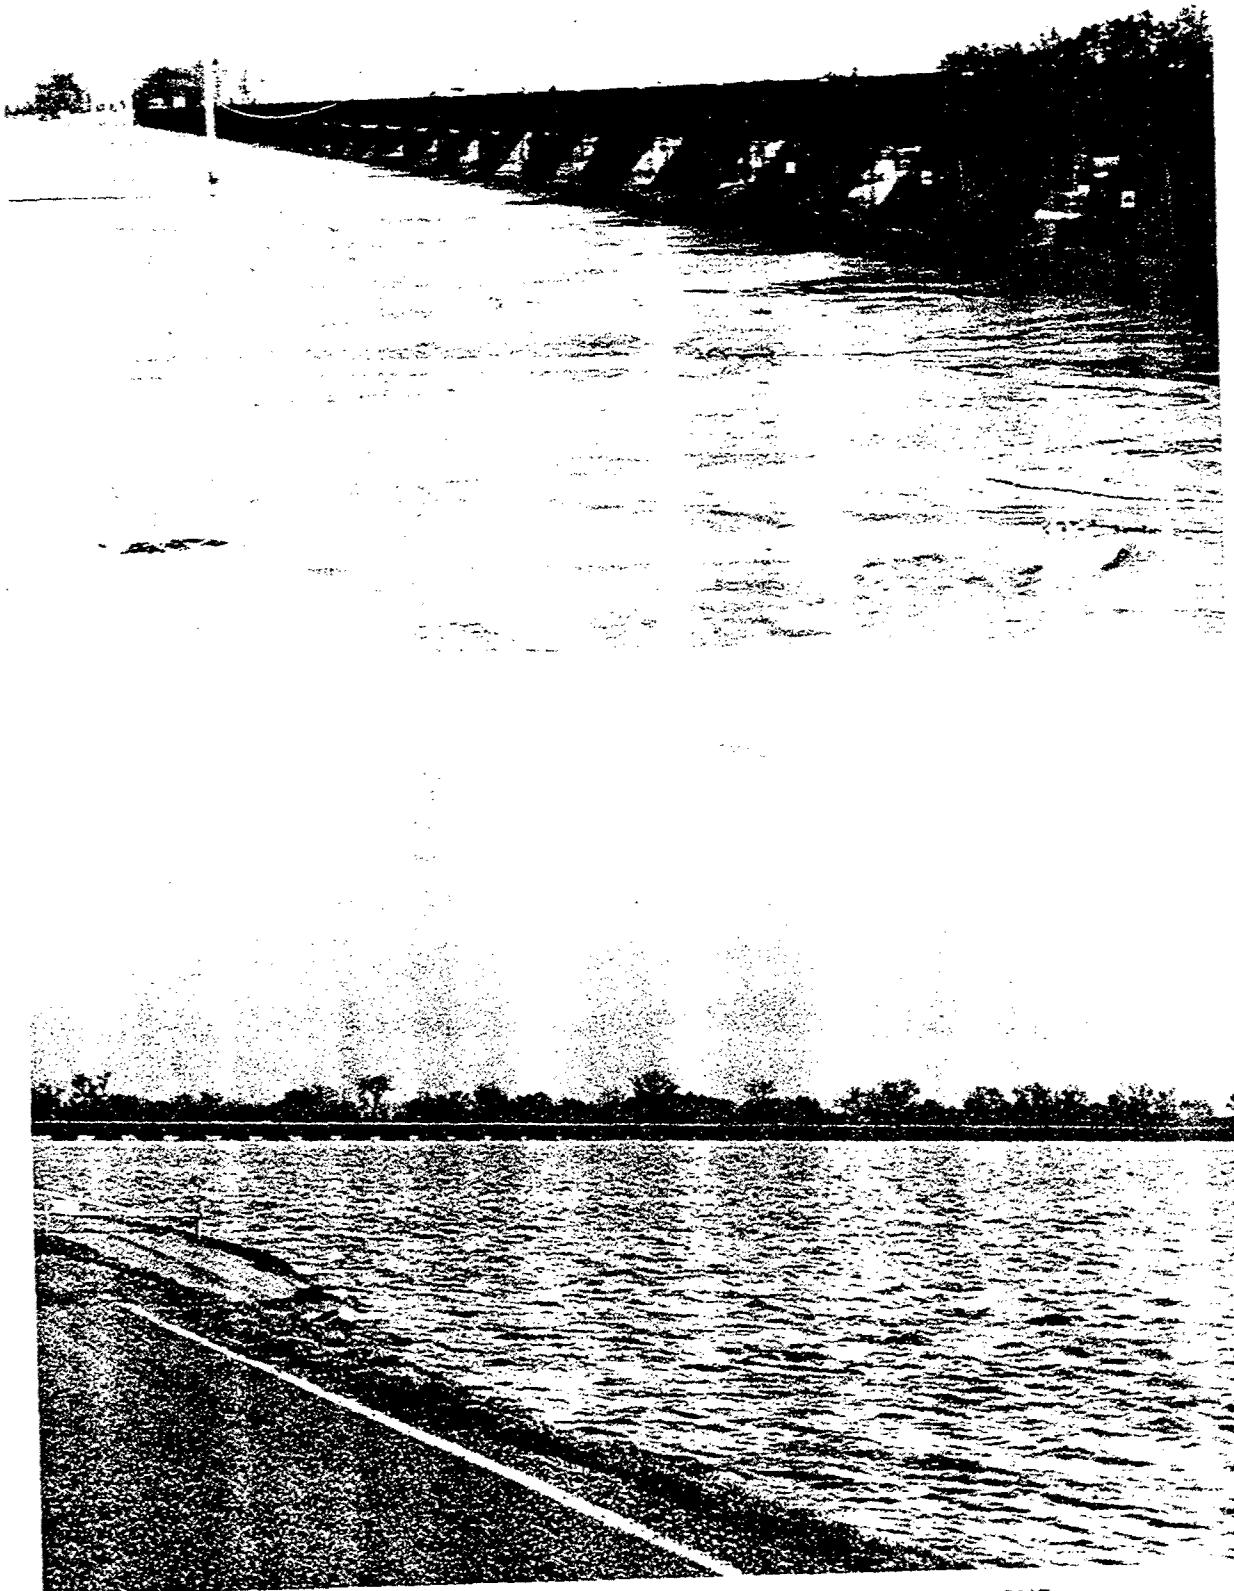
FEBRUARY 1986 FLOODFLOWS EXCEEDED DESIGN CONDITIONS  
FOR SACRAMENTO WEIR AND BYPASS.
