ERDC/EL TR-04-10

## **Guidance and Lessons Learned from Monitoring Completed Navigation Projects**

Compiled by Lyndell Z. Hales and Donna L. Richey

June 2004

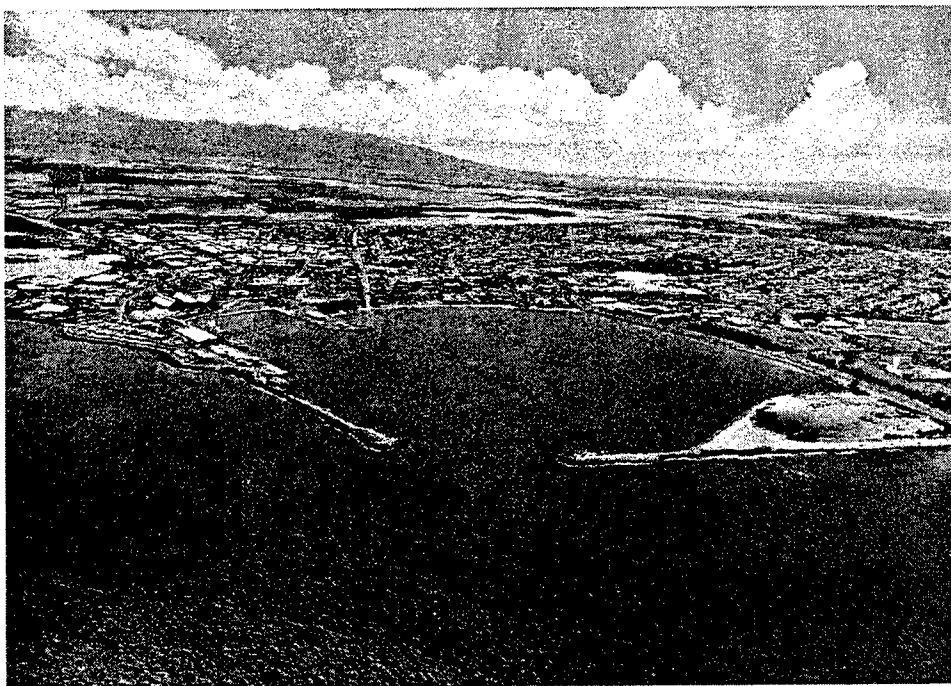
Figure 2. Kahului Harbor, Maui, HI (after Bottin and Meyers 2002b)

breakwater. An inspection in 1973 revealed that 29,965-kg (33-ton) tetrapods on the sea side of both heads had sustained considerable damage and they, along with the 7,265-kg (8-ton) stone areas on both trunks, were in need of repair.

- b. For the west breakwater, however, comparisons of target coordinates showed relatively close agreement with those obtained in 1993. The average movement of all targets in both the horizontal and vertical directions was less than 0.02 m (0.5 ft). Considering the movements of targeted armor units' centroids, average movements in both the horizontal and vertical directions were less than 0.2 m (0.6 ft) for the east breakwater, and less than 0.1 m (0.4 ft) for the west breakwater.
- c. A total of 29 broken/cracked armor units on the east breakwater and 58 on the west breakwater were identified during the 2001 survey. These data establish a base from which to evaluate future breakage in subsequent surveys. The areas of concentrated breakage on the Kahului east and west breakwaters should be inspected annually to monitor any increase in breakage and thus reduction in stability.

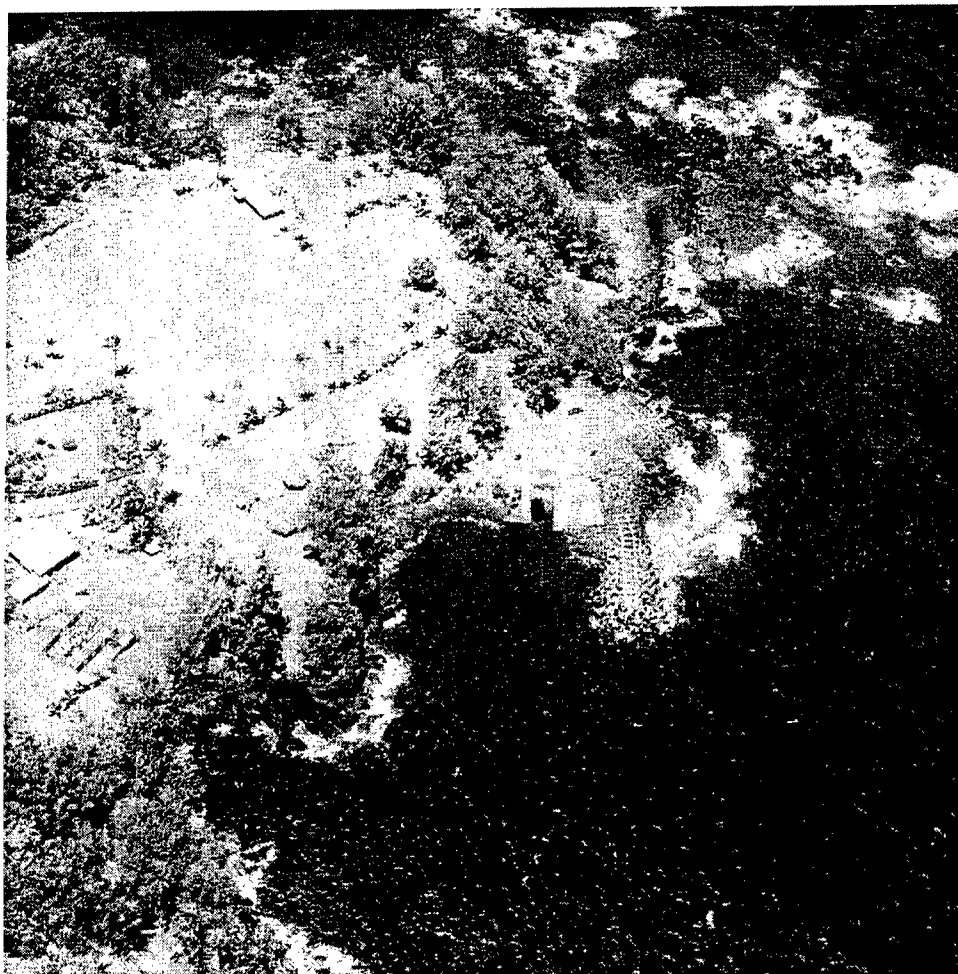
Figure 3. Laupahoehoe Boat Launching Facility, HI (after Bottin and Meyers 2002b)

- a. Similar data were obtained during 2001 and compared with the 1993 data. An analysis of these data indicated negligible movement on the breakwater.
- b. Average target movement in both the horizontal and vertical directions was less than 0.1 m (0.2 ft). Considering the movements of targeted armor units' centroids, average movements in both the horizontal and vertical directions were around 0.03 m (0.1 ft) for the Laupahoehoe breakwater.
- c. No broken/cracked armor units were found on the Laupahoehoe breakwater.

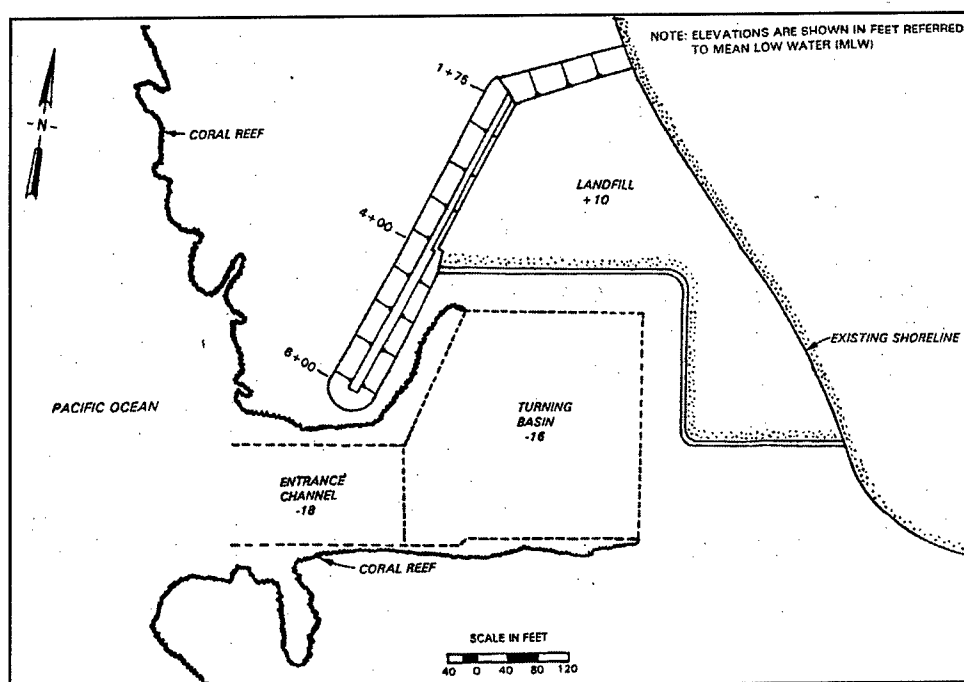
Figure 6. Ofu Harbor, American Samoa (after Bottin and Boc 1997)

- b. Ofu Harbor is subjected to severe storm conditions in the South Pacific, including tropical storms, hurricanes, and cyclones. The original revetment and mole used for harbor protection was damaged several times, and in 1991, was almost completely destroyed. As a result, a new breakwater was constructed in 1994 which included the use of 4,080-kg (4.5-ton) concrete tribar armor units. Various concrete underlayer units were also used in the structure, since local stone was not available. No sound, quantifiable data relative to the movement or positions of the concrete armor units had been obtained for the structure prior to this study.
