AFRL-ML-WP-TR-2004-4196

**ENDURANCE PUMP TEST WITH MIL-PRF-83282 HYDRAULIC FLUID,
PURIFIED WITH MALABAR
PURIFIER**

JUNE 2004

Interim Report for 01 January 2002 – 01 June 2004

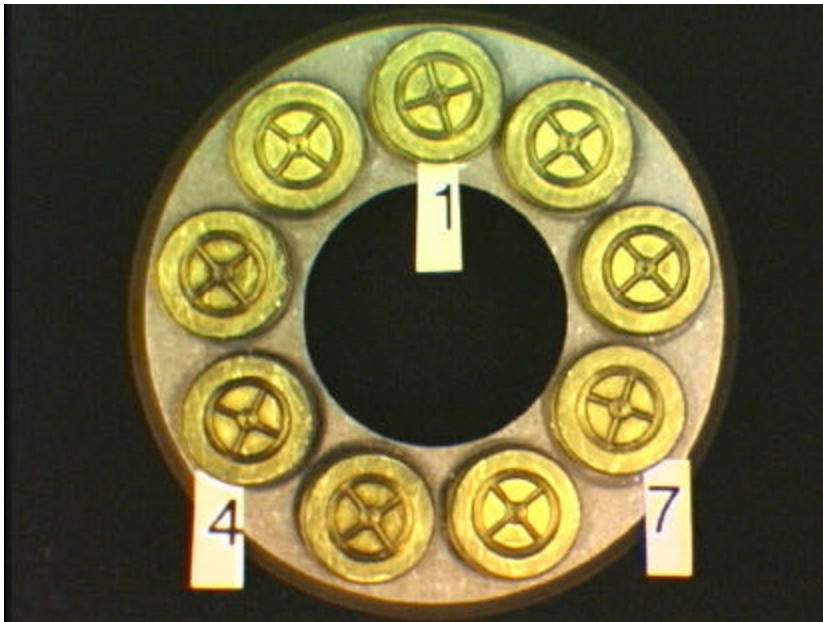
Piston Shoe Faces at 1500 Hours
Purified Fluid

- a) The shoes are very clean, showing no cavitation damage and appear more or less new. Very mild polishing over the face of each shoe is almost indiscernible from new. Each shoe was dimensioned for ball joint endplay and shoe flange thickness. The dimensional differences for shoe flange thickness have stopped decreasing measurably.

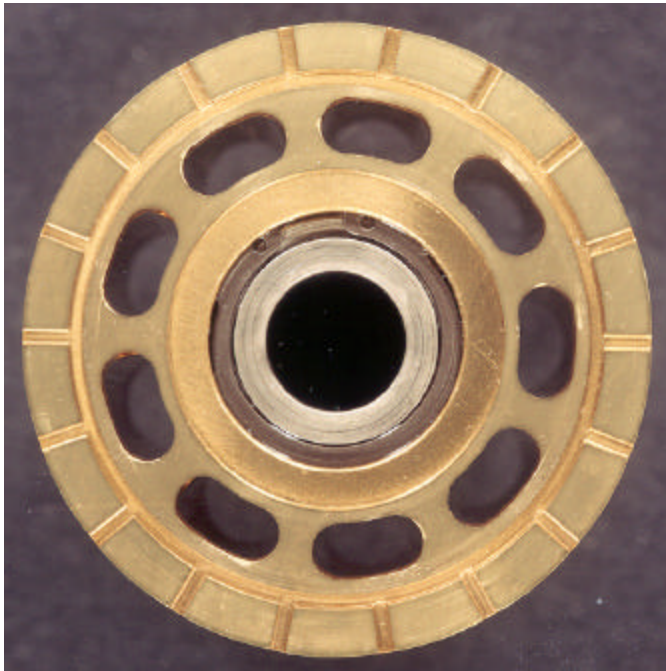
Cylinder Block Face at 1515 Hours
Fresh Fluid

- a) The mild cavitation erosion located on the outer trailing edge of the cylinder block kidney ports has not increased since last inspection.
- b) The shoes are very clean, showing no cavitation damage and appear close to new, except for polished axial fretting marks on the outside periphery of the gimbal ball joint sockets. The original tooling pattern is still visible on the shoe faces. Very gentle polishing on the outer shoe perimeter is almost indiscernible from new. Each shoe was dimensioned for ball joint endplay and shoe flange thickness, showing typical change in dimensions listed below.

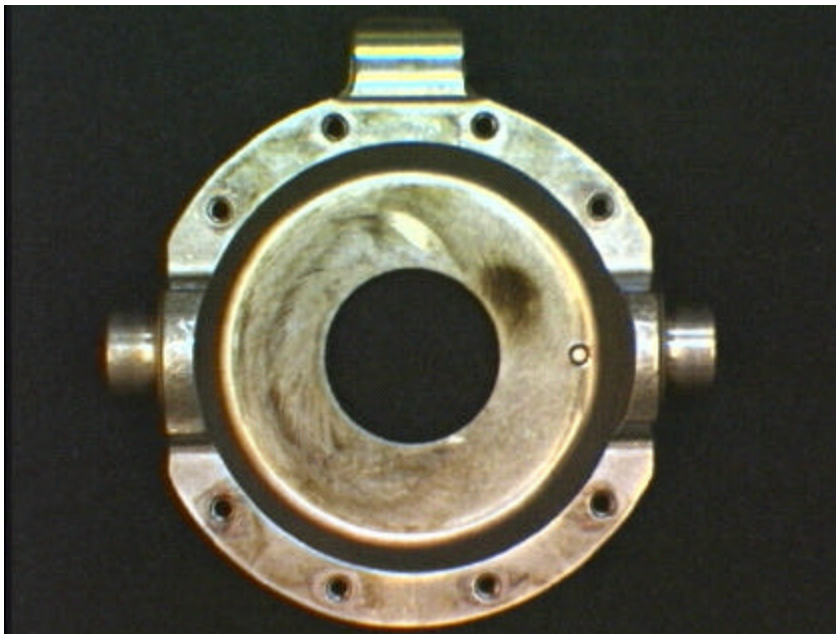
Yoke at 1500 Hours
Purified Fluid

- f) The yoke boss is in excellent condition. Partial polishing of the bearing plate is highlighted from the mild olive green tarnish in the no-contact zones. The ball bearing in the yoke boss is free of any perceptible wear. The pintle bearing tangs and mating foot for the actuator piston remain almost unworn.

- g) The actuator piston face shows fairly uniform additional radial polish wear, implying some rotation occurred during use. Both yoke pintle bearings are clean and roll freely.

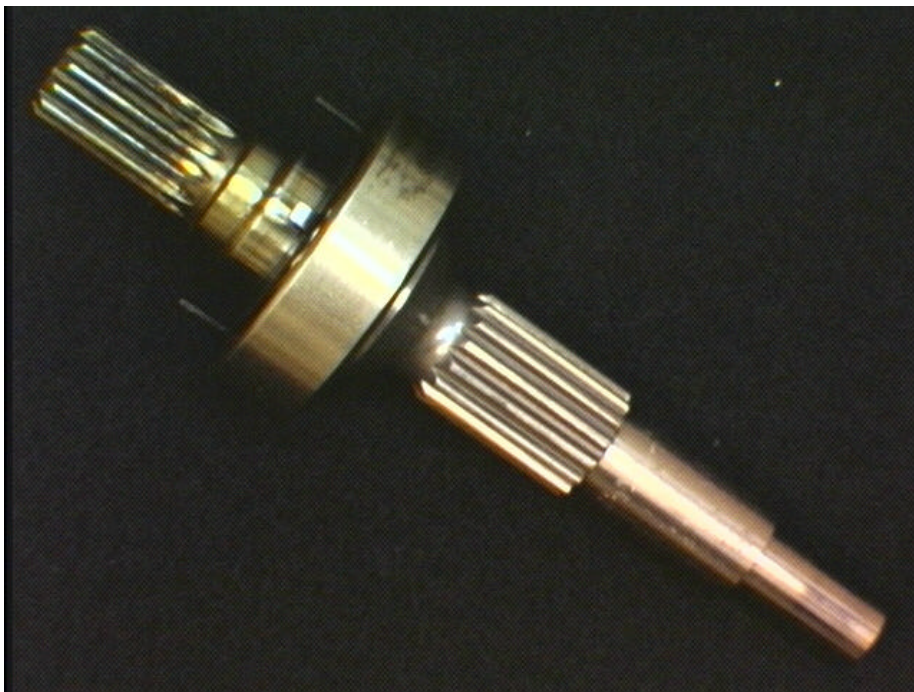
Shaft at 1500 Hours
Purified Fluid

- h) Some of the case drain port side bearing rollers have crescent shaped contact marks on the flats.
- i) The drive shaft inner splines appear excellent, with almost no visible fretting. The condition of the drive shaft bearing and carbon seal appear virtually new.

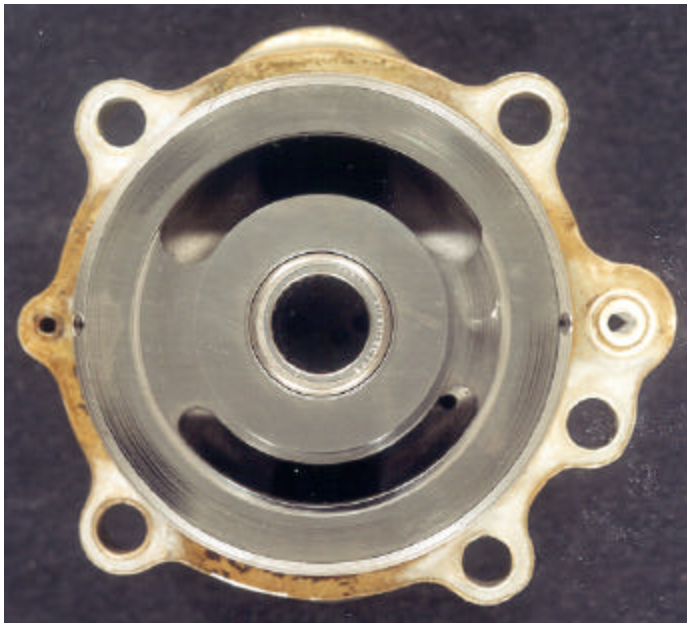
Valve Plate at 1515 Hours
Fresh Fluid

- e) No change in the valve plate surface occurred. This surface appears almost new except for the same shallow irregular cavitation pit noted before, which showed no additional growth, found roughly midway between the inlet and outlet ports on the piston recharging side.

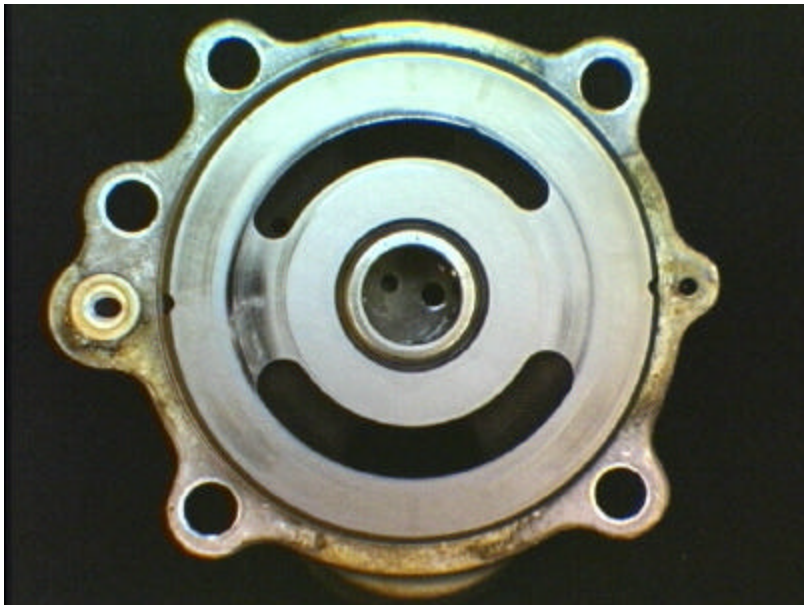
Valve Plate at 1500 Hours
Purified Fluid

- c) No appreciable wear on the inner race of the valve plate bearing is evident.
- d) The valve plate surface still appears almost new, except for the small cavitation pit and earlier formed shallow irregular cavitation pit, which have hardly changed.

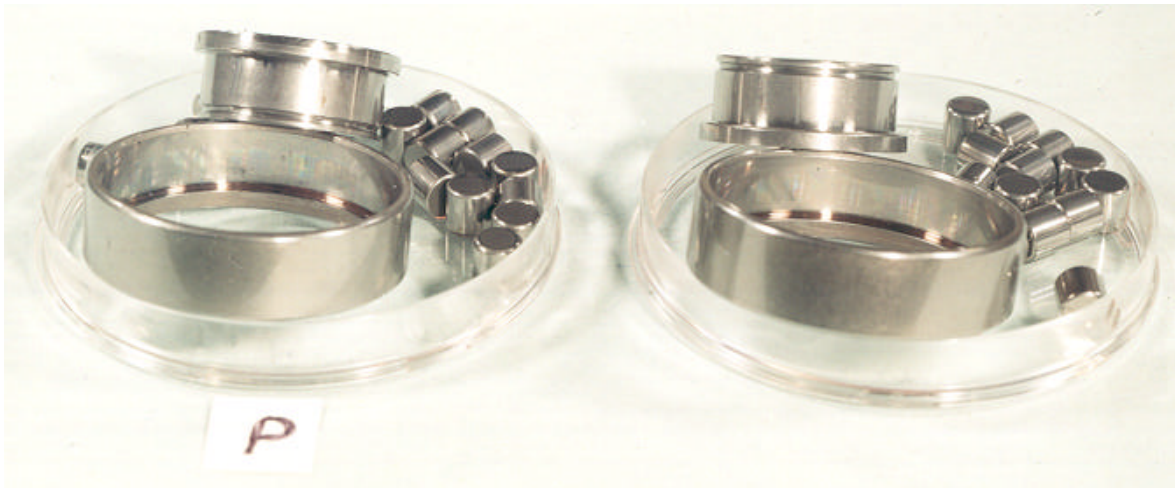
- h) Both yoke trunion bearings have excellent rolling surfaces; but the rollers in the bearing closest to the case drain port still display the crescent profile polish marks (unchanged), found on the edges of both sides of those rollers.
- i) The actuator piston's minute circular polishing mark in the extreme center of the contact surface has started to broaden, overall much less wear than in previous tests at this interval.
- j) The torque coupler mating splines on the external coupling shaft do not show any difference in the existing fretting.

Yoke Pintle Bearings at 1515 Hours
Fresh Fluid
[white square denotes case drain outlet side]

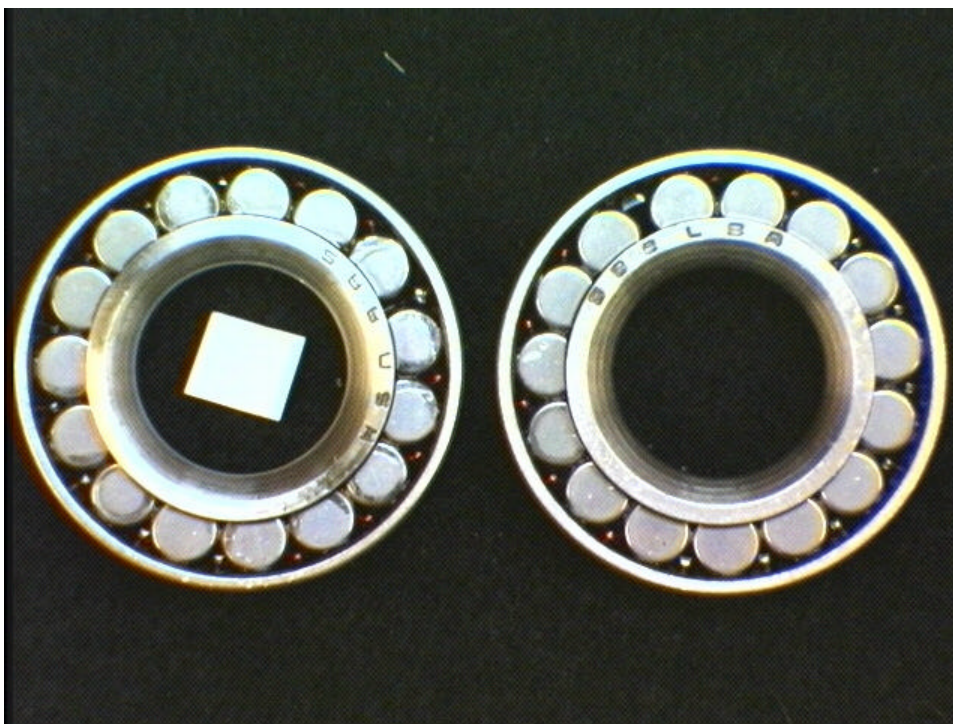
Pintle Bearings at 1500 Hours
Purified Fluid
[white square denotes case drain outlet side]
