**Collision With Trees on Final Approach
Federal Express Flight 1478
Boeing 727-232, N497FE
Tallahassee, Florida
July 26, 2002**

Aircraft Accident Report
NTSB/AAR-04/02

**NTSB/AAR-04/02
PB2004-910402
Notation 7501B
Adopted June 8, 2004**

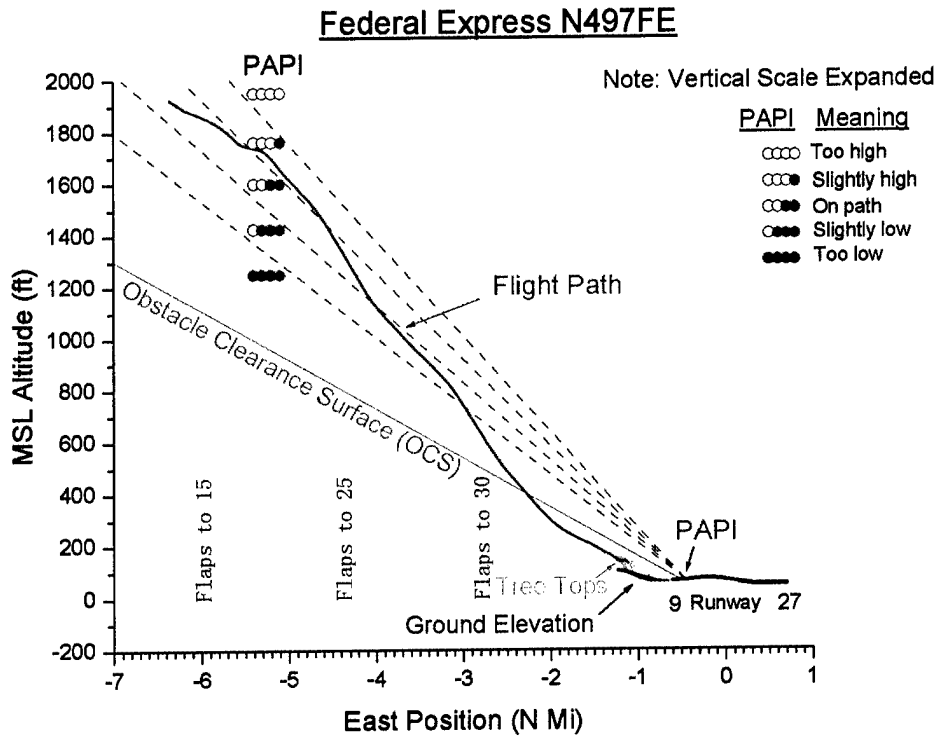
Figure 1. Descent profile of FedEx flight 1478.

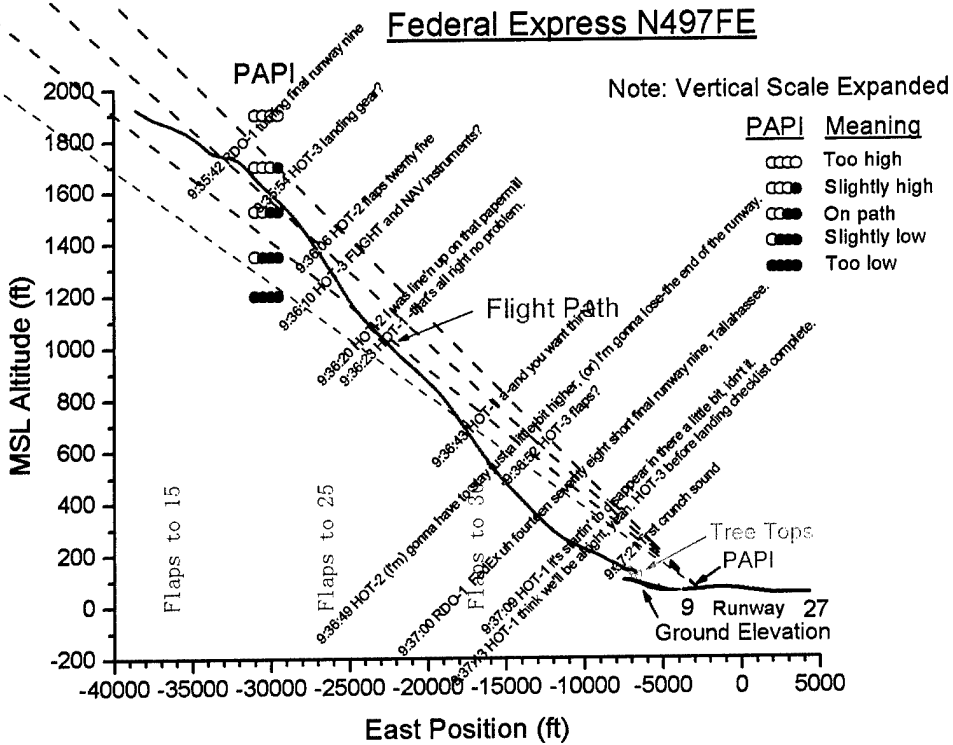
Figure 2. Descent profile of FedEx flight 1478, with select CVR comments overlaid.

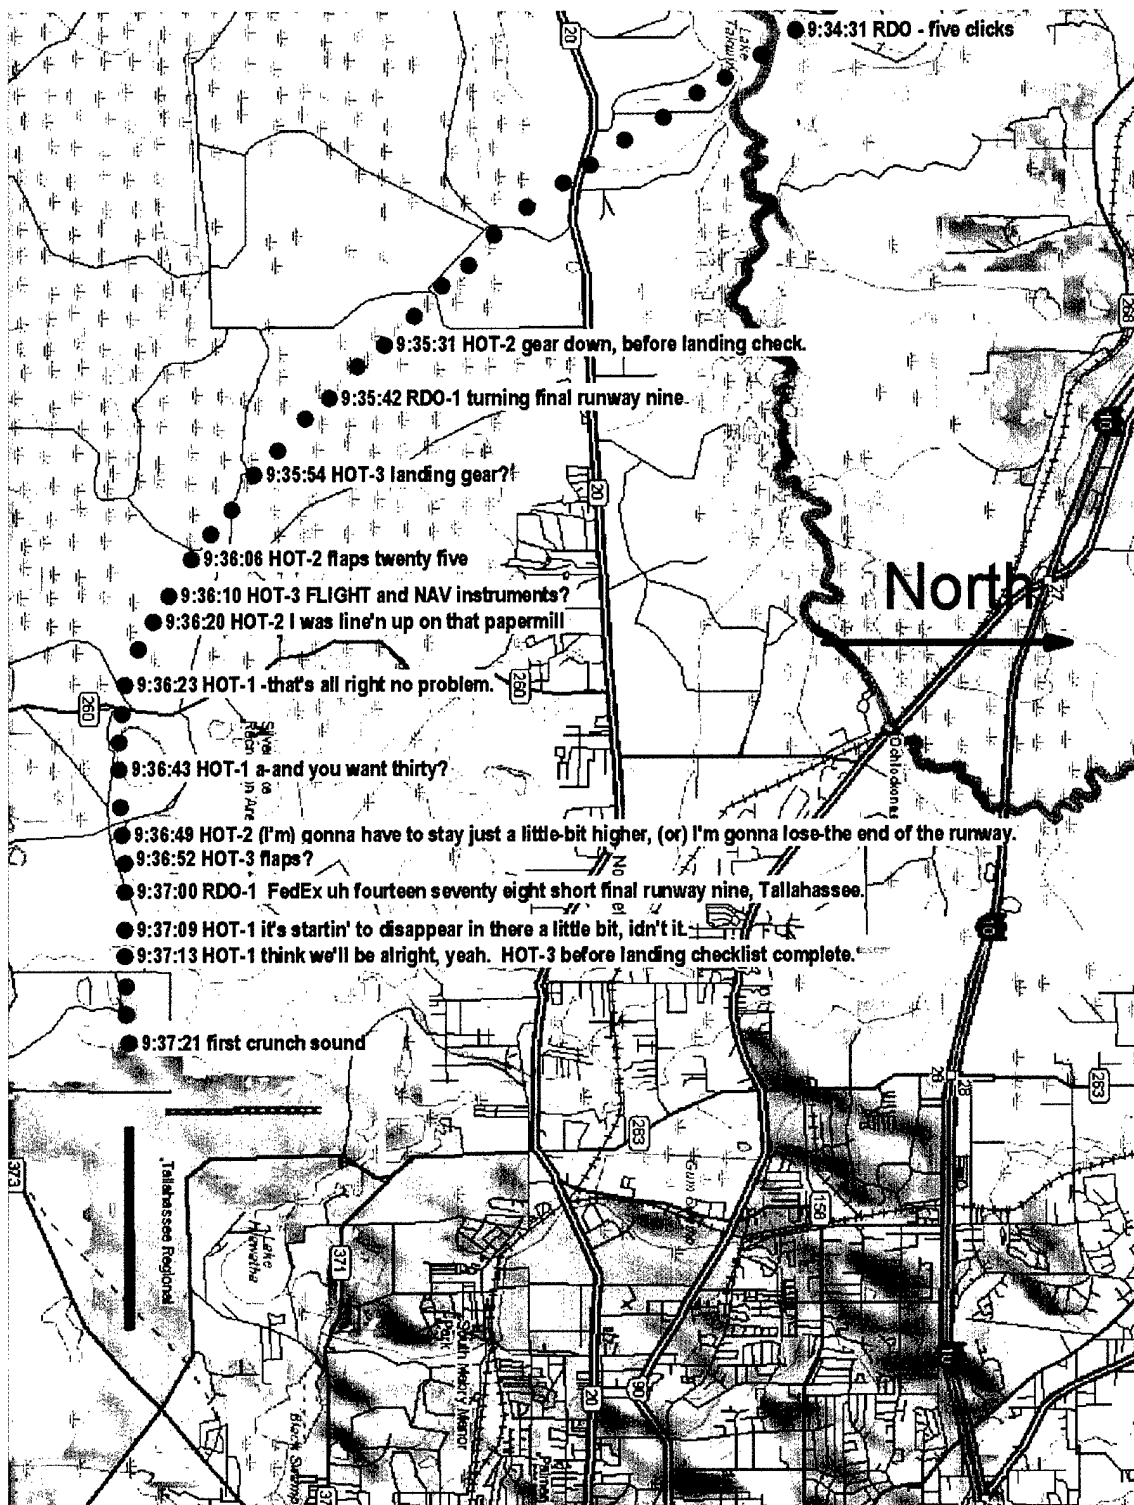
Figure 3. A map overlay of FedEx flight 1478's radar track into runway 9 at TLH, with excerpted CVR comments.

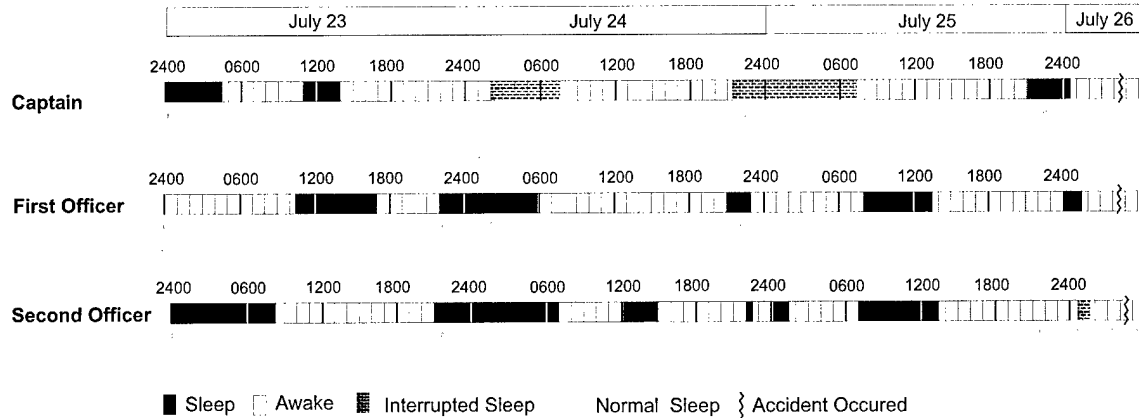
Figure 4. The three crewmembers' estimated sleep schedule during the 72 hours before the accident.

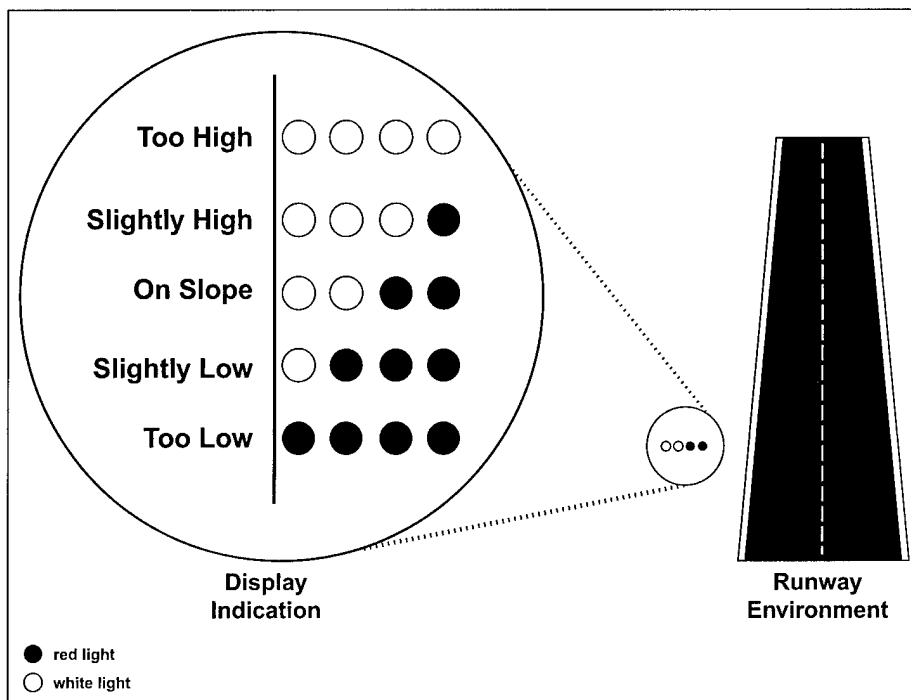
Figure 6. PAPI indications from various approach path angles.
