# FAILURE OF TUNGSTEN HEAVY ALLOYS SUBJECTED TO DYNAMIC TRANSVERSE LOADING

## ABSTRACT

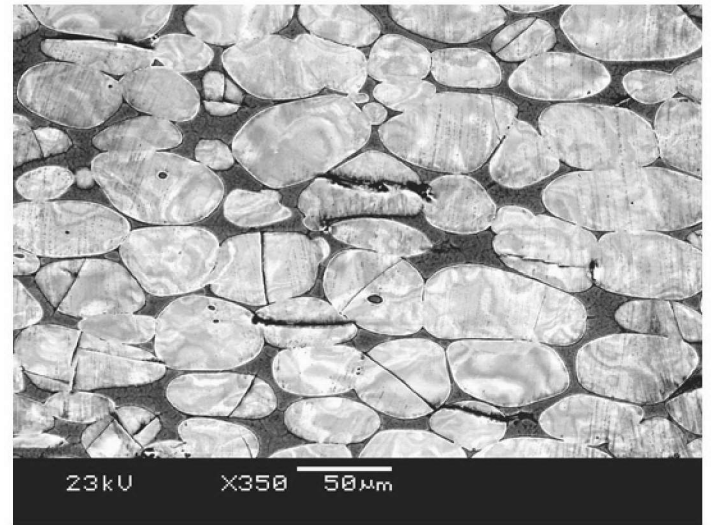
The measured properties of the specimens are summarized in Table 2. It was found that there was a fundamental difference in the nature of the different surface finishes, causing them to fall into two distinct categories: those with processing-induced surface damage and those without. Upon close SEM examination of the EDM, SP, and EP surfaces of both alloys, it became apparent that significant damage existed in the form of extensive microcracking of W grains. EP surfaces offer the best example of this, having effectively removed the EDM residue layer from the surface and revealing the true nature of the base material. In the EP surface micrograph in Fig. 3, fully 33% of complete surface grains in the image (20 out of 60) are either flawed or associated with flaws. The surface flaws were introduced by the EDM cutting. Only the CG and CG-SP-EP finishes totally removed the layer of cracked surface grains. Details of the effects of surface preparation can be found in Tarcza [2004].

Figure 3. SEM surface micrograph of EP WNiFe

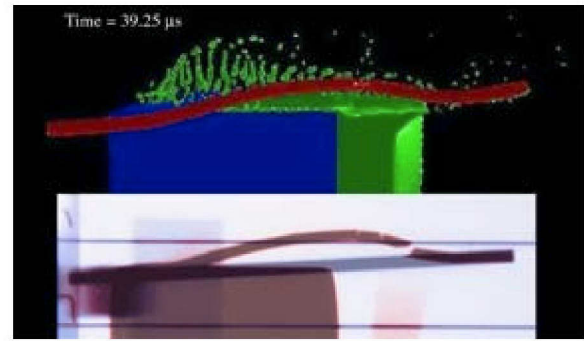
The general response of rods is to be thrown into an arc trajectory. The initial part of the rod that misses the steel block is undeflected. However, the lateral force increases as the rod is more embedded into the plate – giving the back of the rod the highest transverse velocity. The x-rays are taken soon after exit from the plate, so the gentle curvature of the rod shown in the x-rays does not wholly reflect the fact that the back of the rod has experienced a more violent event than the front. This idealized behavior of the rod is most easily shown in a numerical simulations, displayed here in Fig. 5 (from Fuentes, 2003), where it is compared to an experimental result from Shot 717, conducted at 2.3 km/s with EDM WNiFe material.

Figure 5. Upper: CTH simulation of rod showing leading part that missed the block, next part that has been deflected, and trailing part that is still within slot. Lower: Shot 717: x-ray superposition of initial position of rod and dynamic deflection of rod.

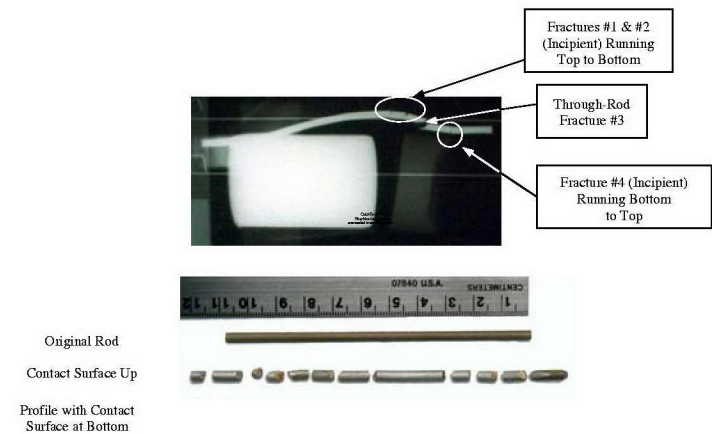
The actual tungsten rods emerged from the target with multiple fractures, as shown in Fig. 6. These fractures are initiated under tensile loading, typically on the side of the rod opposite that interacting with the target. Fractures deflect gradually toward the rod tail, the direction of sliding load motion, developing a characteristic lazy-S shape. The one exception to this is shown in Fig. 6 fracture #4, caused by initial rod-launch package contact in the vicinity of fracture #3, which forced the nose of the rod to whip clockwise. This generated a backwards-fracture running from bottom to top, opposite from the fractures caused by the rod bending in response to contact with the launch package, such as in fractures 1–3 in Fig. 6. The rod segments have a fairly uniform size, with an average mass of 1.0 g as determined from recovered fragments.

Figure 6: Recovered fragments from shot 717.

The results of the above experiments can be explained in terms of fracture of a rod that was deflected by the cavity stress in the target, deformed in flight, and fractured due to the bends that resulted from transverse velocity gradients.

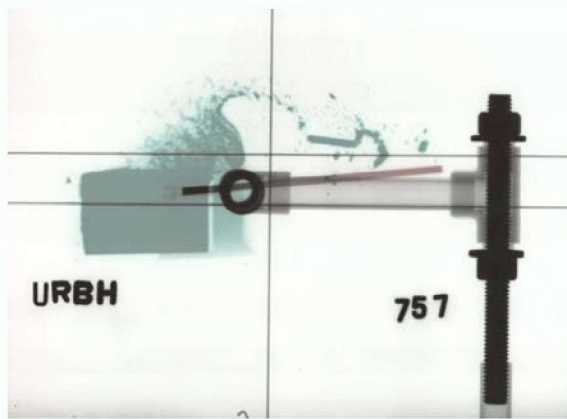
An entirely different failure mode was observed, for example, in Shot 757, shown in Fig. 7. In this experiment, the slot-cutting process has become unstable. There resulted a violent disruption that produced locally very high velocity gradients and very fine fragmentation of the rod. Figure 8 shows the fragments recovered from shot 757. The fractures involve axial splitting of the rod, as opposed to the transverse rupture that occurs normally.

Figure 7. X-ray of deflected rod in Shot 757.

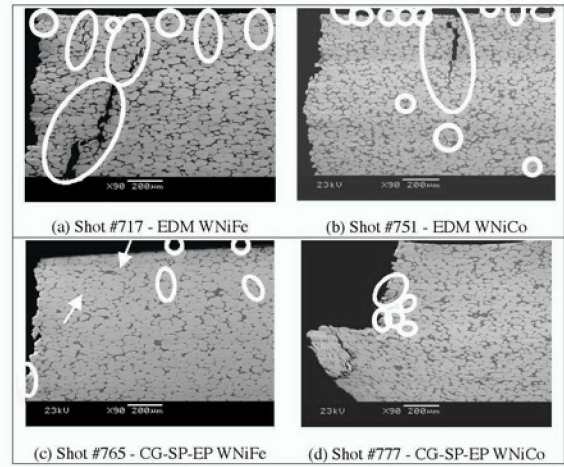
of the distribution of fractures initiated on tensile surfaces after reverse ballistic tensile surfaces show the largest cracks to be uniformly spaced approximately 200  $\mu\text{m}$  apart. In contrast, CG-SP-EP surface improvement greatly reduces the damage visible at a 90x magnification for both alloys, and the largest fractures are linked W grain cleavages nucleated in the interior of the rod segments, as shown in Fig. 10. In the case of the WNiCo specimens, the proximity of internal fractures to the tail end of the segment and the absence of any other incipient fractures makes a strong case for rod failure from internally nucleated damage; this is less clear for the WNiFe CG-SP-EP specimen.

Figure 10. Normal cross sections of specimens with fracture initiation sites identified (tensile side on top).

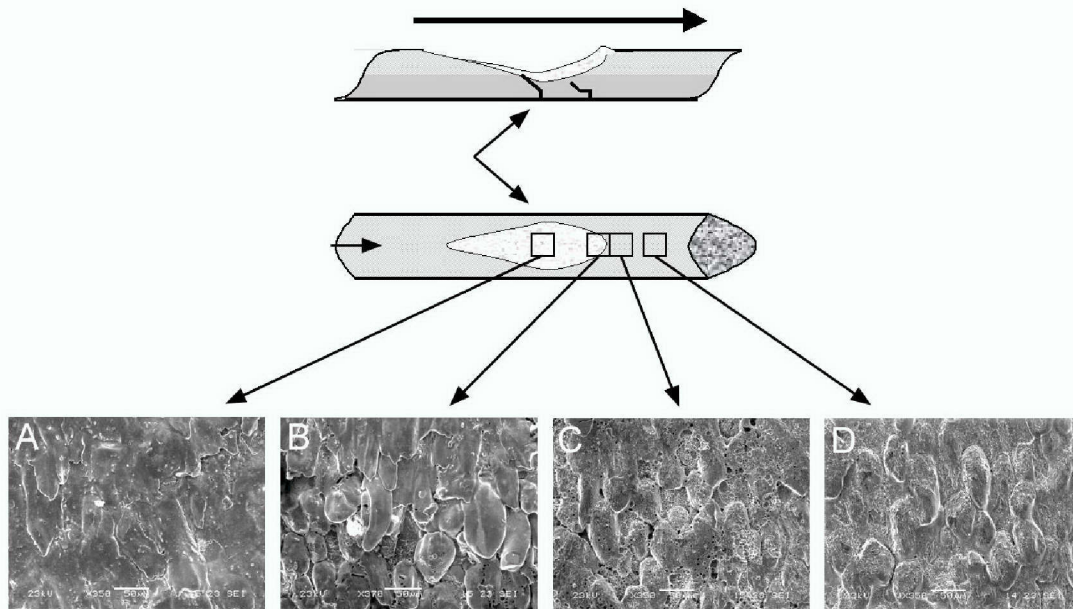
Recovered specimens with gouges were examined. Transient loading induced by high velocity sliding contact acts first at a discrete location, triggering an expanding region of significant plastic surface deformation. Contact conditions become more severe as the gouge region expands, leading to surface melting and material removal, as well as gross W grain deformation. This causes a scaly, smeared appearance as W grains are elongated, flattened, and overlapped, as shown in Fig. 11(a). Contact surfaces on the rod and target are expected to gouge simultaneously, and material from the growing crater(s) is drawn downrange as the transient load begins to diminish. Gouges terminate with a lip of this material pushed up at the tail end of the gouge as shown in Fig. 11(b), followed by the region of gradually diminishing surface melting and solidification seen in Fig. 11(c). As steady-state contact conditions resume, the surface reverts to the more usual, scoured appearance of Fig. 11(d).

Figure 11. Examination of shot 757 gouge crater and nearby surface details. A) Gouge surface interior; B) Downstream gouge lip; C) Near beyond gouge; D) Far beyond gouge.
