US Army Corps  
of Engineers®

## Coastal Barrier Island Breaching, Part 2: Mechanical Breaching and Breach Closure

*by Ty V. Wamsley and Nicholas C. Kraus*

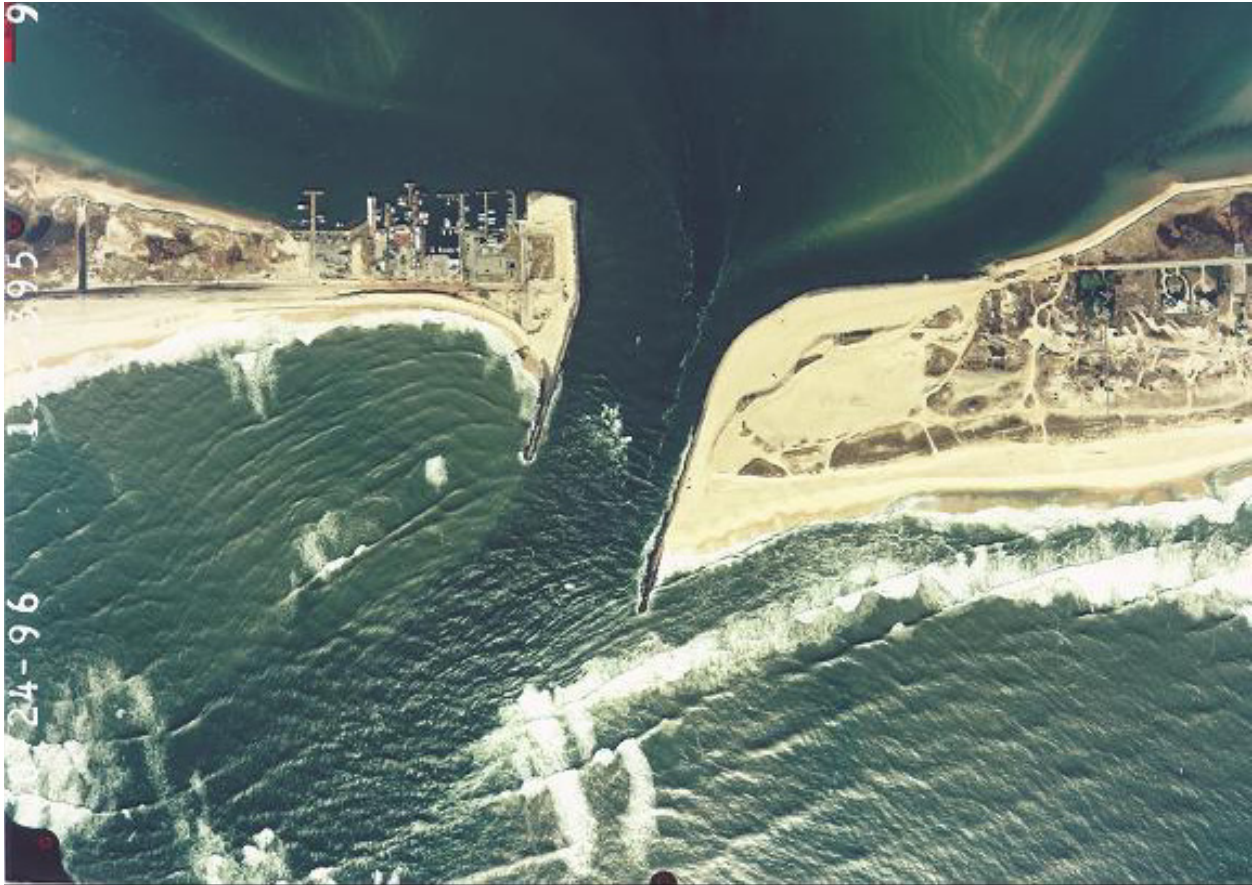
Figure 1 shows Shinnecock Inlet in October 1996, with the western beach (left side of jetties) eroded to endanger the public road and the marina complex on the north (bay) side of the barrier island. Emergency measures have been taken by the county and town during severe storms to prevent breaching. The U.S. Army Engineer District, New York, places material dredged from the Federal channel onto the eroding beach segment as a least-cost disposal alternative.

Figure 1. Shinnecock Inlet, NY, showing severely eroded downdrift beach adjacent to downdrift jetty

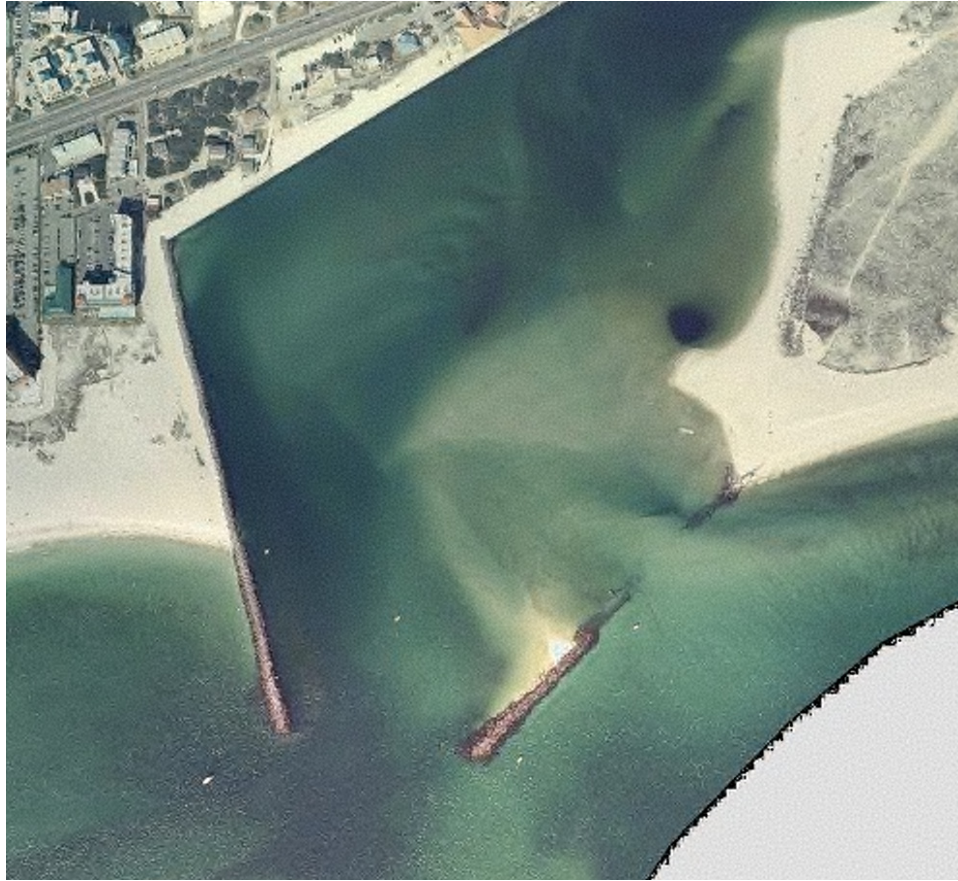
Perdido Pass, FL, is an example of breaching that occurs on the updrift side of the inlet because the jetty does not extend sufficiently landward (Figure 3). The updrift (east) beach adjacent to the east jetty is monitored and filled by the U.S. Army Engineer District, Mobile, to prevent further opening of breaches that occasionally occur there, such as after 2004 Hurricane Ivan.

Figure 3. Perdido Pass, FL, February 2003, with spit on right side protruding into channel behind weir jetty

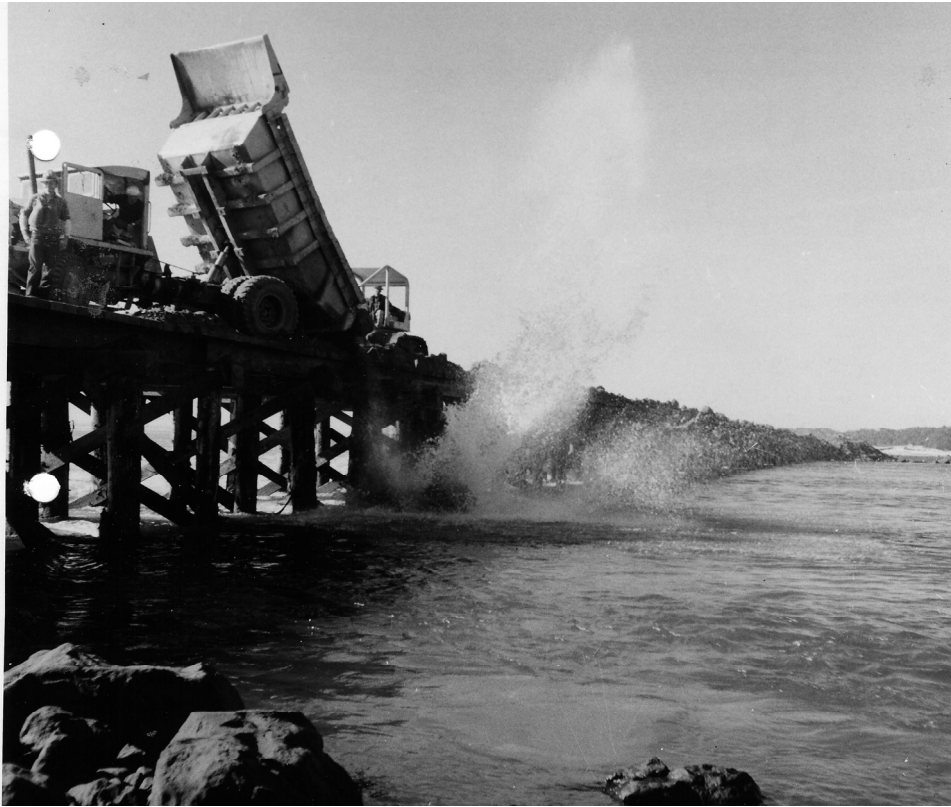
The rock fill was placed across the breach channel from the mainland to the north wing spit. The first stone was placed in May of 1956. The rock fill was built with conventional end-dump methods (Figure 4). A dozer made the final placement of the rock. It had a top elevation of 6.1 m (20 ft) mllw and a top width of 4.6 m (15 ft). The side slopes were 1 on 1-1/2. Eighty percent of the rock on the

Figure 4. Rock fill by conventional end-dump method (Henshaw 1956)

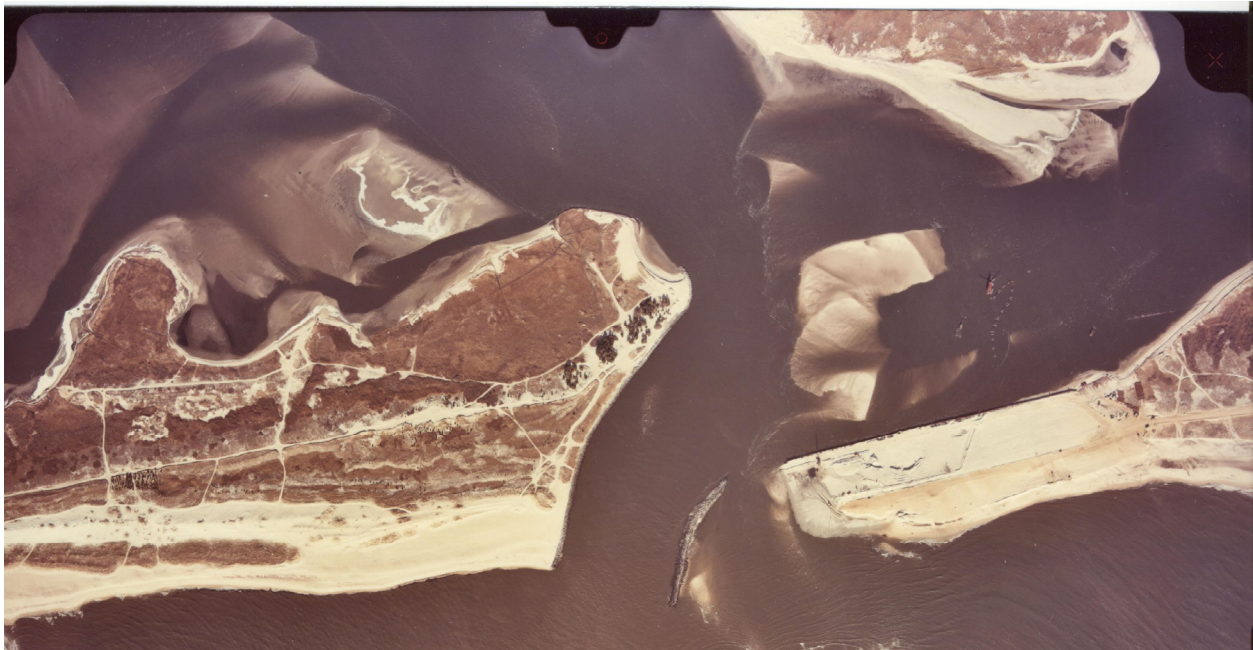
Figure 6. Moriches Inlet breach fill construction nearing completion, 4 December 1980

The method selected for the breach fill included construction of two temporary sheet-pile walls 9.1 m (30 ft) apart and parallel along the bay side of the breach. The initial option of placing the sand with no temporary retaining structures was discarded because of the potential for a high loss of fill material as the operation was to take place during the winter storm season. In addition to minimizing

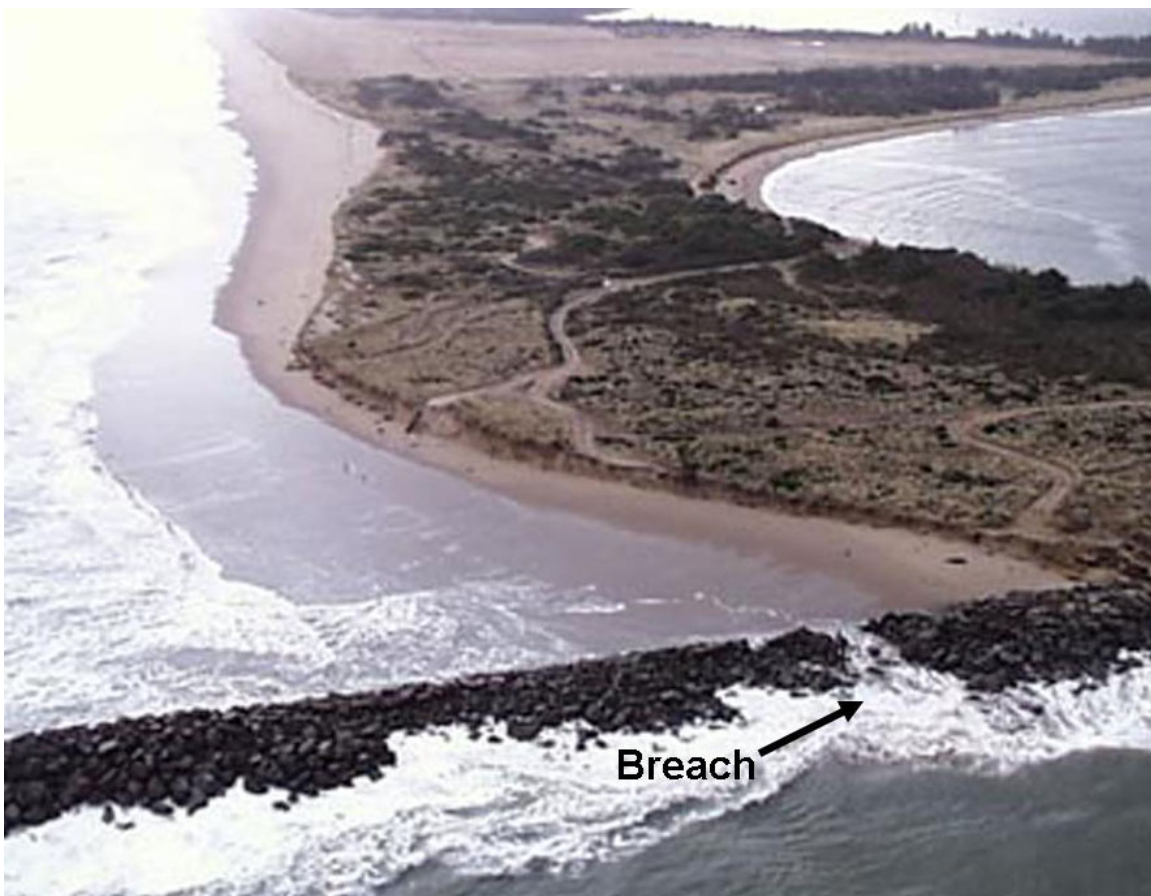
Figure 8. Coos Bay, OR, breach of north jetty (Hays et al. 2003)

Following the breach, the beach adjacent to the north jetty eroded, losing an estimated 30,582.1 cu m (40,000 cu yd) of sand through the breach and into the entrance. The beach profile elevation was lowered approximately 75 m (6.5 ft). Tidal flow through the breach widened the damaged area in the weeks following the storm. Approximately 40 days after the jetty breached, the opening had widened from an initial 4-m (13-ft) width to about 245 ft. The jetty breach caused rapid shoreline recession and, if not closed, could have resulted in a breach of the barrier spit.

Because of the continued damage to the jetty and the transport of sediment through the jetty and into the navigation channel, the U.S. Army Engineer District, Portland, initiated the coordination of an emergency repair on 25 November 2002. Construction began on 20 December 2002, and the repair was completed on 9 January 2003. The jetty was restored to the 1939 design cross section with slightly larger stone to improve structure stability. A jetty “bench” was also constructed along the structure to protect the foundation from return flow scour. The bench is a rubble mound constructed perpendicular to the jetty on the beach side to an elevation of +3 m (+9.8 ft) mllw and 6.1 m (20 ft) wide. The jetty repair also included a 38,227.7-cu m- (50,000-cu yd-) sand fill in the eroded area adjacent to the jetty breach. The fill replaced the sand lost through the breach and advanced the shoreline seaward of the repair area. The fill buried the bench and provides protection to the jetty root. The jetty has not sustained damage since the repair.

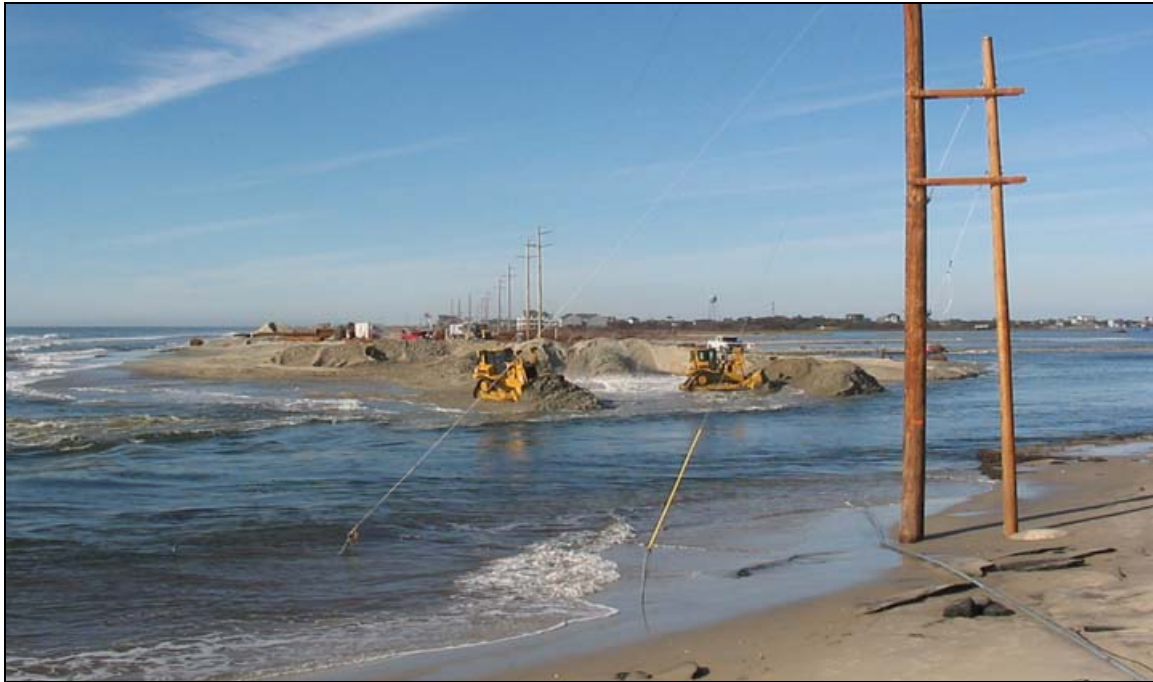
On 1 November 2003, approximately 30.5 m (100 ft) of the breach remained to be filled. Similar to Buxton Inlet, as the cross-sectional area of the breach was reduced, the current velocity increased and scoured much of the sand that was deposited, even with the large pumping capacity. To facilitate rapid advance of the fill and close the remaining portion of the breach, a narrow mound of sand was bulldozed across the breach at slack tide to prevent water flow through it (Figure 9). Once the flow of water was stopped, additional material was added to the narrow mound to fill the remaining design template without the losses caused by the tidal current. The final closure began at high tide and was completed at low tide, thus allowing several hours for the berm to be widened before wave runup began to erode the berm at higher water levels. No material was stockpiled in advance, but a 1,758.5 cu m (2,300 cu yd) per hour dredge production rate provided a sufficient source of sand to build a small dike across the remaining breach. It was observed that the final closure would have been facilitated by stockpiling sand on the bank opposite the dredge pipe outlet. The stockpile would have allowed sand to be pushed from both sides of the breach.

Figure 9. A view of first attempt to complete closure looking to west from eastern bank of breach (Wutkowski 2004)
