# **NAVAL POSTGRADUATE SCHOOL**

**ANALYSIS OF THE FAILURE OF A VACUUM SPIN-PIT  
DRIVE TURBINE SPINDLE SHAFT**

Jason M. Pettitt

September 2005

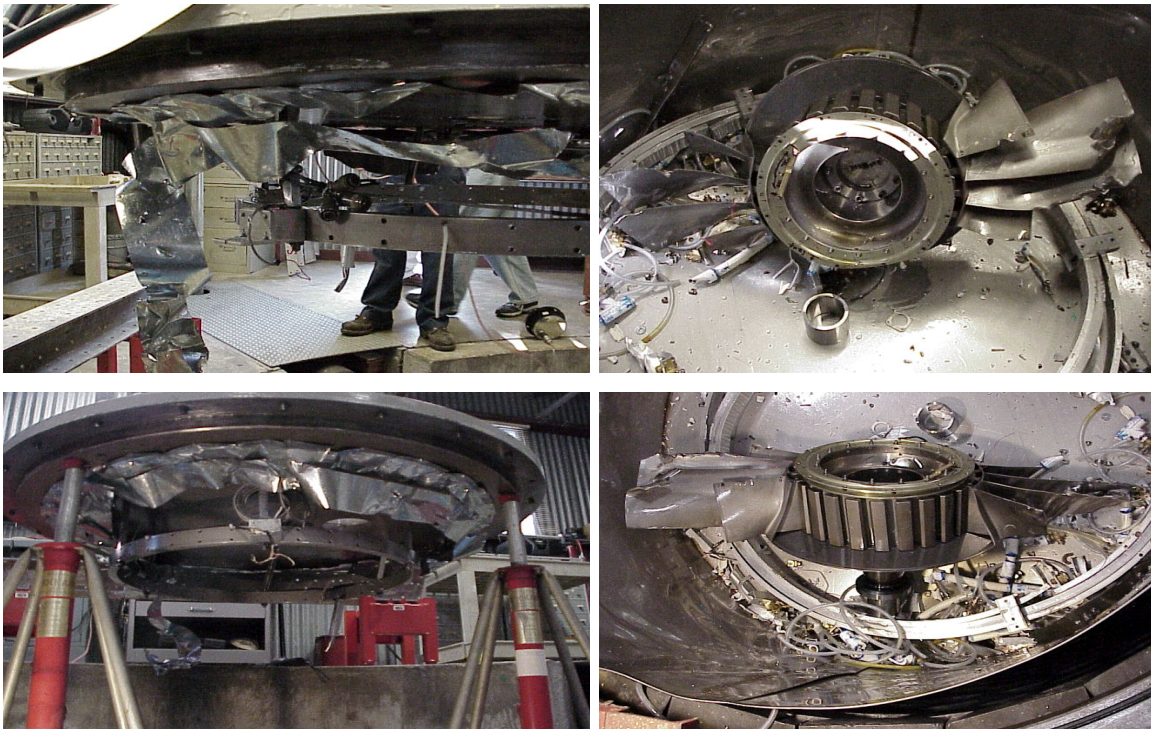
Figure 6. Images of Failure Aftermath

7600 RPM. However, during this initial run, while checks were being made of the instrumentation, the RPM drifted up to around 1600 RPM. Once the operator realized the upward drift, the speed was immediately increased to 2000 RPM. Once all checks were completed, the RPM was then steadily increased towards the target speed. After about 15-18 minutes of operation, and at about 2500 RPM, the spindle shaft failed, dropping the rotor into the spin pit. There was extensive damage done within the pit. All instrumentation and the oil-excitation system were destroyed. However, the pit itself, and the stainless steel liner which collected the injected oil, were intact.

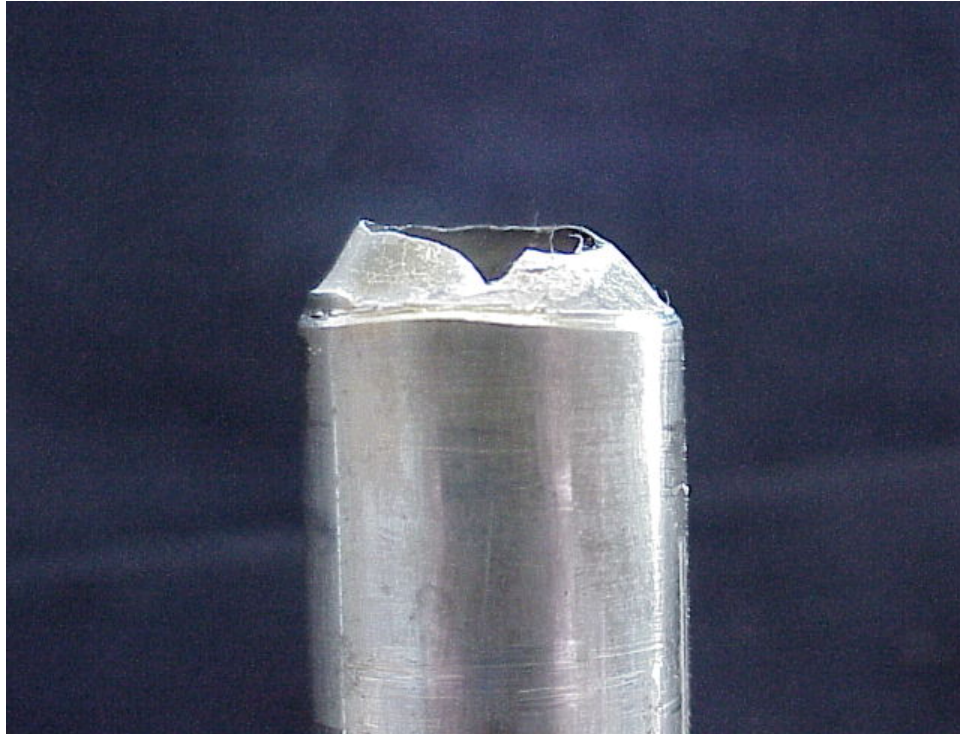
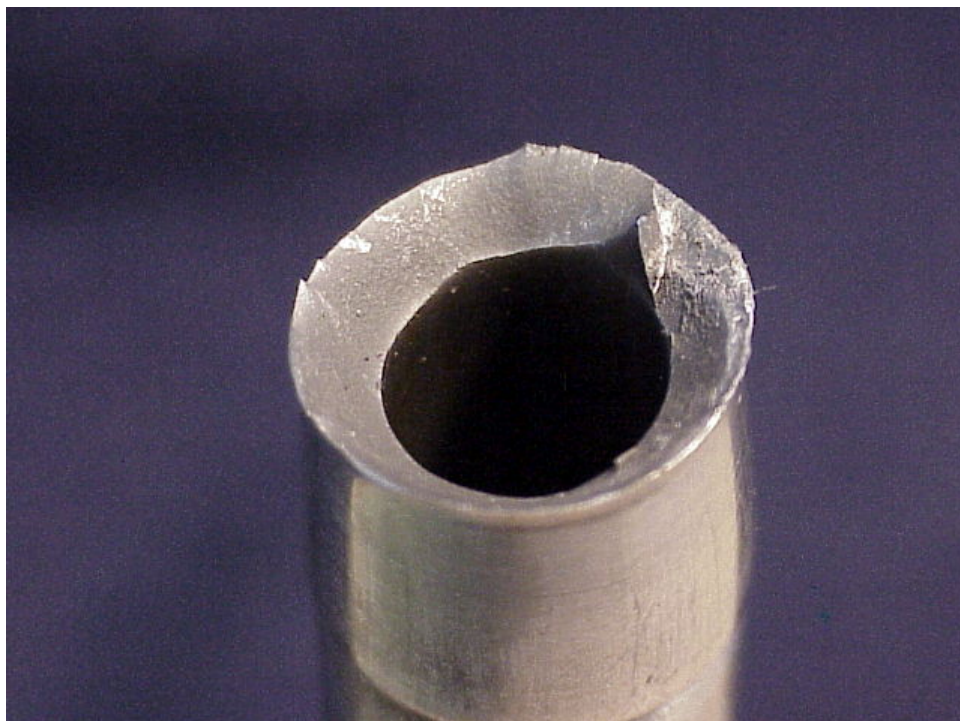
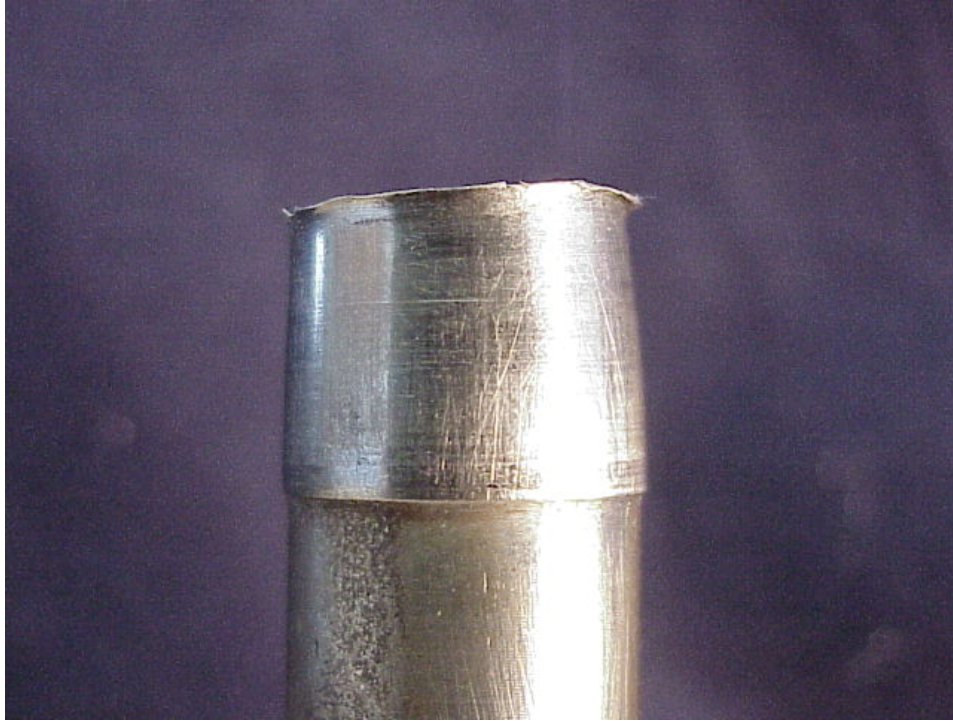
The shaft was removed from the spin pit and care was taken to not damage the fracture surfaces on the spindle. Photographs were taken, as shown in Figures 9-13. A cursory visual analysis of the failed shaft and photographs revealed extensive plastic deformation and a generally dull, fibrous surface texture, - two observations that are strongly indicative of ductile failure by microvoid formation and coalescence. Also, the failure plane was approximately 45 degrees to the longitudinal axis, - suggestive of a ductile fracture in tension. The elongation and deformation was most noticeable on the outer diameter of the shaft whereas the inner diameter remained relatively unchanged.

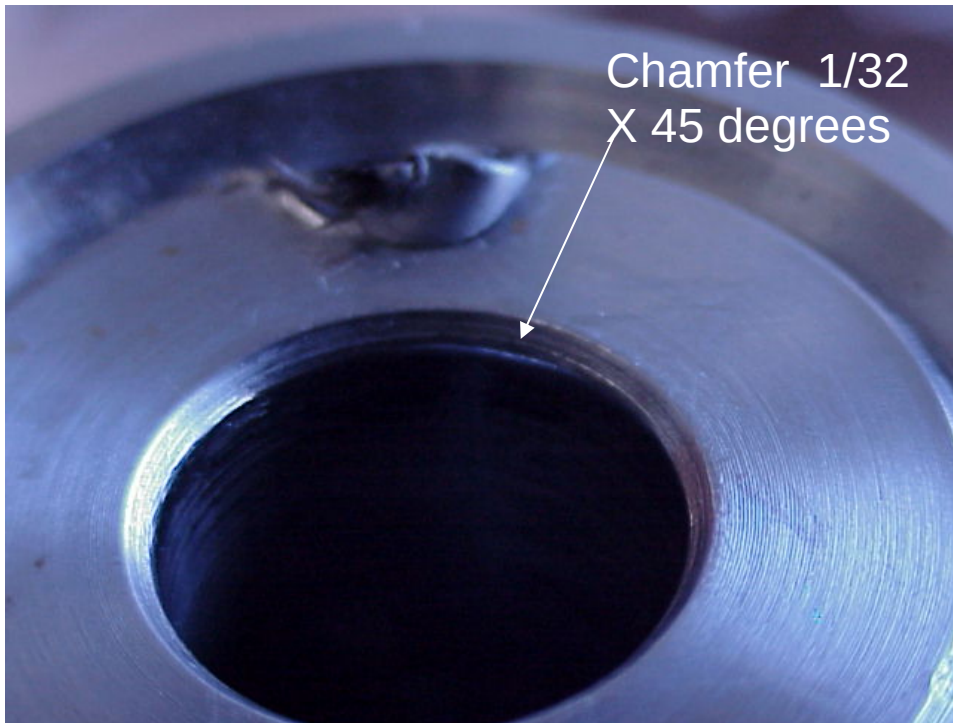
Figure 13. Spindle/Adapter Interface with 45° Chamfer

Figure 13 shows a picture of the adapter/spindle interface, the location where the fracture occurred. One interesting aspect is the 45 degree chamfer at the plane of fracture. This (sharp) chamfer would put a stress raiser on the outer diameter of the shaft. Also, the adapter connected to the spindle shaft through a pinned connection approximately 3 inches below this interface. Because the shaft transmitted torque to the adapter through the double pinned threaded connection, it is possible that a phase shift could have occurred between the shaft and adapter. This shift would have put a torsional stress on the shaft. Both the upper spindle fracture and the adapter interface had a shiny, worn region on the outer and inner diameters, respectively, at the plane of fracture. This shiny, worn region likely would be caused from constant friction and angular movement between the shaft and adapter at the chamfer.

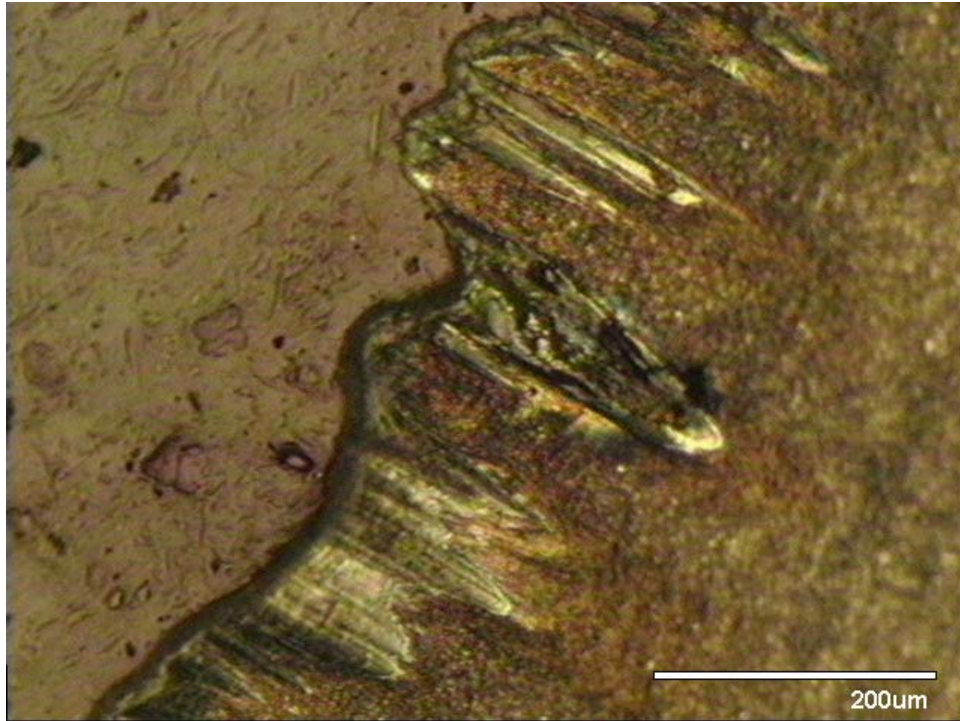
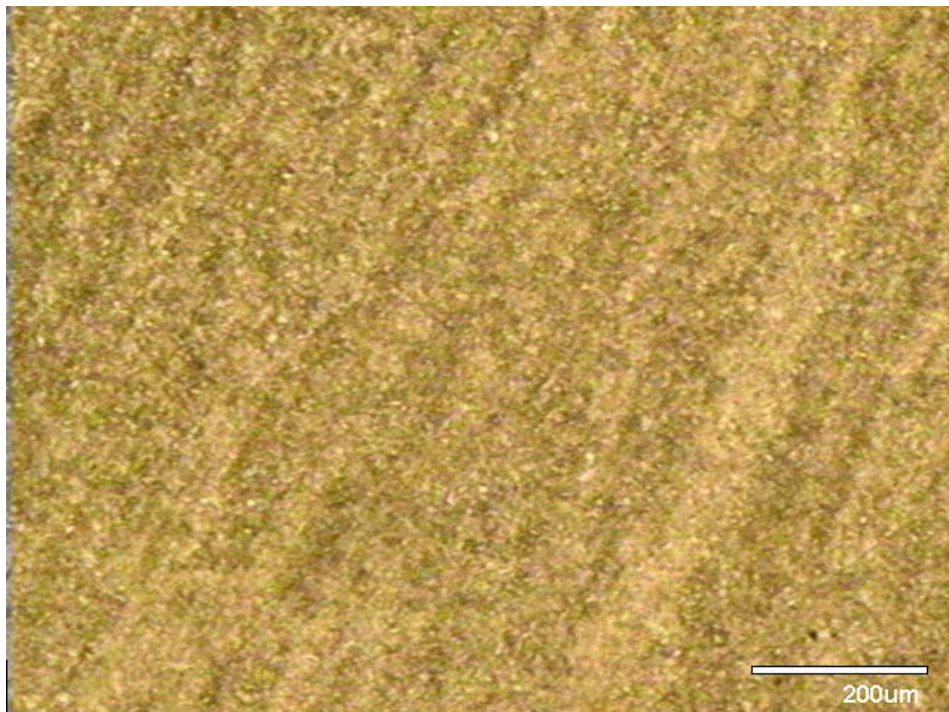
Images taken at 290 $\times$  magnification (Figures 15 and 16) provided little conclusive evidence as to whether or not the material was potentially flawed. The images taken at this low magnification did provide an exceptional macroscopic image of the fracture surface perimeter and documented the steel's heat treatment.

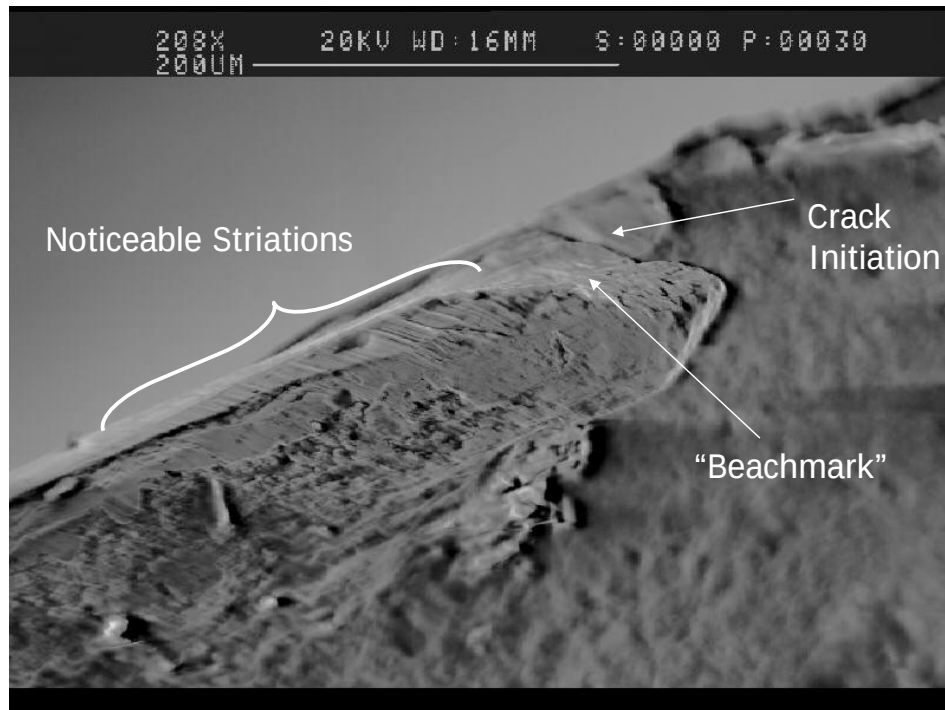
Figure 24. SEM Fractograph 4 (Crack Initiation)

Continuing around the perimeter, an image of the crack initiation point was captured. Figure 24 clearly shows the point of crack initiation. There is a large beachmark present which indicates the large initial propagation of the crack. The noticeable striations indicate the cyclic propagation of the crack that occurred during each spin-up of the spin pit.

These four SEM fractographs suggest failure by two distinct modes: (1) low cycle, high-stress fatigue (LCF) and (2) ductile failure through microvoid formation and coalescence. The latter mode is indicated by the presence of numerous spherical, equiaxed microvoids ranging from approximately 1-3  $\mu\text{m}$ , as well as generally fibrous texture of the fracture surface. Fatigue is also strongly

indicated by the presence of striations. Also, the size of the fatigue zone compared to the instantaneous zone is relatively small, less than 10% of entire failure area, which supports the notion of high stress, low cycle fatigue.

In the interest of preventing this type of failure in future tests, some recommendations for changes to the system and its operation are made. First, although the standard 1000 RPM dwell speed is away from bending and torsional modes, the ARMD program does not have the ability to couple bending and torsion together in a single analysis. Therefore, because the most harmful resonant modes are at lower operating speeds, it is recommended that all system checks be performed before start up, or expedited as much as possible, and speed quickly increased to the target operating speed. Also, an increase in thickness of the spindle shaft is recommended. An increase in thickness will decrease the stresses on the outer diameter of the shaft. Also, by increasing the thickness, critical crack depth will increase and crack presence should be easier to identify. With this increase, it is also recommended that a visual inspection of the system be performed after every test. Special attention should be given to the spindle shaft, thoroughly looking for cracks and deformation. At the spindle/adaptor interface, it is recommended that the 45 degree chamfer be changed to a radiused chamfer in order to alleviate the stresses at the plane where the fracture took place. Also, proximity probes should be placed above the interface (on the spindle shaft) and below the interface (on the adaptor). Two probes should be placed at each location and should be set 90 degrees apart. They should then be monitored in order to determine if there is a substantial phase shift occurring between the spindle and adaptor configuration. Finally, it is recommended that staff at the Turbopropulsion Laboratory take a training course or

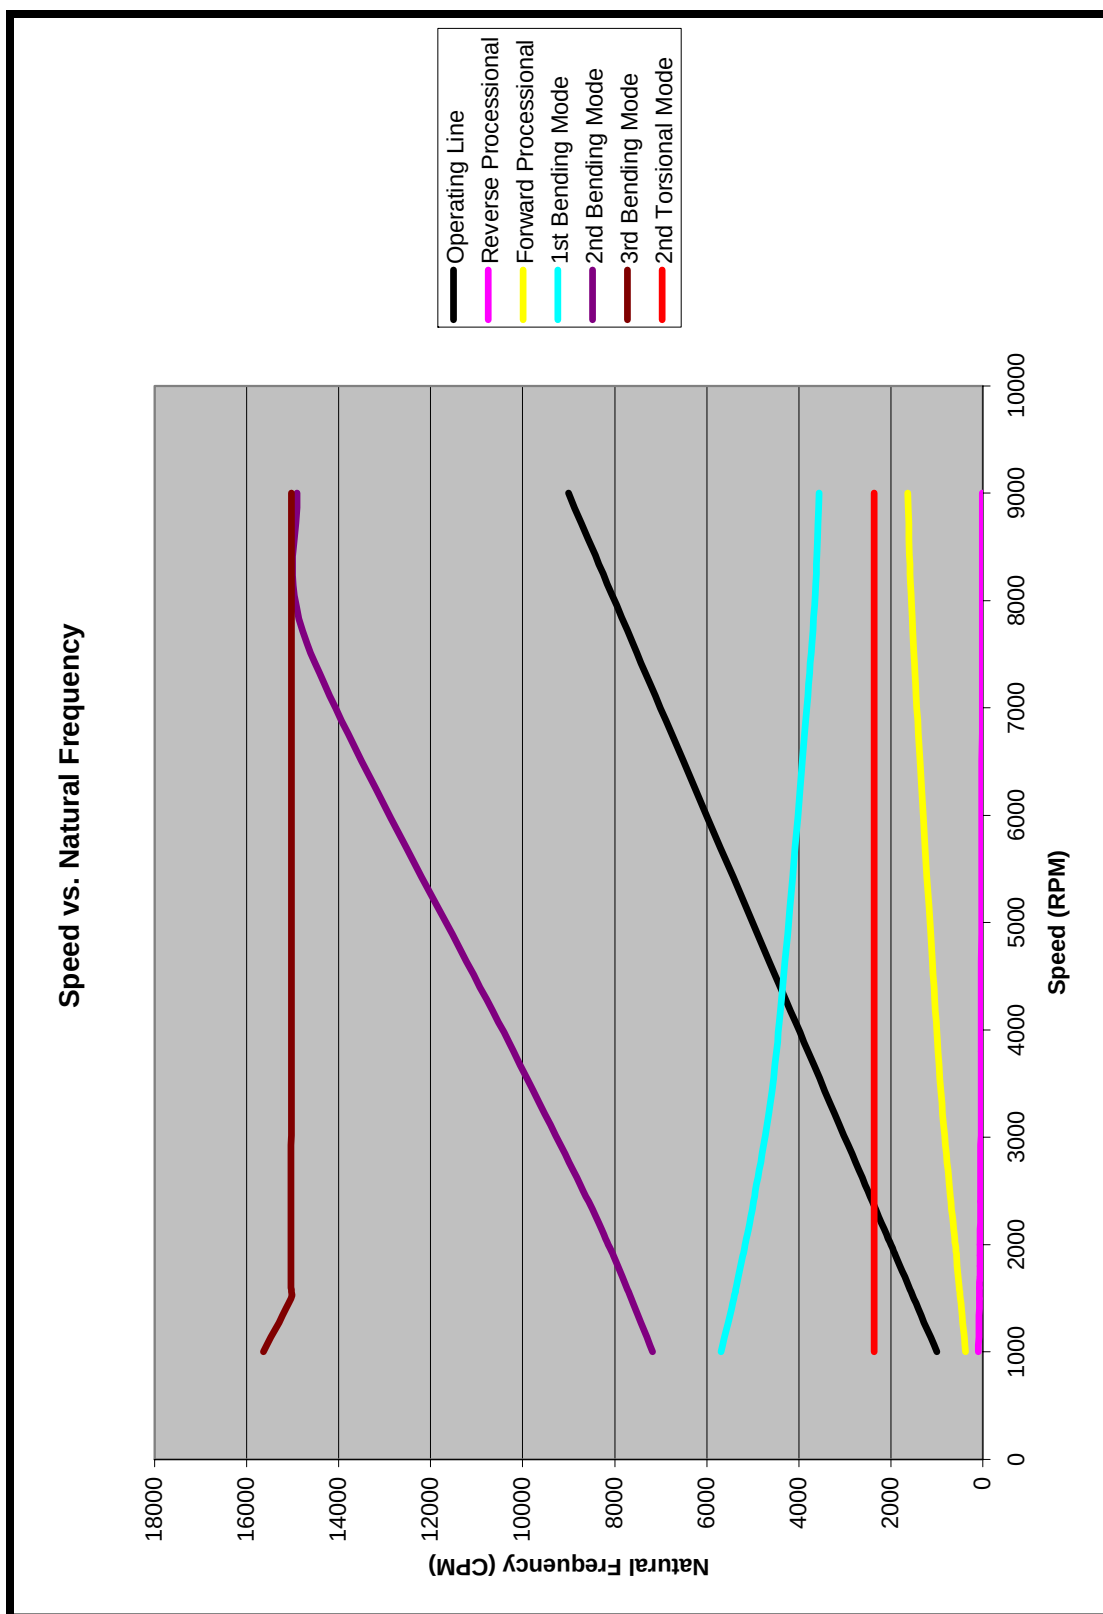
Figure 28. Campbell Diagram

From the Campbell diagram it is clear that the only bending mode that could possibly present a problem is the 1<sup>st</sup> bending mode. However, this mode intersects the operating line (1/rev) at approximately 4300 RPM, which is outside the normal operating speed range. As long as the speed of the system never dwelled at this speed, no damage would have occurred due to 1<sup>st</sup> bending.

The torsional vibration analysis yielded two torsional modes that existed within the operating speeds. The first torsional mode is present at an insignificantly low speed of approximately 15 RPM. However, the second torsional mode is located at approximately 2350 RPM. This mode is close to the speed of 2500 RPM where failure occurred.
