**NSWCCD-65-TR-2005/24** October 2005

### **Structural Irregularity and Damage Evaluation Routine (SIDER) for Testing of the 1/2-Scale Corvette Hull Section Subjected to UNDEX Testing**

From: Commander, Naval Surface Warfare Center, Carderock Division  
To: Chief of Naval Research (ONR 332)  
Subj: SIDER NDE INSPECTION OF A 1/2-SCALE CORVETTE HULL SECTION  
Ref: (a) Project Agreement RTP-US-GE-N-95-002  
Encl: (1) NSWCCD-65-TR-2005/24, *Structural Irregularity and Damage Evaluation Routine (SIDER) for Testing of the 1/2-Scale Corvette Hull Section Subjected to UNDEX Testing*

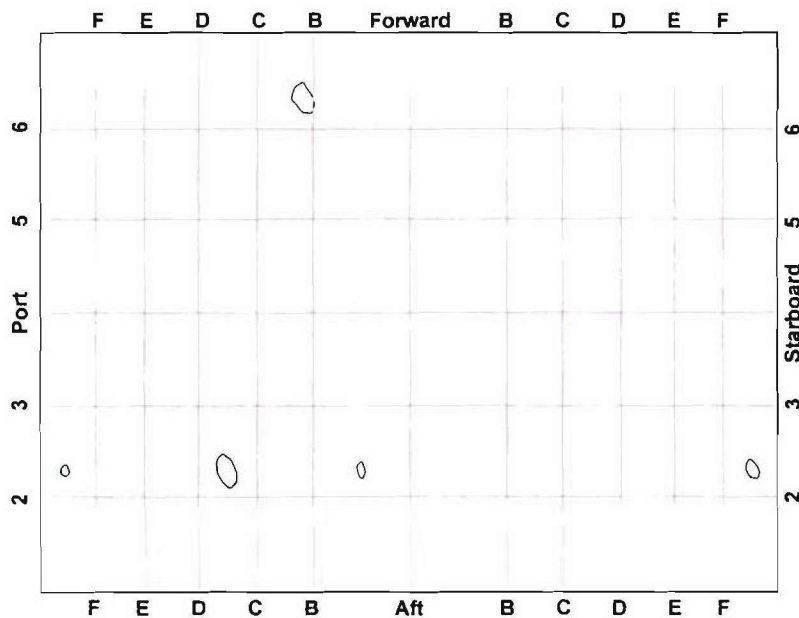
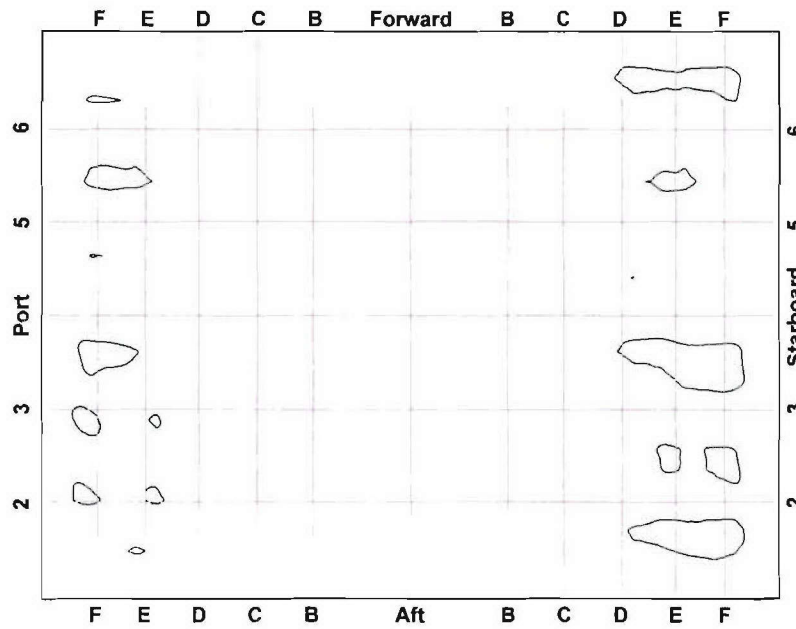
With the patch applied, the difference between this last baseline set ID#0c and the original baseline ID#0a is shown in Figure 12 and Figure 13. The figures show that there is almost no difference between the baseline ID#0a and repeat baseline ID#0c. For the remainder of the results shown here, ID#0a was arbitrarily selected as the true baseline.
