# **Commercialization of Technologies to Lower Defense Costs**

## **Final Demonstration/Validation Report For STAPP Bullet Catcher Evaluation at Fort A.P. Hill March 2, 2006**

Contract No. W74V8H-04-D-0005  
Task No. 0403  
CDRL A012  
Report Number: NDCEE-CR-2006-001

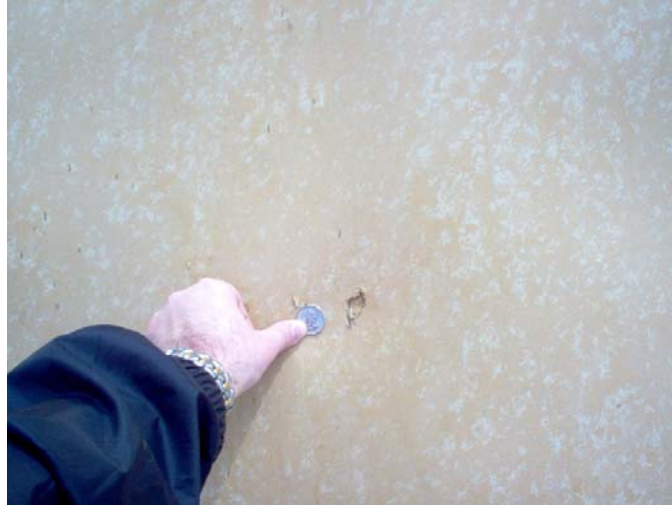
The top rubber cover had a small v-shaped tear approximately the size of a US quarter (See Figure 33). There was not a gaping hole, just a tear. It is believed that a tumbling bullet that had hit the target frame prior to the top rubber cover caused the tear. Mr. Mike Hargett of BAHHR Training Group determined that no maintenance repairs were necessary at this time.

**Figure 33. Tear in Top Rubber Cover, Approximately the Size of a U.S. Quarter.**

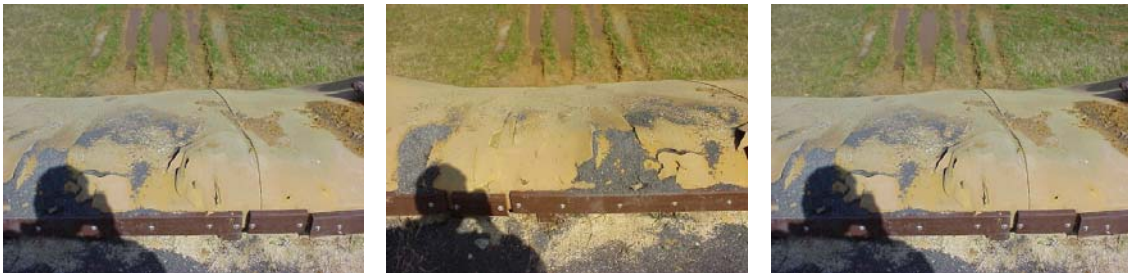
The top of the Bullet Catcher had severe damage to the upper portion of the top rubber cover (See Figures 38, 39, and 40).

**Figures 38, 39, and 40. Damage to the Upper Portion of the Top Rubber Cover of the Range 5 Bullet Catcher.**

The bullets hit the top portion of the Bullet Catcher because of the long distance between the firing point and the Bullet Catcher (approximately 271'). This large distance allows bullets to "travel" to the edges of the Bullet Catcher and beyond. Bullets that impact the Bullet Catcher at or near the edges are not able to penetrate the Bullet Catcher properly and therefore cannot be appropriately retained. The top portion of the Bullet Catcher, where it becomes flat, showed the most damage. Bullets that were fired at an upward angle or from the prone position caused this damage. When the bullets finally reach the Bullet Catcher they have traveled roughly 271' and have had the opportunity to "climb". The bullet then lightly penetrates the flattened out portion of the Bullet Catcher and simply skims the top rubber cover, tearing it as it passes. This damage is not due to a malfunction or inadequacy of the Bullet Catcher to perform, but is a direct result of the range design. Perhaps if the Bullet Catcher had been designed and constructed several feet taller this damage would not be an issue.

The top portion of the Bullet Catcher was patched. Steps taken to repair the damaged area were the same as for the smaller patches. Two large repair patches were needed for this top portion. Approximately 25-30 minutes were required to repair the entire top portion of the Bullet Catcher.

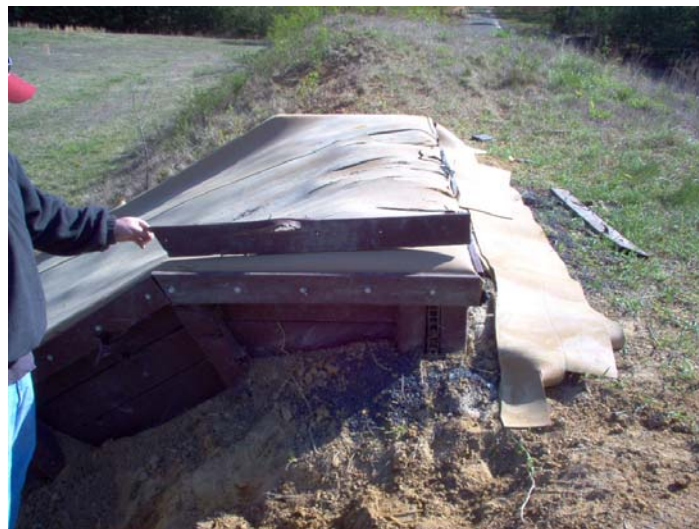
There was also a small piece of planking on the top left corner as well as a small damaged area of planking on the top right corner that needed to be replaced (Figure 41 shows the replacement planking for the right side.). After each piece of replacement planking was cut to size it was screwed into place. These repairs required approximately 5 minutes per section to complete.

**Figure 41. Damaged Frame/Plank Above-Replacement in Place Below.**

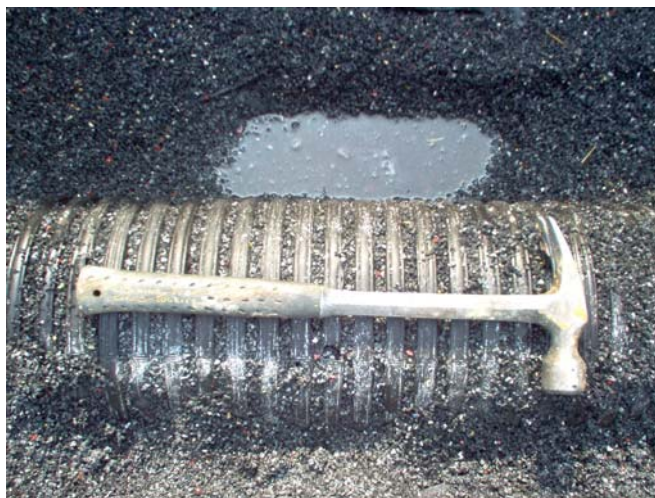
After the granular rubber was removed, it was noticeable that there was some water accumulation in the Bullet Catcher. A puddle of water, roughly one-half gallon, was lying next to the water collection pipe at Lane 53 (See Figure 50). This was an indication that precipitation had entered the Bullet Catcher, which would be sampled, analyzed, and properly disposed of.

**Figure 50. Puddle of Water at Lane 53.**

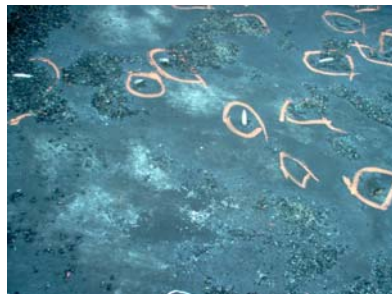
Again, Clean Harbors chose to utilize the STAPP-sifter during the sifting process. Range 5 had bullets throughout the depth of the granular rubber. Once the granular rubber was removed from the hot spot, the bottom rubber liner was visually inspected. Upon inspections it was noted that there were roughly thirty holes/tears in the bottom rubber liner caused by bullets penetrating beyond the depth of the granular rubber. Some of the holes/tears had bullets protruding from them with several facing away from the bottom rubber liner. For more detail please see Figures 53, 54, and 55.

**Figures 53, 54 and 55. Holes/Tears (circled) in Bottom Rubber Liner of the Range 5 Bullet Catcher.**
