# **Failure Analysis of a Cracked UH-1 Tailboom Former, P/N 205-030-807-97**

**ARL-TR-3828**

**June 2006**

**Scott Grendahl  
U.S. Army Research Laboratory  
Weapons and Materials Research Directorate  
Aberdeen Proving Ground, MD 21005**

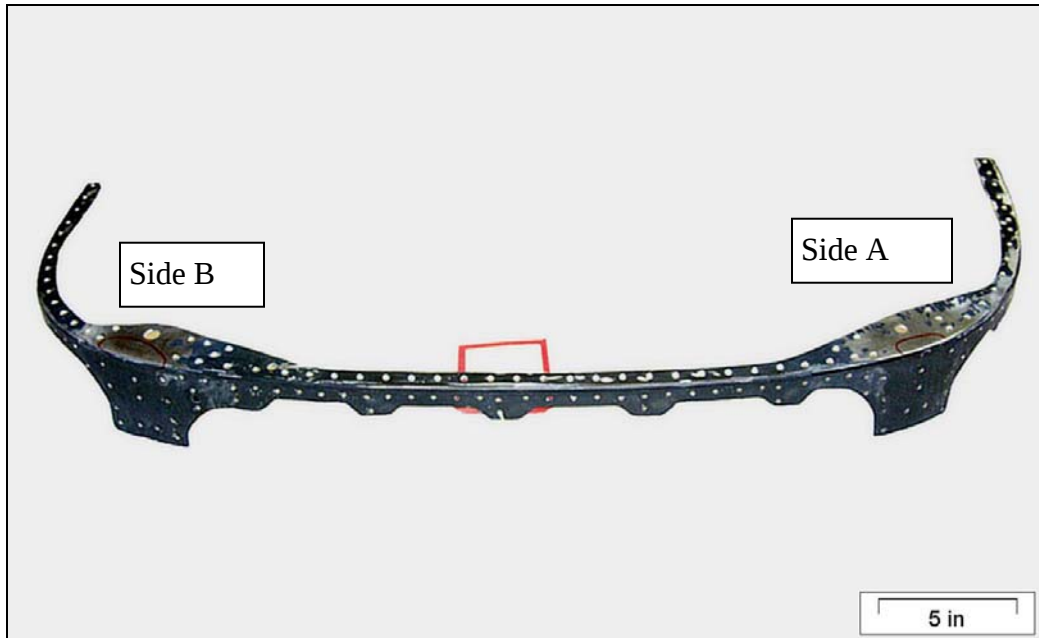
The U.S. Army Aviation and Missile Command sent the U.S. Army Research Laboratory Weapons and Material Research Directorate a UH-1 tailboom former (P/N 201030-807-97) from the U.S. Army Kwajalein Atoll facility (USAKA) in the Marshall Islands for investigation. The component was being investigated due to the presence of cracks observed near bolt hole locations on the part. This component was quality deficiency report exhibit number M24H90327. The material utilized to manufacture the former was specified to be clad 2024-T4 aluminum alloy sheet IAW QQ-A-362. QQ-A-362 is a very old cancelled specification. No copies of that specification could be recovered. It was superseded by QQ-A-250/5B, which was subsequently cancelled, and superseded by the current specification for clad 2024-T4 aluminum sheet, SAE-AMS-QQ-A-250-5. The part was characterized through nondestructive inspection, chemical analysis, optical microscopy, scanning electron microscopy, and mechanical testing. Figure 1 depicts the as-received tailboom former from USAKA.

Figure 1. As-received component UH-1 tailboom former.

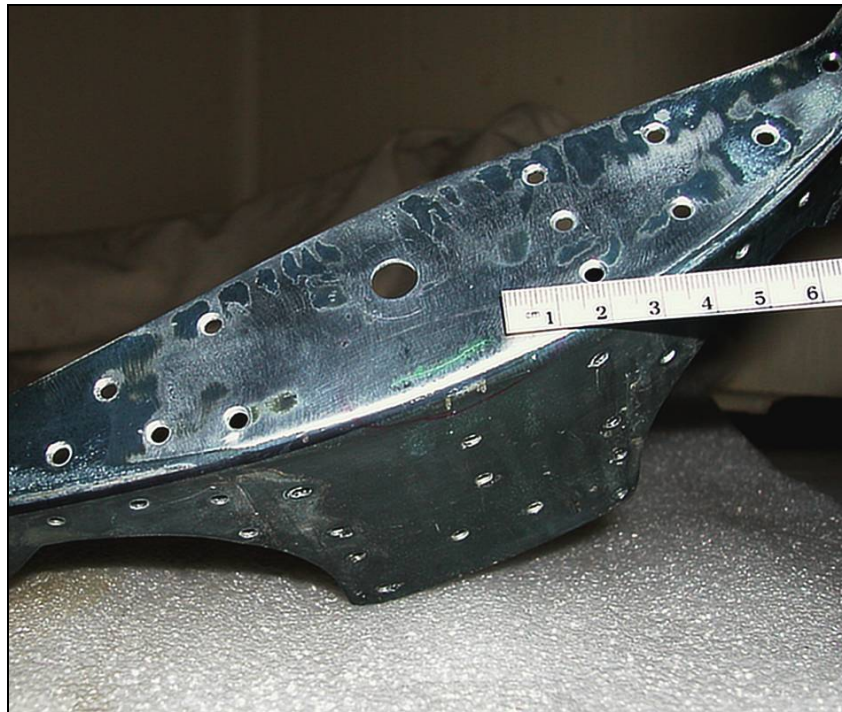
A 2.69-cm indication was noted on side A of the as-received image in figure 1. The crack can be observed at a higher magnification in figure 2. The ECI revealed the approximate depth ranged from 0.020 to 0.04 in and the width ranged from 0.003 to 0.005 in. No penetrant bleed through was noted on the inside face of the former (paint was not removed from the inside, concave surface).

Figure 2. Fluorescent indication of the crack on side A.

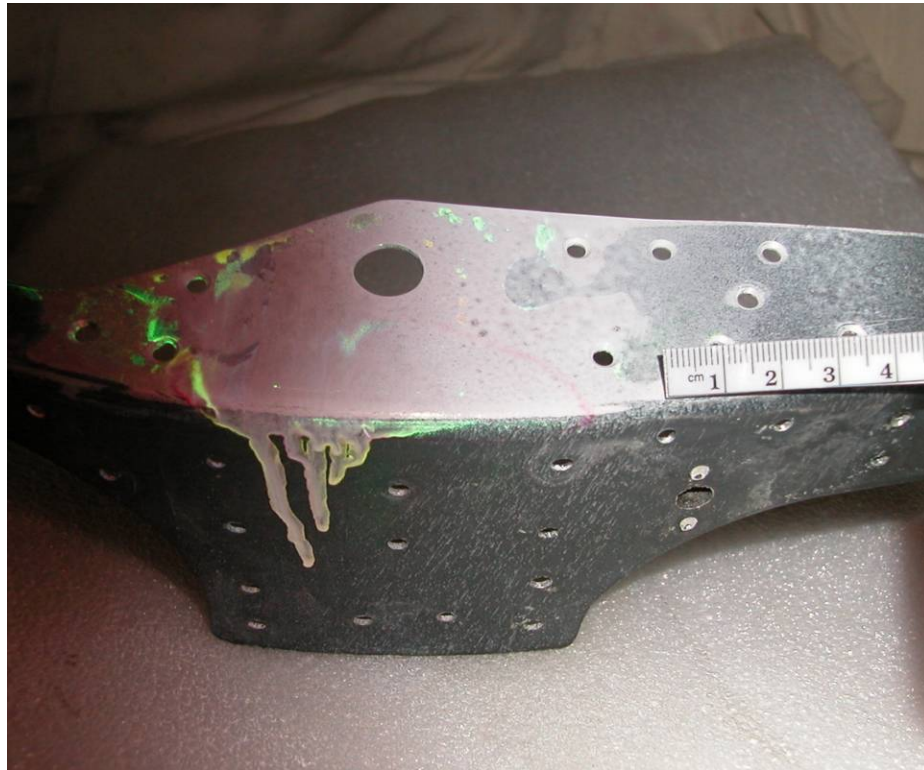
An extremely faint 3.50-cm indication was noted on side B of the as-received image in figure 1. The crack can be observed at a higher magnification in figure 3. The ECI revealed that the depth ranged from 0.020 to 0.040 in and the maximum width was 0.005 in. The eddy current measurements were approximate, as the proximity to the edge made the inspection difficult. No penetrant bleed through was noted on the inside face of the former (paint was not removed from inside concave surface).

Figure 3. Fluorescent indication of the crack on side B.

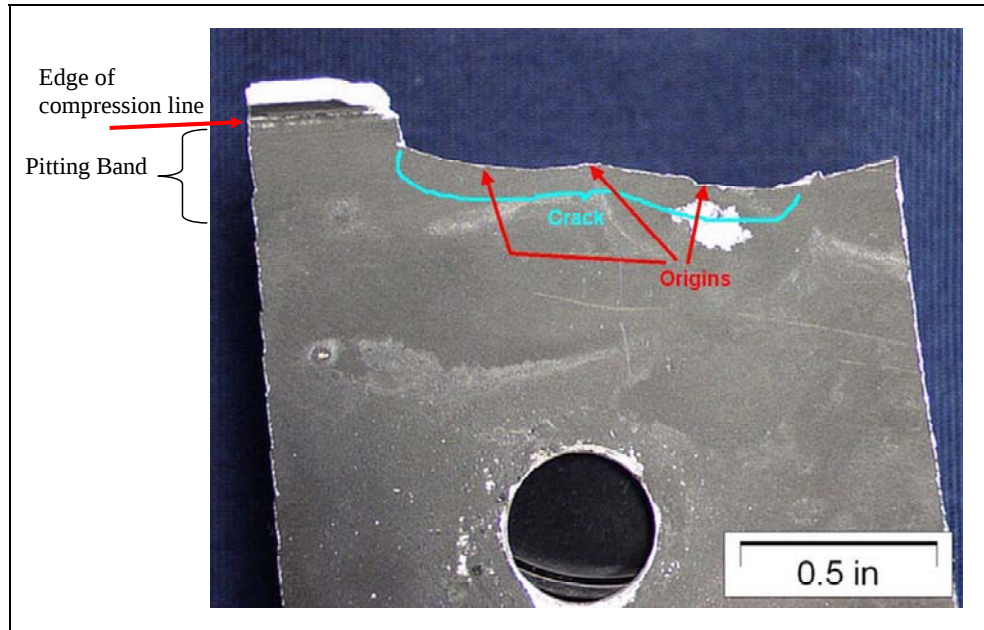
The tailboom former was inspected visually and with light optical microscopy. Two cracks were observed, one near the hole on side A, and the other near the hole on side B. The proximity of the crack to the hole was  $\sim 0.75$  inches in each case. The crack on side A was opened mechanically for fractographic examination. The opened crack is shown in figure 4, with the origins labeled in red. One half of the fracture surface is shown in figure 5. This crack had three distinct origins. Two of the origins were corrosion pits initiating on the concave side. The corrosion initiation site on side A can be observed in figures 6 and 7 (figure 7 depicts a  $45^\circ$  tilt). There were three small corrosion pits in this area, so the initiation site was actually a region rather than a specific point. The largest of the corrosion pits appeared to be  $\sim 0.005$  in deep. The

Figure 4. One half of the fracture surface of the crack on side A.

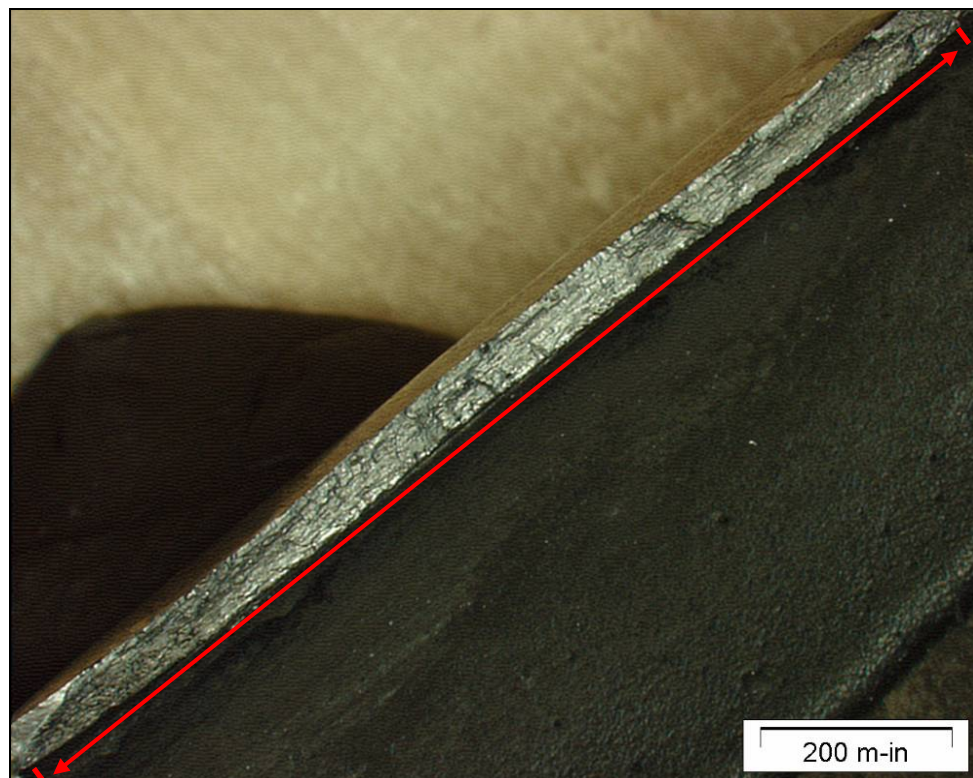
Figure 5. Fractograph of one half of the fracture surface.

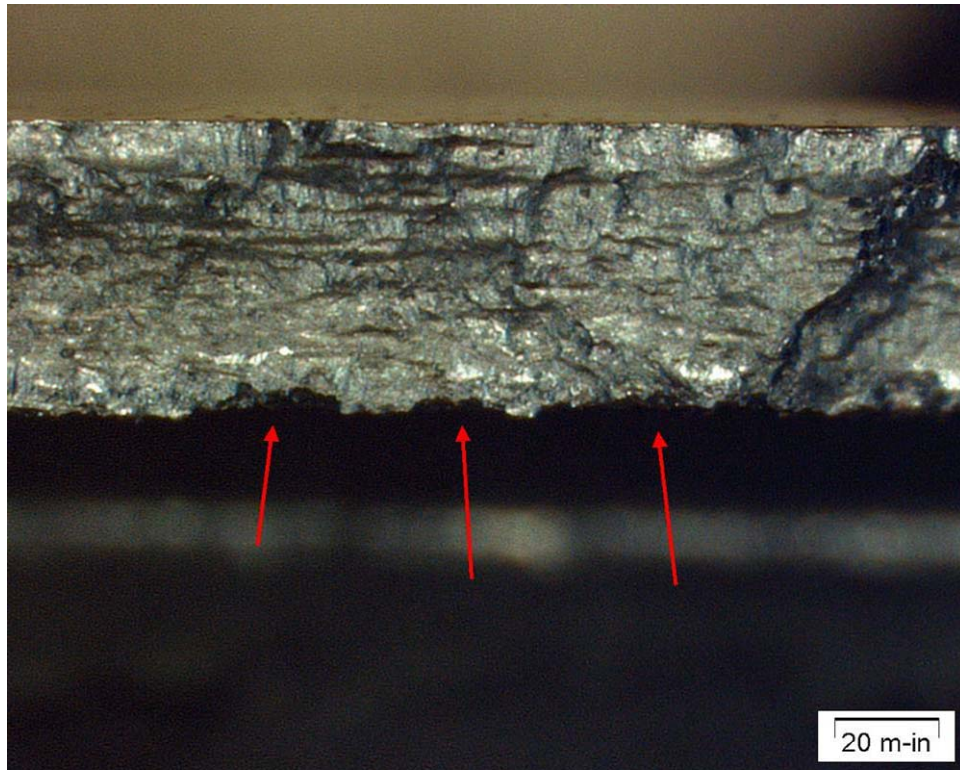
Figure 6. Fractograph of the corrosion initiation site on side A.

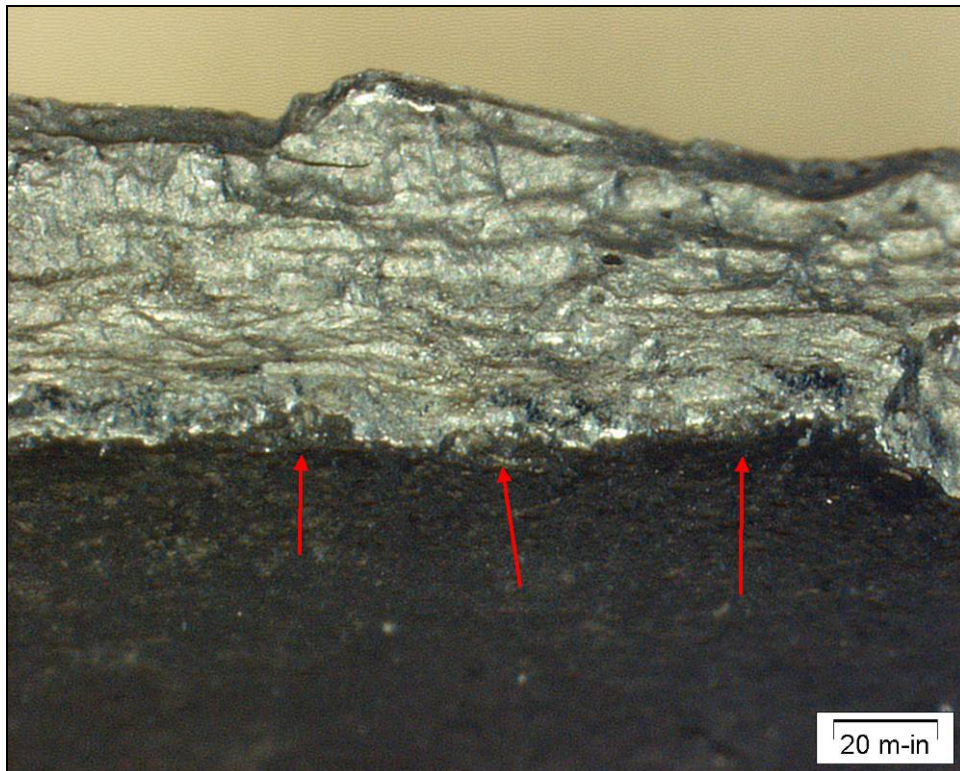
Figure 7. Fractograph of the corrosion initiation site on side A at 45°.

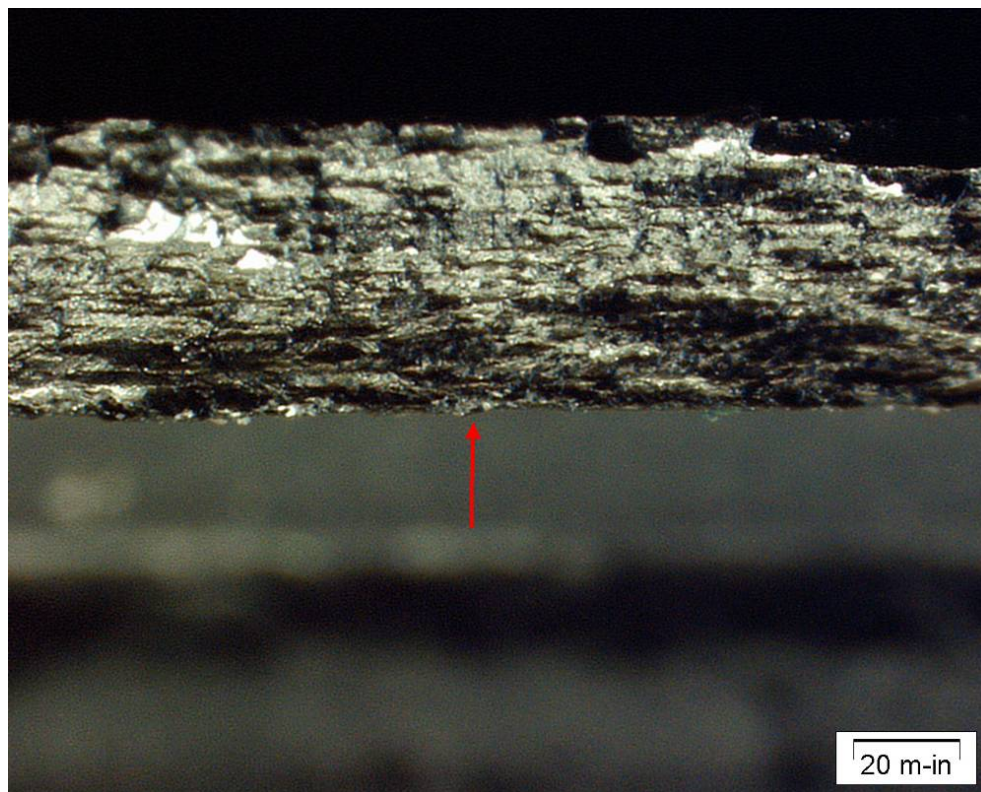
corrosion initiation site on side B can be observed in figures 8 and 9 (figure 9 depicts a 45° tilt). Crack arrest lines (beach marks) and chevron patterns were observable on the fracture surface near these origins. The third origin was fatigue initiated at a surface imperfection unrelated to corrosion, but also on the concave side of the component. This initiation site can be observed in figure 10. The crack progression spread out symmetrically from these three points to form a final crack length of 1.25 in, as observed in figure 5. It was apparent that the cracks joined together and propagated entirely through the 0.050-in thickness of the tailboom former.

Figure 8. Fractograph of the corrosion initiation site on side B.

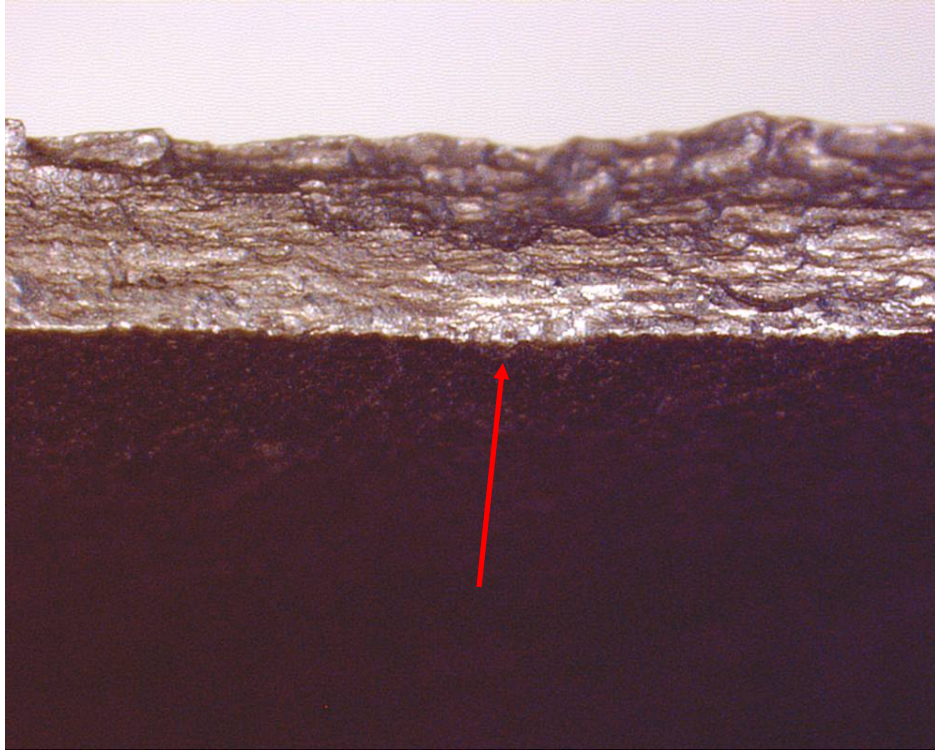
Figure 9. Fractograph of the corrosion initiation site on side B at 45°.

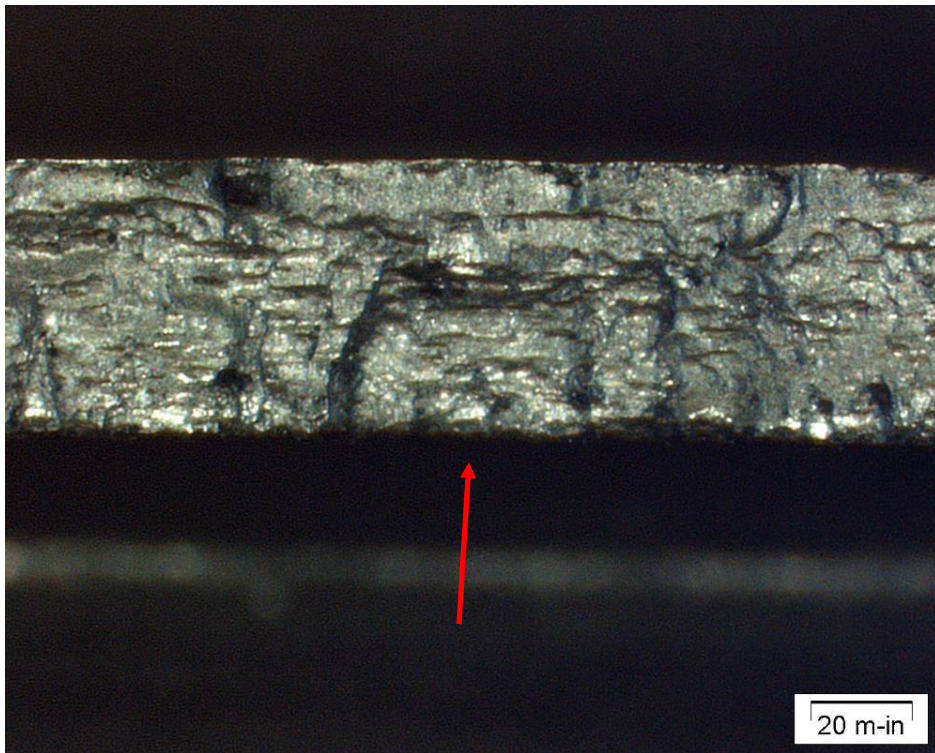
Figure 10. Fractograph of the origin near the center of the crack.

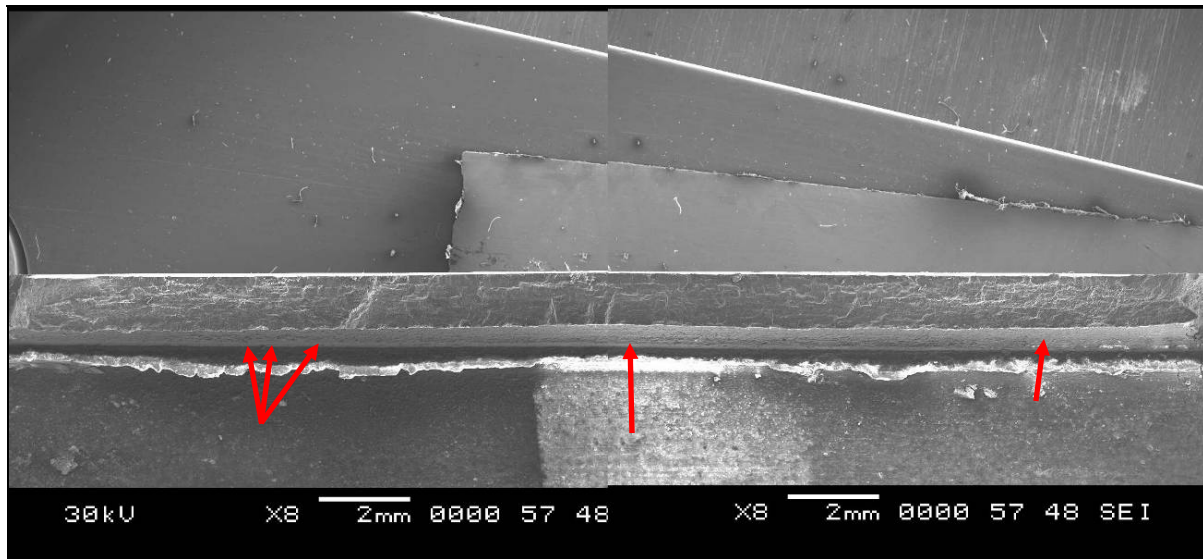
SEM, utilizing a JEOL-JSM 6460-LV, was performed to investigate the fracture surfaces in greater detail. The fracture surface of the opened crack is depicted in the electron fractograph in figure 11. The total crack length measured 1.25 in. At closer inspection, evidence of cyclic fatigue crack propagation was present (figure 12). Fatigue progression lines can easily be observed (this is the transition region at the end of the crack between transgranular fracture and ductile overload). The fracture morphology was transgranular throughout the cracked region. The origin area on side A is depicted in figure 13 and at 45° in figure 14. A higher magnification image of the large corrosion pit on side A is shown in figure 15. The origin area on side B is depicted in figure 16 and at 45° in figure 17. The third initiation site can be observed in figures 18 and 19. All the origins were on the concave side of the part.

Figure 11. SEM fractograph of the whole crack on one fracture half.

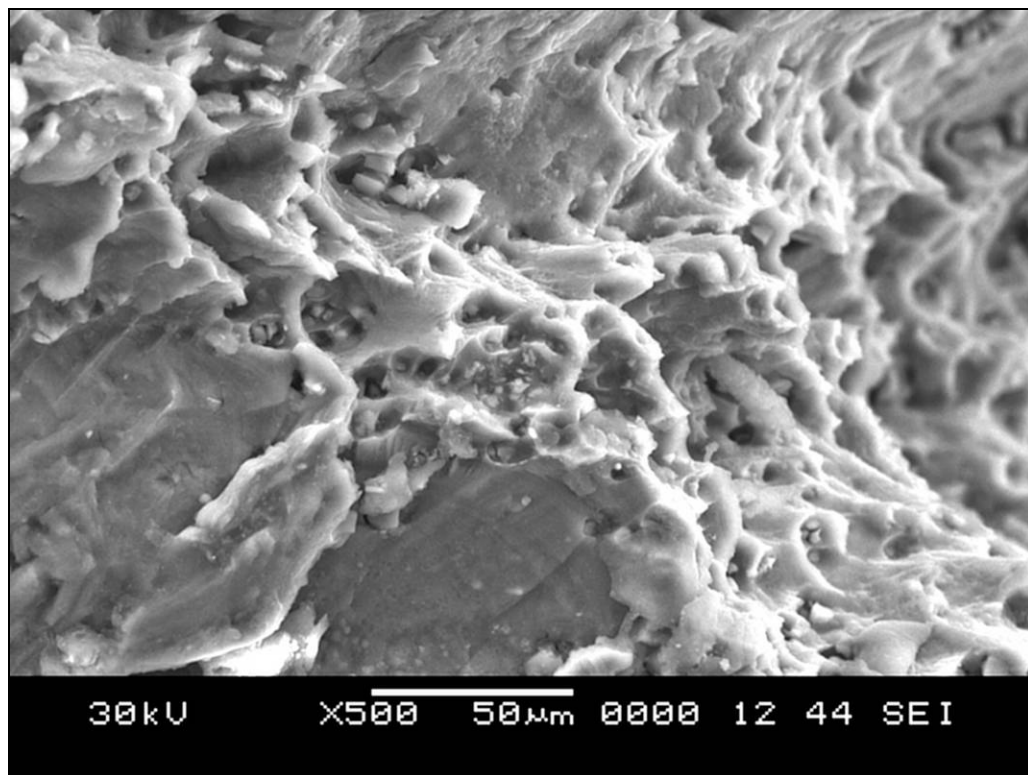
Figure 12. Transgranular fatigue to ductile overload transition zone.

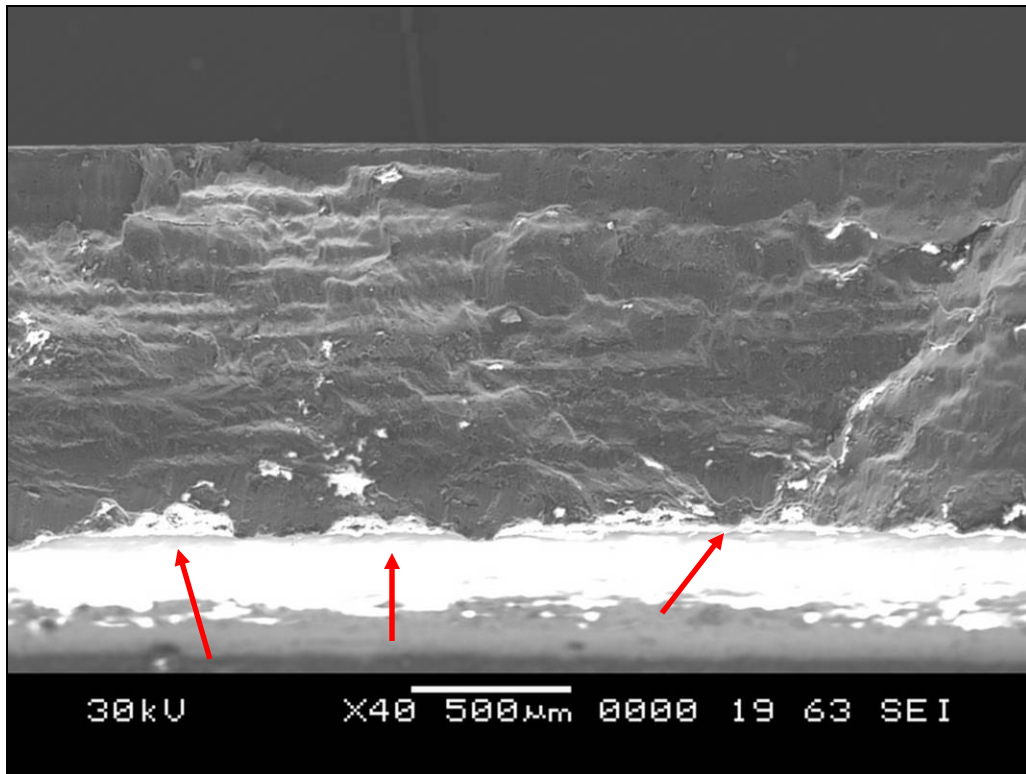
Figure 13. Fractograph of the origin area on side A.

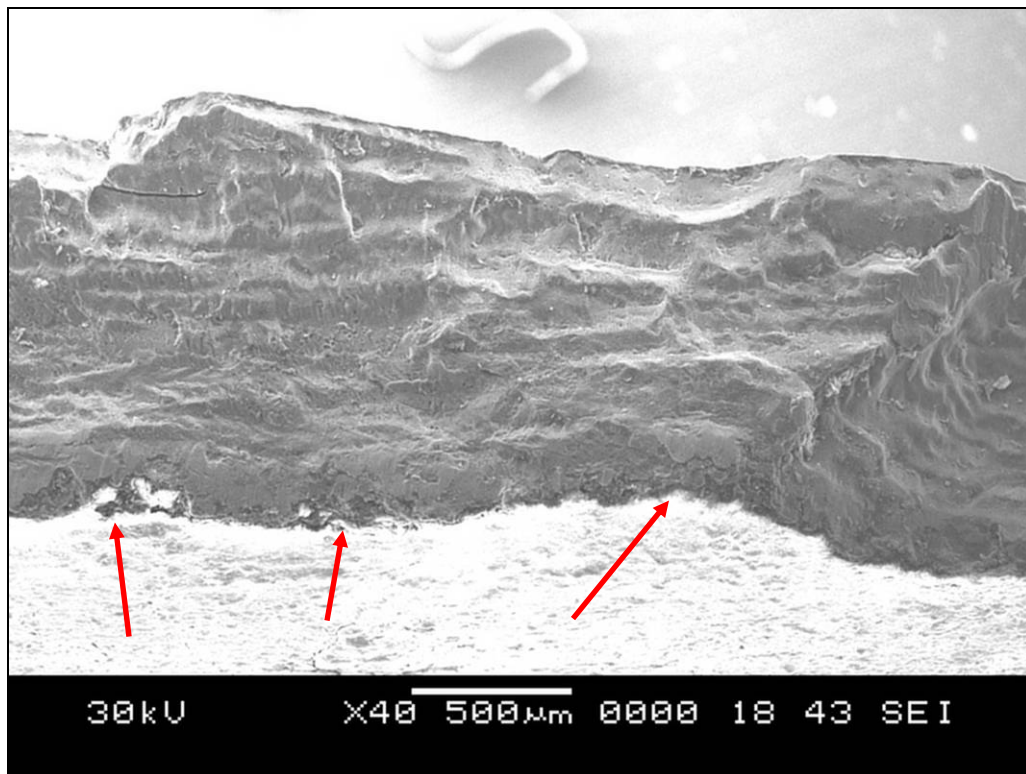
Figure 14. Fractograph of the origin area at 45° on side A.

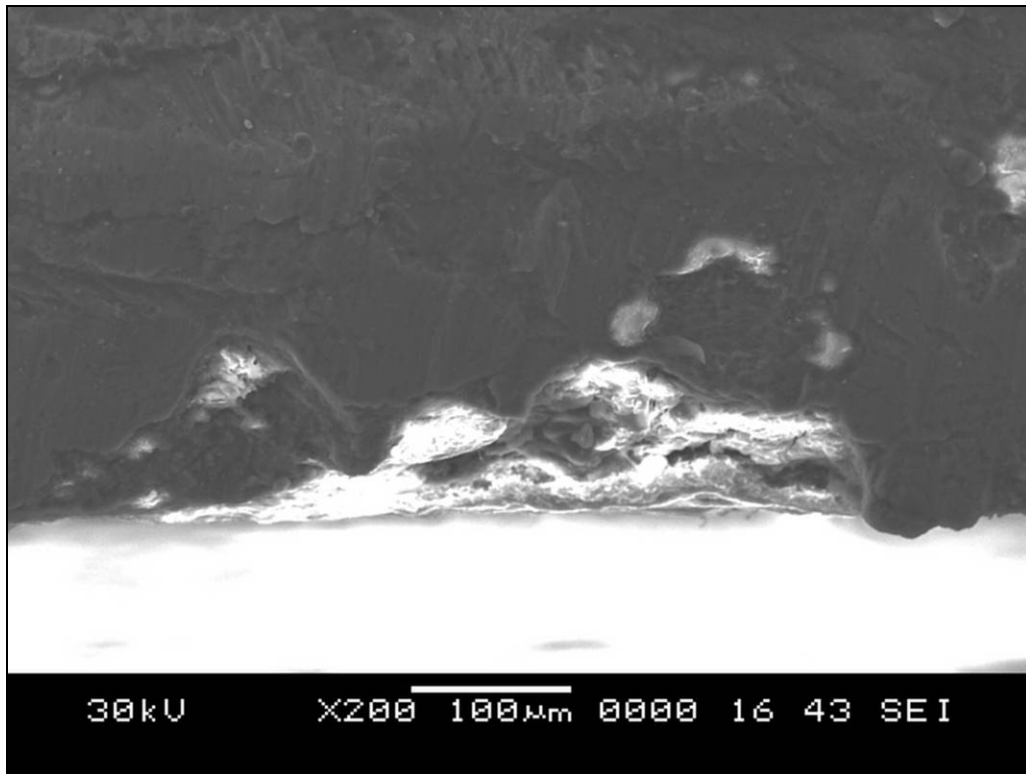
Figure 15. Higher magnification image of the large corrosion pit on side A.

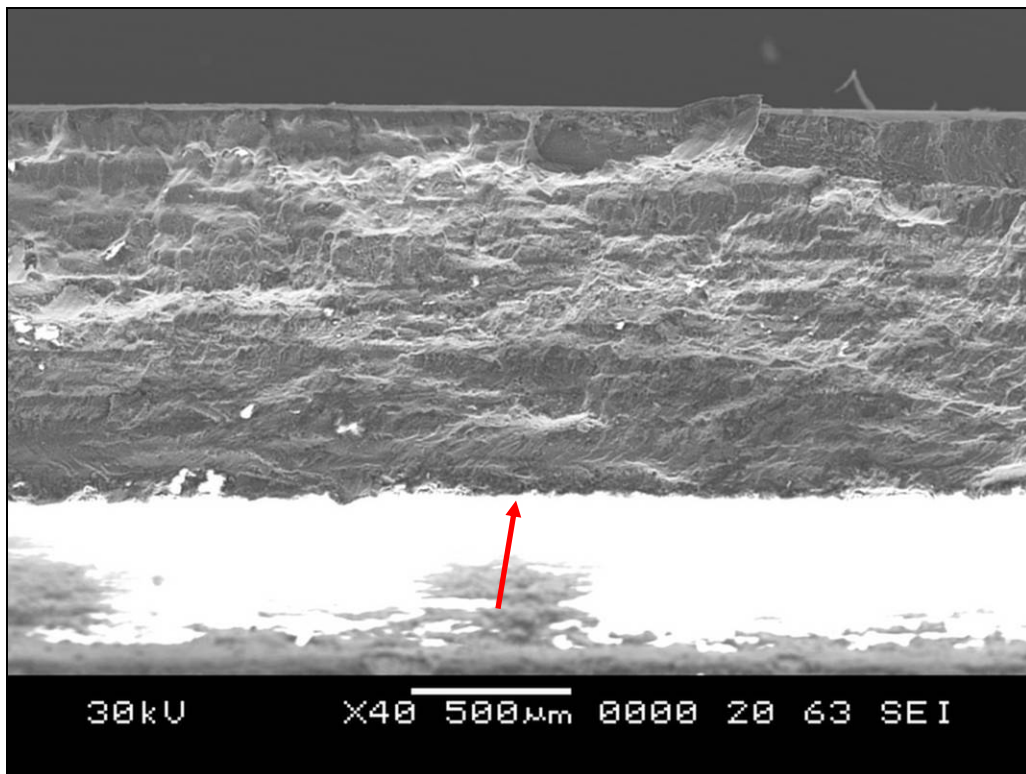
Figure 16. Fractograph of the origin area on side B.

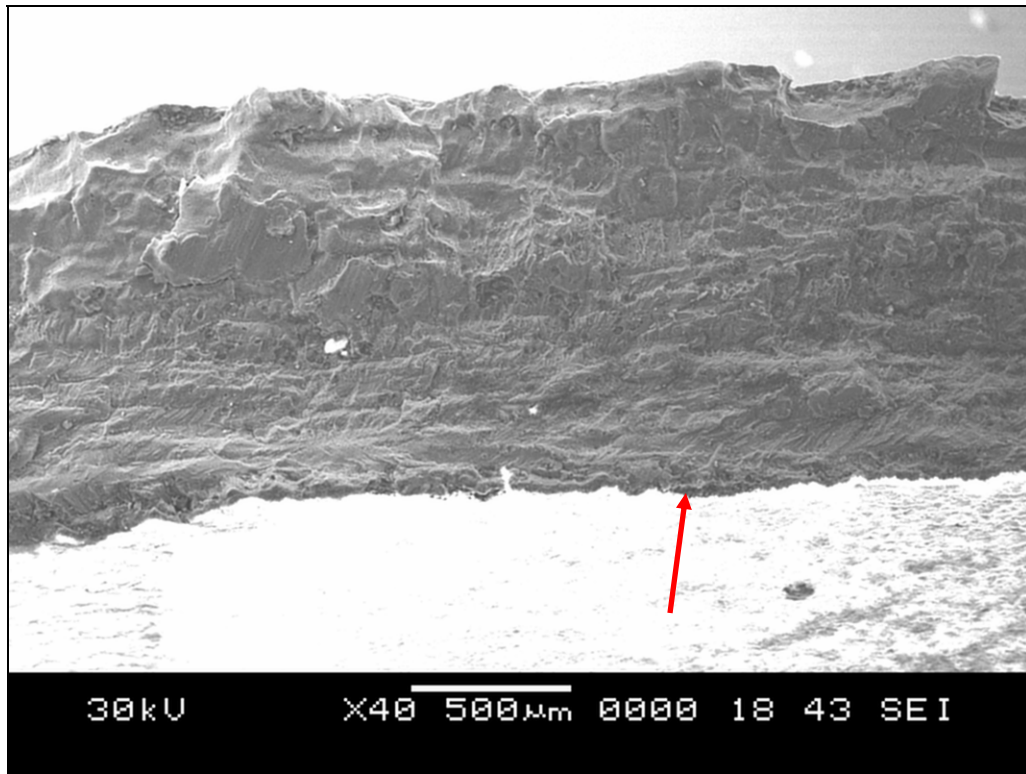
Figure 17. Fractograph of the origin area at 45° on side B.

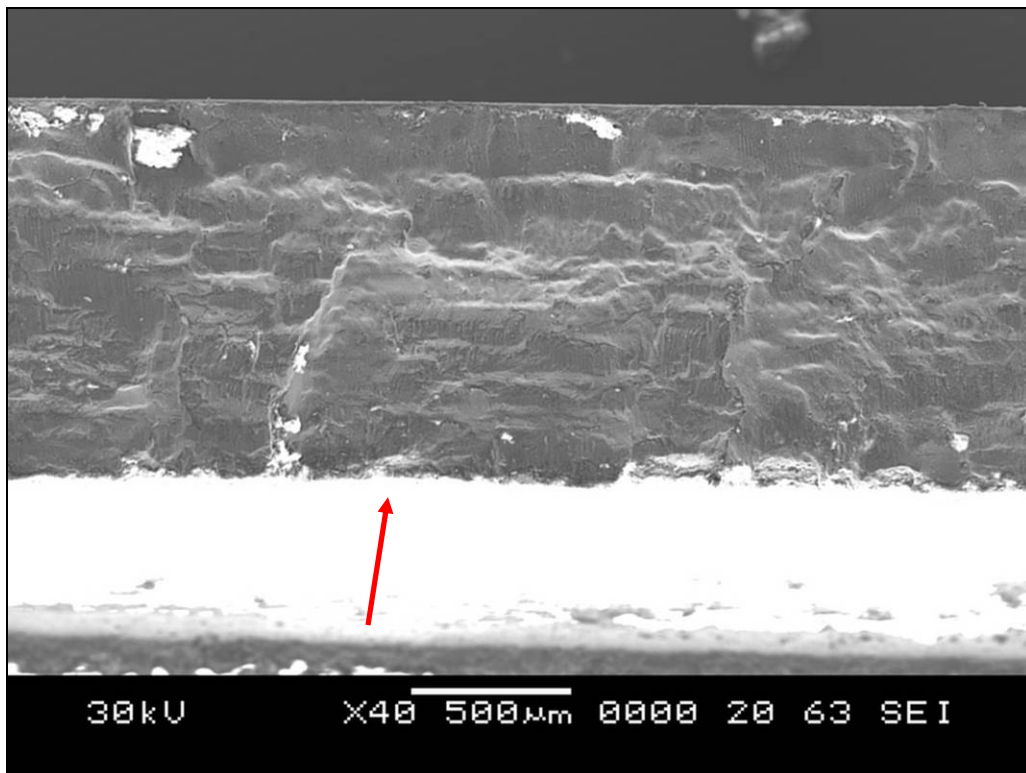
Figure 18. SEM micrograph of the center fatigue initiation site.

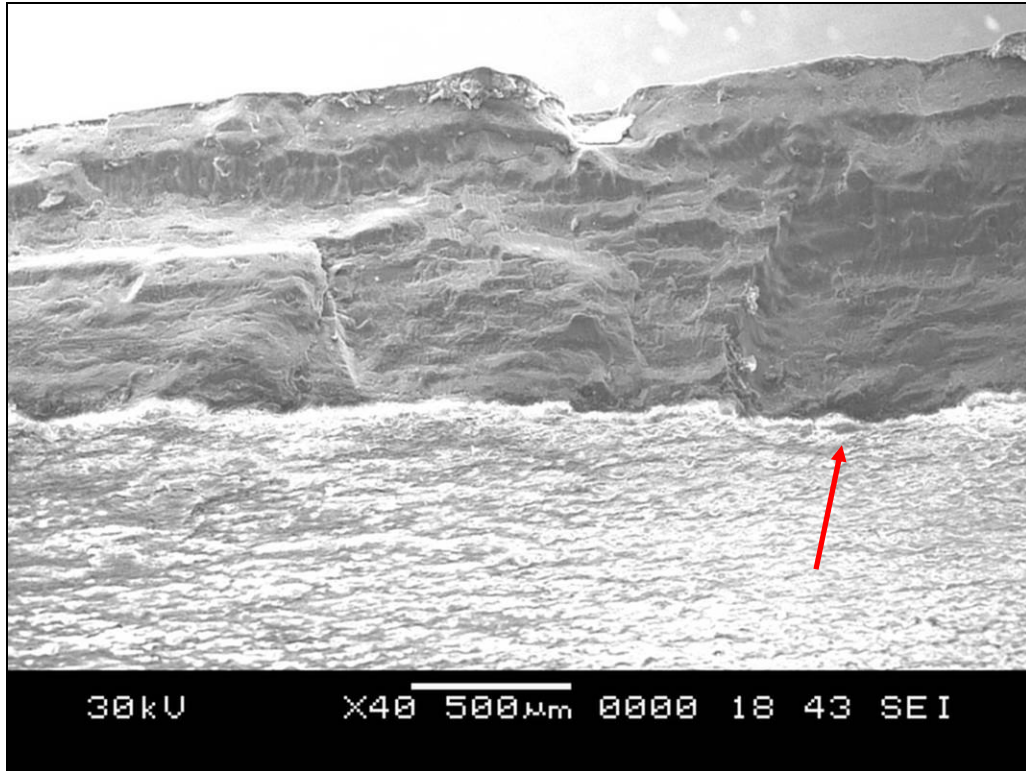
Figure 19. SEM micrograph of the center fatigue initiation site at 45°.

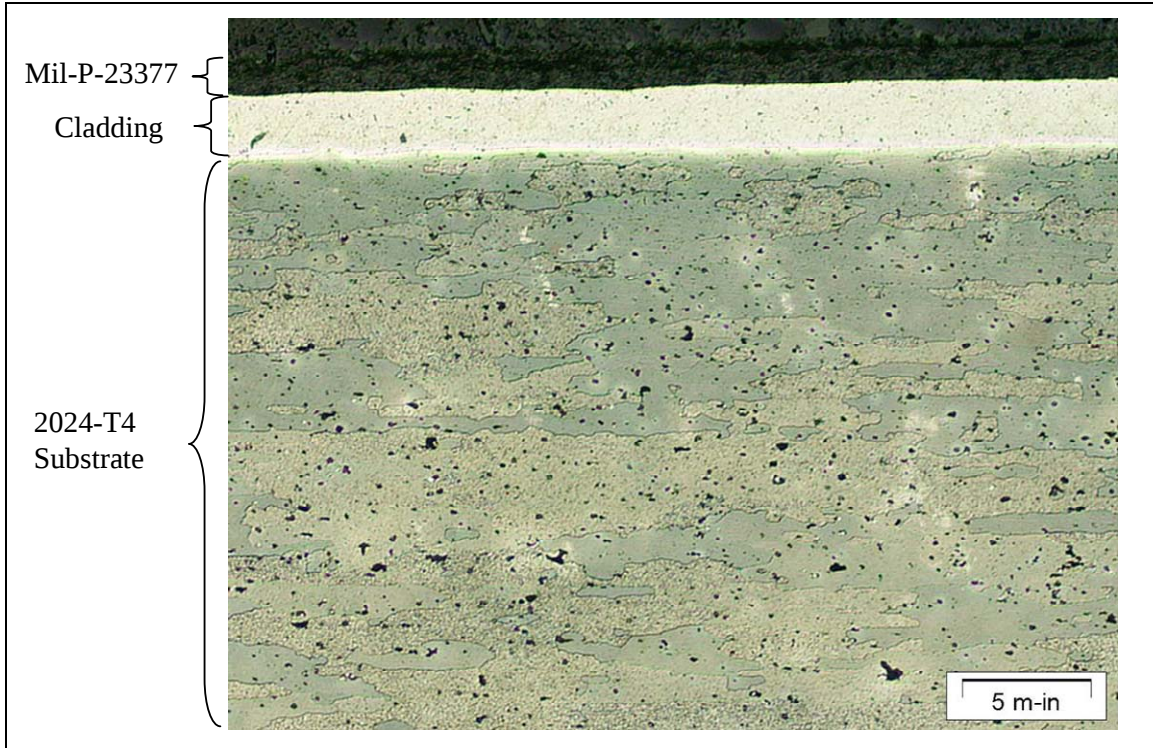
Figure 20. Longitudinal cross section showing the cladding of the 2024-T4 alloy.

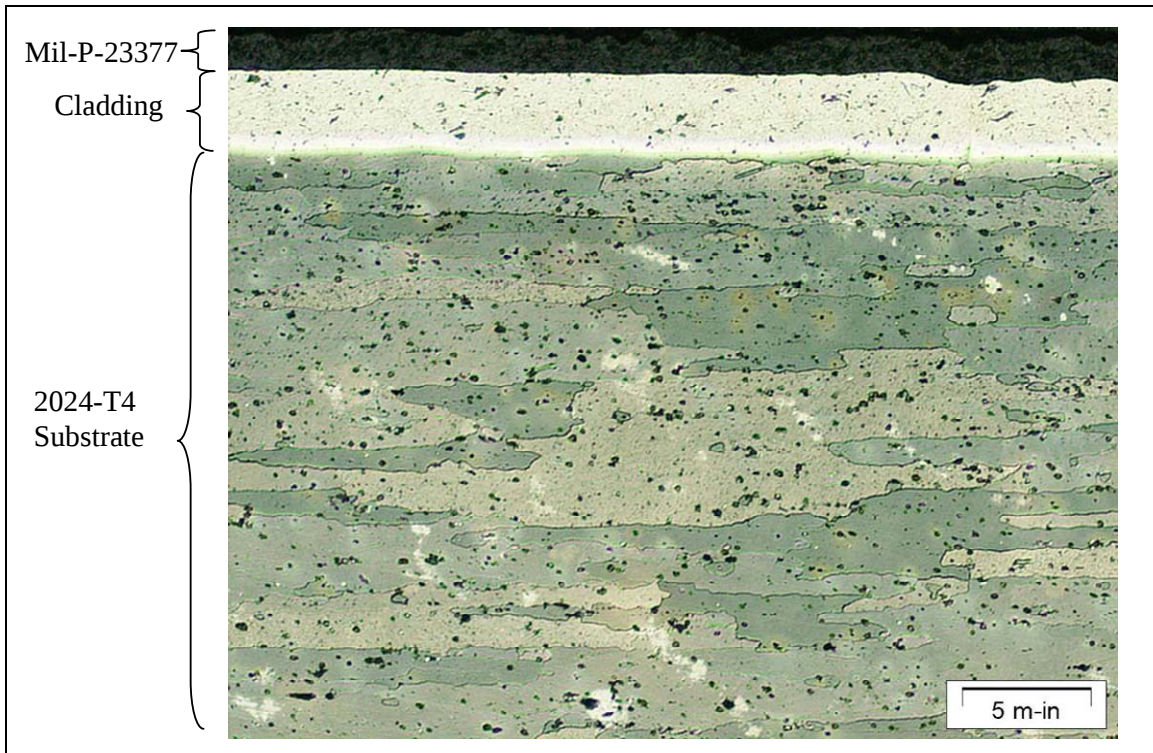
Figure 21. Transverse cross section showing the cladding of the 2024-T4 alloy.

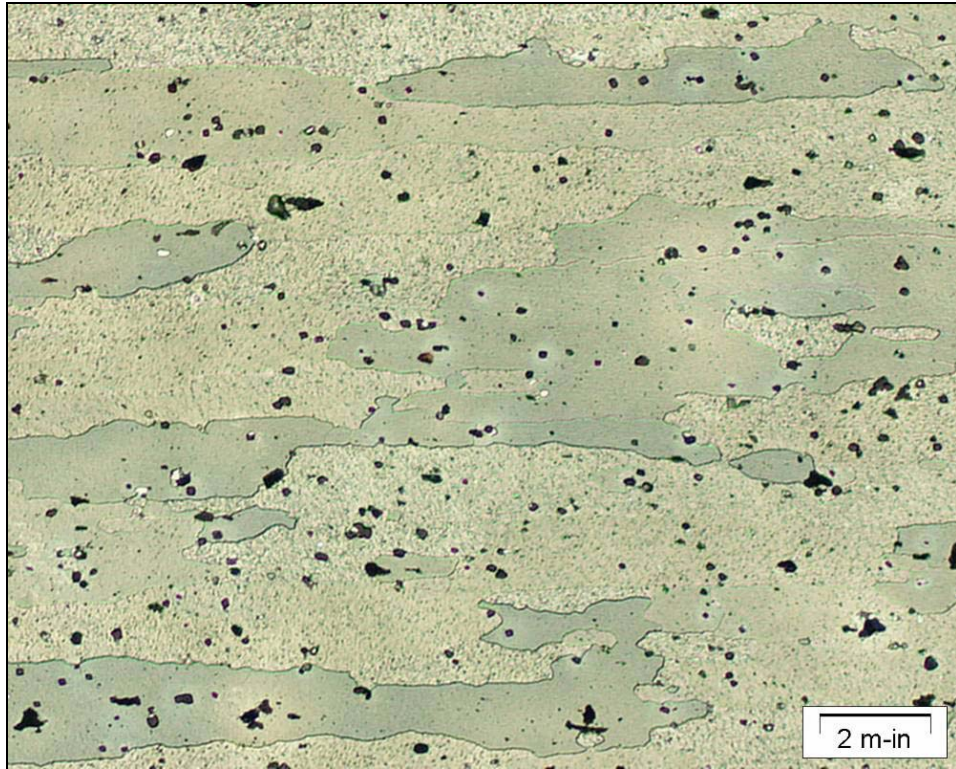
Longitudinal and transverse (to the sheet rolling direction) cross sections were metallographically prepared. The sections were ground and polished through 0.025- $\mu\text{m}$  noncolloidal silica. Subsequently, the specimen was etched with Keller's reagent. The microstructure of the tailboom former material was found to be consistent with clad 2024-T4 aluminum alloy. The cladding can be observed in the longitudinal and transverse direction in figures 20 and 21. The precipitates were determined to be  $\text{CuMgAl}_2$ ,  $\text{Cu}_2\text{MnAl}_{20}$ , and  $\text{Cu}_2\text{FeAl}_7$ . The smaller precipitates formed during the annealing process, while the larger precipitates were undissolved from the solutionizing treatment. No abnormalities were observed. Representative photos of both the longitudinal and transverse cross sections are observable in figures 22 and 23, respectively.

Figure 22. Longitudinal microstructure of the 2024-T4 alloy.

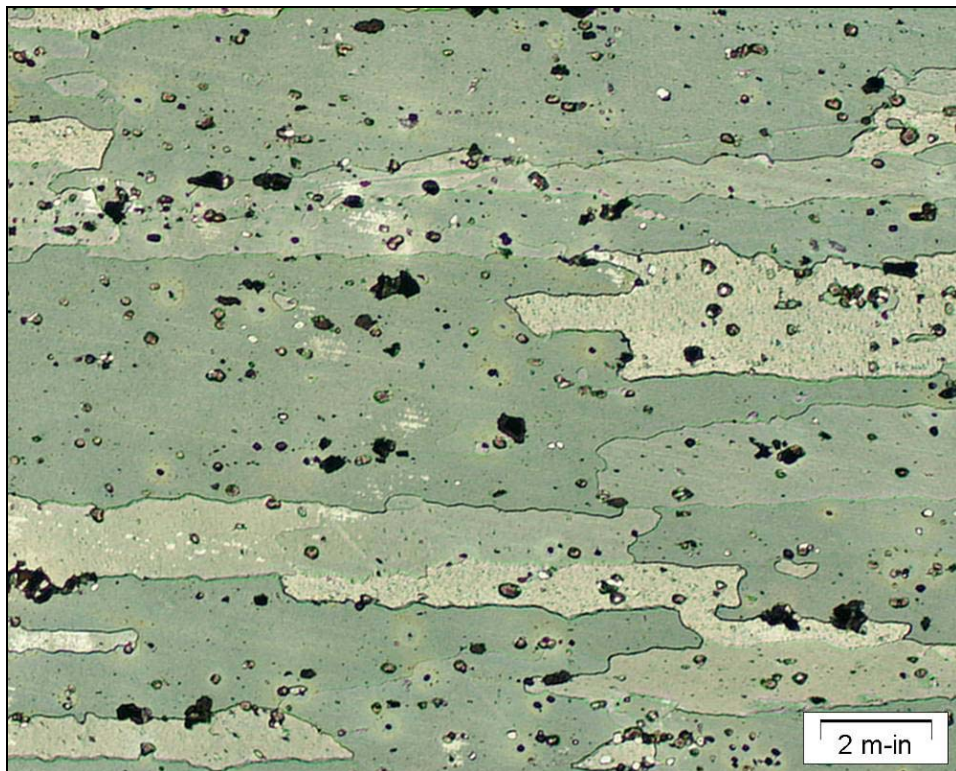
Figure 23. Transverse microstructure of the 2024-T4 alloy.

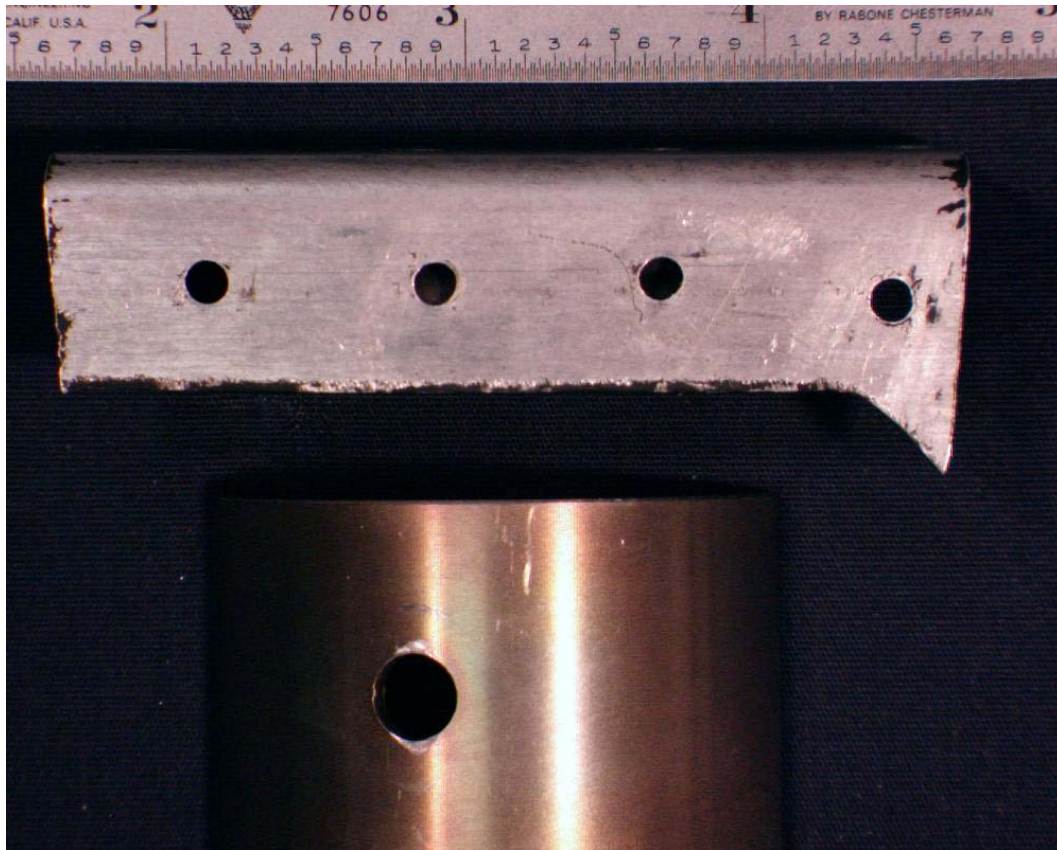
conversion coating could be visually inspected. There was no visible golden yellow to brown chromate conversion under the primer. Two important notes accompany this fact. The first is contingent upon the age of the component; the golden yellow to brown color can fade over time as it is meant to be sacrificial. The second is simply that a clear coat chromate conversion treatment (not in accordance with the specification) would not be visible. So the case exists that either the chromate coating has degraded over time or it was never applied correctly when the part was manufactured. The primer itself contains chromates so chemical analysis of the surface proved futile. A comparison of the exterior surface of the former with the primer removed vs. a golden yellow chromate conversion coated component is presented in figure 24. The typical exterior surface of the primed coating can be observed in figure 25. This figure also includes the crack prior to it being opened. The coating system can be observed in cross sections in figures 20 and 21. The primer measured ~0.001 in thick and was within the 0.0008–0.0012-in requirement. The chromate chemical conversion coating is usually just a dip process, and while it leaves a chemical signature, it cannot be observed in a cross section. The MIL-P-23377 coating was intact, relatively undamaged, and appeared uniform and consistent in application. The tailboom former mates with a larger section of a tailboom, and the cracks were within this compressed section forming a crevice. The primer was not marred or worn, just uniformly compressed from the assembly. The edge of this compression can be observed in figure 25. There appeared to be a band of corrosion pitting of various sizes and depths extending to ~0.150 in from the edge of the crevice formed by the assembly. This band can be observed in figure 26. Examples of the corrosion pits adjacent to the fracture are depicted in figures 27 and 28. The largest pit observed was estimated to be 0.004 inches deep and 0.005 inches in diameter. It is important to note that the pits in figure 27 were fully and completely painted over; the paint conformed to the pit surface topography. Therefore, the pits did not form under the paint; they existed immediately prior to the last painting. They either formed during service within the crevice or during overhaul processing. They were not found all about the exterior surfaces, so it is more likely that they formed within the crevice during service.

Figure 24. Former compared with a golden yellow chromate conversion coated component.

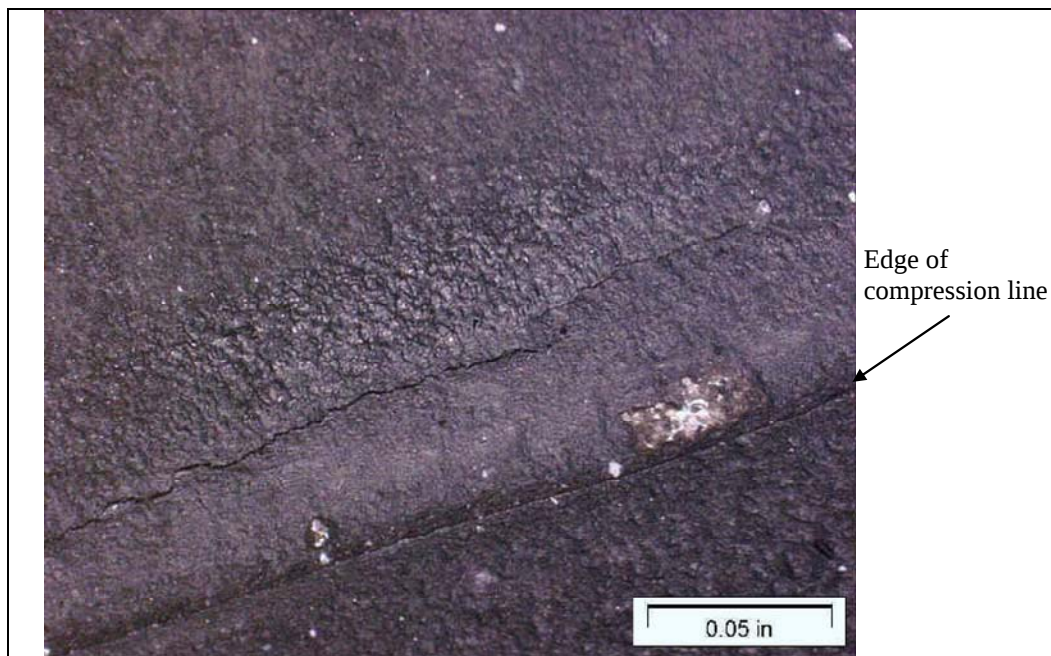
Figure 25. Exterior surface of the tailboom former coated with MIL-P-23377.

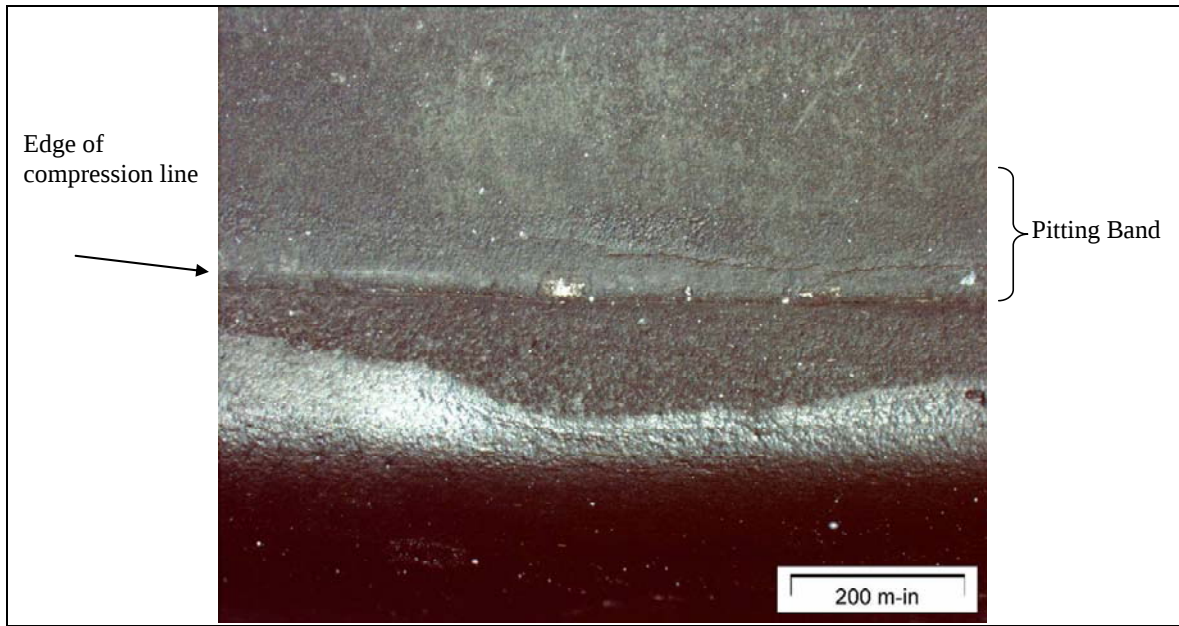
The tailboom former failed by a fatigue mechanism initiated at corrosion pits. These pits likely developed over time either from damage induced during overhaul or within the natural crevice formed by the tailboom former and its mating component in the assembly. Pits were observed both with paint covering them and inactive, and recently active and corroding. It is likely that some of the pitting corrosion was missed during overhaul and paint was reapplied over them.

Figure 26. Corrosion pitting band near edge of crevice compression line.
