# **Failure Analysis of a Cracked UH-1 Tailboom Former, P/N 205-030-807-97**

**ARL-TR-3828**

**June 2006**

**Scott Grendahl  
U.S. Army Research Laboratory  
Weapons and Materials Research Directorate  
Aberdeen Proving Ground, MD 21005**

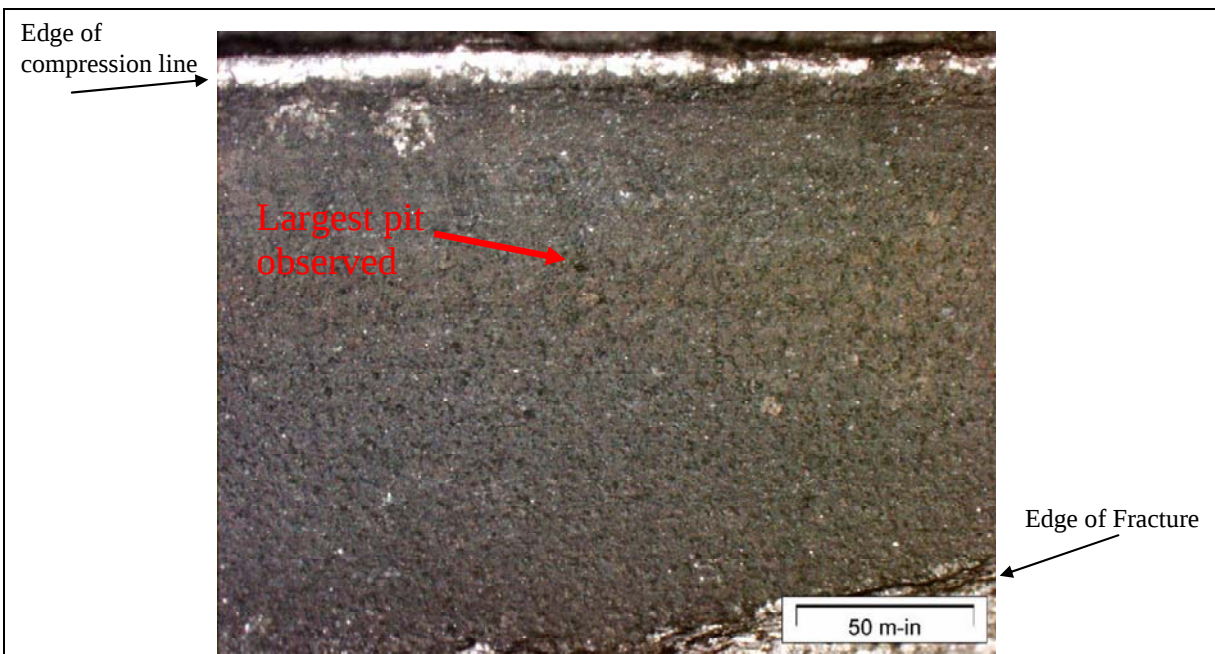
Figure 27. Pits adjacent to the edge of the fracture.

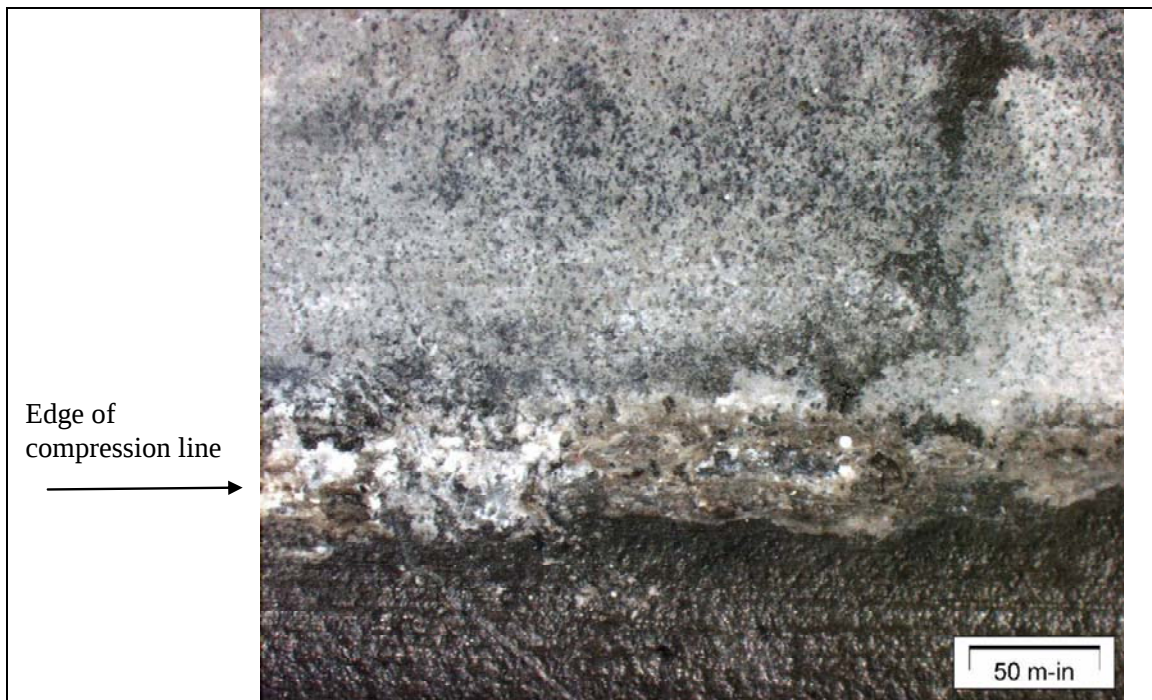
Figure 28. Pitting and corrosion product along the edge of compression line.
