## **Failure Analysis of OH-58 Kiowa Warrior Drive Gear Shafts**

**ARL-TR-3827**

**June 2006**

U.S. Army Research Laboratory  
Weapons and Materials Research Directorate  
Aberdeen Proving Ground, MD 21005-5069

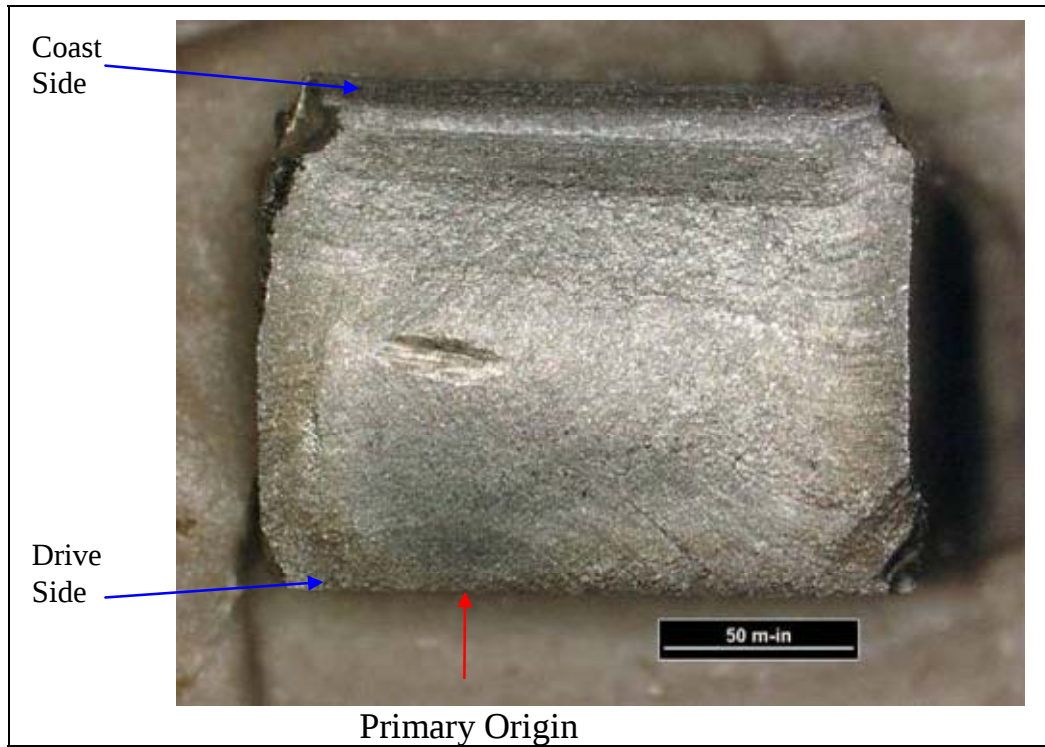
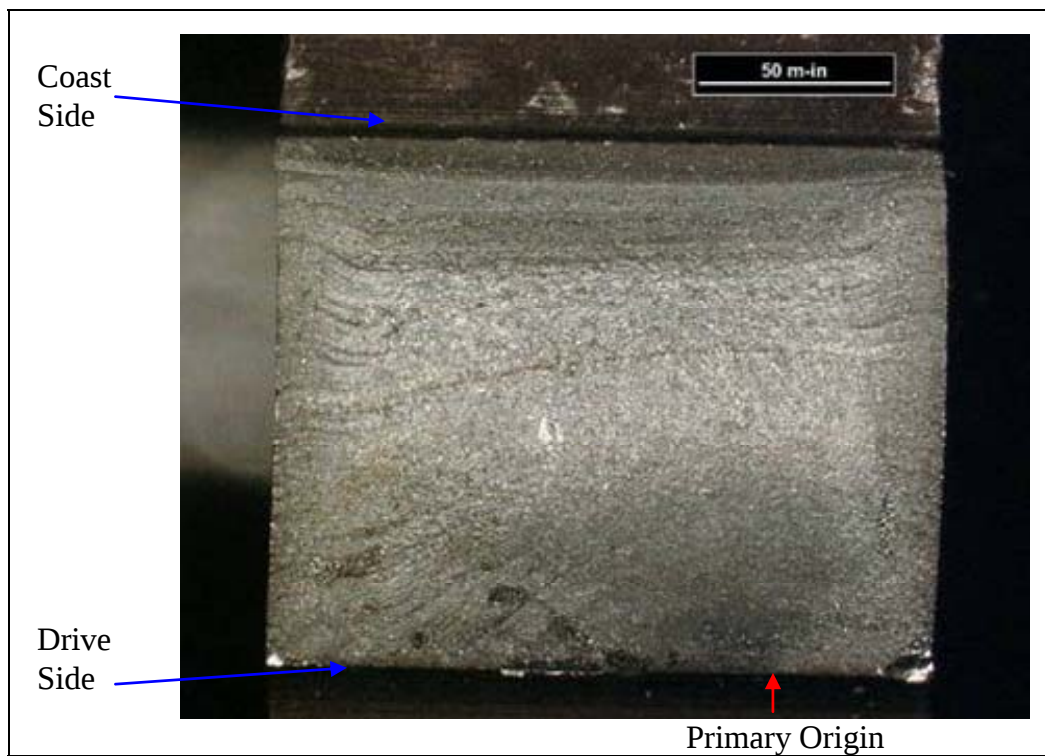
Fracture surfaces for tooth 1 are shown in figures 2–5. The primary origin for this tooth is shown in figure 4. Propagation was by fatigue with a secondary crack initiating on the coast side. A very small overload region was present, as depicted in figure 5.

Figure 2. Tooth 1, tooth fracture half.

Figure 3. Tooth 1, gear fracture half.

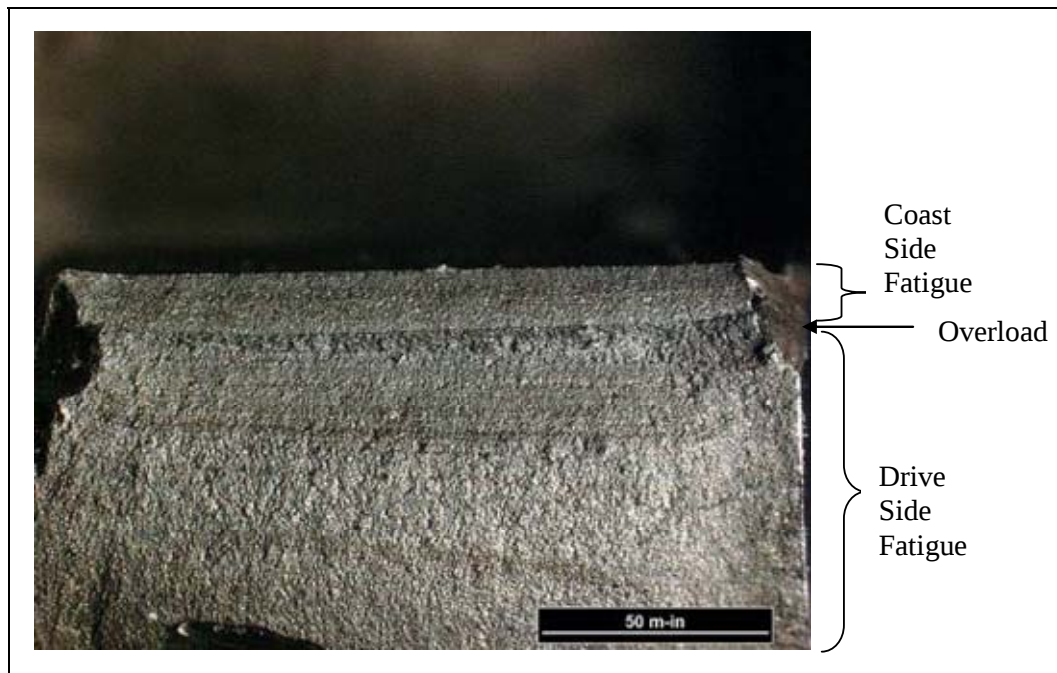
Figure 5. Coast side of tooth 1, tooth fracture half.

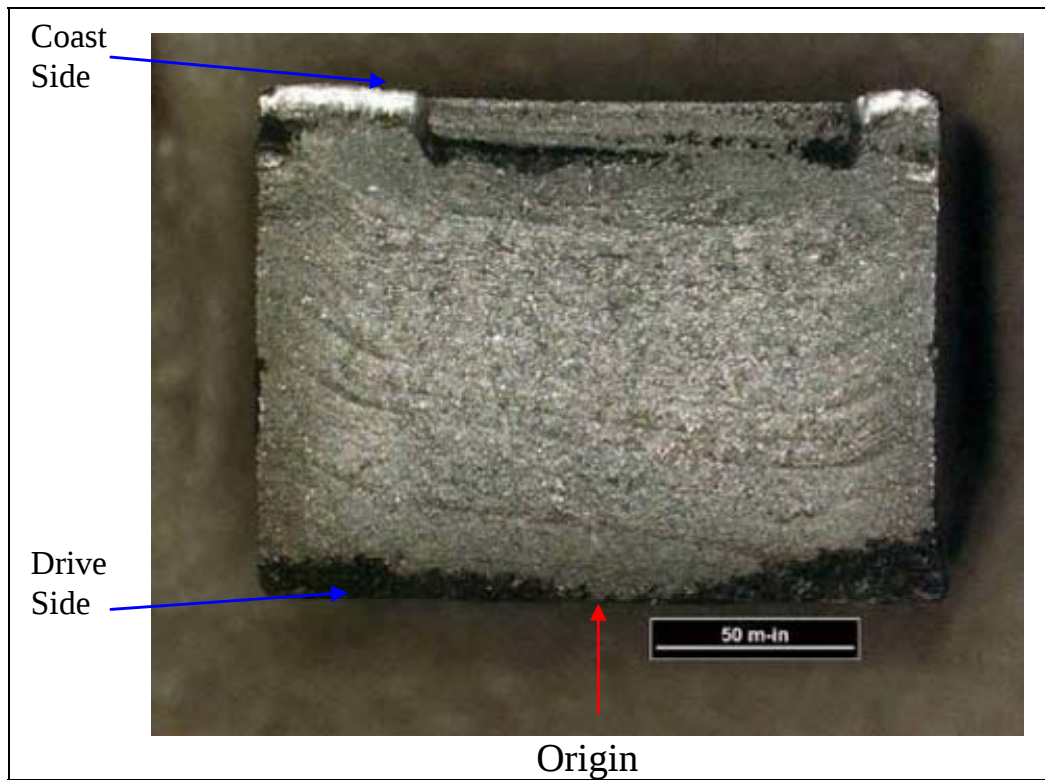
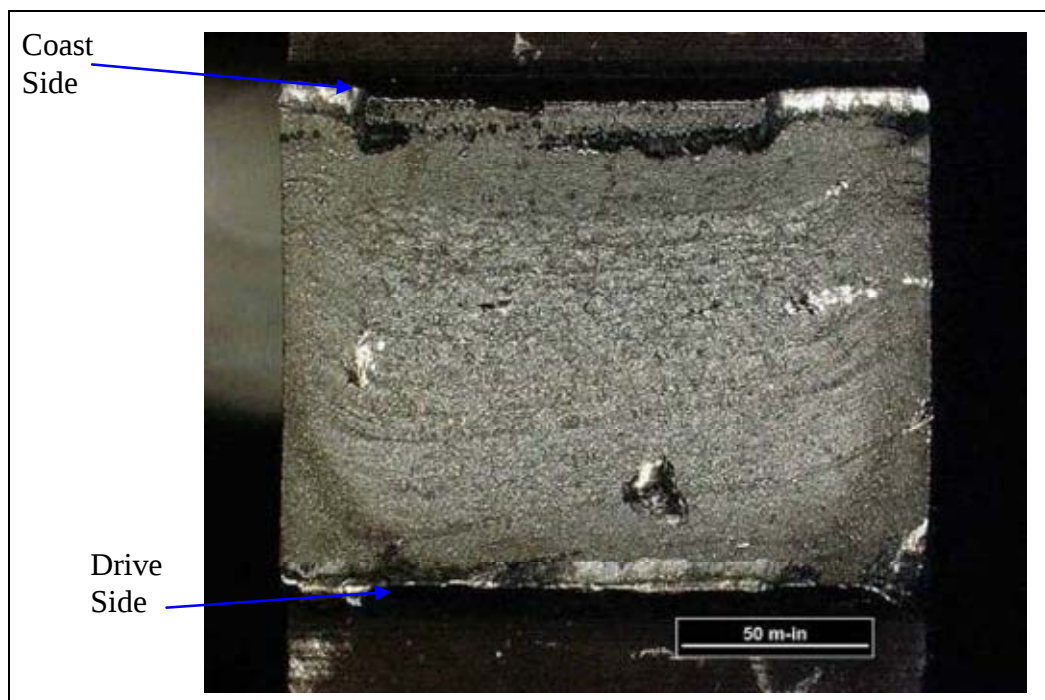
Figures 6 (tooth half) and 7 (gear half) show the fracture surfaces observed on tooth 2. Note the more pronounced beach marks relative to tooth 1.

Figure 6. Tooth 2, tooth fracture half.

Figure 7. Tooth 2, gear fracture half.

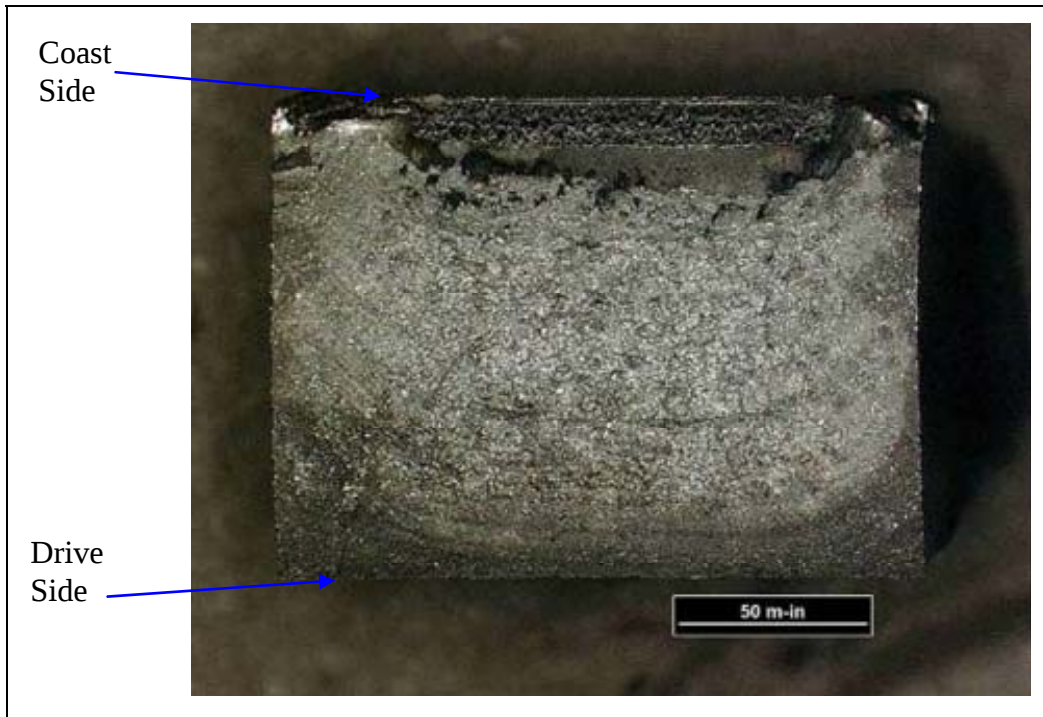
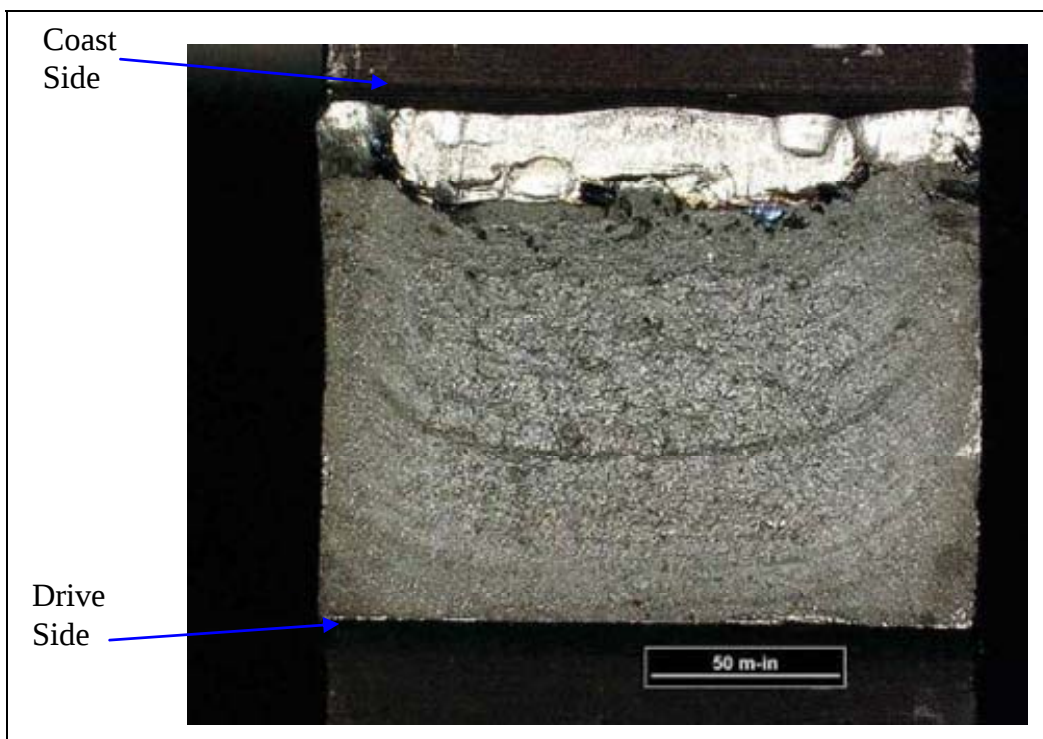
Figures 8 and 9, respectively, present the tooth and gear fracture halves of tooth 3. The overload region was significantly larger than on the preceding teeth.

Figure 8. Tooth 3, tooth fracture half.

Figure 9. Tooth 3, gear fracture half.

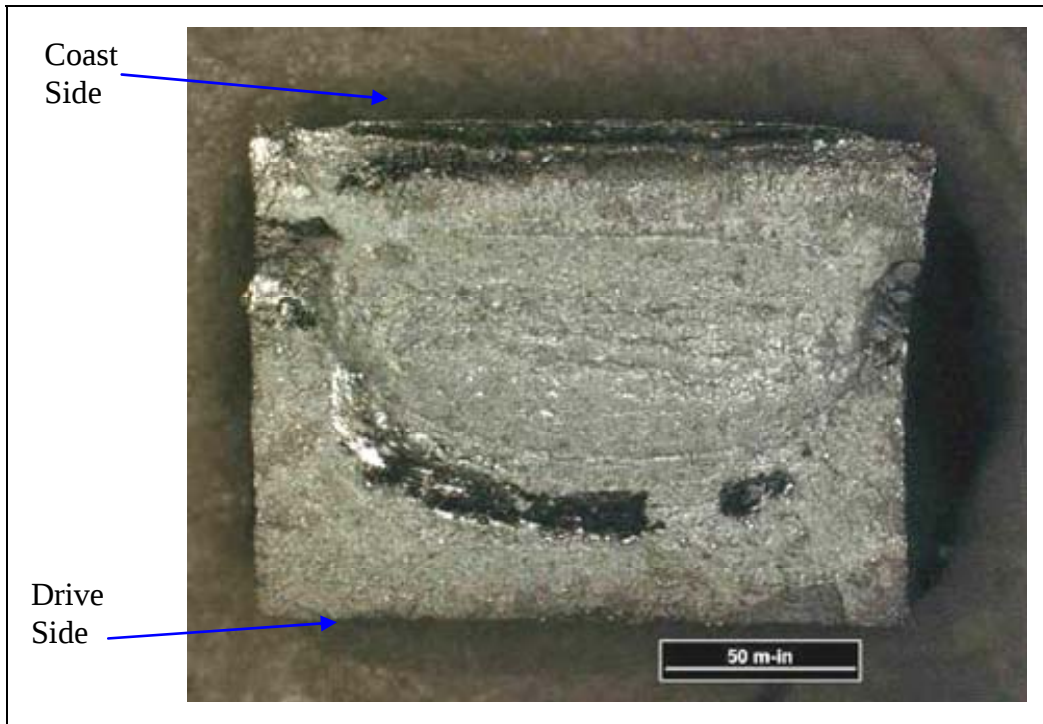
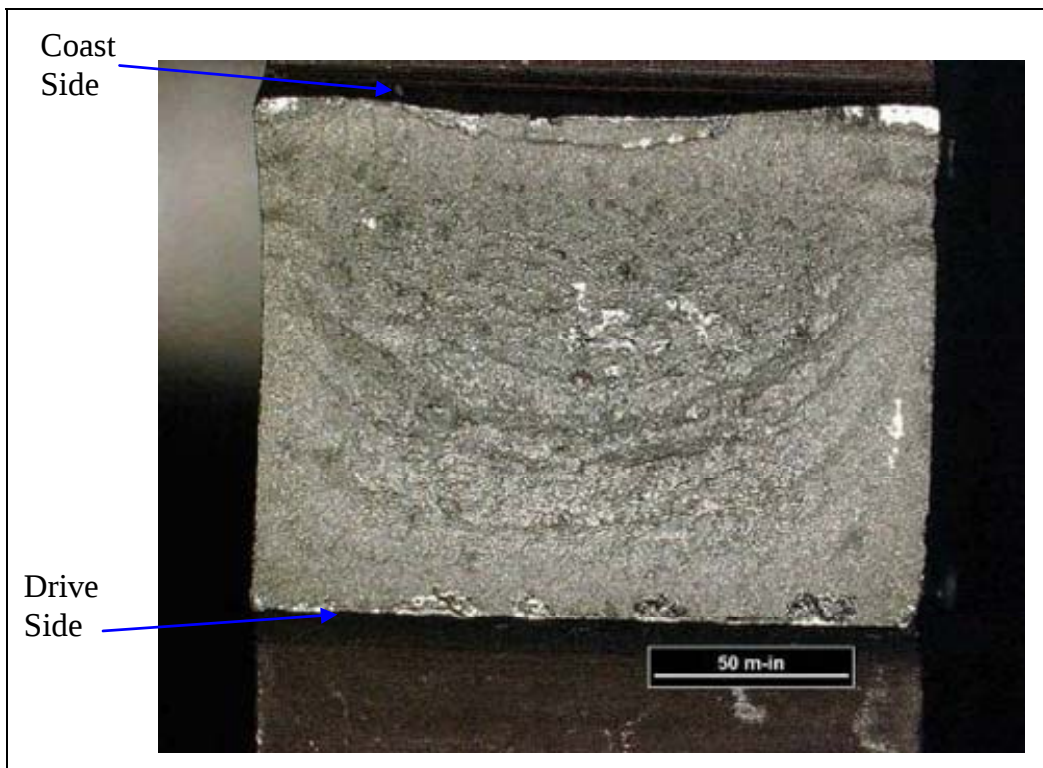
The fracture halves of tooth 4 are presented in figure 10 (tooth half) and figure 11 (gear half). The beachmarks exhibited a “U” or bathtub shape. A large mound can be seen in figure 10; the mating cavity can be seen in figure 11.

Figure 10. Tooth 4, tooth fracture half.

Figure 11. Tooth 4, gear fracture half.

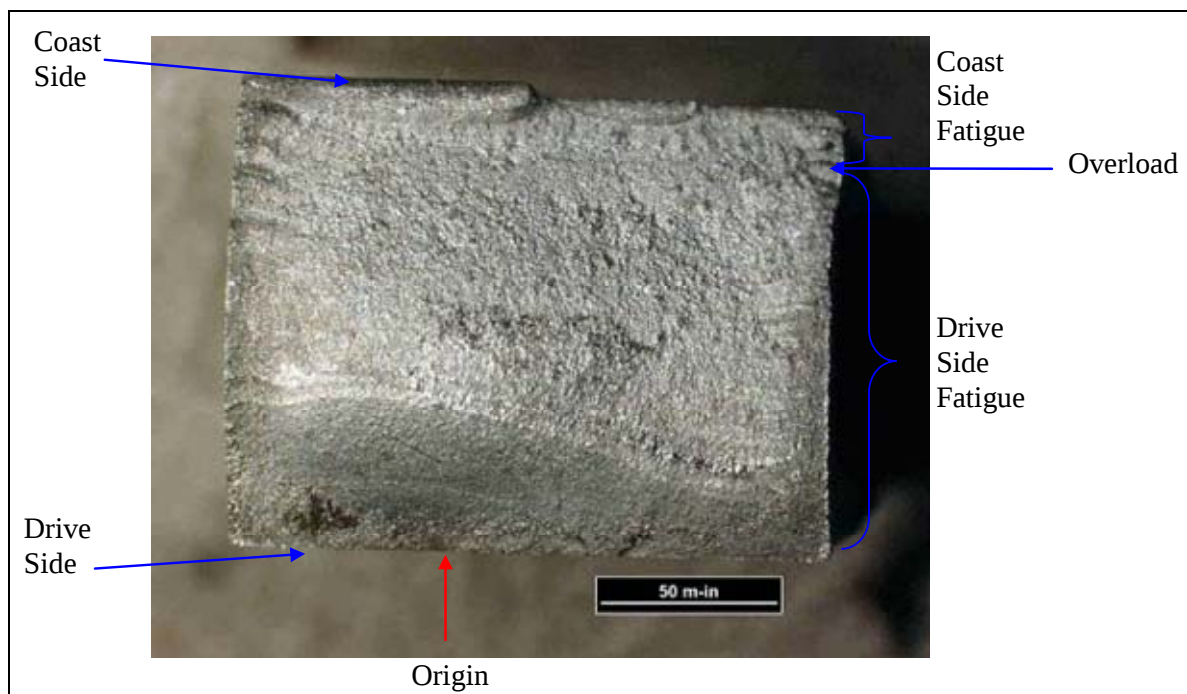
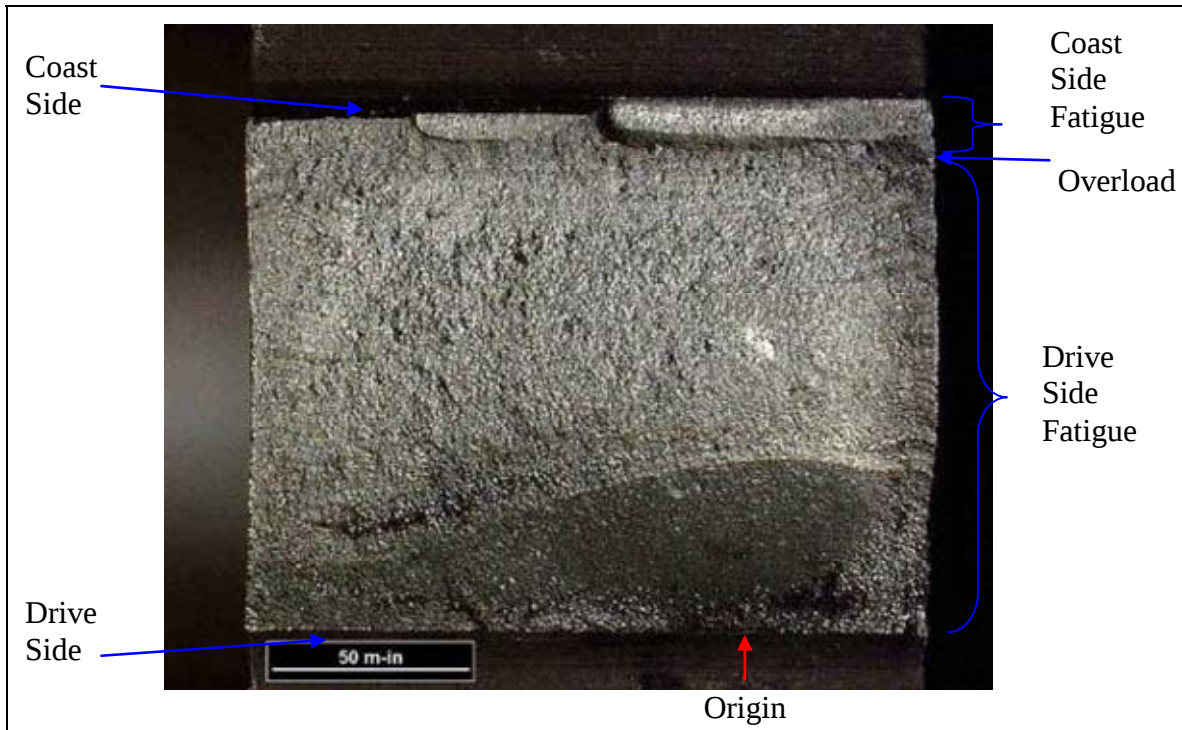
The primary failure for this group was tooth 28. The fracture halves are shown in figures 12 and 13. As in tooth 1, a secondary crack originated on the coast side. A small overload region was present.

Figure 12. Tooth 28, tooth fracture half.

Figure 13. Tooth 28, gear fracture half.

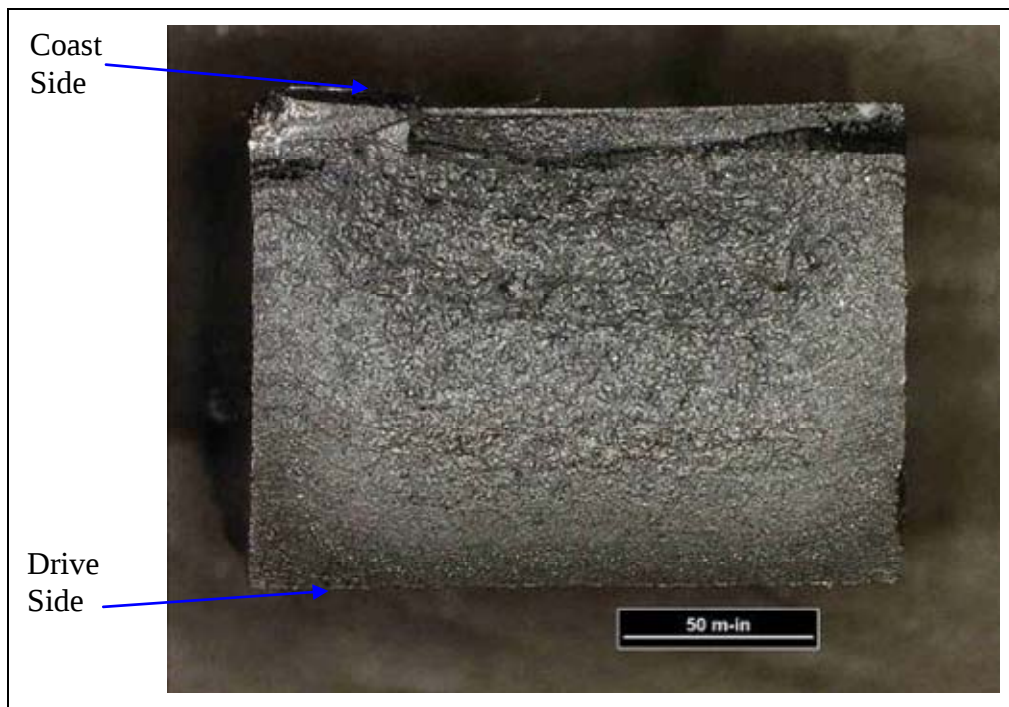
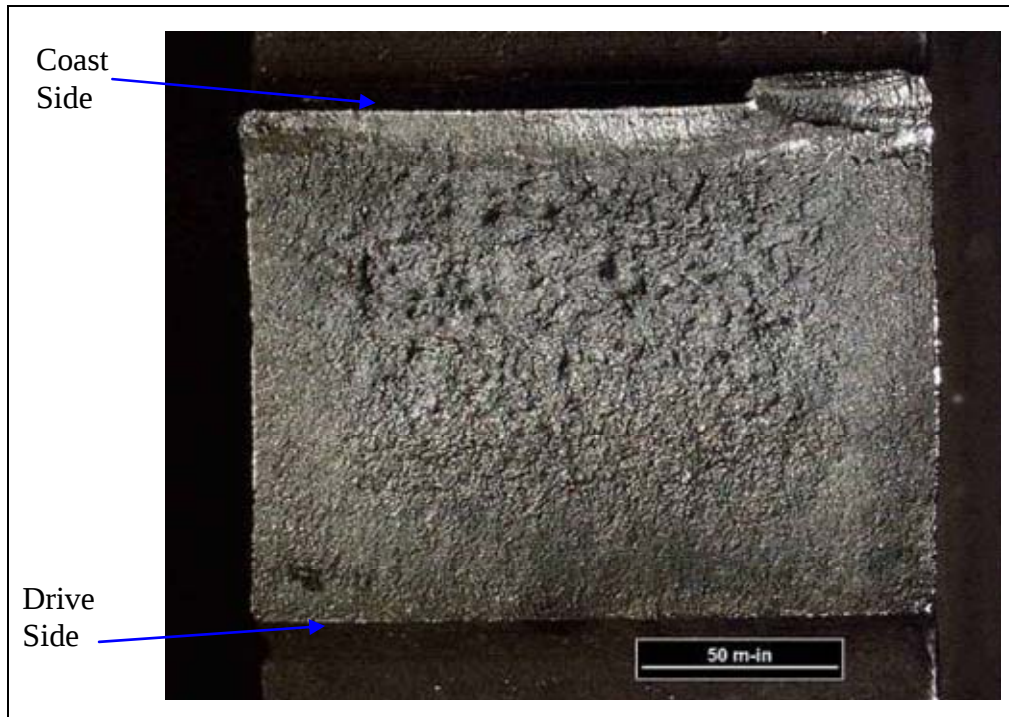
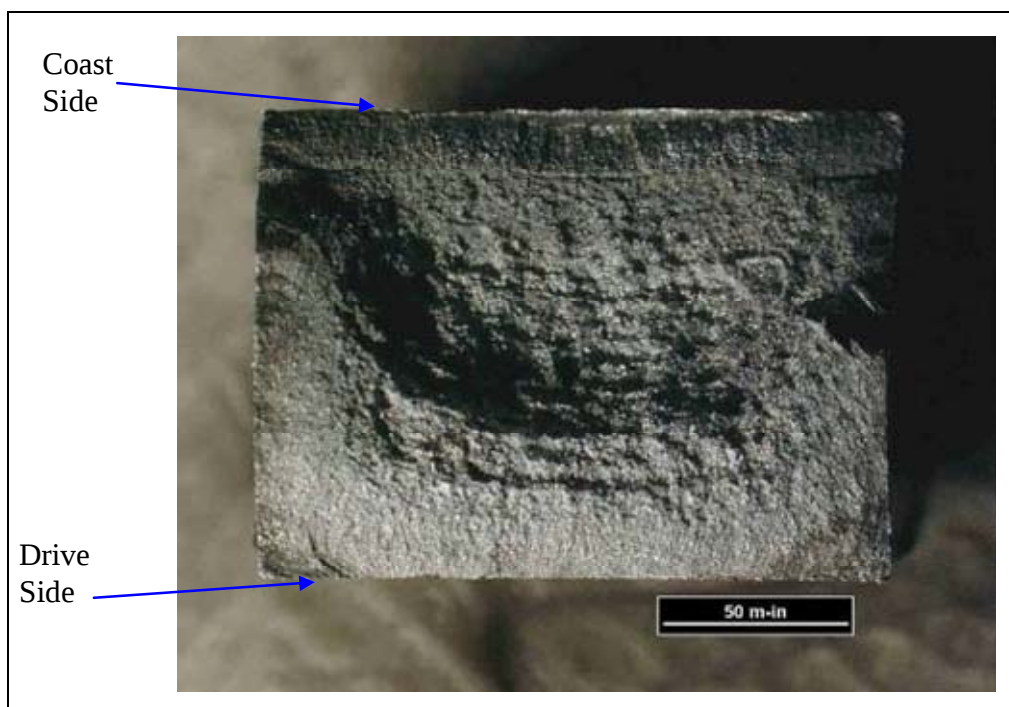
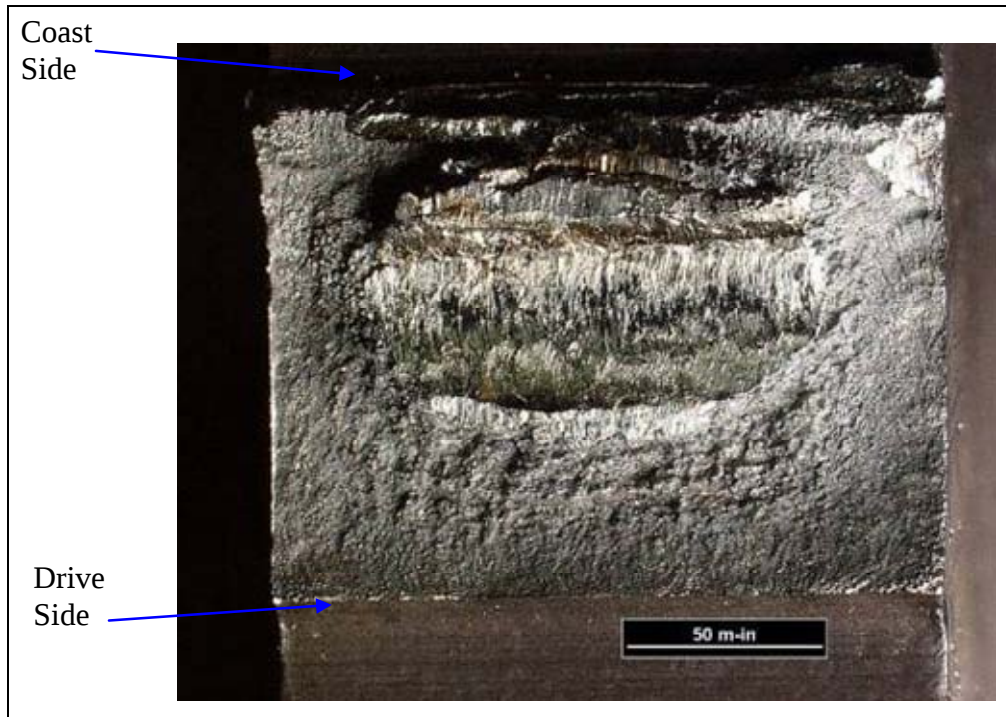
Tooth 29 fracture halves are shown in figures 14 and 15. Fracture halves for tooth 30 are shown in figures 16 and 17.

Figure 14. Tooth 29, tooth fracture half.

Figure 15. Tooth 29, gear fracture half.

Figure 16. Tooth 30, tooth fracture half.

Figure 17. Tooth 30, gear fracture half.

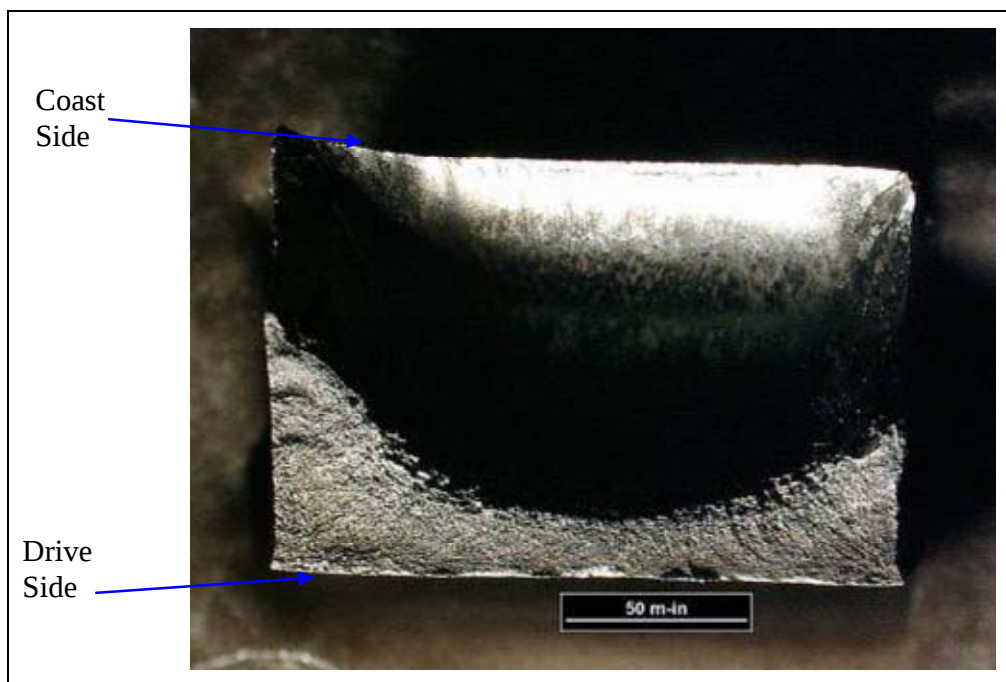
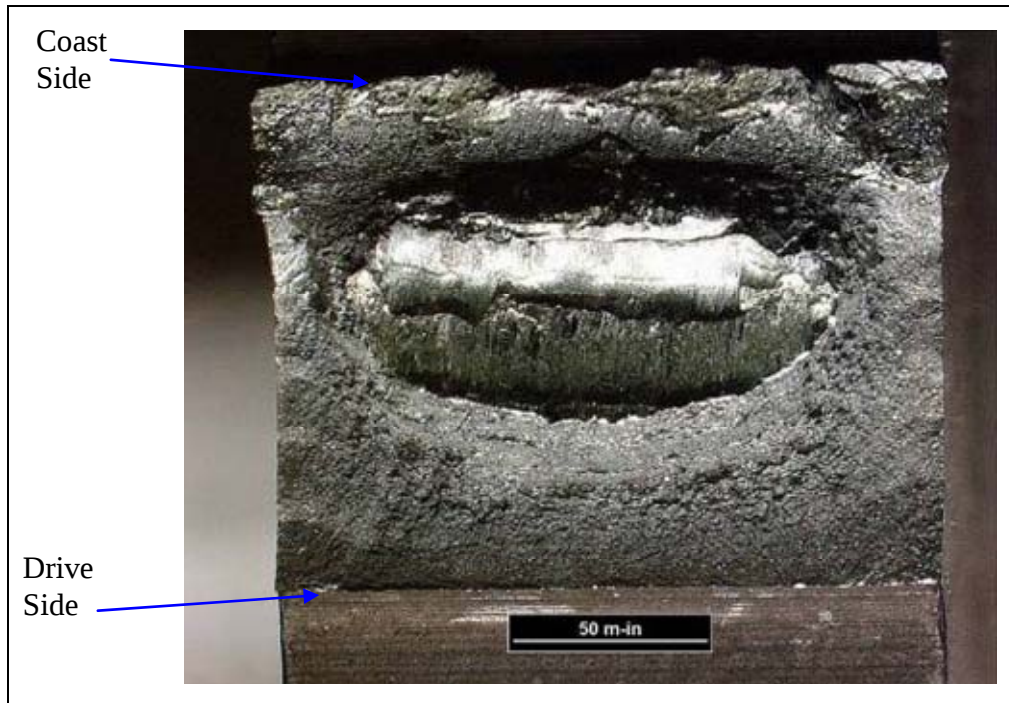
Figures 18 and 19 present the fracture halves for tooth 31. Wear was present at the drive side origin for this tooth (figures 26–28). Note that this was the last tooth in this sequence to fail by bending fatigue.

Figure 18. Tooth 31, tooth fracture half.

Figure 19. Tooth 31, gear fracture half.

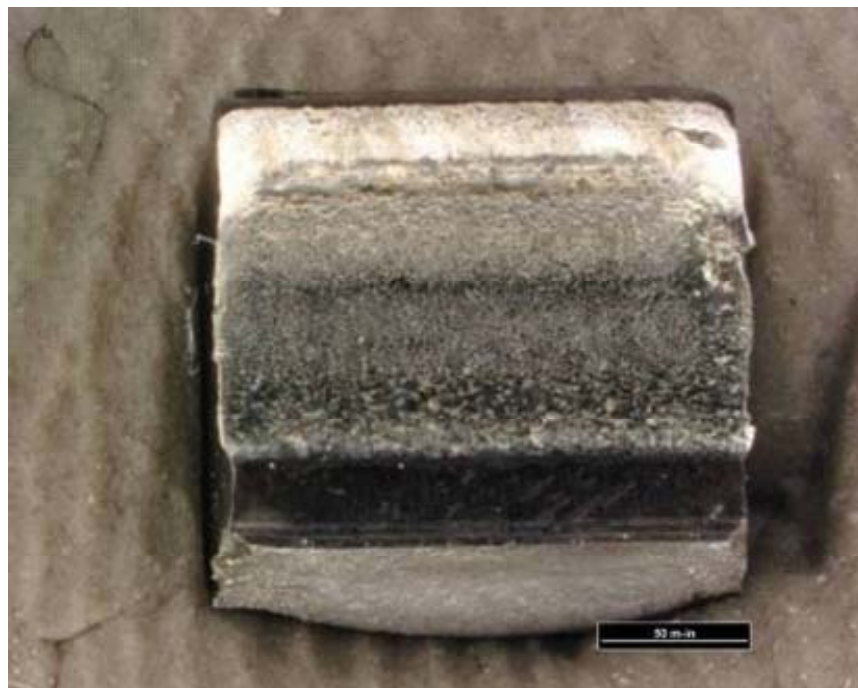
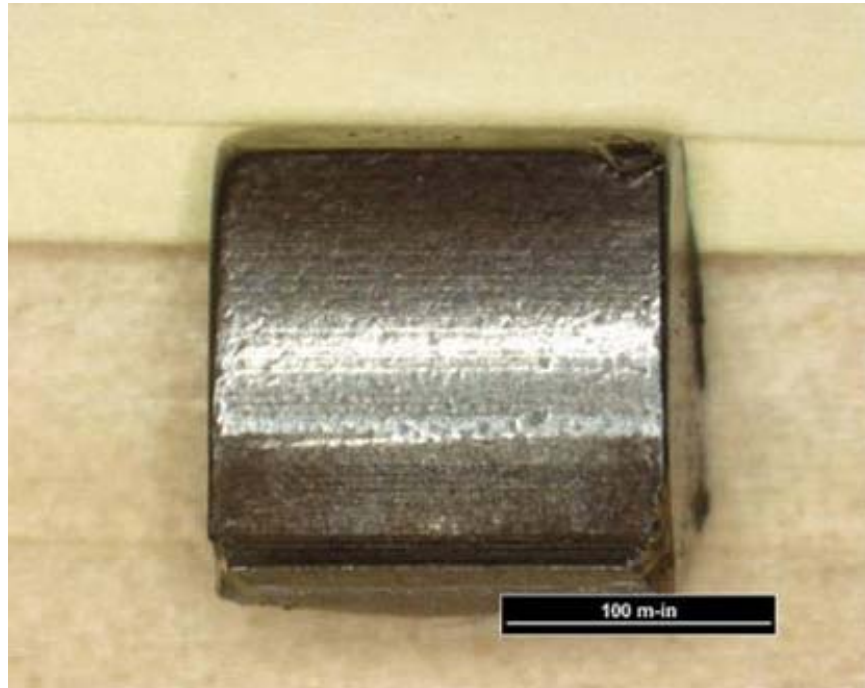
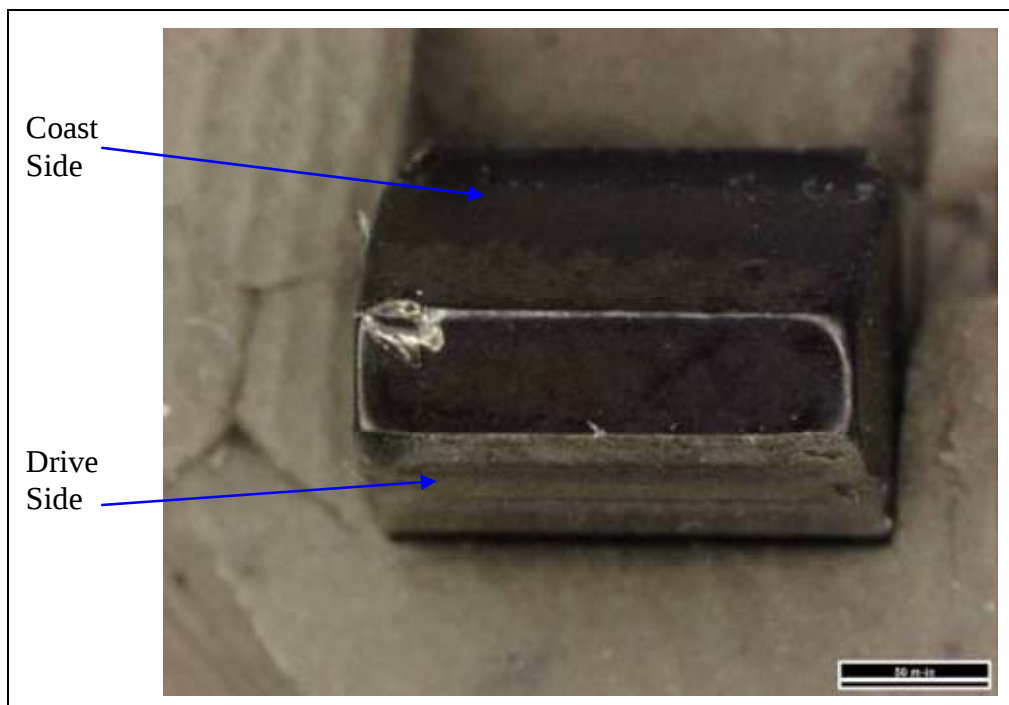
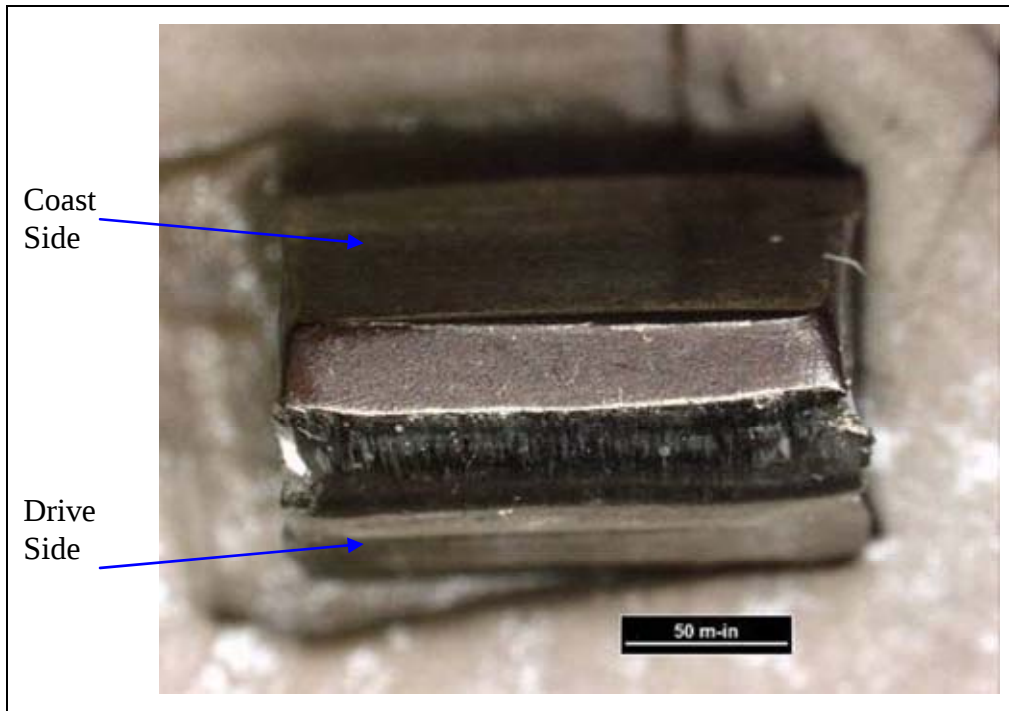
Figures 20–28 are representative of the wear pattern observed on most of the teeth recovered.

Figure 20. Drive side, tooth 1.

Figure 21. Coast side wear, tooth 1.

Figure 22. Top of tooth 1.

Figure 25. Top of tooth 18.

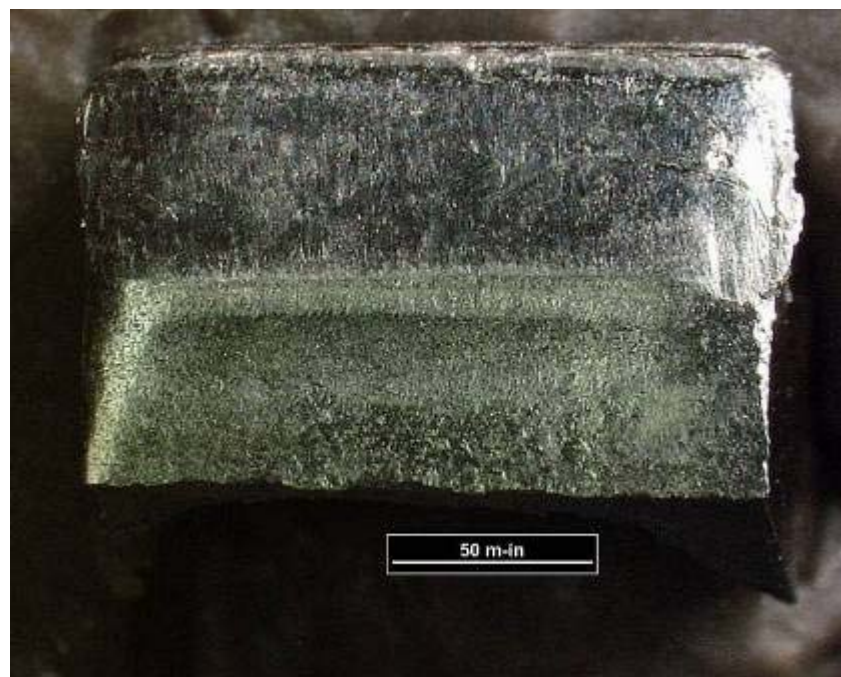
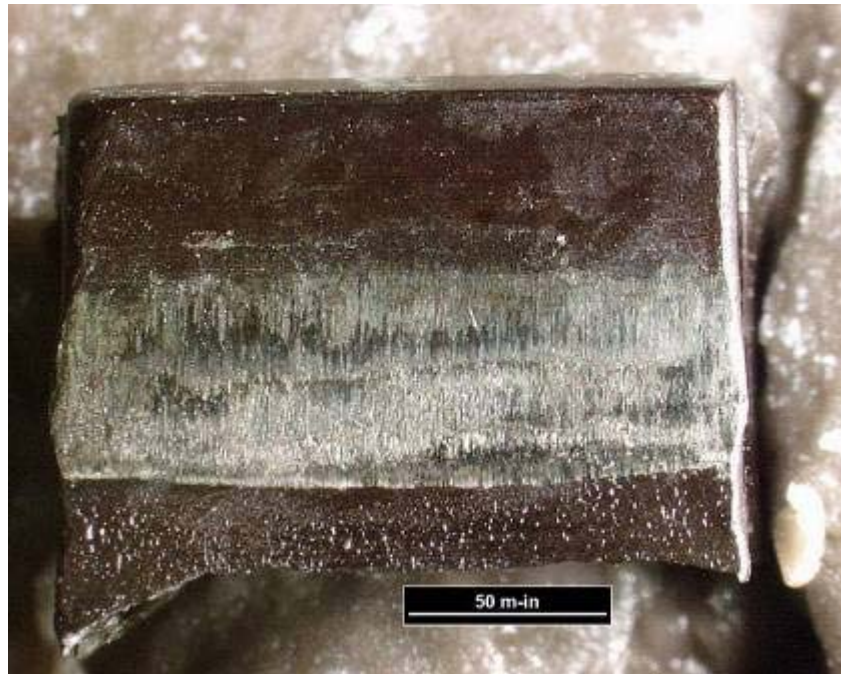
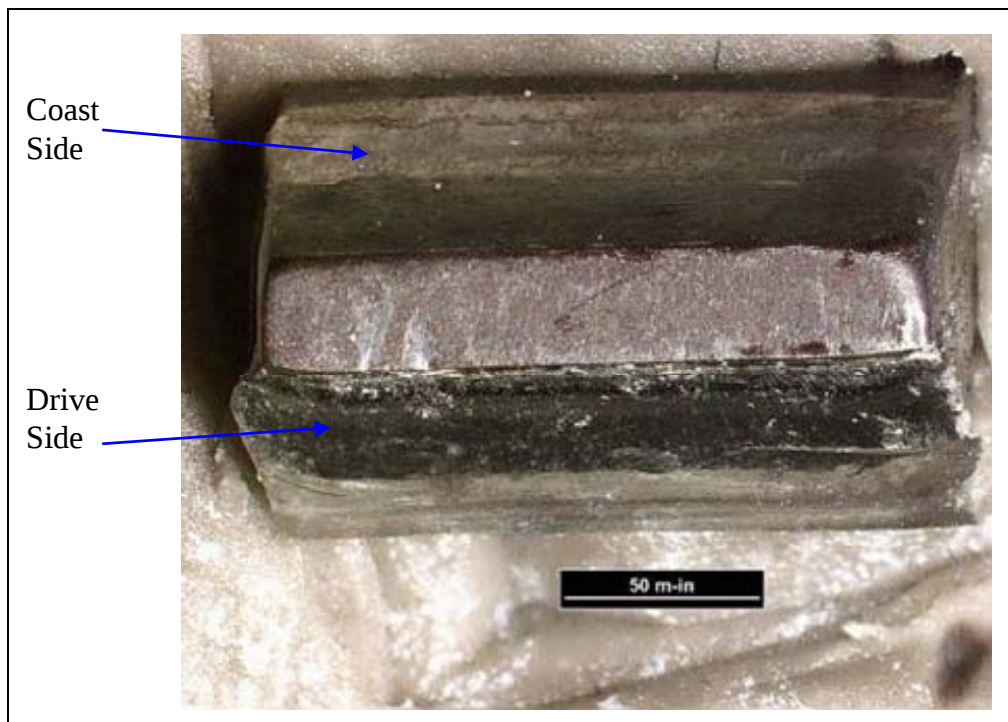
Figure 26. Drive side, tooth 31. (Note: worn adjacent to fracture surface.)

Figure 27. Coast side, tooth 31.

Figure 28. Top of tooth 31.

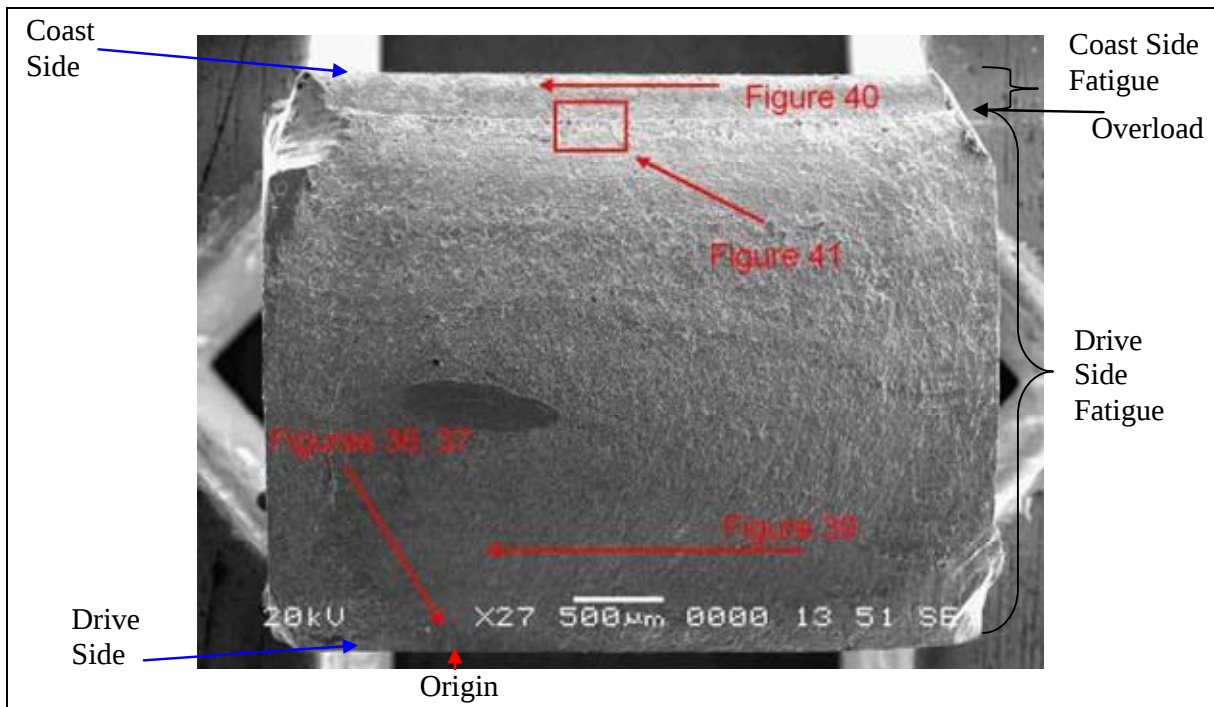
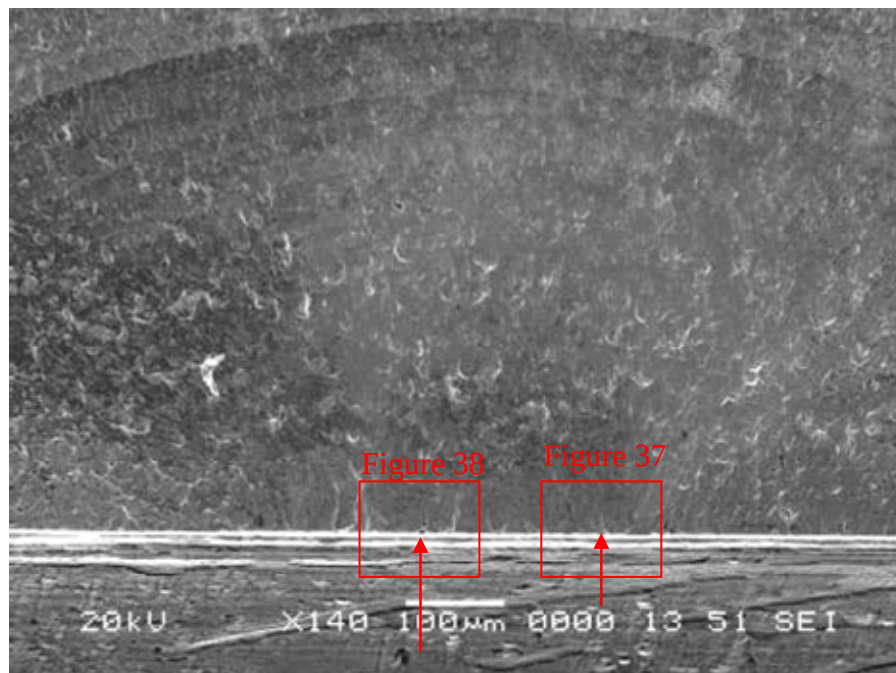
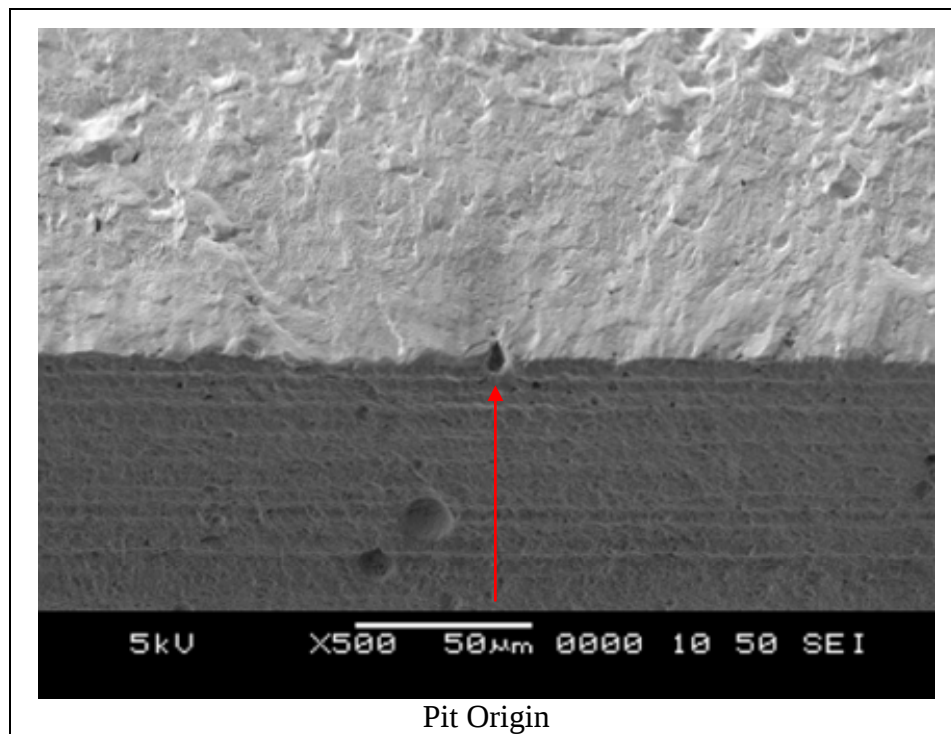
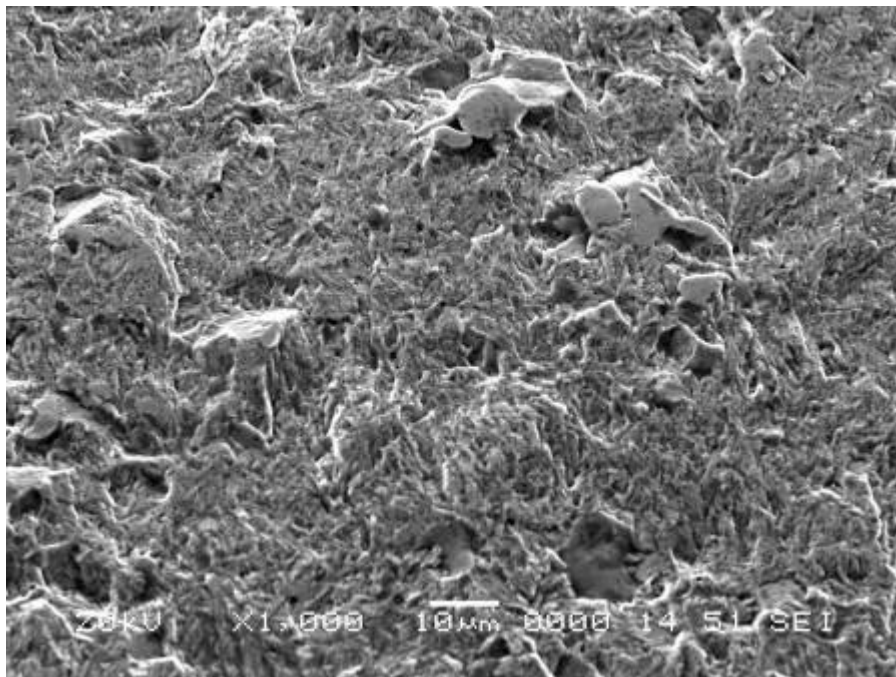
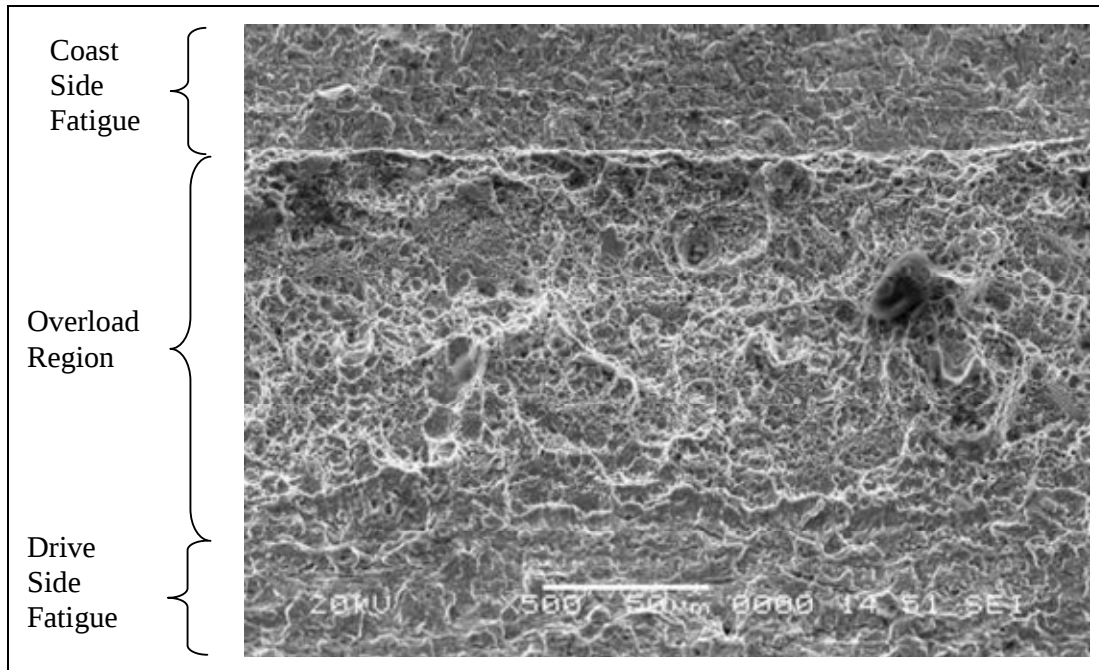
Figures 35–41 show SEM micrographs of tooth 1. Figures 36–38 present the origin for this primary failure. The pit origin can be clearly seen in figure 38. A separate crack originated from the coast side of the tooth and can be observed in figures 35 and 41. The two fractures connected through a small (100–150  $\mu\text{m}$ ) overload region as shown in figure 41.

Figure 35. Tooth 1.

Figure 36. Tooth 1 drive side origin.

Figure 37. Tooth 1 drive side pit origin site.

Figure 38. Tooth 1 primary origin, drive side gear fracture half.

Figure 39. Transgranular morphology, tooth 1 drive side.

Figure 40. Transgranular morphology, tooth 1 coast side.

Figure 41. Overload transition, tooth 1.

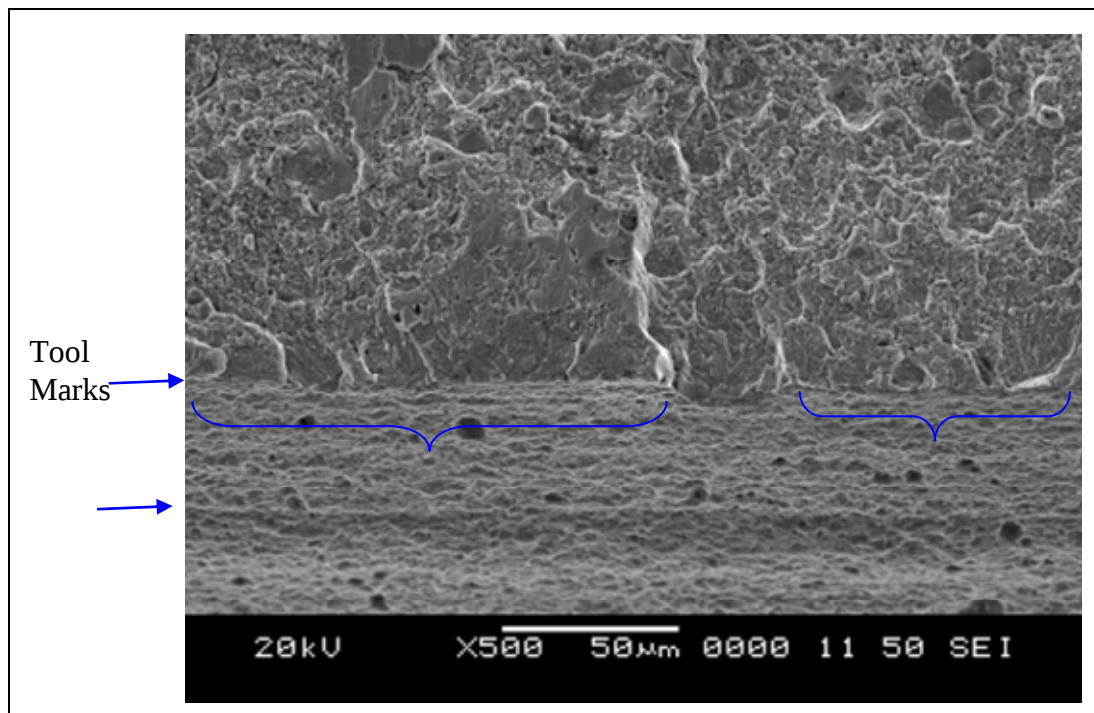
Figure 44. Drive side, tooth 3, primary origin gear half.
