## **Failure Analysis of OH-58 Kiowa Warrior Drive Gear Shafts**

**ARL-TR-3827**

**June 2006**

U.S. Army Research Laboratory  
Weapons and Materials Research Directorate  
Aberdeen Proving Ground, MD 21005-5069

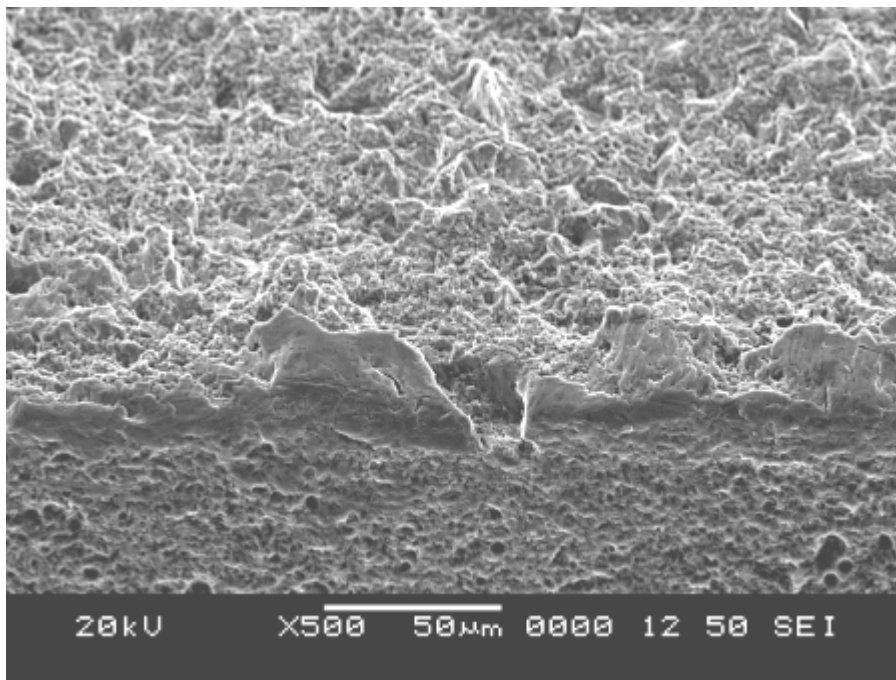
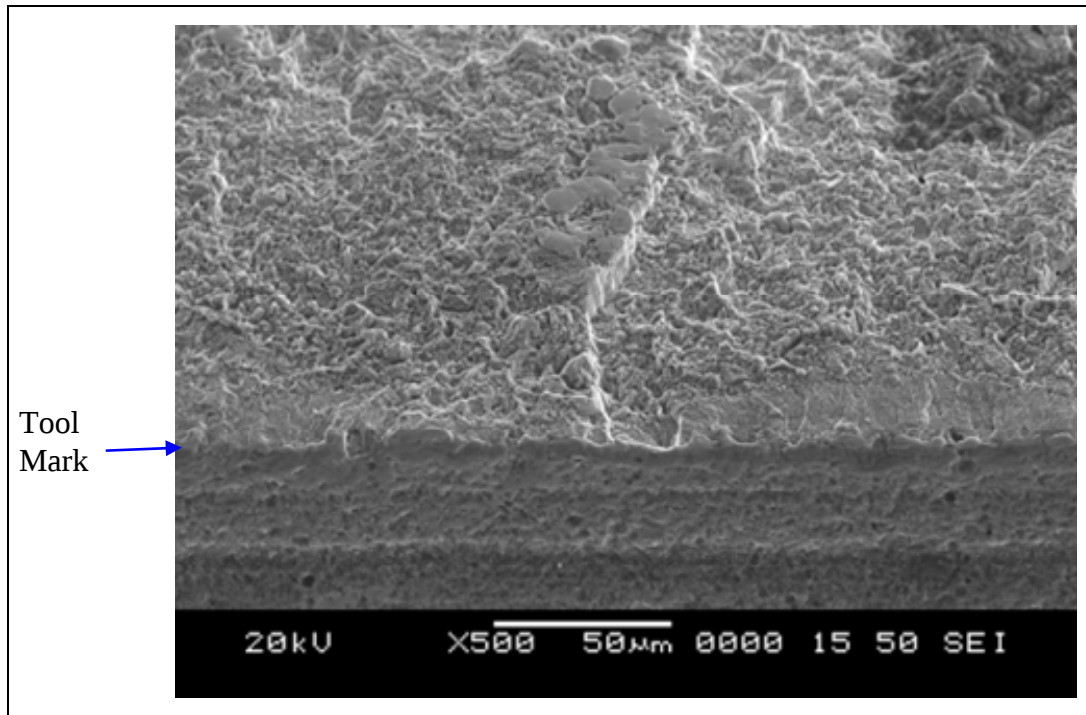
Tooth 4 had multiple origin sites (both pits and tool marks), which are shown in figures 45–47. There was a pit that led to cracking that can be observed on both the tooth and gear fracture halves (figures 45 and 46).

Figure 45. Tooth 4 drive side primary pit origin.

Figure 46. Tooth 4 drive side primary pit origin, gear fracture half.

Figure 47. Tooth 4 drive side.

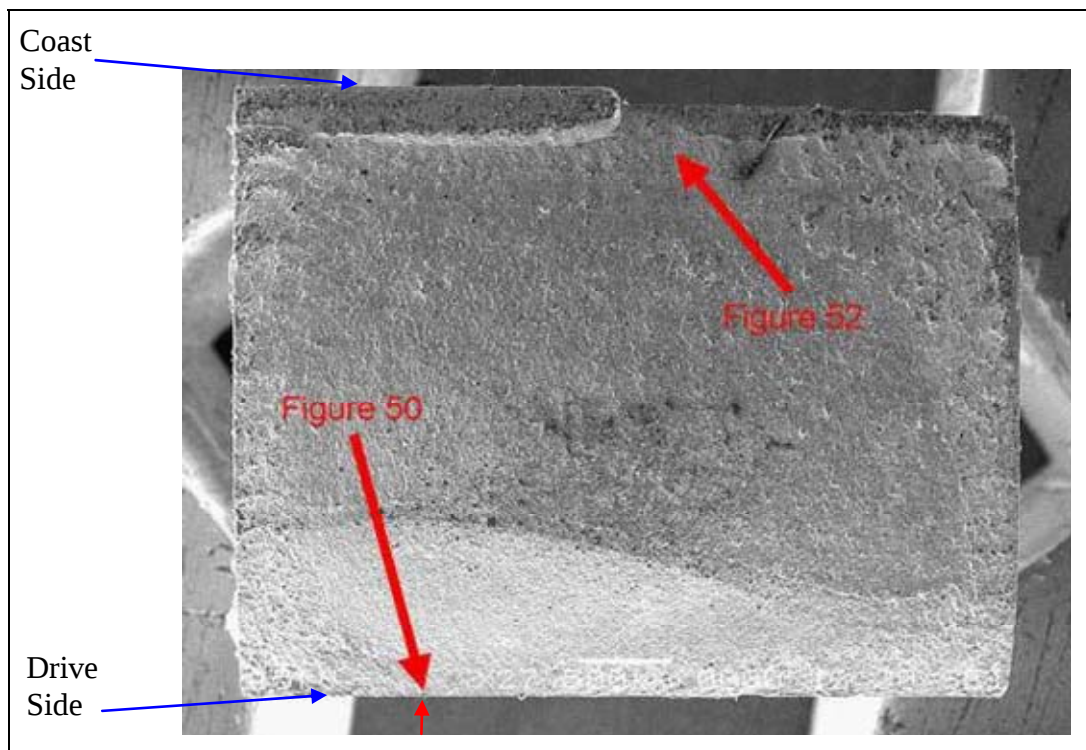
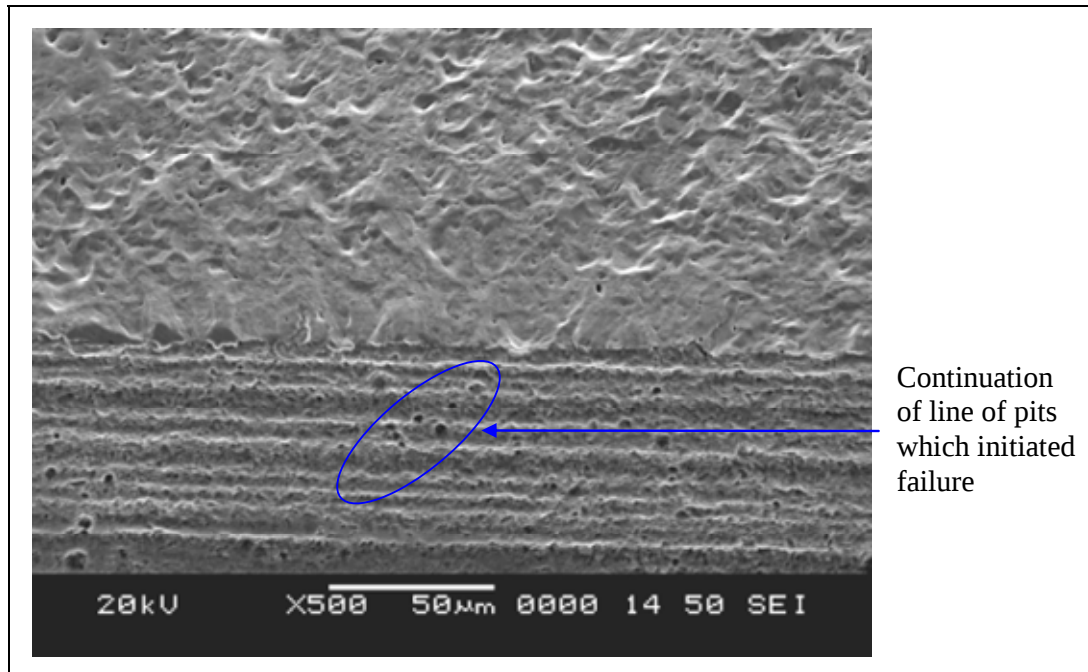
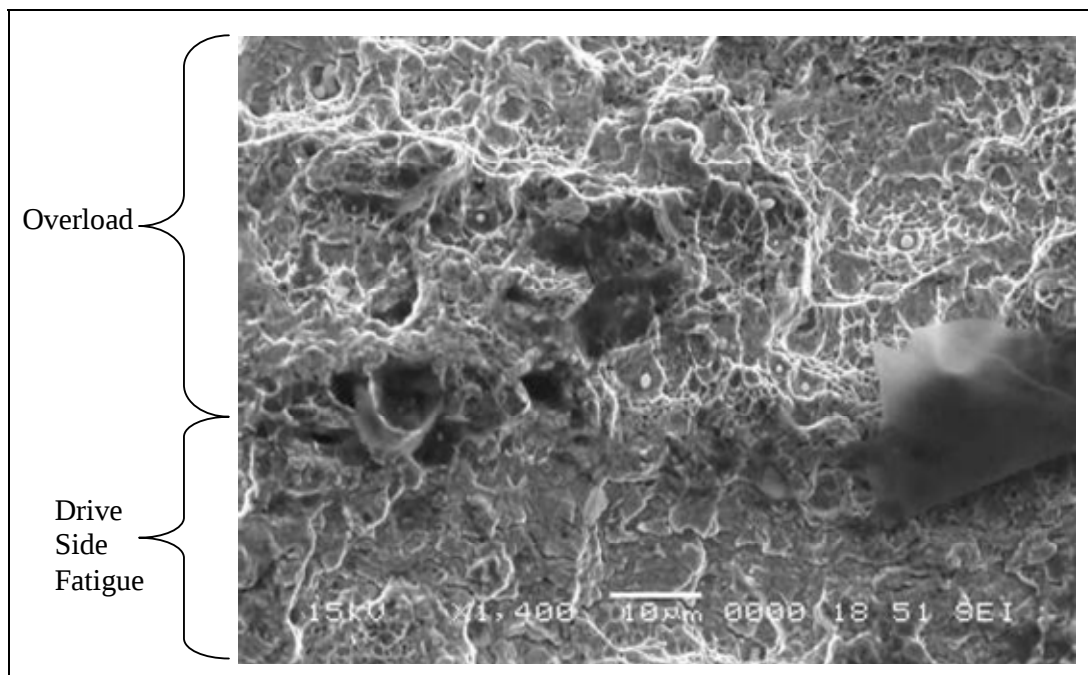
Tooth 28 is shown in figures 48–52. The fracture was remarkably similar to tooth 1; both fractures possessed a primary pit origin (drive side), initiation and propagation from the coast side, and a very small overload region. Figures 49–51 show the origin of fatigue on this primary failure that can be traced to a line of pits including the pit which initiated failure.

Figure 48. Tooth 28 fracture surface.

Figure 49. Tooth 28 drive side, primary origin.

Figure 50. Tooth 28 drive side, primary pit origin.

Figure 51. Tooth 28 drive side origin site, gear fracture half.

Figure 52. Tooth 28 fracture surface, transition to overload at top.

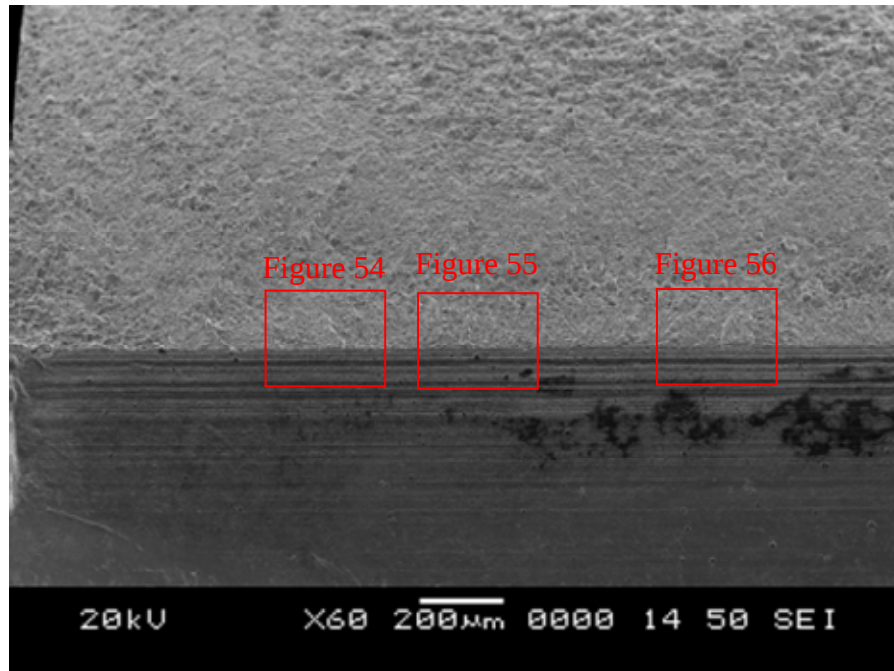
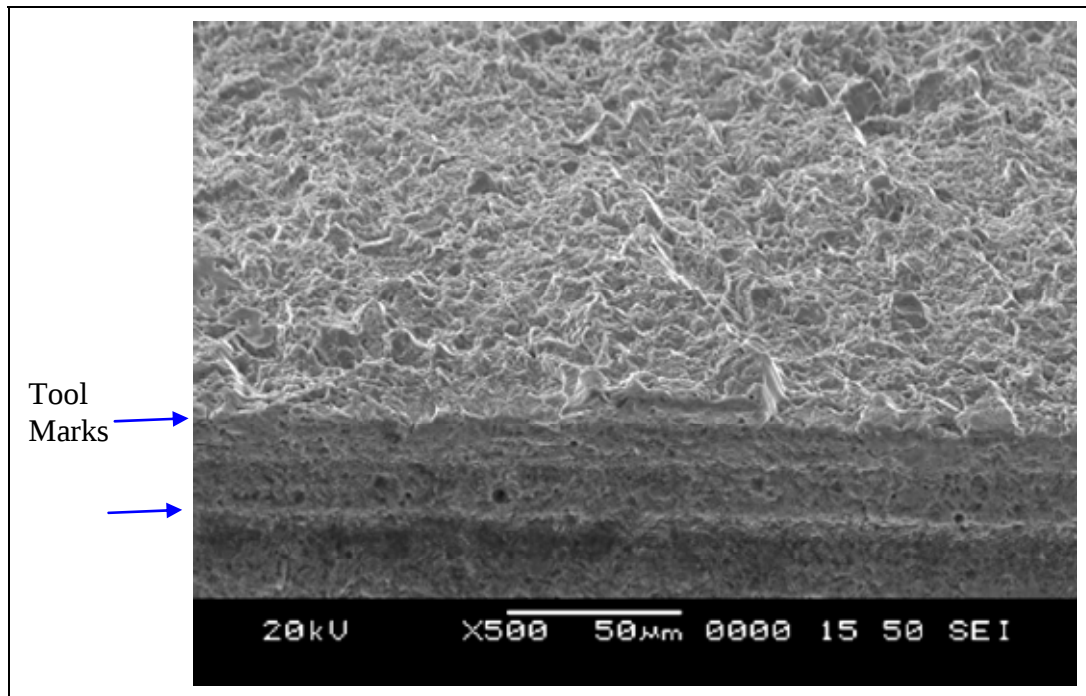
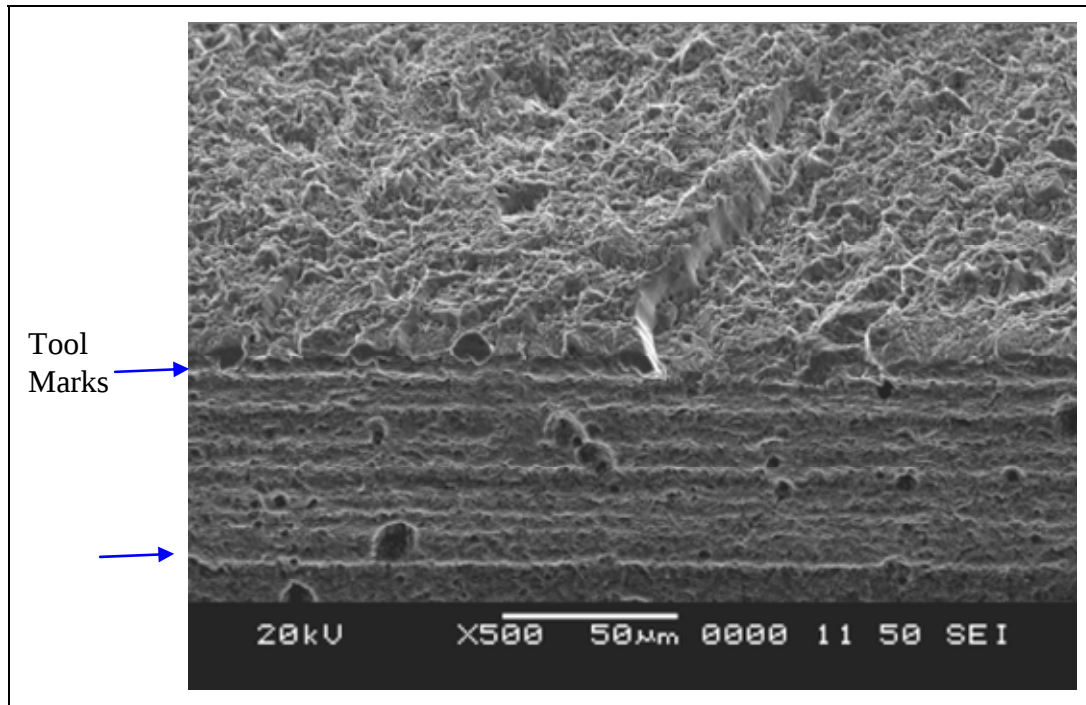
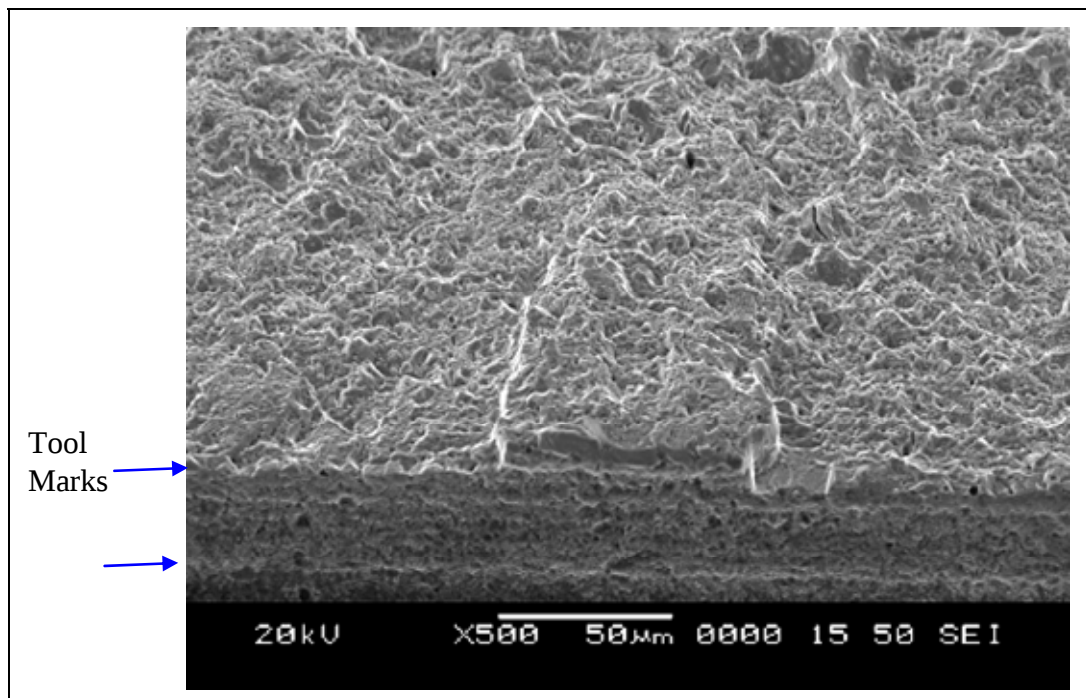
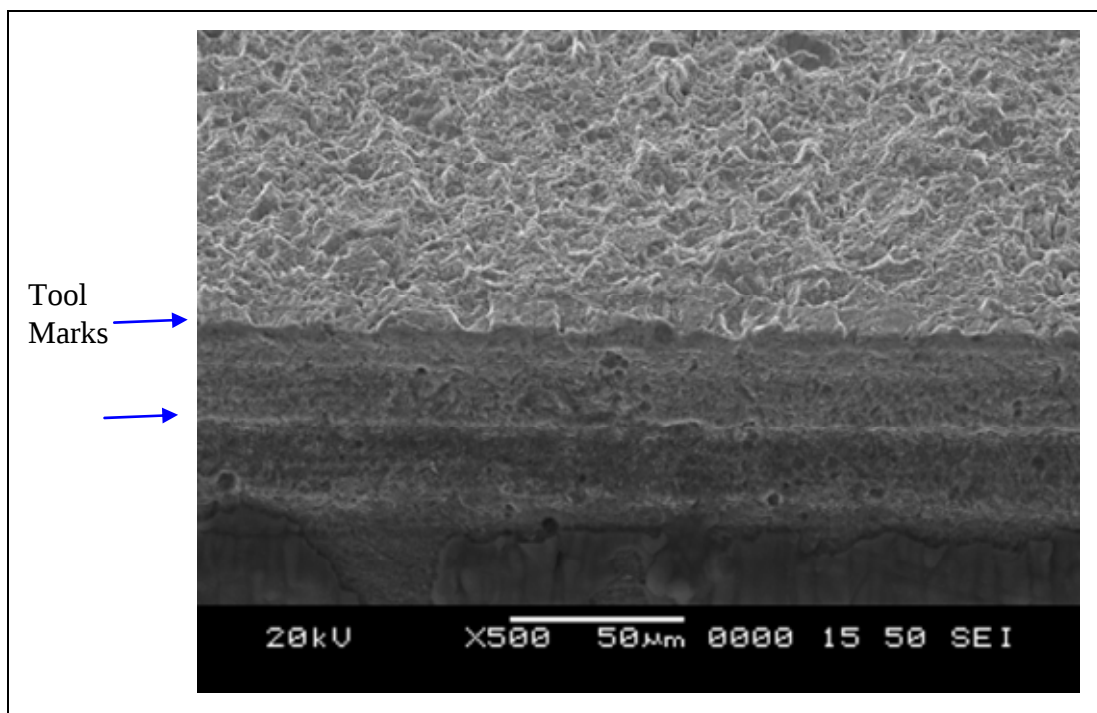
Figures 53–58 show the fracture surfaces associated with tooth 29. Failure originated at multiple points along the drive side, which are seen on both the tooth and gear fracture halves, including both pits and tool marks.

Figure 53. Tooth 29 drive side origin area.

Figure 54. Tooth 29 drive side origin, site no. 1.

Figure 55. Tooth 29 drive side origin, site no. 2.

Figure 56. Tooth 29 drive side origin, site no. 3.

Figure 57. Tooth 29 drive side, primary pit origin.

Figure 58. Tooth 29 drive side origin, site no. 4.

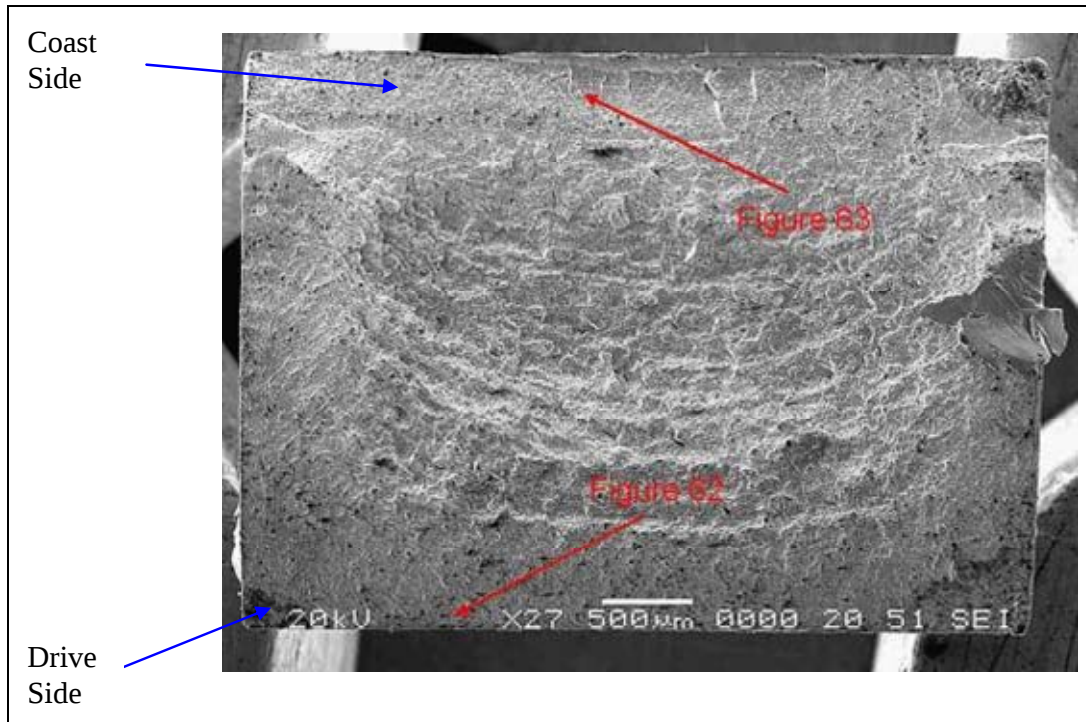
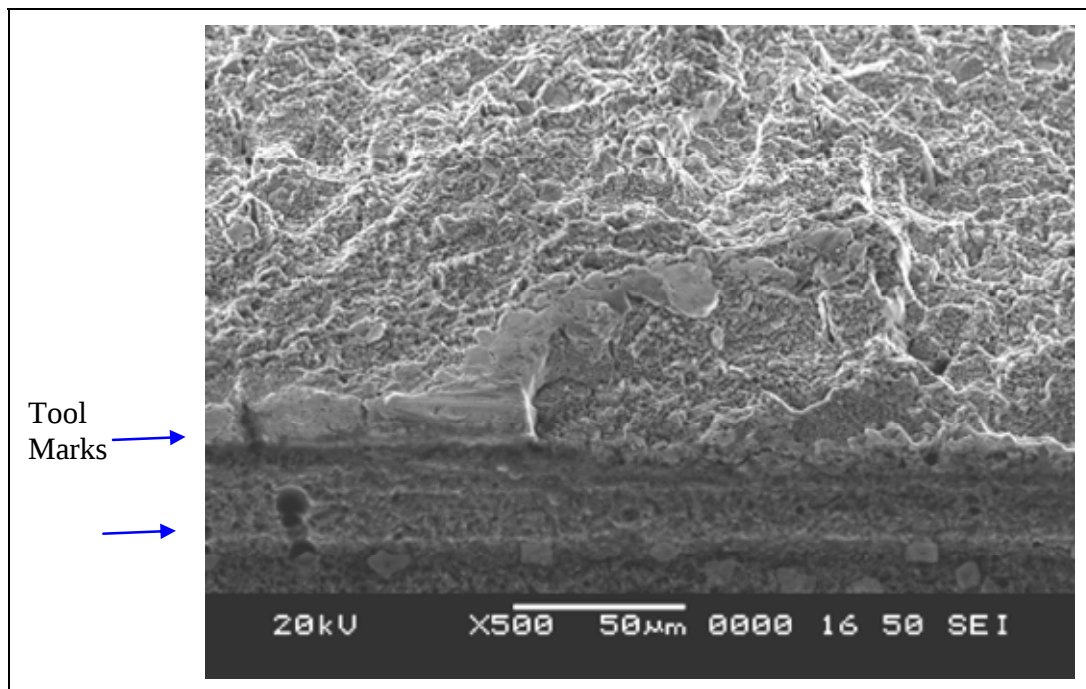
Tooth 30 is shown in figures 59–63. Multiple origins were found on the drive side, shown in figures 60–61.

Figure 59. SEM tooth 30 fracture surface.

Figure 60. Tooth 30 origin, gear fracture half.

Figure 61. Tooth 30 pit origin, gear fracture half.

Figure 62. Tooth 30 fracture surface, drive side.

Figure 63. Tooth 30 fracture surface, coast side.

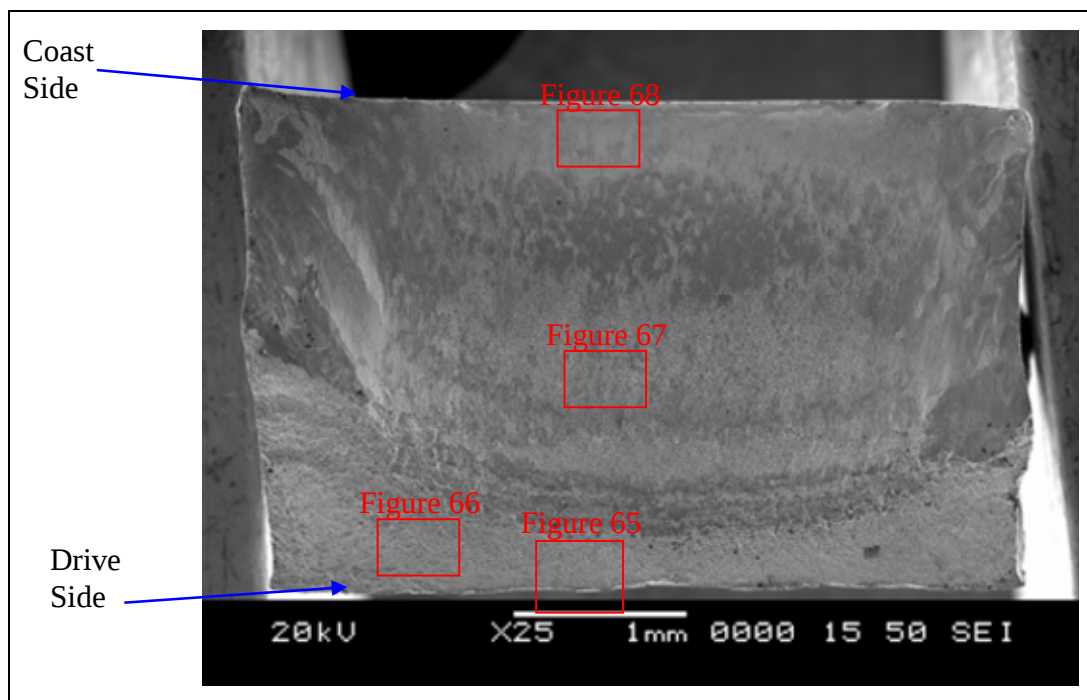
The fracture surface generated by the low cycle fatigue failure of tooth 31 is presented in figure 64. The drive side origin is shown in figure 65. The fracture morphology includes a small amount of mixed mode fracture (figure 66), but is dominated by cyclic overload in the middle of the tooth (figure 67) and near the coast side (figure 68).

Figure 64. SEM tooth 31 fracture surface.

Figure 65. Tooth 31 origin.

Figure 66. Tooth 31 fracture surface.

Figure 67. Tooth 31 fracture surface, showing cyclic overload fracture.

Figure 68. Tooth 31 fracture surface, ductile overload.

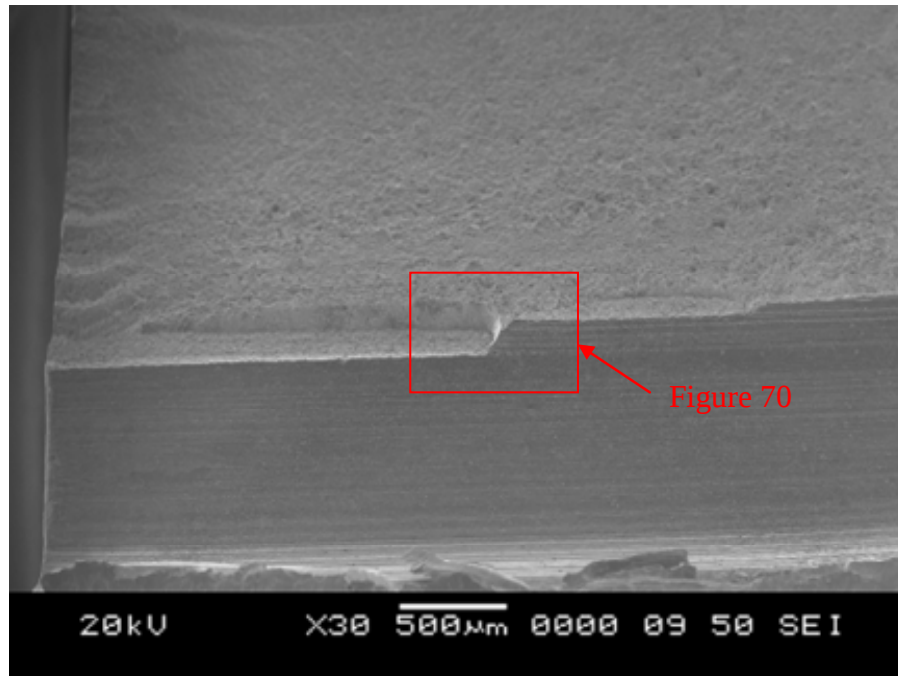
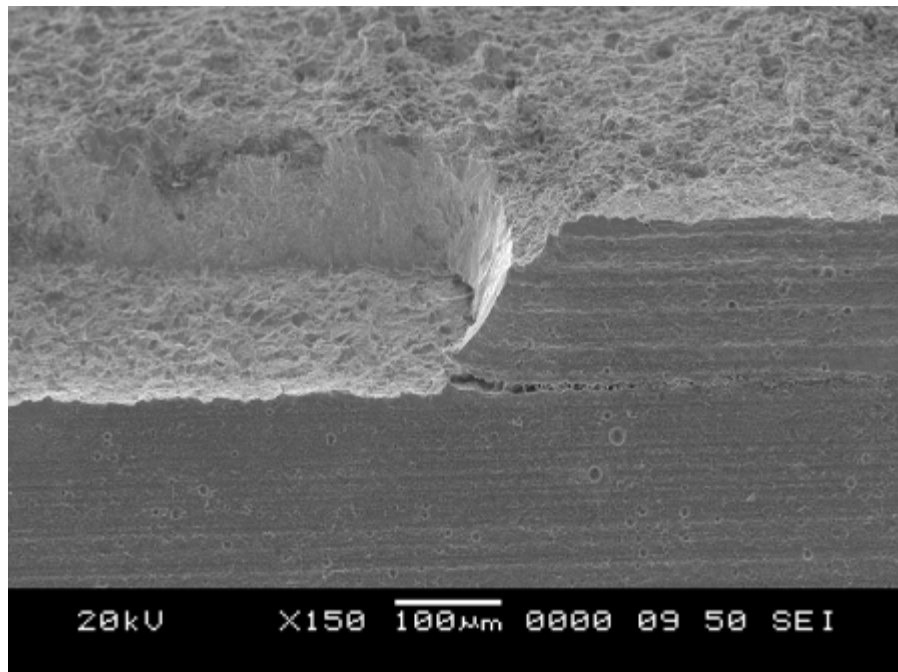
Cracking originating from coast side tool marks is shown in figures 69–75.

Figure 69. Tool marks, tooth 28 root, gear half.

Figure 70. Coast side tool marks, tooth 28 root, gear half. (Note the undercut parallel to tool marks.)

Figure 71. Tooth 28 root, gear half, coast side cracking along tool marks.

Figure 72. Tooth 29 root, gear half, coast side tool marks.

Figure 73. Tooth 29 root, gear half, coast side tool marks.

Figure 74. Tooth 29 root, gear half, coast side tool marks, cracking along tool marks.

Figure 75. Tooth 29 root, gear half, coast side, cracking along tool marks.

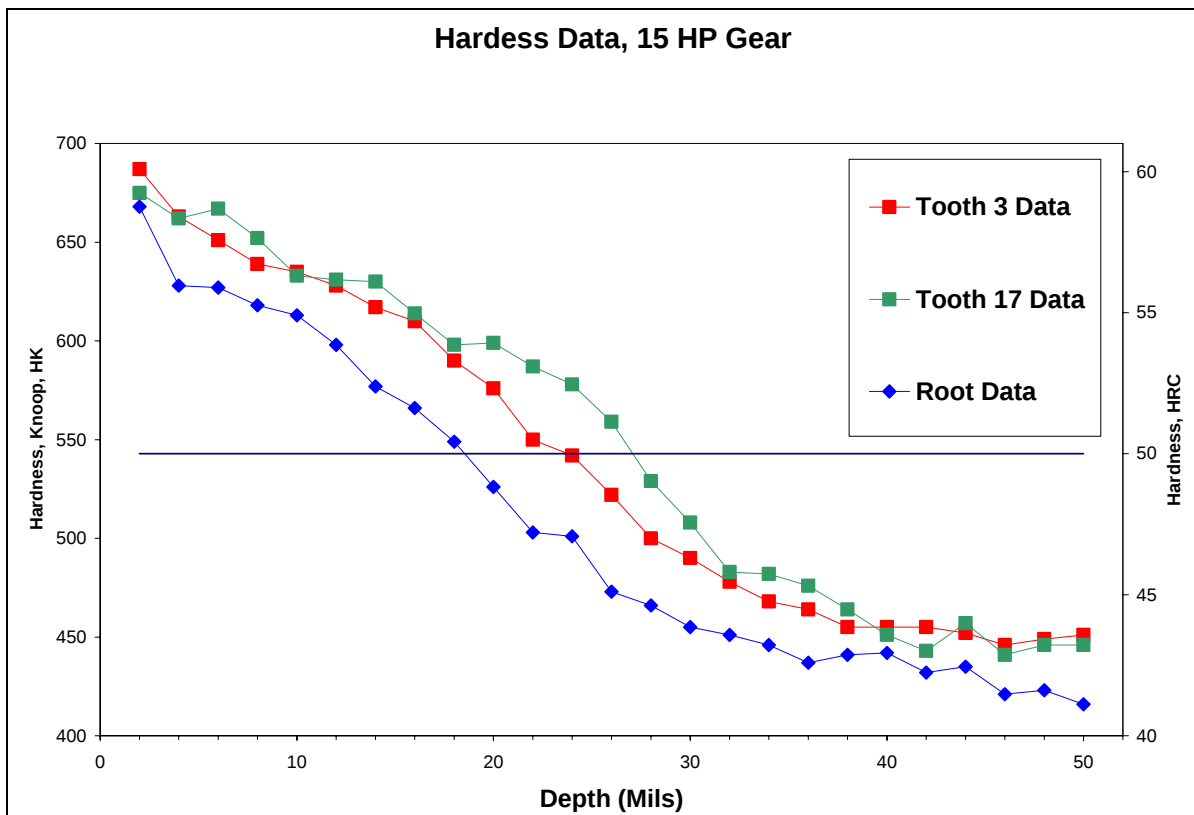
Hardness measurements were provided by Redstone Technical Test Center. They were made at the tooth root and at the face (near the pitch line) using an Instron Model Tukon 2100 microhardness tester. Effective case depth (EFD) (defined as the depth at which hardness drops to 50 Hardness Rockwell C-scale [HRC]) was found to be approximately 0.026 in at the pitch line and 0.018 in at the root. Hardness data for the profile and root are given in tables 1–3 and shown in figure 76.

Figure 76. Hardness data tooth and root profiles.
