# **THE NATIONAL SHIPBUILDING RESEARCH PROGRAM**

## **Evaluation of New Surface Preparation and Coating Repair Techniques in Ballast Tanks - Phase IV**

**EVALUATION OF  
NEW SURFACE PREPARATION AND COATING REPAIR  
TECHNIQUES IN BALLAST TANKS-PHASE IV  
TWENTY YEARS OF BALLAST TANK COATING SYSTEM TESTING**

**NSRP 3-96-2**

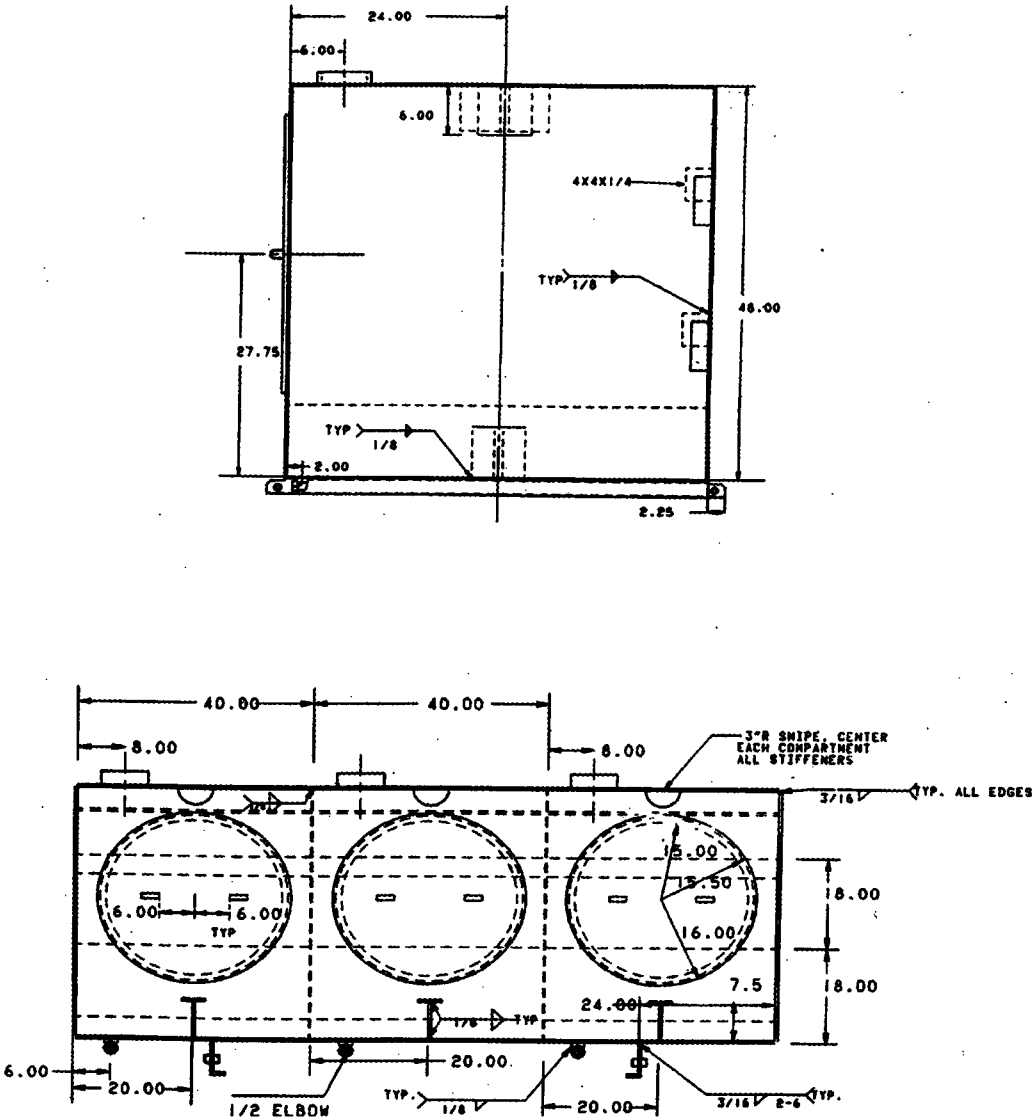
**Figure 1: Drawing of Test Tank Assembly**

The approximate dimensions of each tank assembly are twelve feet long by four feet wide and four feet high. Each tank assembly is divided into three separate test cells for a total of nine test tanks. Each tank assembly is constructed to simulate the internal geometry of an actual ballast tank to include angles, built up frames, "T" bars, and wide flanges. One side of each tank has bolted construction to facilitate access for coating application and inspection. See Figure 1 and Photograph 1.

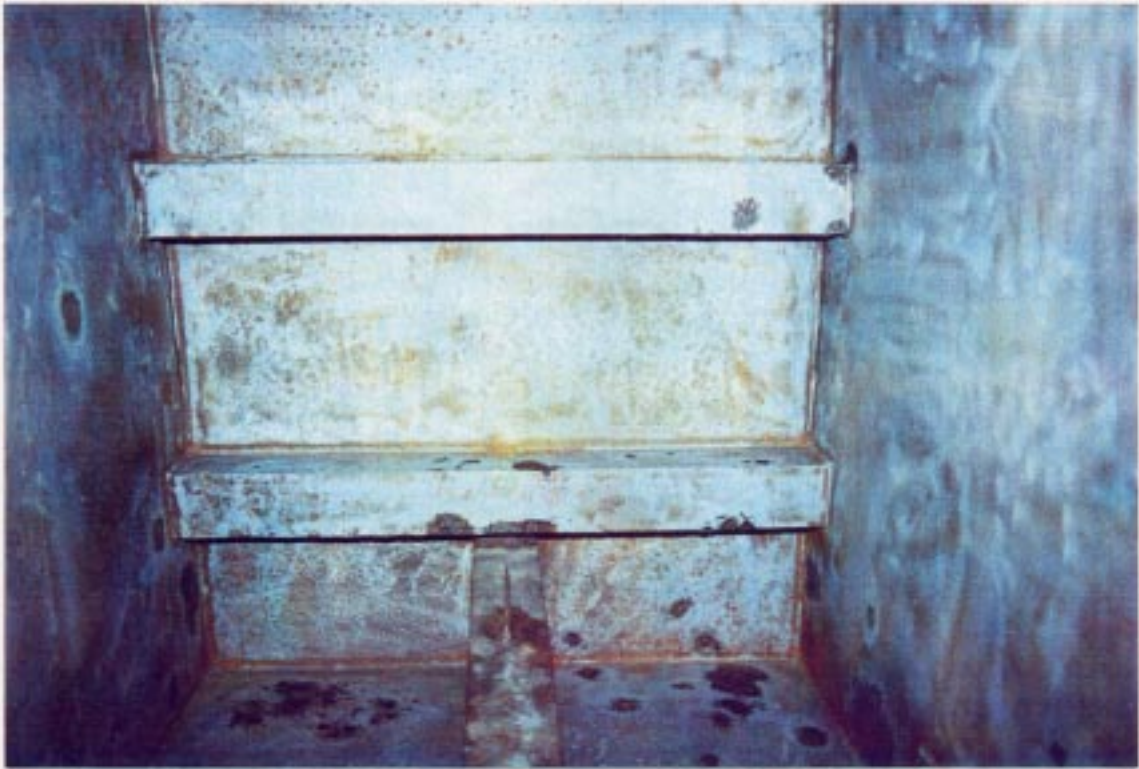
**PHOTOGRAPH 3- REPAIR SURFACE PREPARATION TO MIL-P-24441**

Photograph 3 shows the repair surface preparation of the Mil-P-24441 system prior to spot priming and full refresher topcoat application.

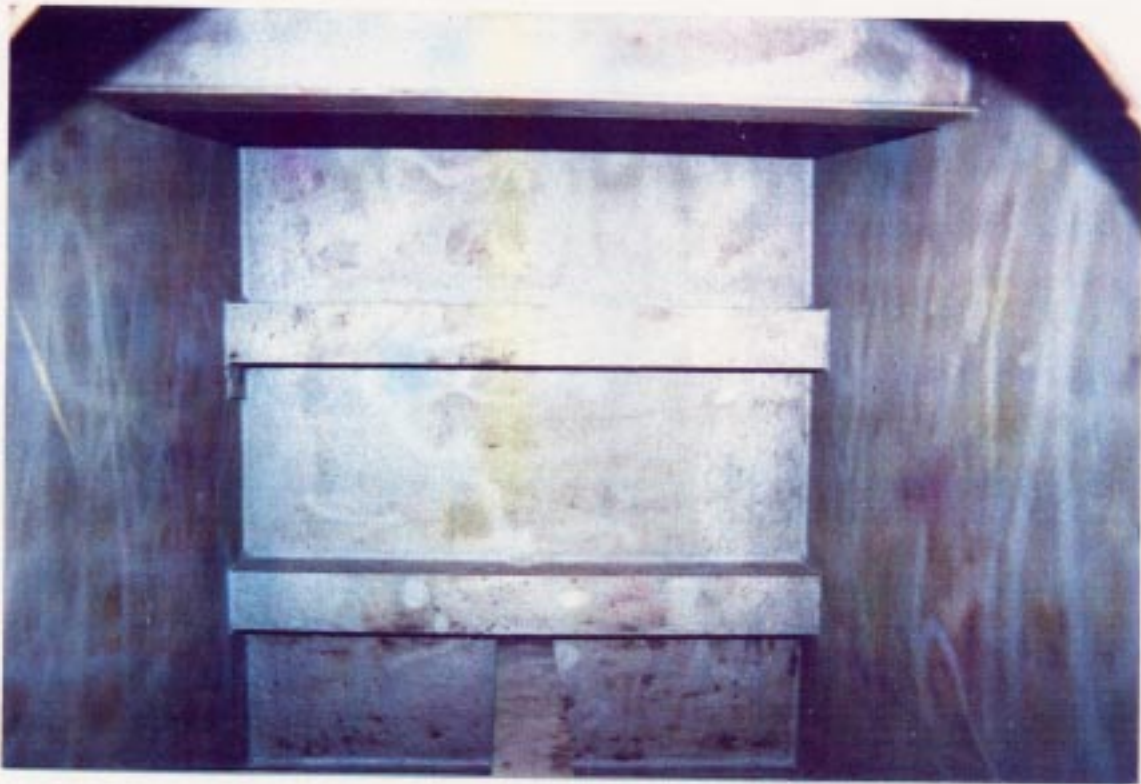
During the maintenance phase of the program, no attempt was made to remove invisible salt surface contamination, as one of the goals was to verify performance over substandard surfaces. A flash rust-back-free surface preparation was not achievable when using abrasive blast cleaning techniques. Due to the high chloride contamination of the corroded steel, the blasted surface would flash rust within a matter of minutes. See Photograph 4. This statement holds true for all the tanks, which were re-blasted for this phase of the project.

The chloride levels were determined to be 5 milligrams per square meter for Near White Blast Cleaned surfaces. This may seem low, based on the fact that the surface preparation flash rusted in a less than four hours; but may be due to the limitation of the swab technique used to determine chloride contamination. Sodium chloride salts bound up as ferric or ferrous chloride and combined with other complex salts could have influenced the solubility of the salts removed. After allowing the solution to set for three hours, the conductance of the solution increased resulting in a revised reading of 15 milligrams per square meter.

**PHOTOGRAPH 4- NEAR WHITE CLEANED SURFACE SHOWING FLASH RUST**

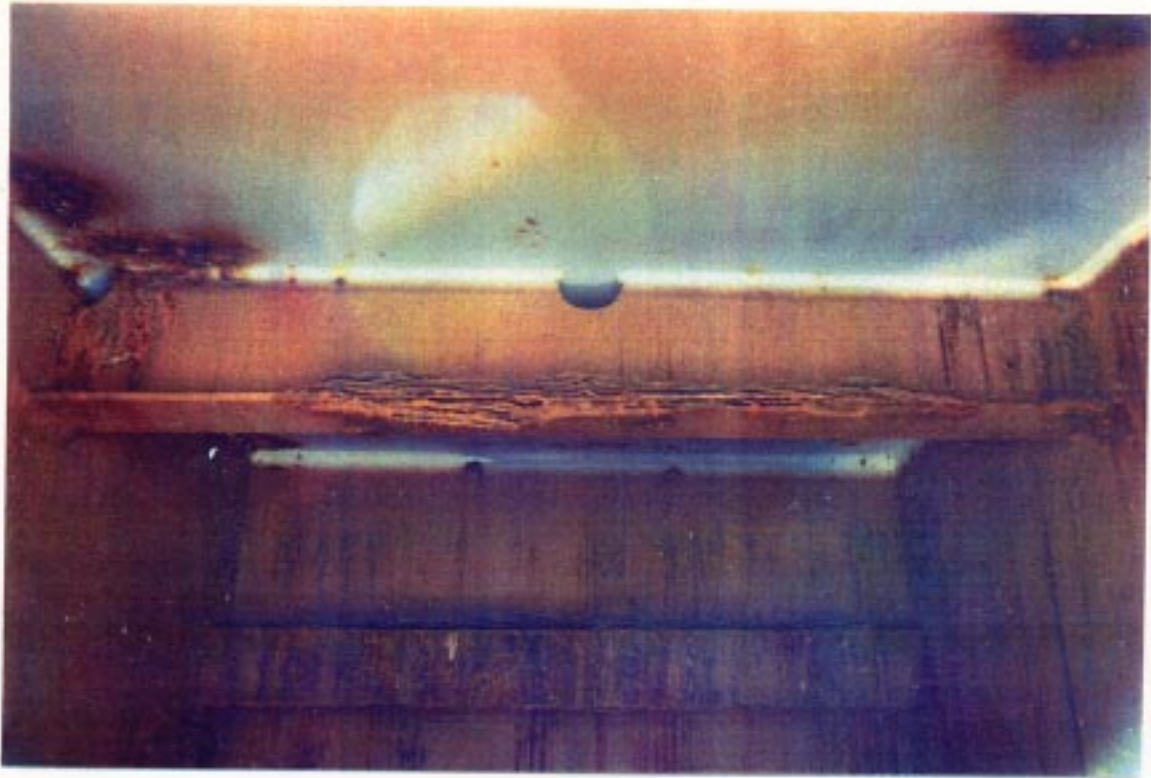
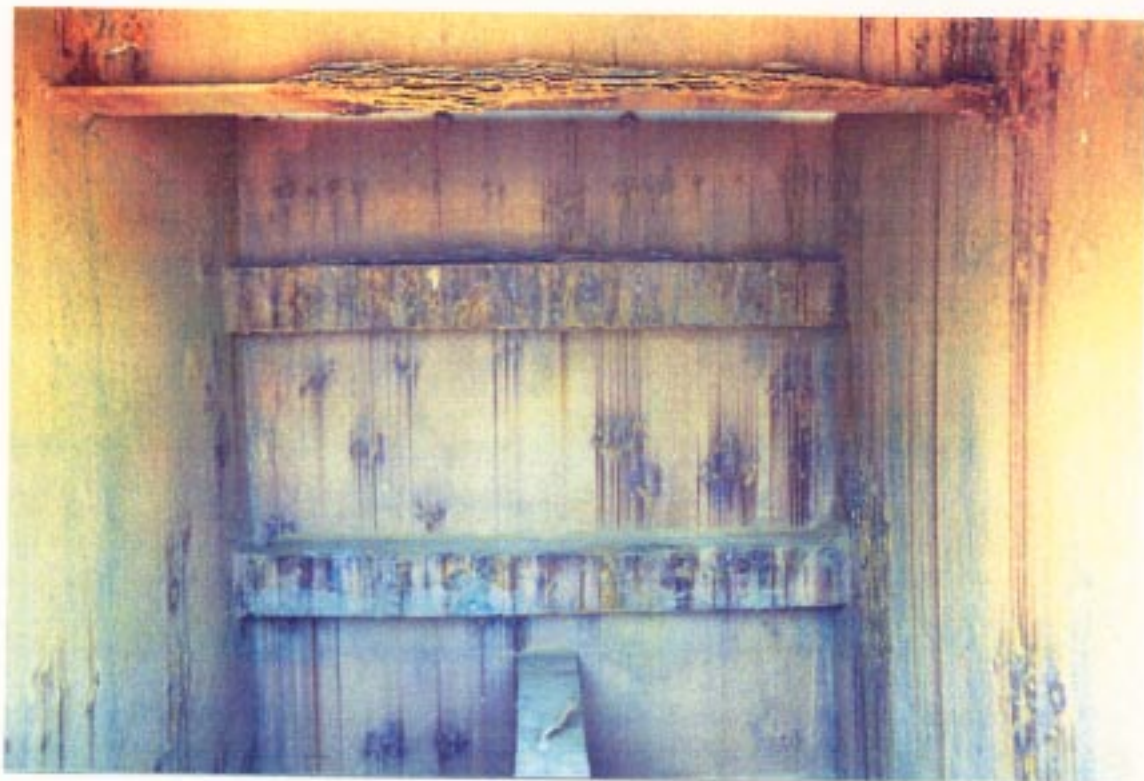
**PHOTOGRAPH 6-SURFACE TOLERANT EPOXY A OVER HAND TOOL CLEANED SURFACE**

use of power tool cleaning in lieu of abrasive blasting. This is especially true since, after five years of testing (two additional years), the performance of the two systems reversed and the hand tool cleaned tank was graded to be a Rust Grade 4, Failure – requiring replacement. The abrasive sweep blast cleaned (SSPC SP-7) tank was a Rust Grade 6. See Photographs 6 and 7.

From the ultrasonic thickness readings after twenty years, Tank One (Surface Tolerant Epoxy “A” over hand tool cleaned substrate) had very little metal loss on the flats except for one area on the tank bottom. There was major reduction in section on one back stiffener. Tank Four (Surface Tolerant Epoxy “A” over sweep blast cleaned substrate) had more overall metal loss; however, not significantly different from the baseline data from the 1987 report. The original system in Tank Four was the pre-construction primer with aluminum anode, which failed in three years. Subtracting the present thickness readings from the baseline data for each tank, Tank One has an overall average metal loss of 0.006 inches or 6 mils. Tank Four has an overall metal loss of 17 mils. If the stiffening metal loss is not considered for Tank Four, there is no measurable difference after twenty years. Remember that the baseline data in 1987 only included flats.

Because the one system had failed, repairs were made to both systems, and the testing was reinitiated. The hand tool cleaned tank system was repaired using hand tool cleaning techniques. The sweep blast cleaned system was spot blasted to remove failed coatings and the balance of the surface was sweep blasted. After repair and re-exposure for an additional seven years, the sweep blast cleaned tank was superior. The hand tool tank was a Rust Grade 4.5, and the sweep blast cleaned tank was a Rust Grade 7.5. There was major edge breakdown on the top stiffener in the hand tool cleaned tank; however, overall, the Epoxy “A” coating system demonstrated relatively good edge protection.

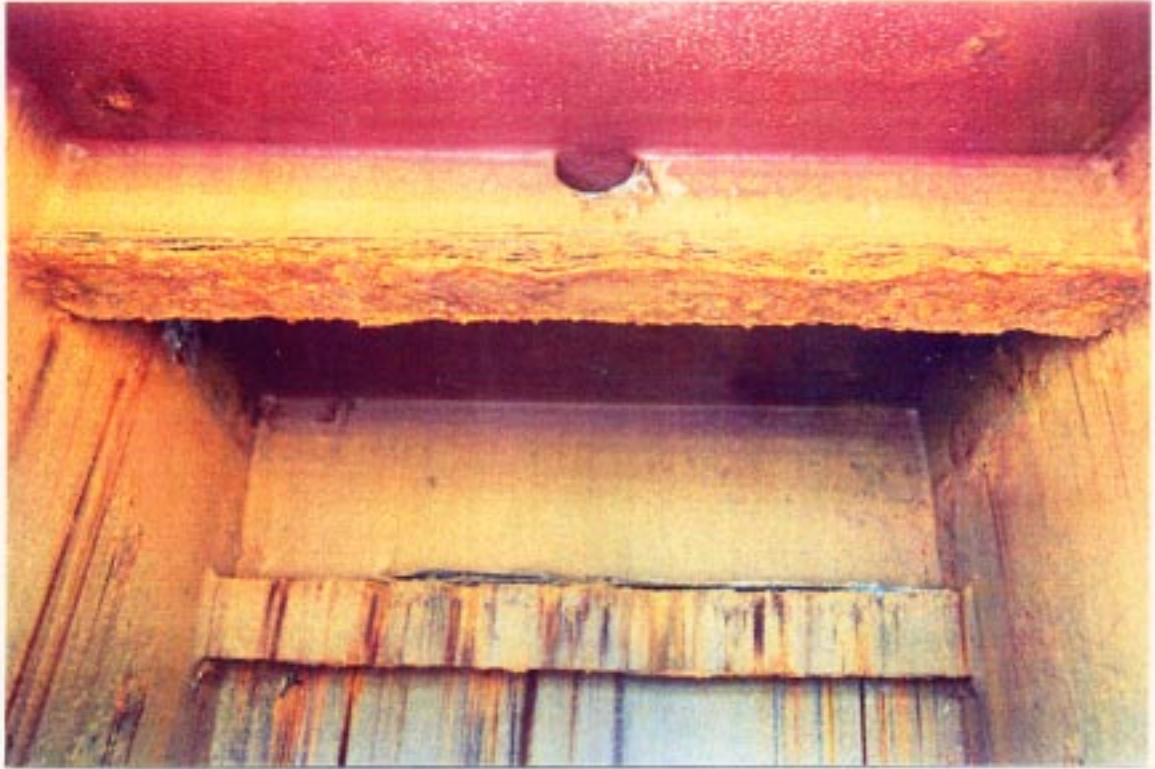
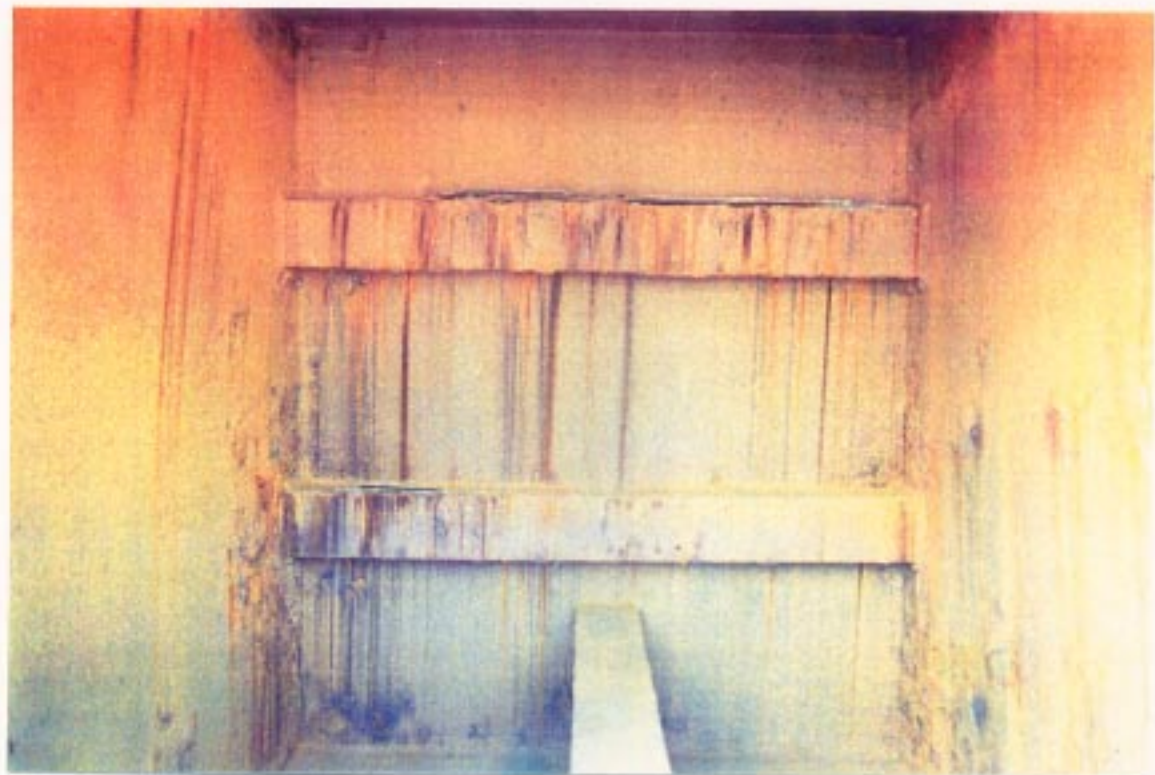
**PHOTGRAPH 8- SURFACE TOLERANT EPOXY B**

The Epoxy “B” coated tank has been under test for a total of fifteen years. See Photograph 8. Following the initial six years of testing, this system was beginning to show significant breakdown – Rust Grade 2. The top of the tank had twenty-five to fifty percent failures. The right side of the tank had totally failed. The balance of the tank had between five and ten percent failure.

The system was repaired using hand tool cleaning (SSPC-SP 2). After another two years of testing (eight years total), the overall failure was less than one percent with only minor breakdown on the edges of the overhead stiffener. No failure was observed on the balance of the structure. The coating system was again spot repaired at this time using hand tool cleaning.

After seven additional years of testing (fifteen totals), the top overhead and top back stiffener have major edge breakdown. The right side, lower left quadrant has also failed. This is an interesting observation in that no matter which coating system has been applied to this tank, this exact location fails during each test project. The reason for this unique failure is not known but it is believed that microbiological influenced corrosion (MIC) may be the cause.

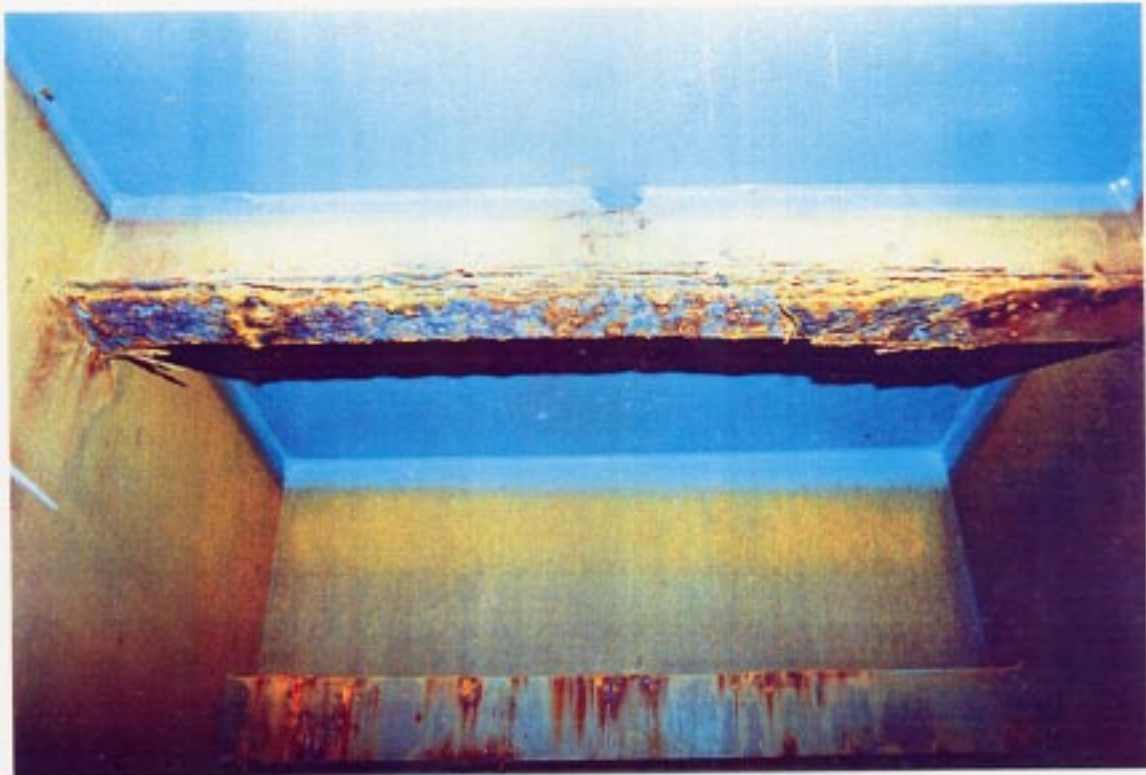
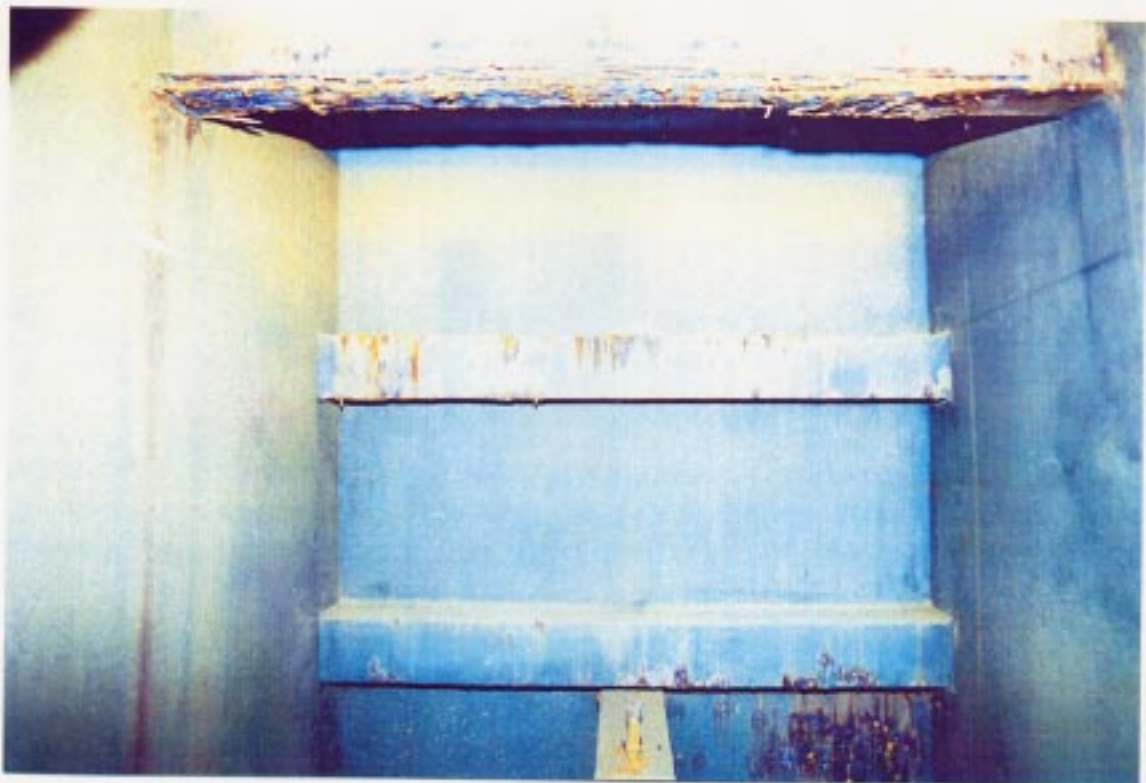
**PHOTOGRAPH 9- MIL-P-24441**

- The VOC compliant version of MIL-P-24441, Type IV (Formula 150/151) provided acceptable corrosion protection to the flat areas for twelve years with interim repairs made at five years; however, the system has total edge failure at the end of the test

period. Initial edge failure was reported at the end of three years. Mil-P-24441 also demonstrated surface tolerance to substandard surface preparation.

As with the two Surface Tolerant Epoxy Systems, the Mil-P-24441 system was initially applied over a salt contaminated, substandard surface preparation. An attempt was made to achieve a Near White Blast Cleaning (SP-10); however, the surface flash rusted due to salt contamination on the surface prior to the application of the coating system. The system was applied over the flash rust. After five years of testing, failed areas were repaired using hand tool cleaning techniques.

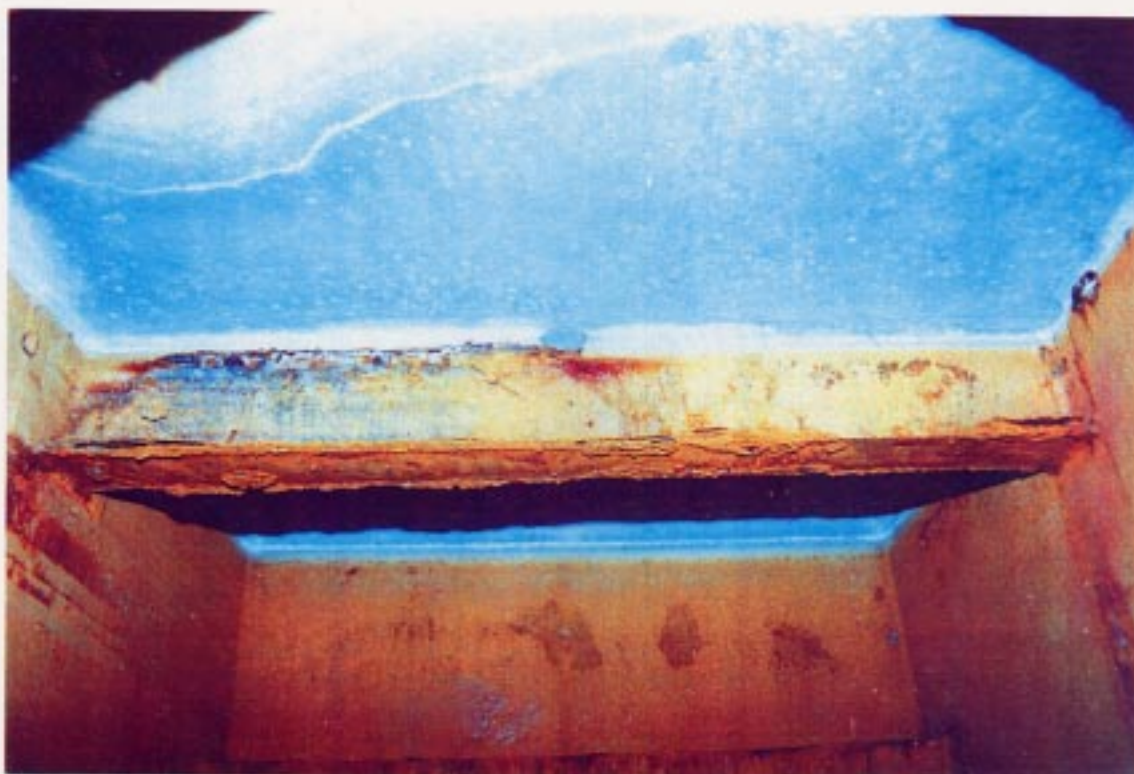
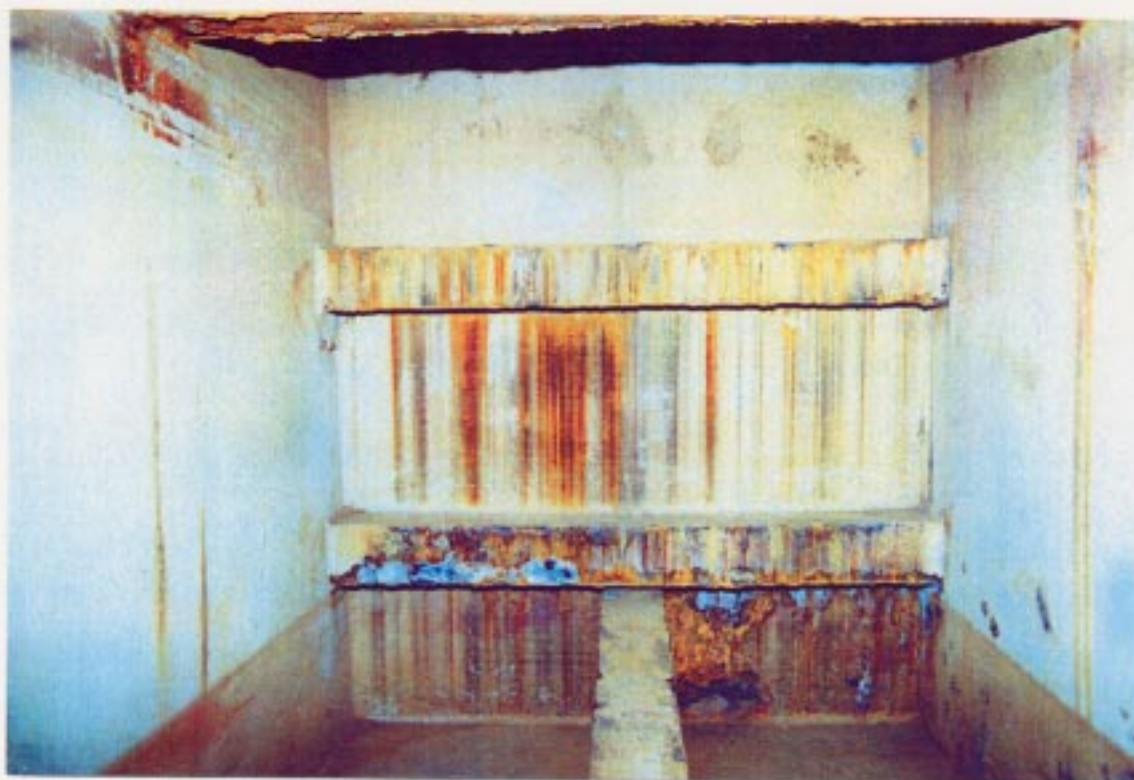
**PHOTOGRAPH 14- HIGH RATIO WATERBORNE INORGANIC ZINC**

- The waterborne, high ratio inorganic zinc failed after eight years. This system did not demonstrate compatibility with the salt contaminated substrate.
