## **Chesapeake Bay Breakwater Database Project, Section 227 Demonstration Site: Hurricane Isabel Impacts to Four Breakwater Systems**

C. S. Hardaway, Jr., D. A. Milligan, C. A. Wilcox,  
L. M. Meneghini, G. R. Thomas, and T. R. Comer

July 2006

Final Report

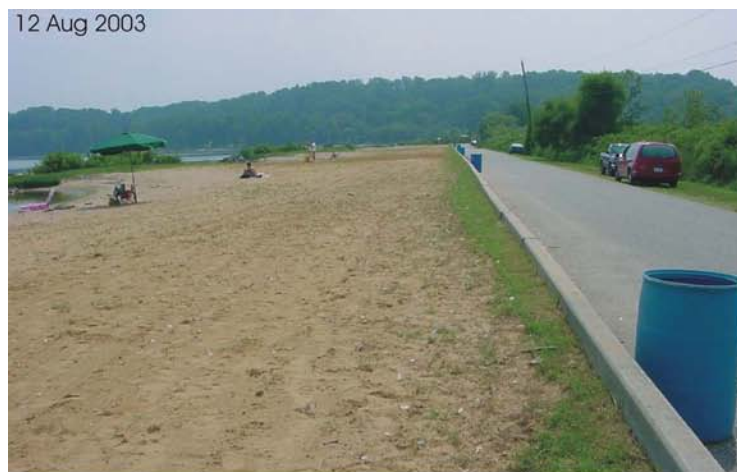
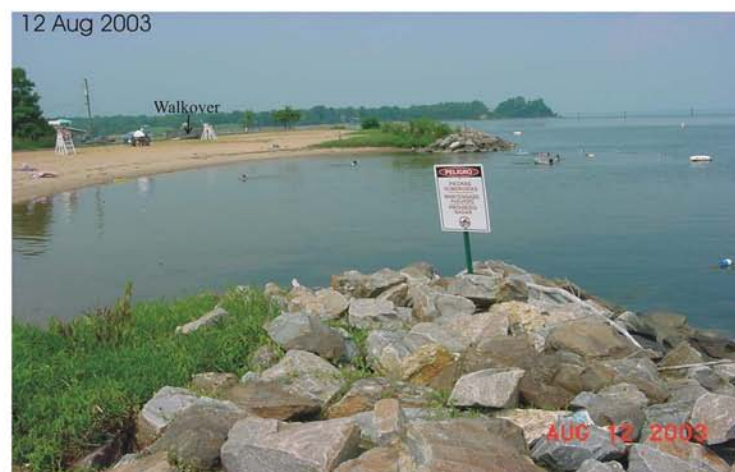
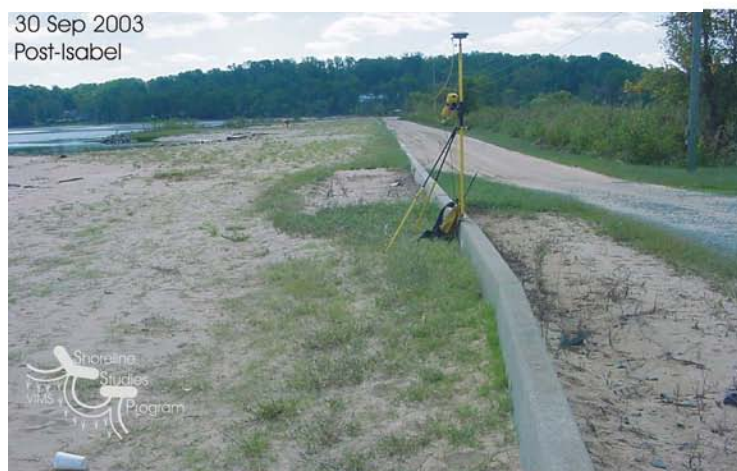
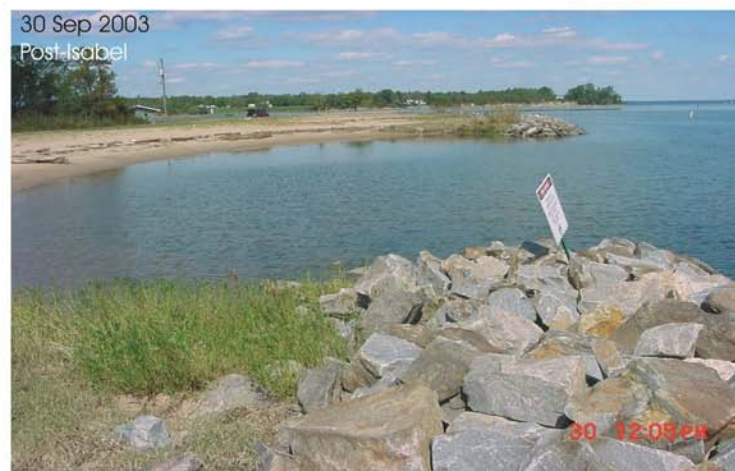
a. Looking south along Jersey wall and access road

b. Looking north from BW 2

Figure 17. Aquia Landing ground photographs pre- and post-Hurricane Isabel

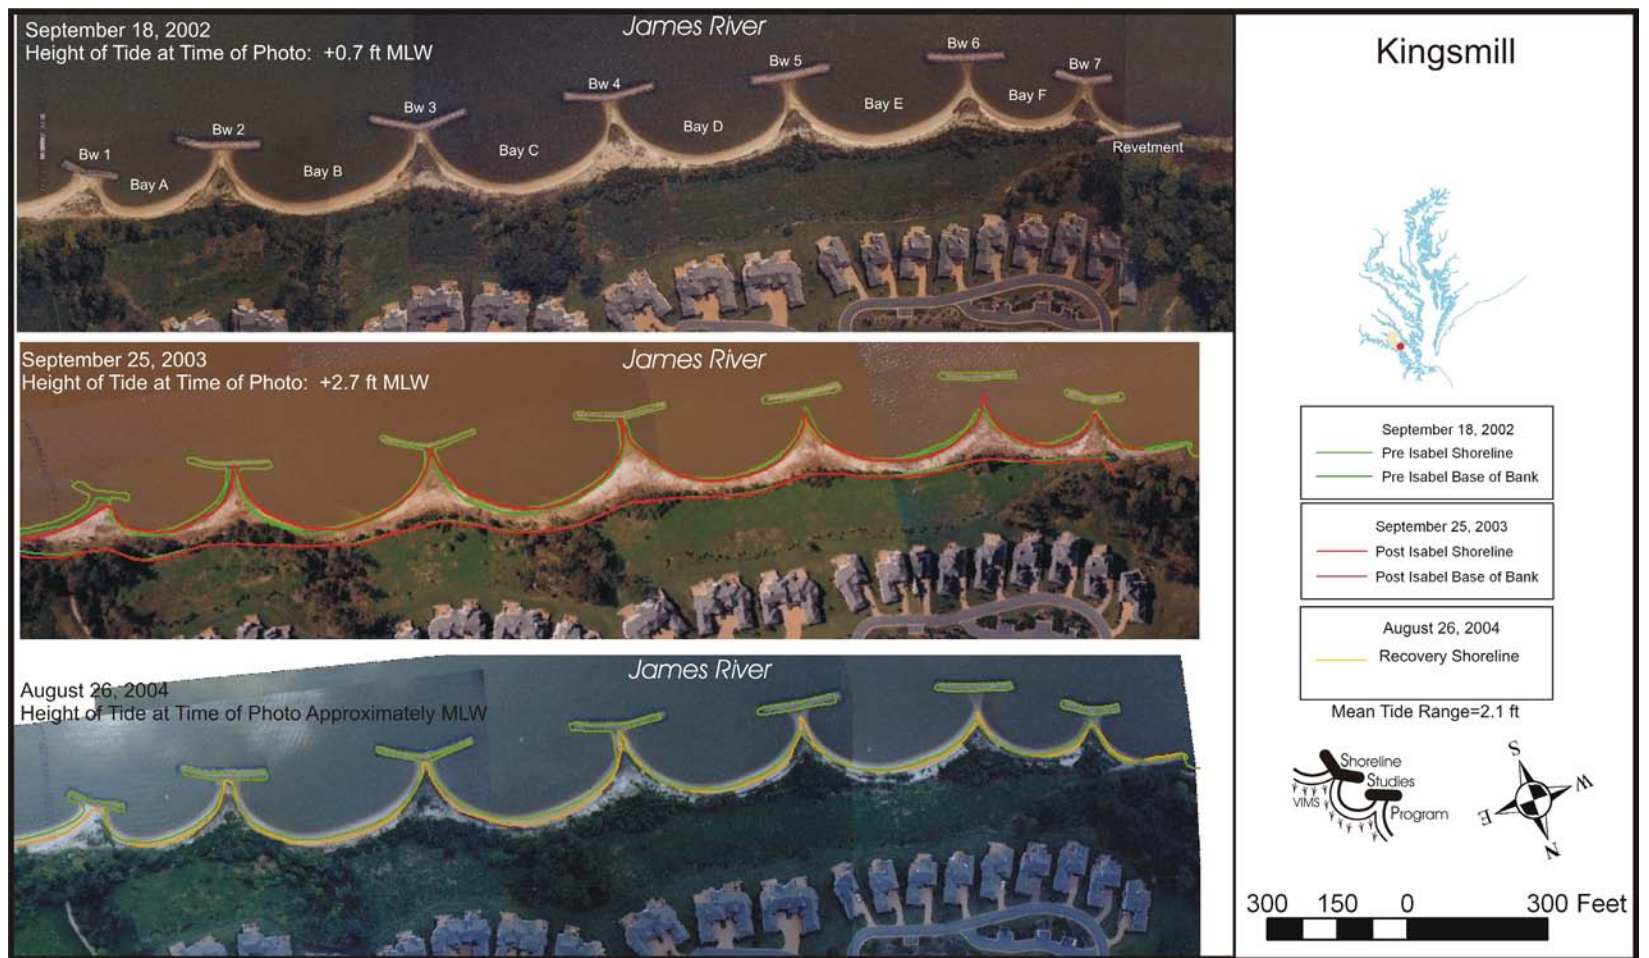
Pre- and post-Isabel aerial imagery of the site show slight changes in shore position (Figure 19). Each tombolo apex had a tendency to shift upriver. Measurable base of bank recession occurred along much of the project, but it was particularly prevalent adjacent to each embayment. These changes are illustrated in the typical bay and breakwater profiles in Figure 20. The combination of storm surge and wave runup limits was measured in the field and are shown for each typical profile at just over el 10. This was a significant event for the site, yet overall damage was minimized by the heavily vegetated backshore/base of bank (Figure 21). Post-Isabel recovery is shown in Figure 19; the beach planforms have returned to approximately their pre-storm positions.

Figure 19. Kingsmill low-level pre- and post-Hurricane Isabel and recovery ortho-rectified aerial photographs

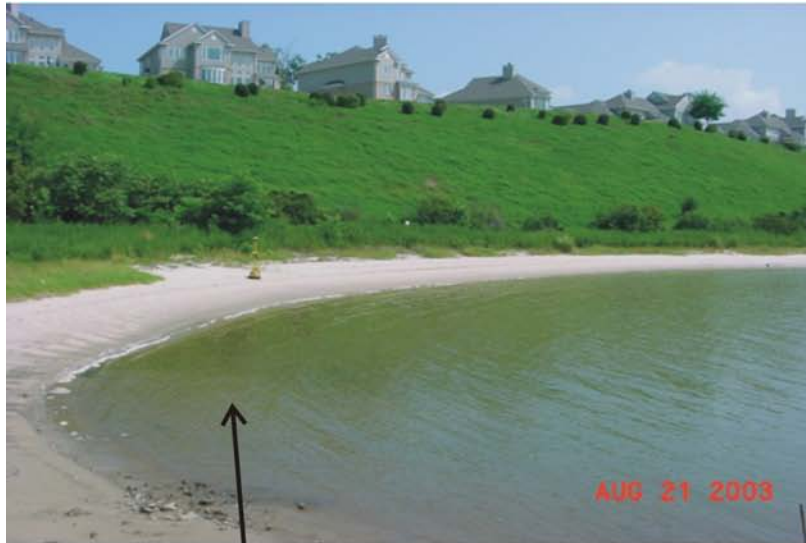
Bay E from BW 6

Figure 21. Kingsmill ground photographs before and after Hurricane Isabel

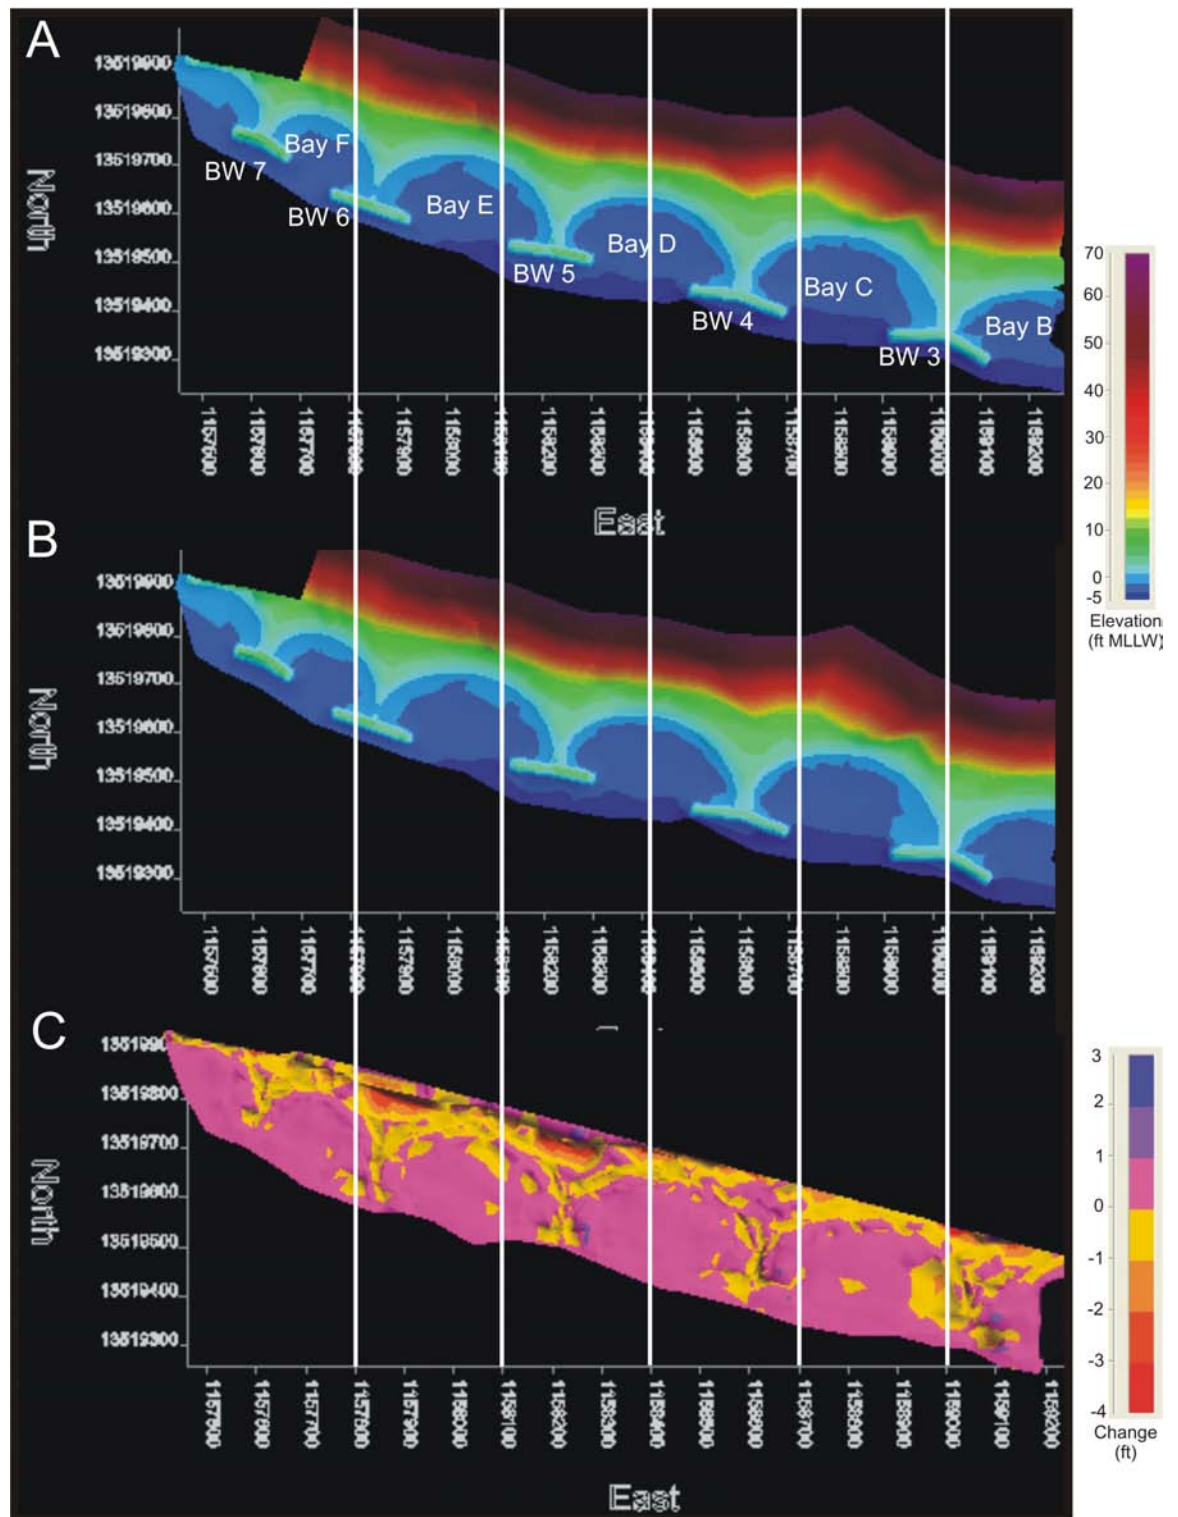
Topographic changes along the site between breakwater (BW) 3 and BW7 are shown in Figure 22. The isopach map that indicates a general pattern of reduction in elevation occurred along the beach, backshore, base of bank, and around each breakwater unit. Most increases in elevation were in the nearshore and in small pockets in the lee of each breakwater unit. The most severe scour occurred along the base of the bank (BOB) between BW5 and BW6. However, the damage did not endanger the integrity of the bank face. No slumping or failure was noted or has occurred since. Just upriver, extensive damage (more than \$3 million) occurred at the adjacent marina, which only had a timber pile breakwater for protection.

Figure 22. Kingsmill color contour maps for: (a) pre- and (b) post-storm conditions, and (c) isopach map showing elevation changes between surveys

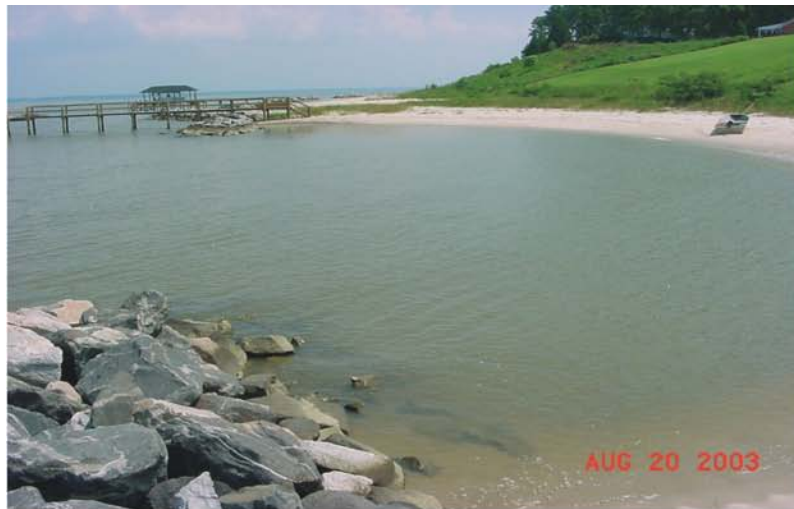
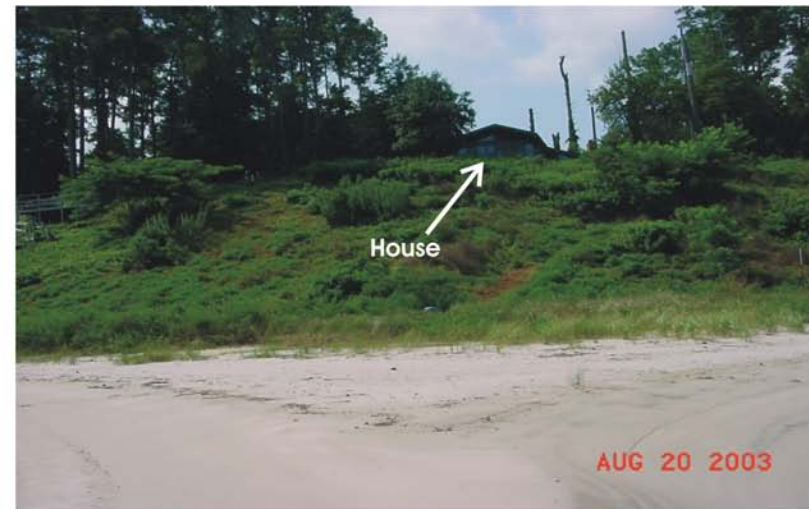
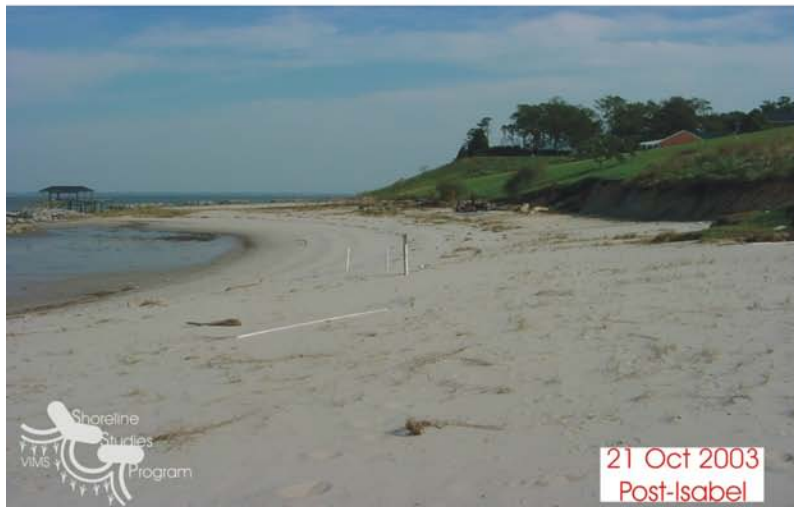
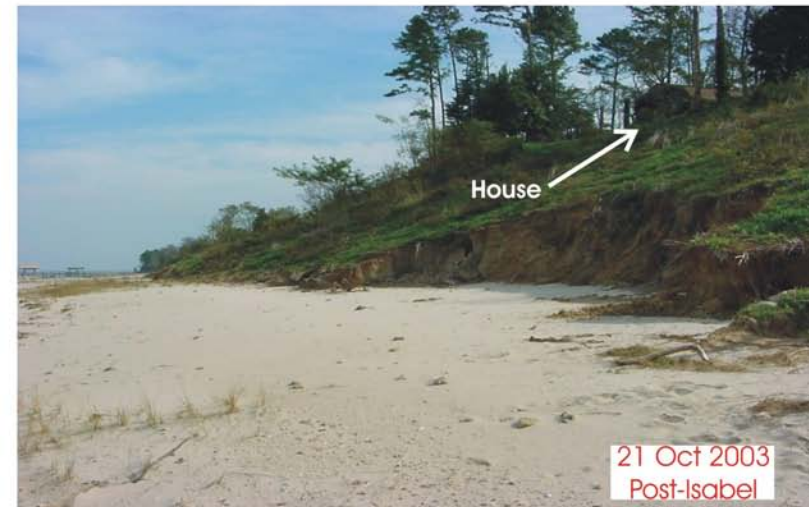
Figure 25. Van Dyke ground photographs before and after Hurricane Isabel

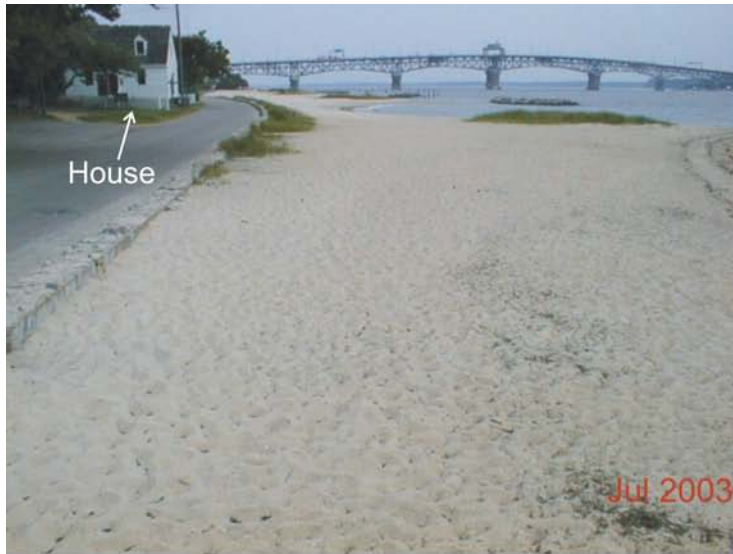
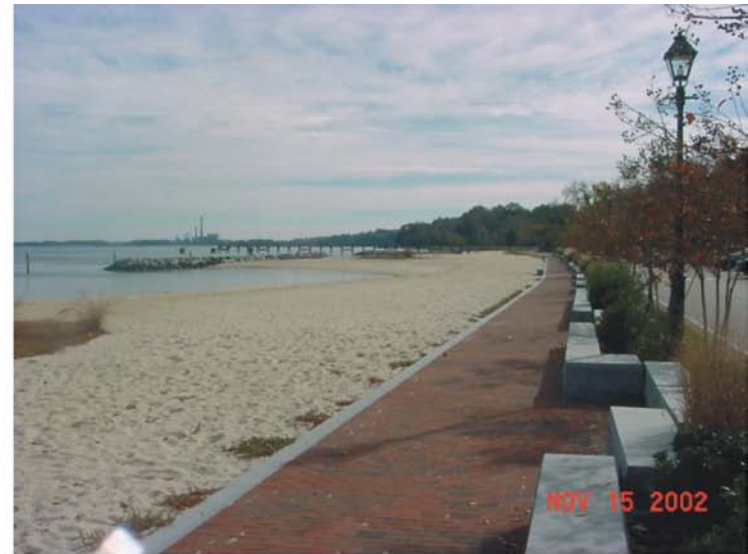
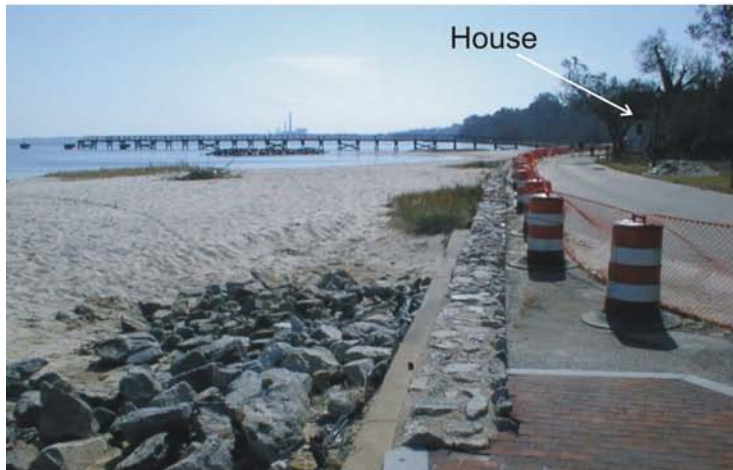
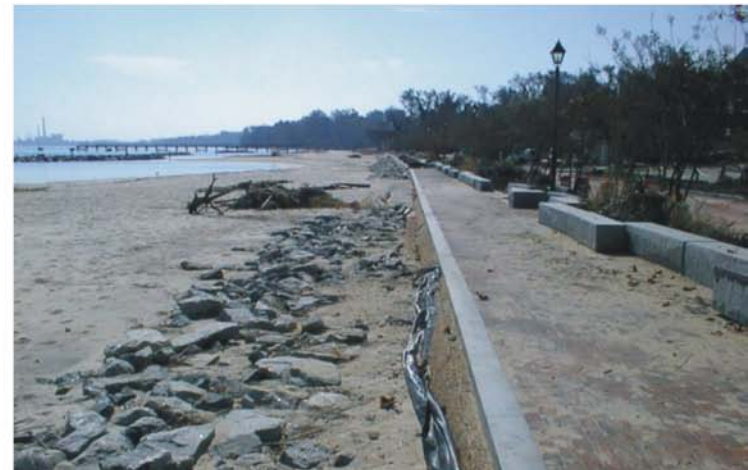
a. View along downriver portion of Water Street

b. View along upriver portion of Water Street at main recreational area

Figure 29. Yorktown ground photographs before and after Hurricane Isabel

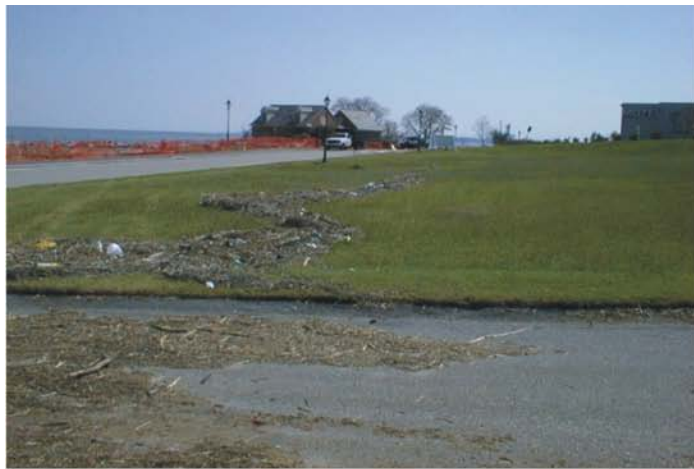
b. Post-storm wrack line

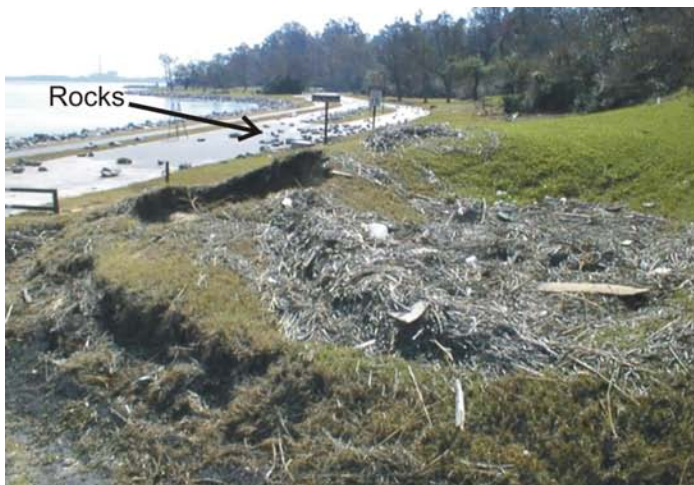
c. Post-storm wrack line downriver

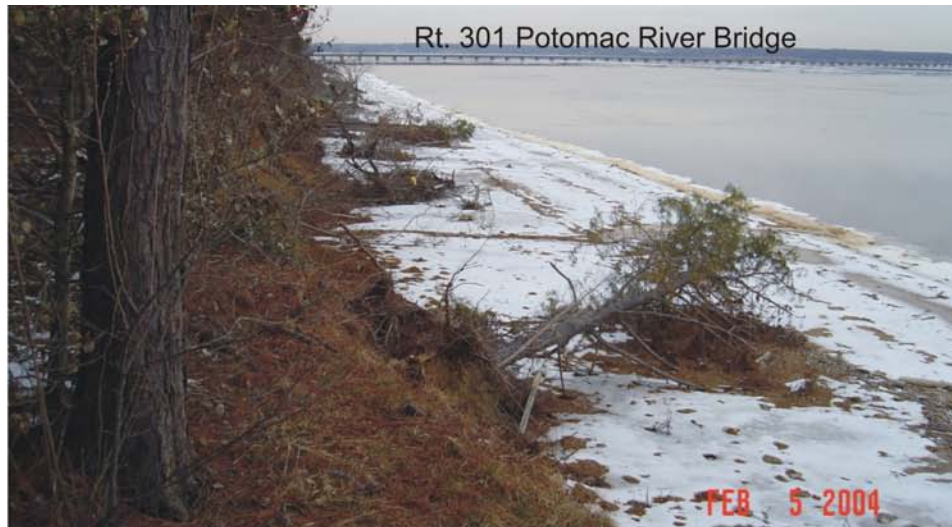
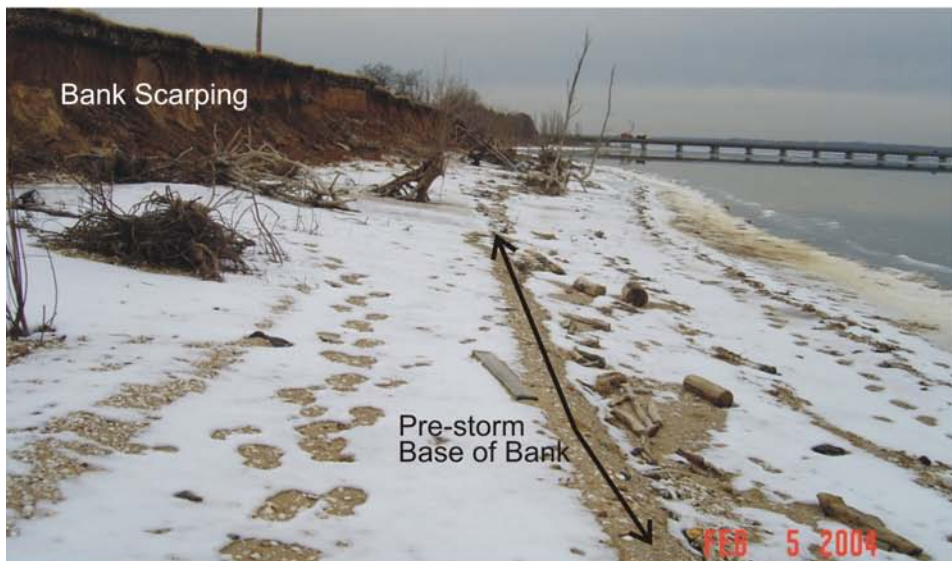
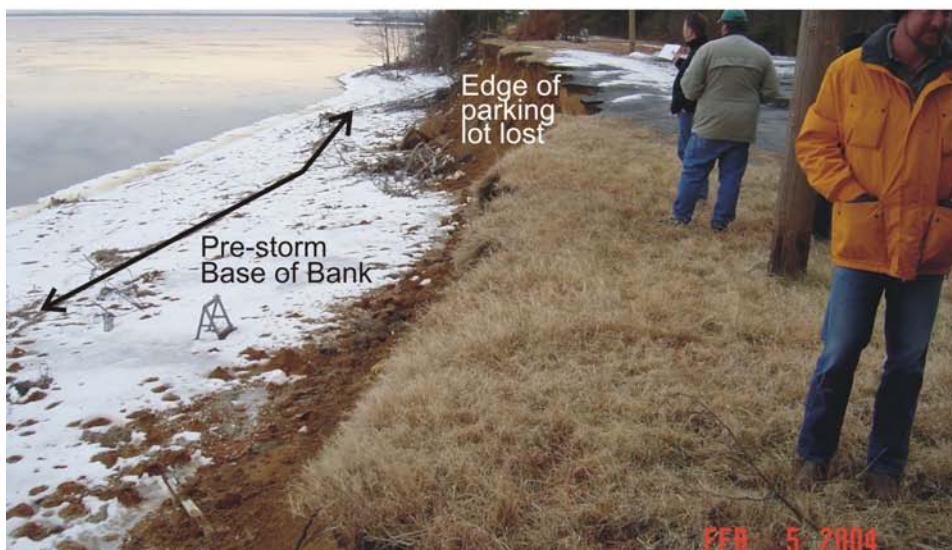
Figure 32. Impacts to unprotected shore at Dahlgren due to Hurricane Isabel

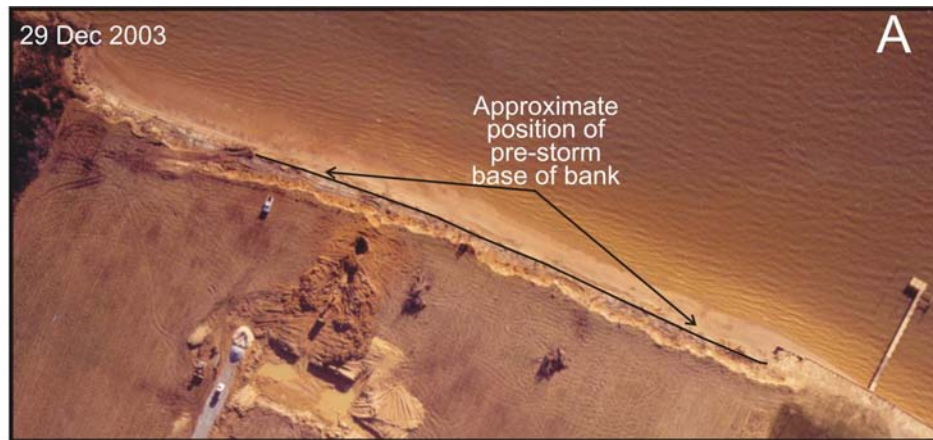
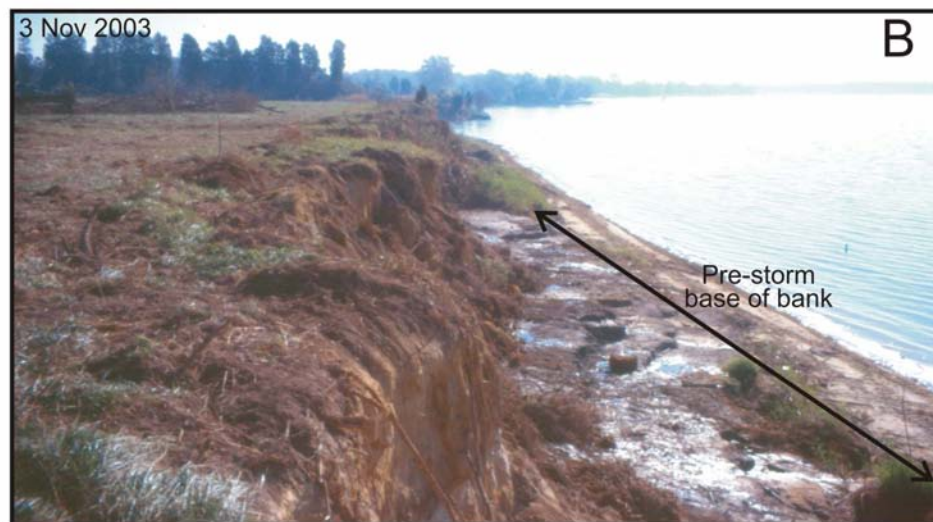
Figure 33. Impacts to unprotected shore at Lenhart due to Hurricane Isabel

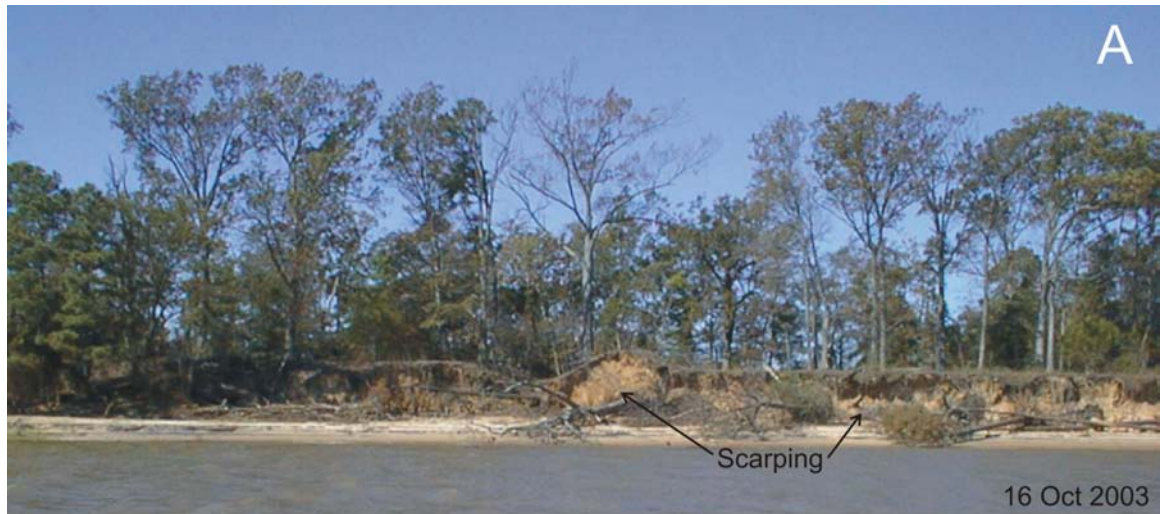
a. At Confederate Fort

Figure 34. Impact to unprotected shores on James River due to Hurricane Isabel

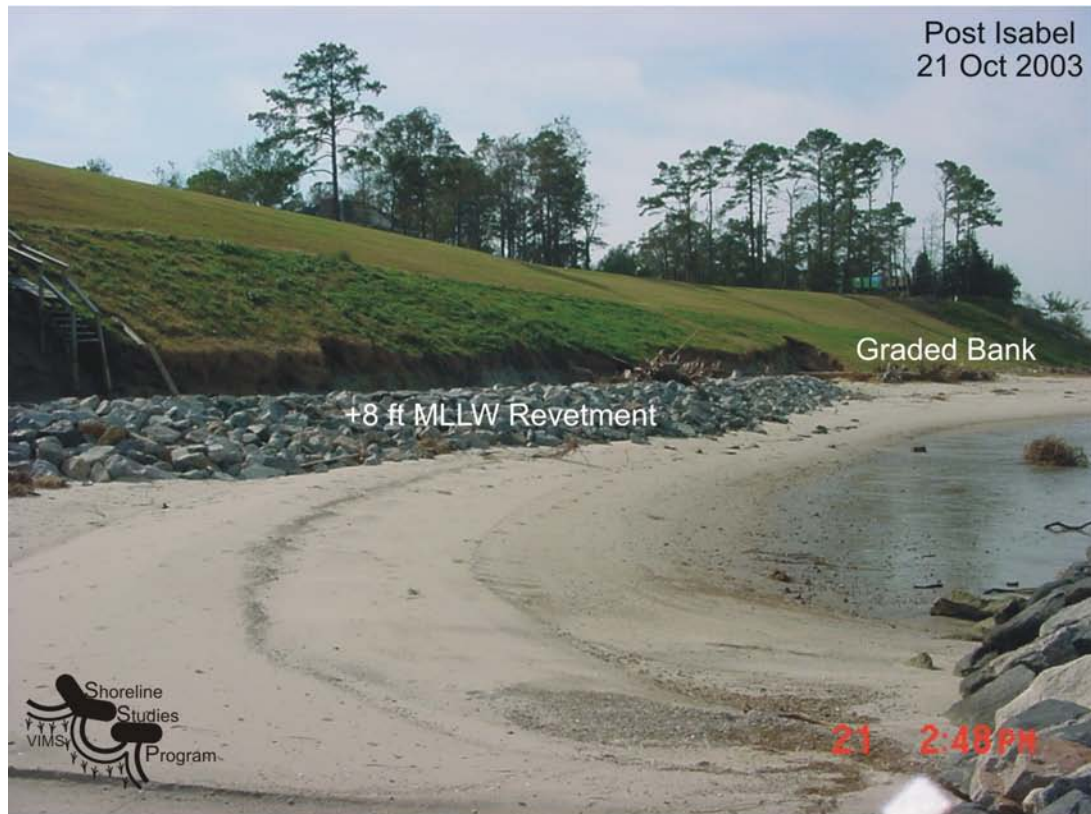
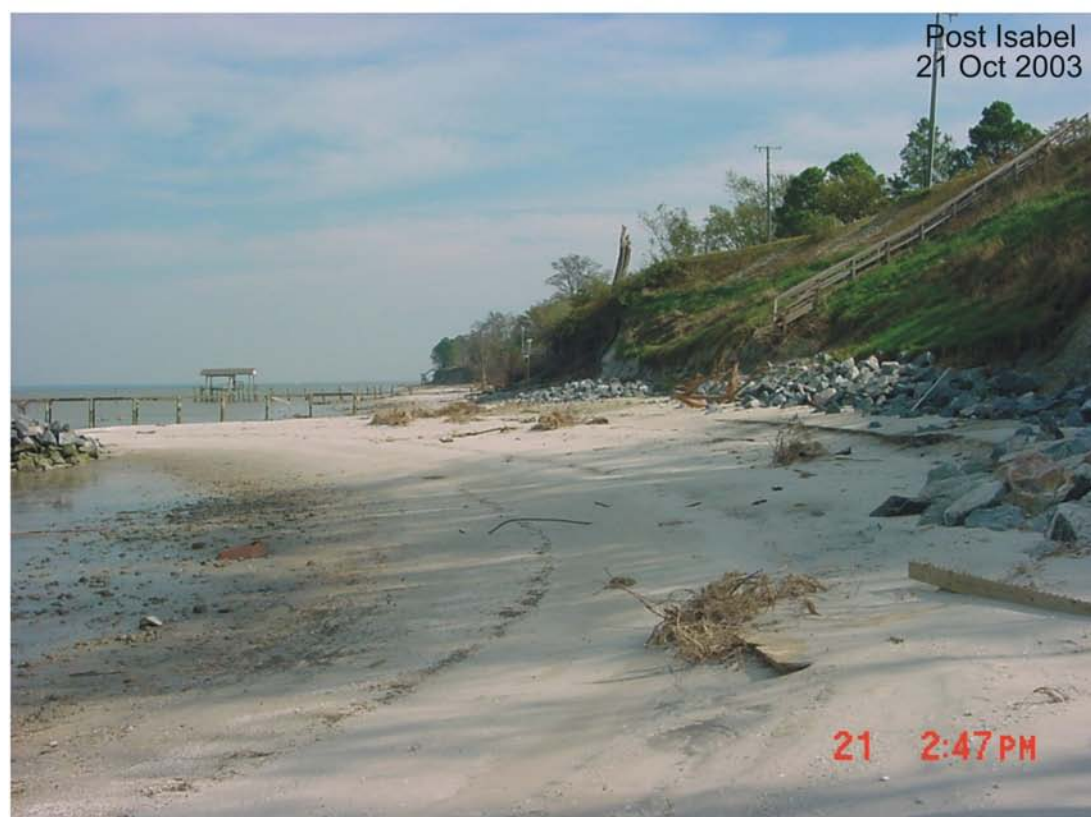
Figure 35. Impacts at downriver end of Van Dyke where shore is protected by a revetment

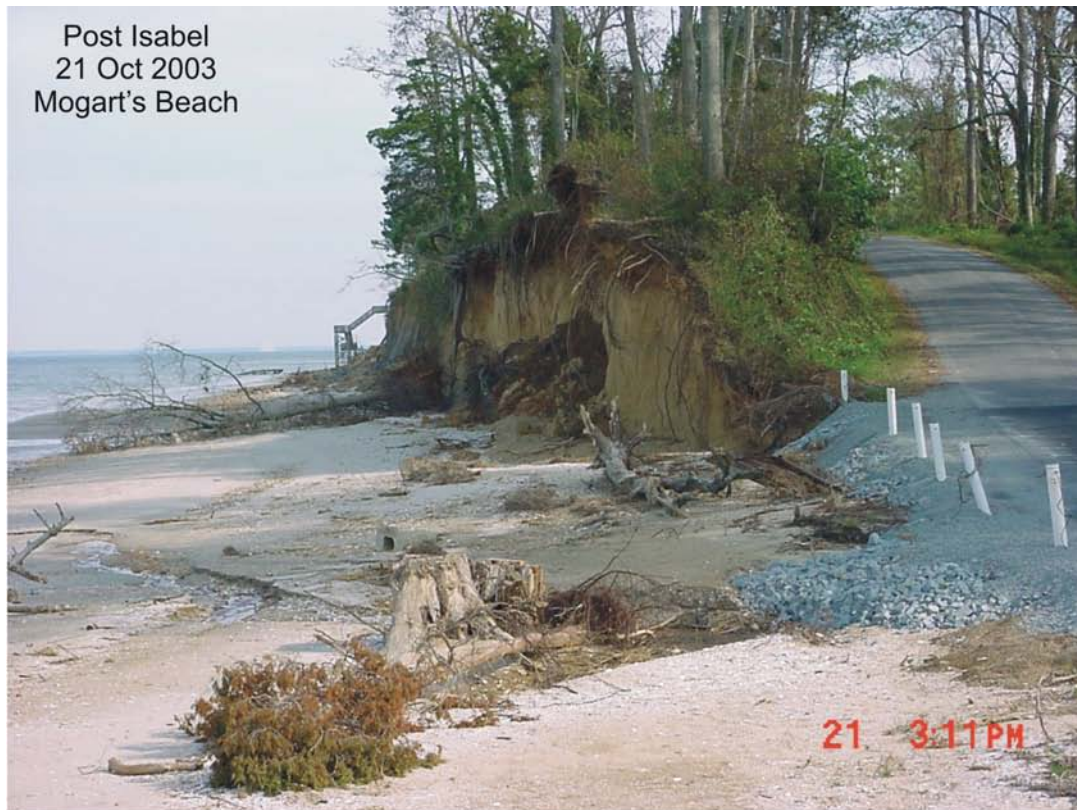
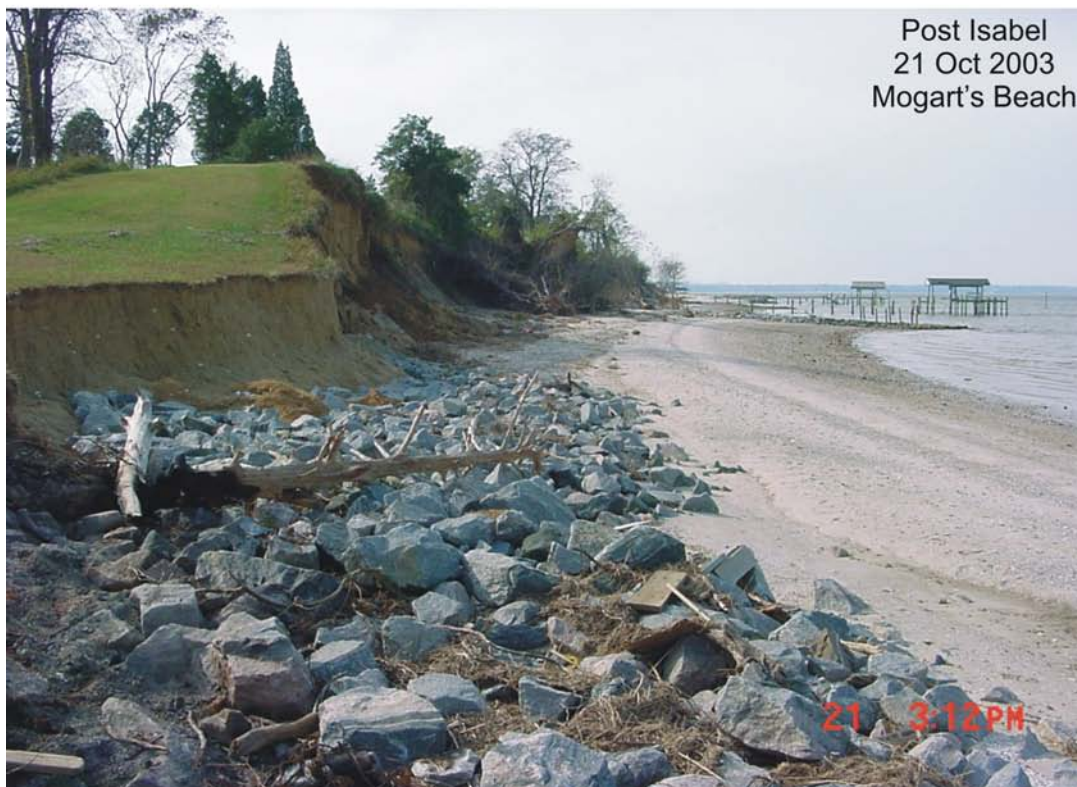
Figure 36. Impacts to shore downriver from Van Dyke at Mogarats Beach

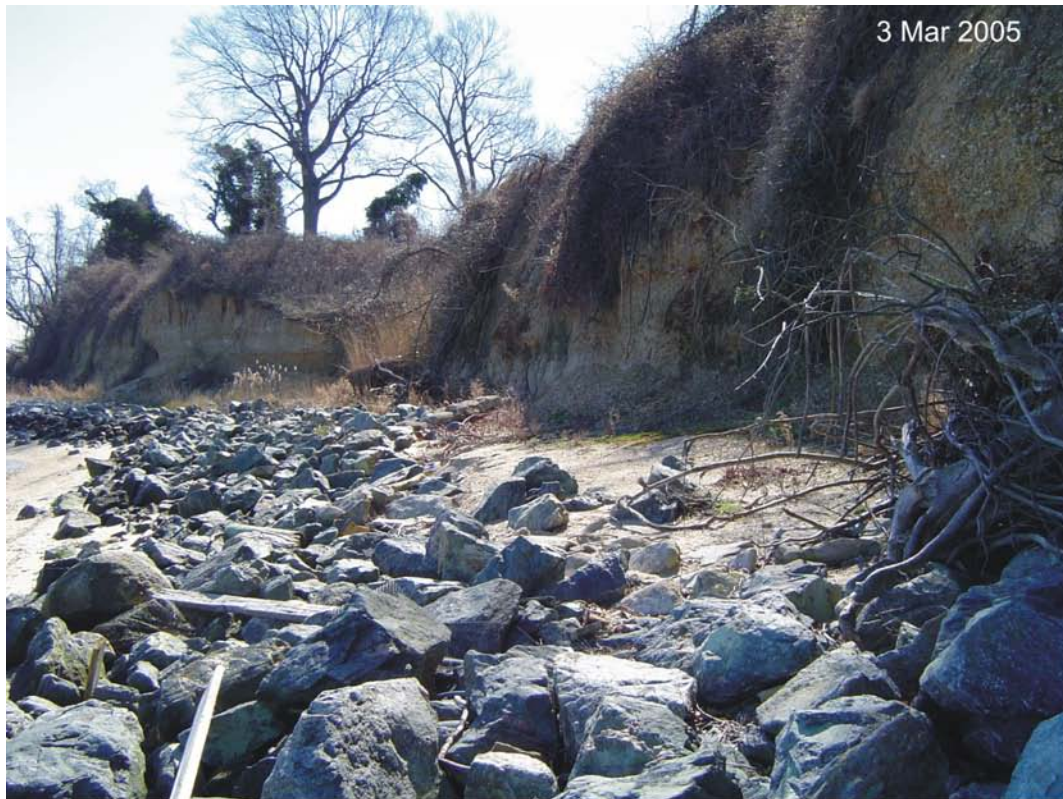
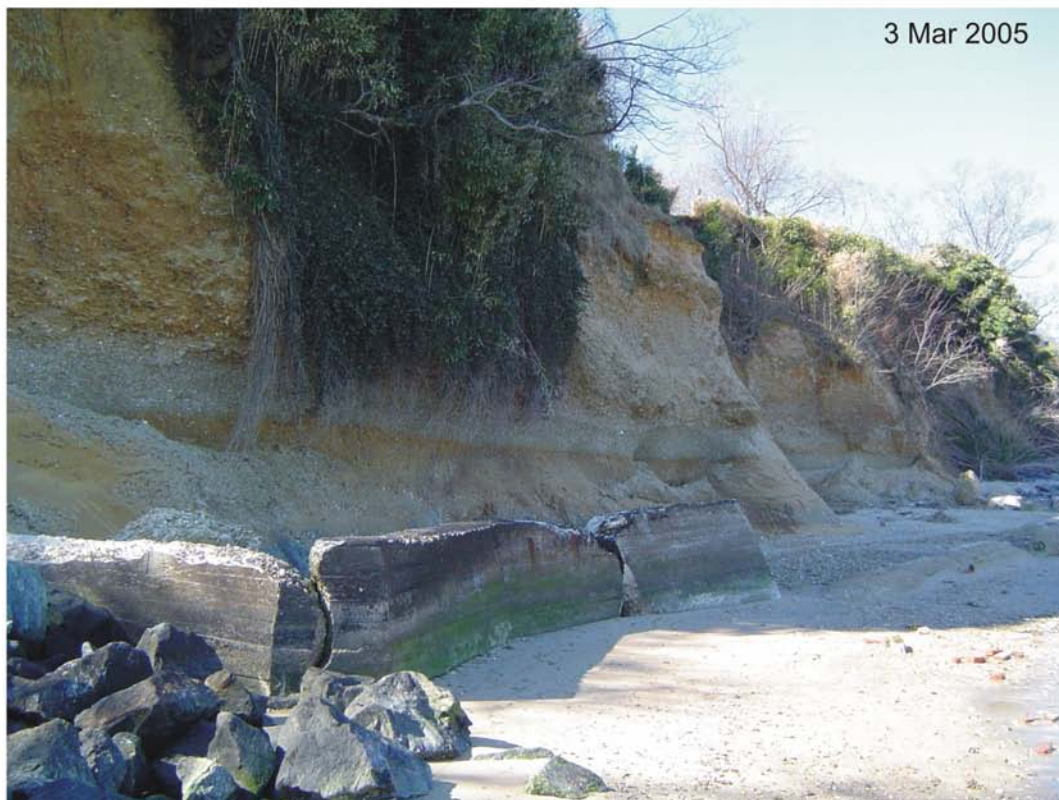
Figure 37. Impacts to shoreline downriver from Yorktown Beach at National Park Service's Moore's House
