**1991 Ship Production Symposium  
Proceedings:  
Paper No. IIIB-2  
Permanent Composite Cladding of  
Deteriorating Steel Hulls**

# Permanent Composite Cladding of Deteriorating Steel Hulls

Albert W. Horsmon, Jr., Visitor, University of Michigan Transportation Research Institute

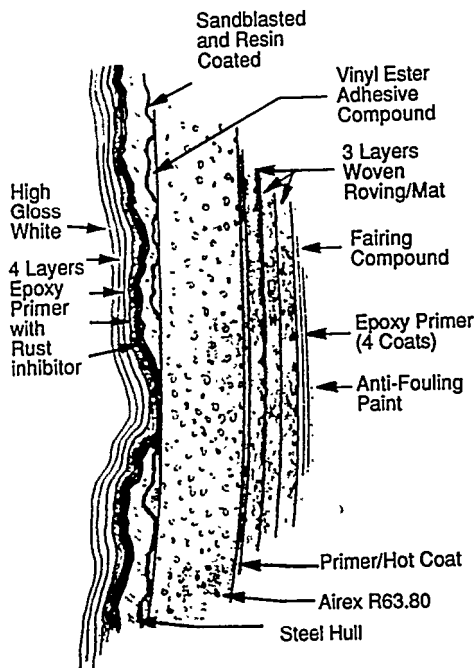
The basics of the FRP cladding are shown in Figure 1 (6). The MEDEA's steel hull was blasted to white metal and given a thin coat of vinyl ester resin to quickly seal the bare steel. A linear polyvinyl chloride (PVC) foam was vacuum bonded to the hull with a putty resin and faired, and three layers of woven glass fibers alternating with chopped strand mat (CSM) were bonded to the foam. Finally the FRP was faired, then painted

Figure 1  
FRP CLADDING
