# Corrosion of Hawk Lead-in-Fighter Hydraulic Pipe Work

DSTO-TR-1833

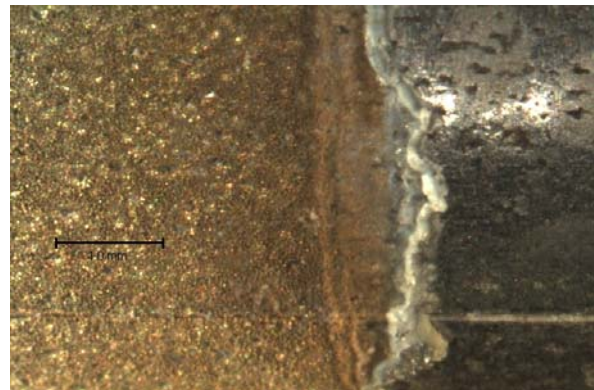
These tests were conducted in an attempt to replicate the type of conditions the hydraulic pipes and fittings would experience in service. That is, contamination with seawater to leave salt residue and exposure to a moist environment. The specimens were left in the humid environment and the corrosion damage assessed on two occasions. After 10 days, white corrosion products typical of cadmium hydroxide and brown-black corrosion product typical of cadmium oxide were observed at the cadmium/stainless steel interface. There was little cadmium corrosion product observed away from this interface indicating that galvanic interaction at the interface had produced the corrosion of the cadmium. Images of this corrosion are shown in Figures 23 and 24 for the bare cadmium and CCC cadmium specimens respectively. The specimens after 46 days of exposure showed extensive corrosion product formation, with black corrosion product more prevalent (Figures 25 and 26). Since no corrosion of cadmium away from the interface was observed, it is concluded that the contact between the cadmium and the stainless steel was responsible for the accelerated corrosion of the cadmium.

Figure 24: Corrosion of CCC cadmium coated stainless steel after 10 days in 85% RH air

The distance that corrosion extended from the cadmium/stainless steel interface was approximately 3-4 mm. This is in agreement with the theoretical calculation of 3.5 mm over which the galvanic interaction between cadmium and stainless steel may extend when covered by a thin moisture film (Appendix A).

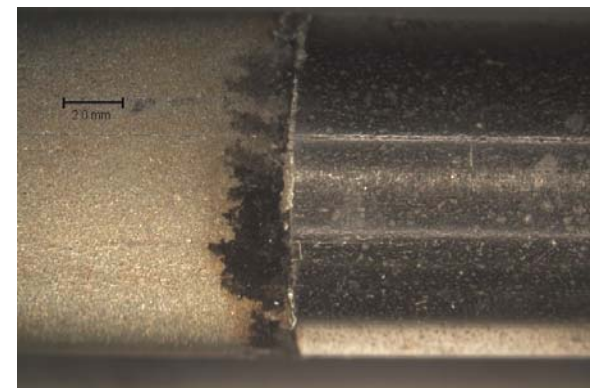
Figure 26: Corrosion of CCC cadmium coated stainless steel after 46 days in 85% RH air
