## **In-Place Pipe Lining of Pre-action Fire Suppression System at Fort McPherson, GA**

Orange S. Marshall

March 2007

Final report

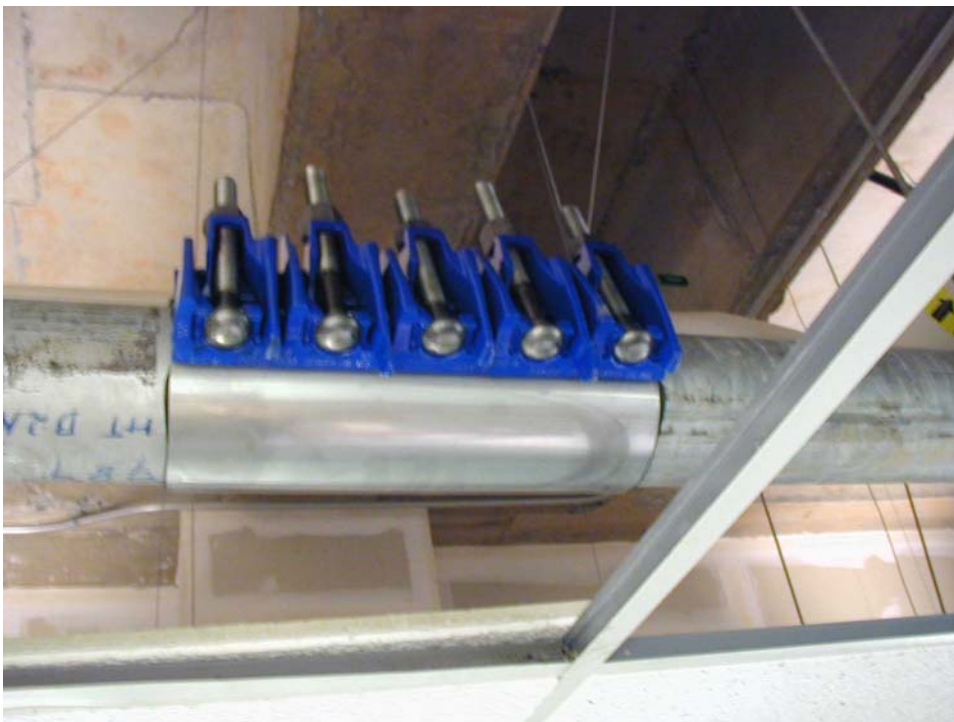
During a visit to Fort McPherson, DPW engineers were briefed on in-situ pipe lining work performed at Fort Drum, NY, in which copper pipes were lined to eliminate lead leaching into the potable water lines from solder joints in family housing piping. Following the presentation, the DPW Deputy Director suggested that this technology could be a solution to problems they were encountering in Building 315, the U.S. Army Reserve Center headquarters building. The building was less than 5 years old and the pre-action fire suppression system in the basement was already developing pinhole leaks due to corrosion, particularly in the Archives area. Figure 1 shows some temporary repairs in the archives room.

Figure 1. Temporary repairs made in the archives room.

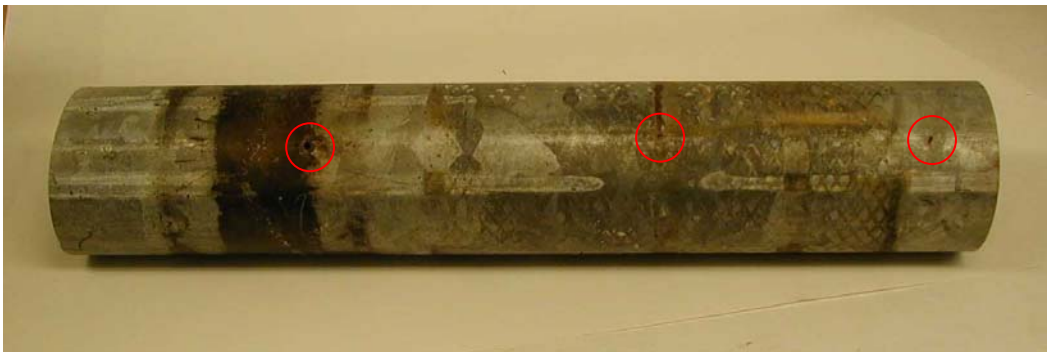
The pipe section provided by the Fort McPherson DPW had three visible pin holes with large tubercle growths on the interior of the pipe. Figure 2 shows the exterior of the pipe section provided. The pinholes are circled. The largest hole (Figure 3), was measured using vernier calipers to be 3/16-inch in diameter. Figure 4 shows the pipe interior clearly depicting the tubercles comprised of corrosion products from the pin holes.

Figure 2. Exterior of pipe section showing pinholes (circled in red).

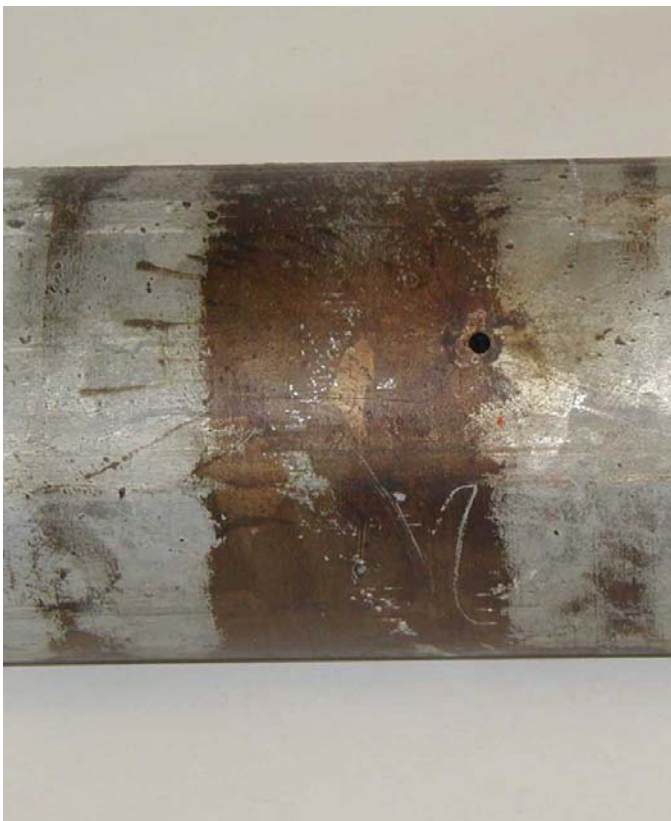
Figure 3. Largest pinhole shown in Figure 2.

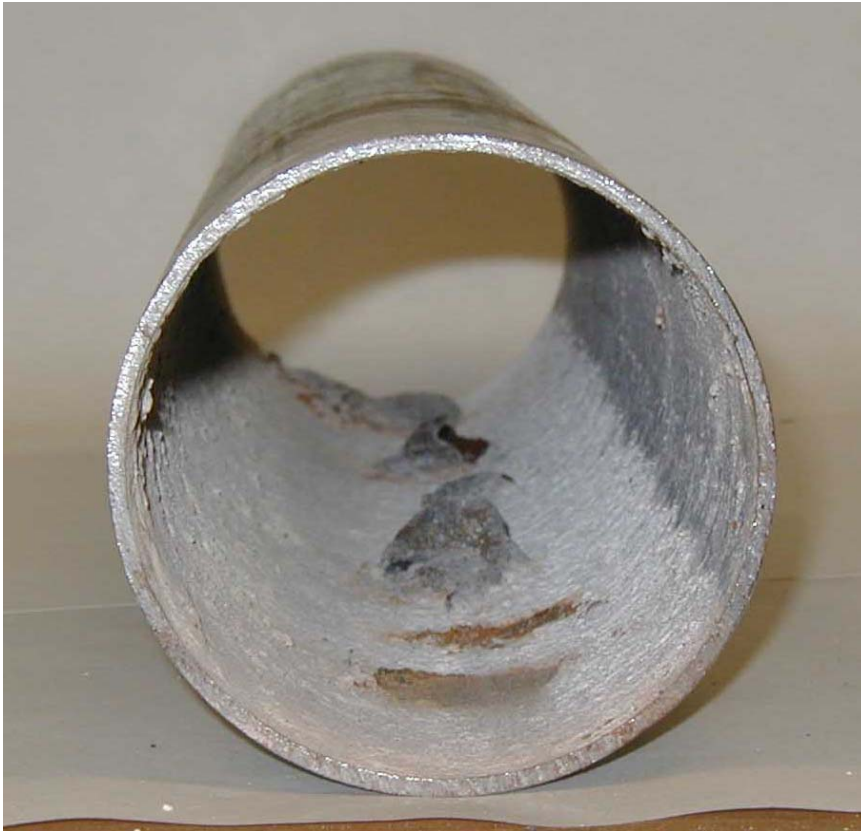
Figure 4. Pipe interior showing tubercles.

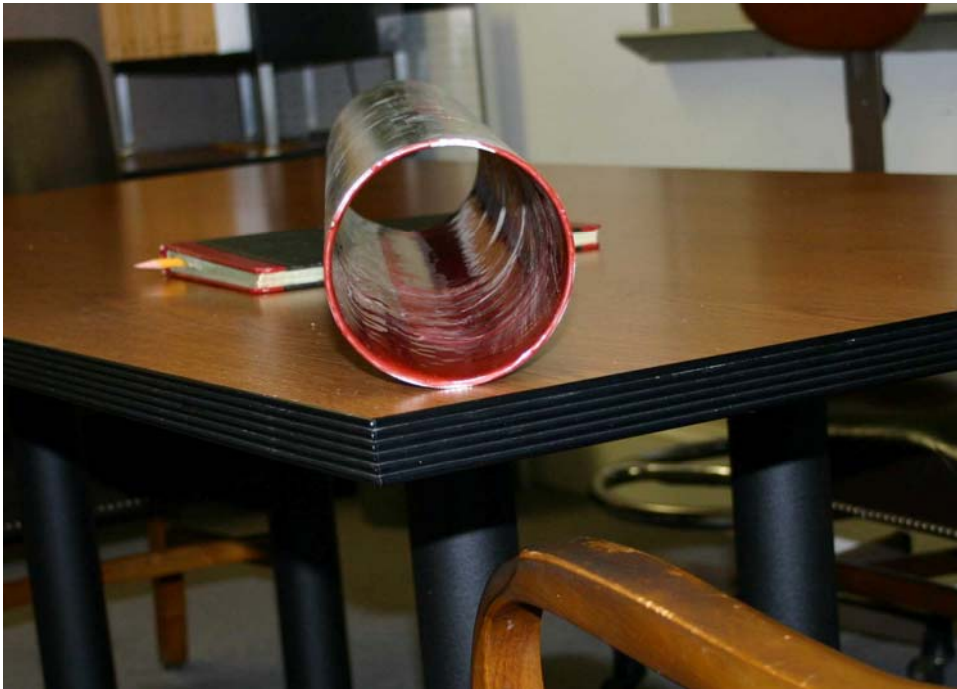
Figure 5. Interior of cleaned and lined pipe section.

After initial evaluation by CERL, the pipe section was sent to APL, where it was lined using two coats of epoxy and pressure tested. Figures 5 and 6 show the exterior and interior respectively of the cleaned and lined pipe section. After examining the lined pipe section, the Fort McPherson DPW provided funds to line the pre-action fire support system in Building 315.

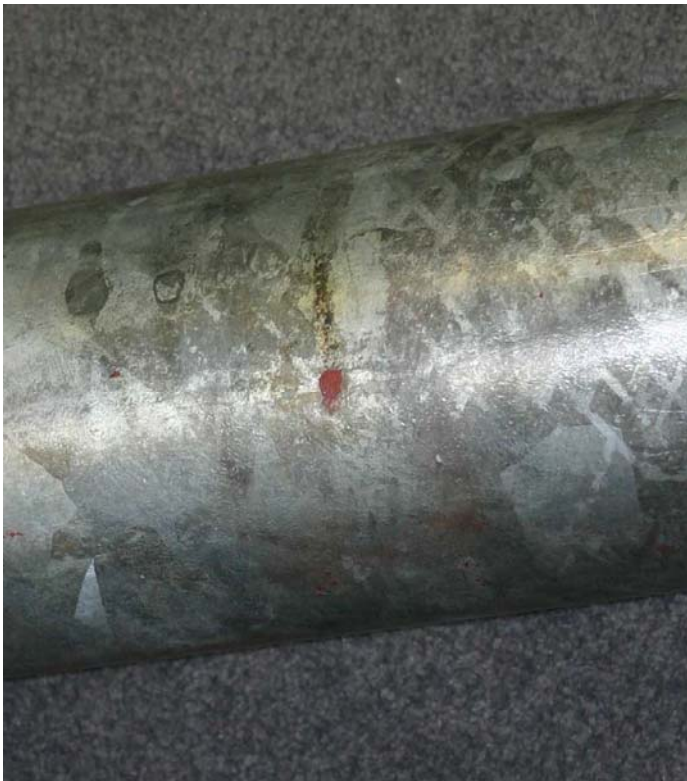
Figure 6. Exterior of cleaned and lined pipe section.

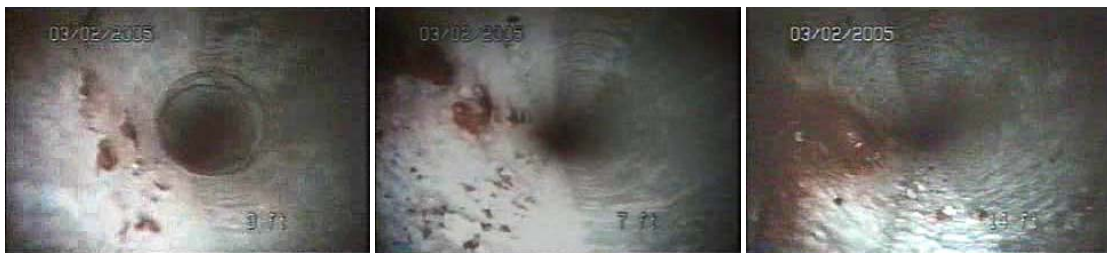
It is generally agreed that a sufficient concentration of an aggressive anion (generally chloride, but also bromide, iodide, and perchlorate) and an oxidizing agent (dissolved oxygen,  $\text{Fe}^{+++}$ ,  $\text{H}_2\text{O}_2$ ,  $\text{Cu}^{++}$ , and certain others) must be present in the electrolyte. A stagnant volume of liquid must exist in the pit or pitting will not occur. In addition, for a given metal/electrolyte system, the redox potential must be more noble than a certain critical value. It is also agreed that the corrosion processes within the pit produce conditions of low pH and high chloride ion content; these keep the localized anodic areas electrochemically active (USACE 1999), accelerating the attack. Figures 9 through 11 document the pipe condition and treatment.

Figure 9. Pipe interior before treatment.

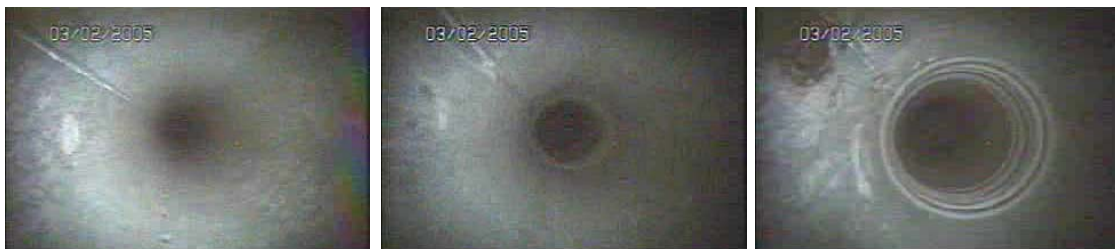
Figure 10. Pipe interior following grit blast.

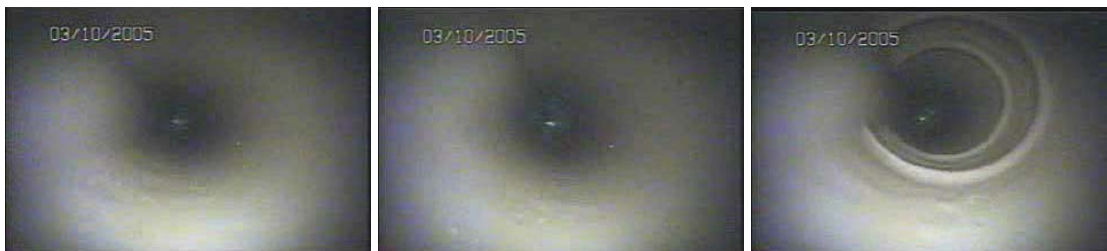
Figure 11. Interior of pipe following epoxy lining.
