## **ASBESTOS SURVEY FOR FORT POINT U.S. COAST GUARD STATION**

**Presidio of San Francisco**

**Contract No. DAAA15-90-D-0018  
Task Order 0002, Data Item A004**

**September 1991**

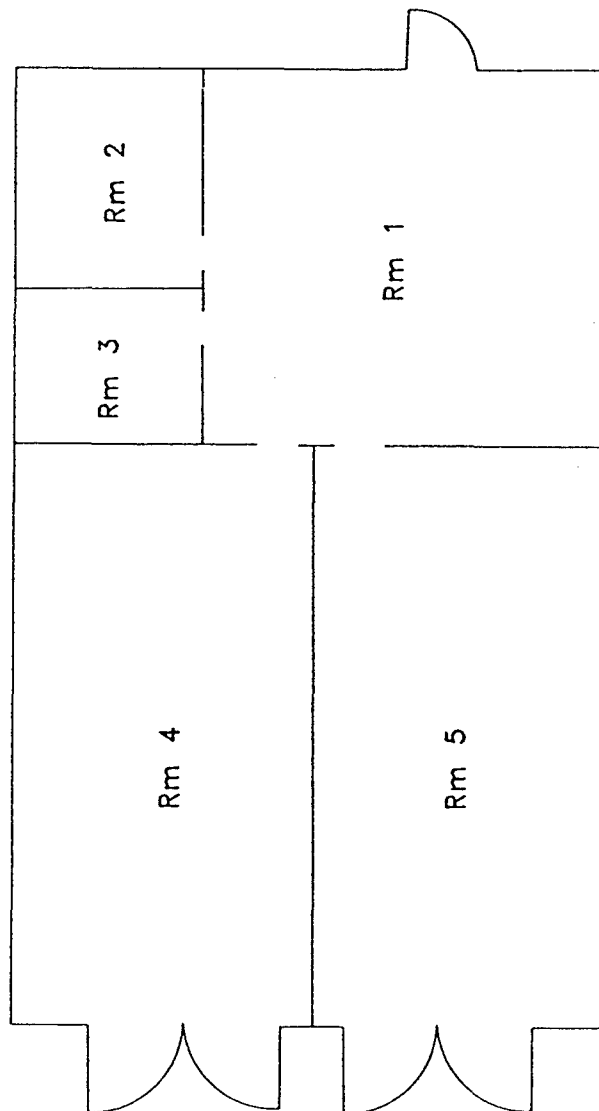
Figure 3.3-1

Building 993 is the OIC's garage, a one-story, wood-frame structure with wood shake siding and roof. No suspect ACM were observed during inspection of this building; therefore, no samples were collected. Figures 3.3-1 and 3.3-2 illustrate the layout of the garage and its attic area.
