## Canadian Forces Experience with Turbofan HCF – Case Study

**Corey Kinart, P. Eng.**  
Magellan Aerospace Corporation  
3160 Derry Road East  
Mississauga, Ontario  
Canada, L4T 1A9  
[ckinart@orenda.com](mailto:ckinart@orenda.com)

*High Cycle Fatigue (HCF) cracking of a Canadian Forces (CF) turbofan engine fuel tube resulted in a six year, multinational effort to identify the root cause and to ultimately develop and implement a solution. The second of three fuel tube failures experienced by the CF during this timeframe resulted in an engine fire that caused significant damage to a military aircraft, underlining the seriousness of the issue at hand. With HCF identified as the mechanism of failure, efforts focused on vibration input to the fuel tube during engine operation. An experiment was developed to instrument an in-service fuel tube and perform comprehensive flight tests to quantify the strains experienced by the tube and identify vibration frequencies that required mitigation in order to eliminate HCF failures. A damper bracket was developed to shift the modal response of the fuel tube away from damaging frequencies experienced in-flight. The prototype bracket then requir

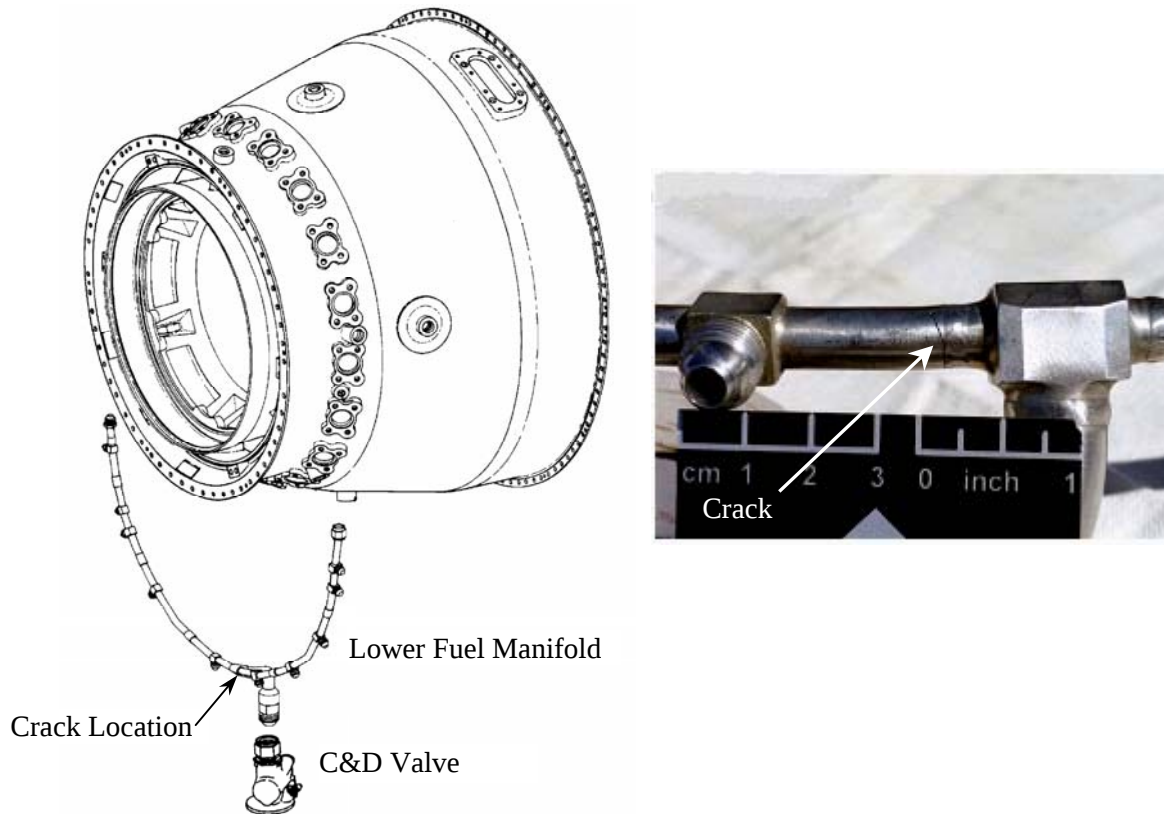
**Figure 1: Lower Fuel Manifold**

The LFM, shown below in Figure 1, is a semi-circular tube encompassing the lower half of the Combustor Case. The LFM carries pressurized fuel to the fuel nozzles of the engine where it is then mixed with compressed air and ignited within the Combustor Case. Incoming fuel is fed to the LFM via an inlet tube located at the 6 o'clock location of the assembly. Fuel is then split between the left and right sides of the Combustor Case at a welded T-junction in the LFM. The incident assembly described above was found to be cracked in the heat affected zone of one of the three welds at this T-junction.

The cracked LFM was removed from the incident engine and forwarded to GEAE for investigation. Although no manufacturing or design defects were found to explain the cracking, fracture surface analysis indicated that the LFM cracked due to High Cycle Fatigue (HCF). GEAE's conclusions suggested that assembly stresses may have led to the fatigue cracking (since this LFM was not the original component).

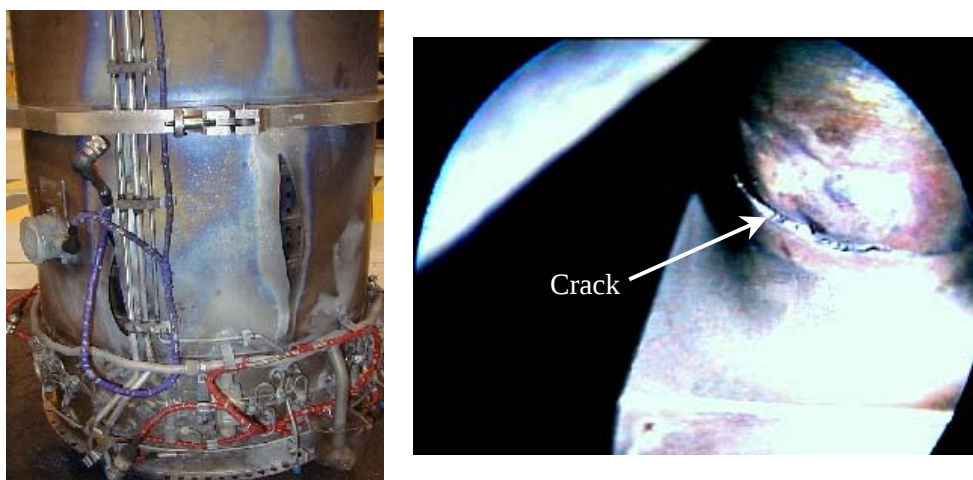
Figure 3: Damaged Engine and Cracked Lower Fuel Manifold

Shortly after takeoff from CFB Cold Lake in August 2001, and after reselecting a throttle setting of maximum afterburner, a CF-18 pilot received audible cautions for a left engine fire. The pilot activated the left engine bay fire suppression system and shut down the incident engine before carrying out a single engine landing without further incident. A preliminary survey revealed multiple ruptures in the afterburner case of the incident engine, through which hot gases escaped, causing significant damage to the airframe. Internal inspection of the incident engine using remote visual inspection equipment revealed a crack in the T-junction of the main LFM. It was concluded that fuel leaking from the cracked LFM was ignited when the pilot advanced the throttles into afterburner operation. Figure 3 depicts damage to the incident engine as well as the cracked LFM.

The engine was removed from its airframe and forwarded to Magellan Aerospace where a controlled disassembly was carried out, documenting the condition of all pertinent hardware and ultimately confirming the cracked LFM. An extensive review of all recorded engine parameters during the incident flight was also carried out in order to gain a better understanding of how the engine performed while being starved of fuel as a result of the cracked LFM. Shortly thereafter, GEAE confirmed HCF to be the mechanism that caused this second LFM cracking event and subsequently recommended that all F404 users take the necessary steps to increase the inspection frequency of all installed LFMs.

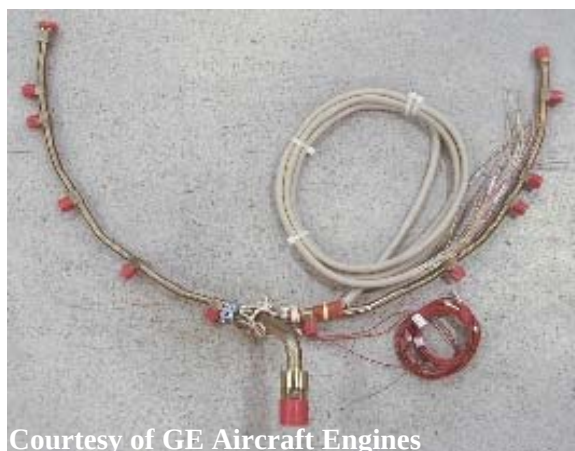
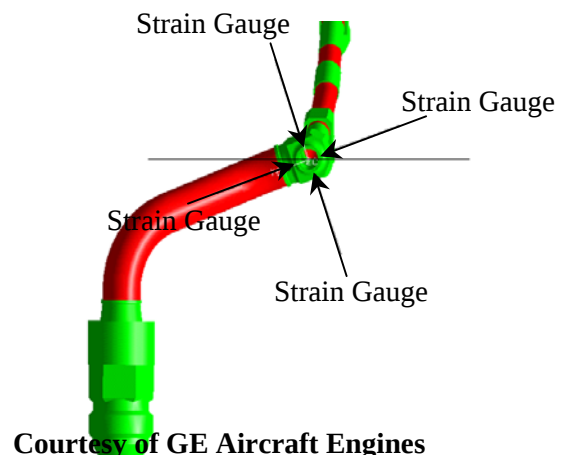
Figure 4: Instrumented Lower Fuel Manifold

An instrumented LFM was provided by GEAE for the engine test. The tube assembly was equipped with eight strain gauges, four on either side of the T-junction, at evenly spaced intervals around the tube circumference as shown in Figure 4.

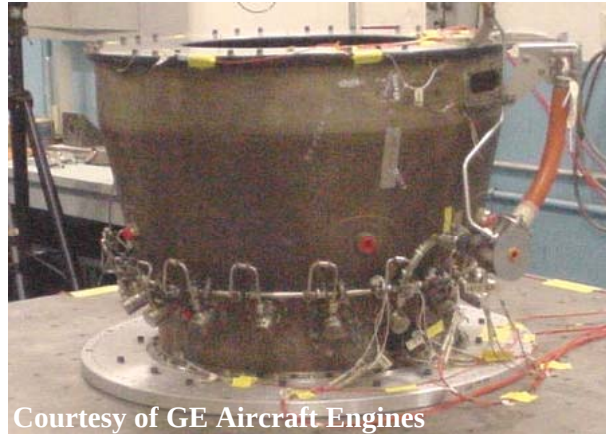
**Figure 5: Shake Table Testing Set-up**

conditions to facilitate evaluation of mitigation options. An instrumented LFM was installed on a Combustor Case with all pertinent hardware as well as simulated interaction between the C&D Valve and the airframe. This apparatus was oscillated in three planes through a 0 – 2000 Hz frequency sweep while measuring the strain induced in the LFM. Figure 5 depicts the shake table testing set-up.

The frequency sweep identified the first seven resonant modes of the installed LFM, with the first and lowest frequency mode nearly identical to the frequency at which the highest LFM strain level was measured during flight tests. This comparison allowed GEAE to use the shake table to accurately reproduce the strain conditions experienced by an LFM during engine operation with excellent correlation. An LFM endurance test was carried out with oscillations at moderate amplitude (approximately 65% of the design maximum allowable strain at the LFM T-junction) within the low frequency range of interest identified during both the flight tests and the frequency sweep tests. The endurance manifold eventually failed in nearly identical fashion to those that were discovered cracked in service, which not only validated the laboratory set-up, but also provided a baseline against which any mitigation options could be tested.

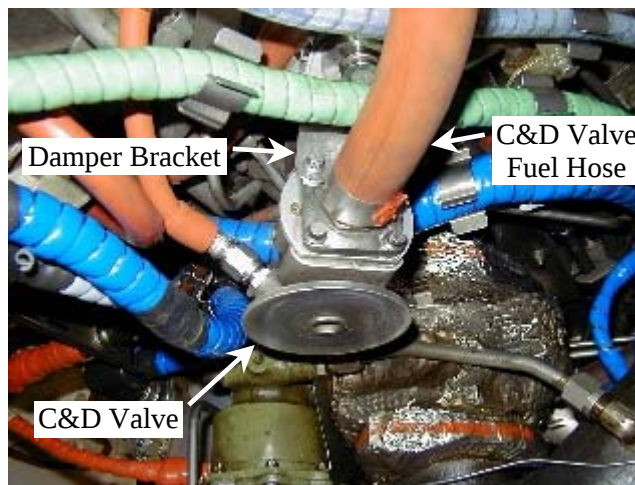
**Figure 7: Second Damper Bracket Design**

variability in the position of the C&D Valve with respect to the OBD meant that the mounting points for the two damper bracket halves could be of varying distances apart. This created a condition where the two bracket halves would become slightly separated, leaving a small gap between the two halves, and creating an undesirable possibility for abnormal wear of the damper bracket as well as the possibility of compromised dampening effect. This necessitated a redesign of the damper bracket in order to incorporate some adjustability that would allow the bracket to be adaptable to the varying installation conditions on all F404 engines. By May of 2003, a newly designed bracket had been produced by GEAE, which incorporated a feature that would allow the length of one half of the damper bracket to be adjusted in order to span the varying distance between the mounting points on the C&D Valve and the OBD. Figure 7 is a photo of an installed damper bracket, conveying the challenge of incorporating a new component within the complex network of existing engine hardware.

Trial installations were carried out on an F404 engine using the newly designed damper bracket with no further complications. The adjustable feature of the new bracket allowed the system to compensate for the variability of mounting point positions between engines and allowed proper installation of the bracket with little increase in complexity or effort. The new bracket was forwarded to CFB Cold Lake in July 2003 in preparation for flight tests at AETE during the following month. Before testing the new damper bracket, baseline flight tests were performed without the bracket installed in order to re-establish the measured strain levels experienced by the LFM in flight and to ensure that the results had not changed significantly from those recorded during the June 2002 flights. The same test matrix was flown as during the previous flight test phase, however this time only JP8 fuel was used. Upon completion of the baseline flight tests, the recorded data was analyzed and found to be very similar to that recorded during the June 2002 flight tests. The damper bracket was then installed and the flight test matrix was repeated.

Analysis of the damper bracket flight test data was completed in September 2003 with the results indicating that with the damper bracket installed, overall strain levels at the LFM T-junction were reduced by approximately 48%, well below design maximum allowable levels. The damper bracket was found to be extremely effective in mitigating vibration input to the LFM in the low frequency range of concern that was identified during the 2002 flight tests. Based on these results, all parties involved in the development of the damper bracket agreed that the flight tested design was sufficient in its ability to mitigate undesired strain levels in the LFM T-junction and reduce the risk level associated with this issue to an acceptable level.
