# **Commercialization of Technologies to Lower Defense Costs**

## **Final Demonstration/Validation Report For STAPP Bullet Catcher Evaluation at Fort A.P. Hill March 2, 2006**

Contract No. W74V8H-04-D-0005  
Task No. 0403  
CDRL A012  
Report Number: NDCEE-CR-2006-001

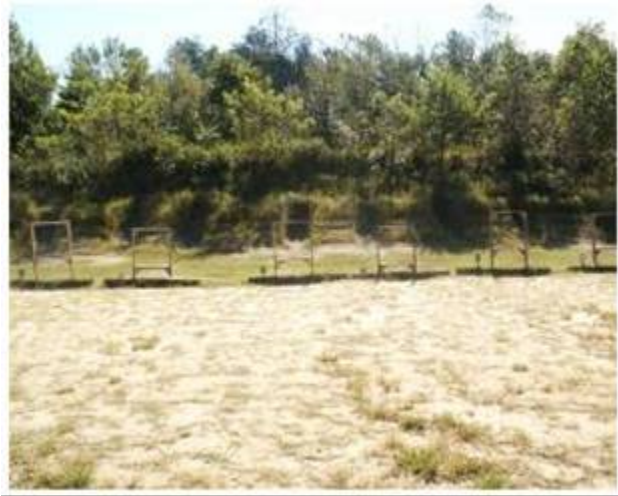
The initial physical condition of the Range 4 berm is best depicted in Figures 1 and 2. Large craters, created from years of firing, are clearly visible. The craters were formed as a result of bullets penetrating the soil and eroding the berm. The craters in the near vicinity of the Bullet Catcher are approximately 80 inches long x 52.5 inches wide x 12 inches deep. There is woody vegetation present for the prevention of soil erosion.

**Figure 2. Original Condition of Range 4.**

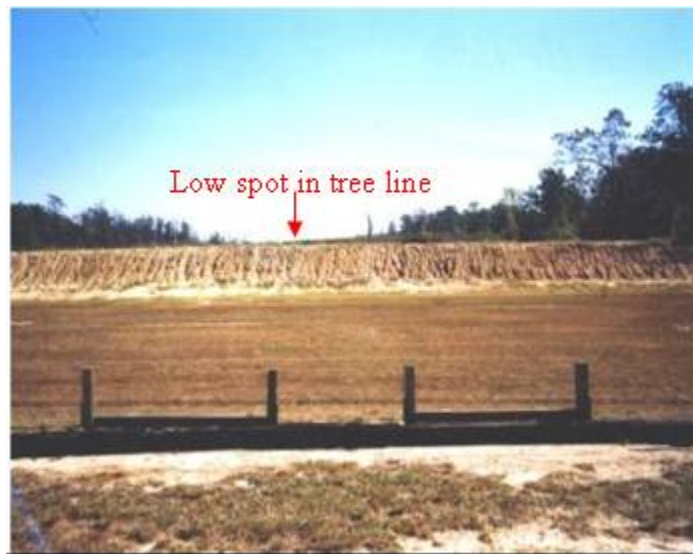
The physical condition of the Range 5 berm is best depicted in the Figure 3. Range 5 does not have any craters similar to the ones seen on Range 4 and has little, if any, woody vegetation or plant life. Erosion of the soil has created deep ruts on the face of the berm. There is also a large distance (271 feet, 6 inches) between the firing point and the berm, which allows bullets to “travel” upwards and beyond the height of the berm. By the observing the surrounding tree line and plant growth, it is obvious that bullets pass over the berm, cutting down trees and plant-life. This is shown clearly in Figure 3.

**Figure 3. Original Condition of Range 5.**

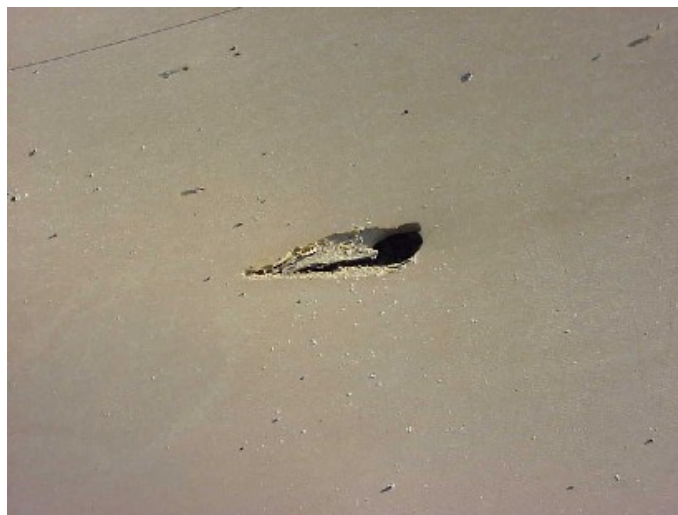
On 27 April 2004, seventy days after test initiation, Fort A.P. Hill reported to the NDCEE that there was damage to the top rubber cover on Range 5 that definitely required maintenance. The damage was caused by the 2,500 armor piercing .50 caliber rounds that were fired upon the Bullet Catcher on 24 April 2004. There was damage to the frame/planking as well as the top rubber cover.

On 29 April 2004 all parties met at Range 5 to observe a small area on the left side of the Bullet Catcher that required patching (See Figure 34).

**Figure 34. Damage on Left Side of Range 5.**

Steps taken to repair the damaged area included sanding the perimeter of the damaged area and wiping it clean using rubbing alcohol. The repair patch

consisted of the very same material as the top rubber cover and was cut slightly larger than the damaged area to allow an approximate 1-2” overlap. The overlap provides a sound surface for the repair patch to adhere to. The under side of the repair patch was also sanded and cleaned with rubbing alcohol. Once the damaged area and patch were sanded and cleaned, a bead of the STAPP supplied glue was placed on both the perimeter of the damaged area as well as the coordinating under side of the patch. The patch was laid on top of the damaged area and hand-pressure was applied. The time required to complete the repair was approximately 5-7 minutes. For repair results see Figure 35.

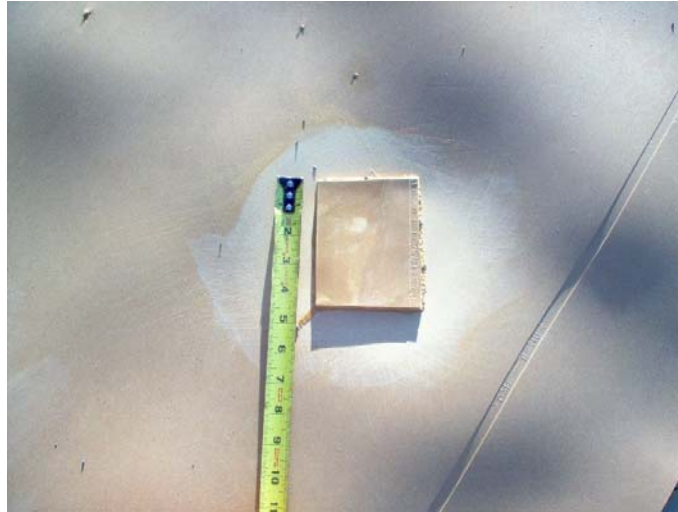
**Figure 35. Repair Patch to Damage Depicted in Figure 35.**

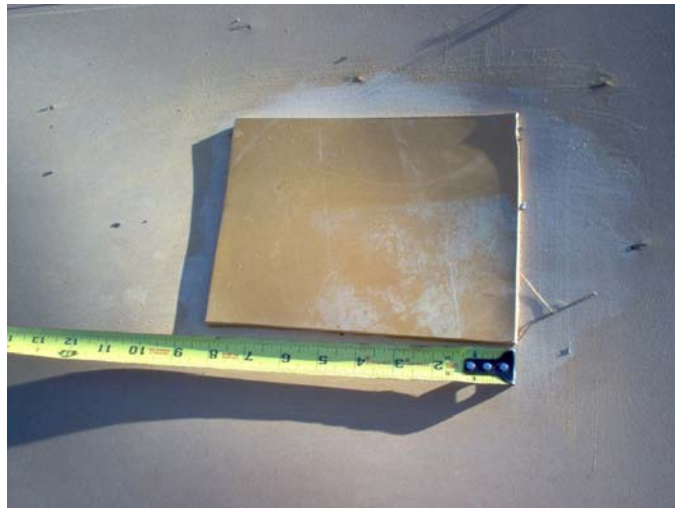
There was a larger area of the top rubber cover on the right side of the Bullet Catcher that required patching as well. The very same steps taken to repair the smaller area on the left side were followed. The repair took approximately 5-10 minutes to complete. For results see Figure 36.

**Figure 36. Top Rubber Cover Patch on Right Side of Range 5 Bullet Catcher.**

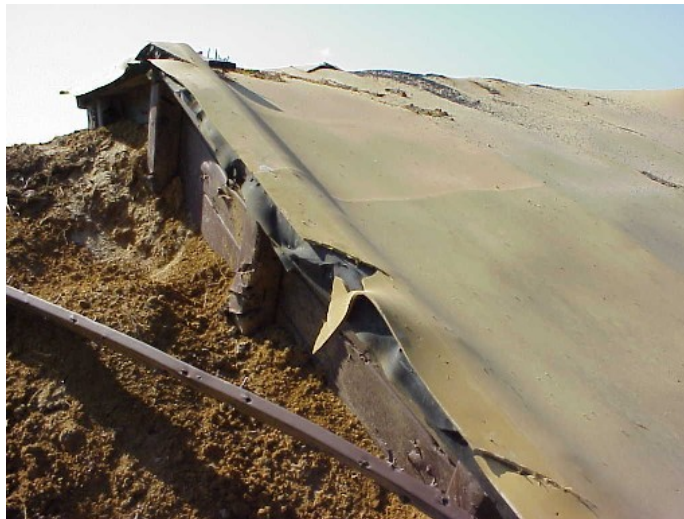
There was also damage along the left side of the Bullet Catcher just inside of the frame/planking, see Figure 37, which required the same repair steps previously mentioned.

**Figure 37. Left Side Damage to Top Rubber Cover and Frame/Planking on Range 5.**

The frame/planking was also damaged and a section needed to be replaced. After a replacement plank was cut to size it was screwed into place. The patch and plank replacement took approximately 25-30 minutes to complete.

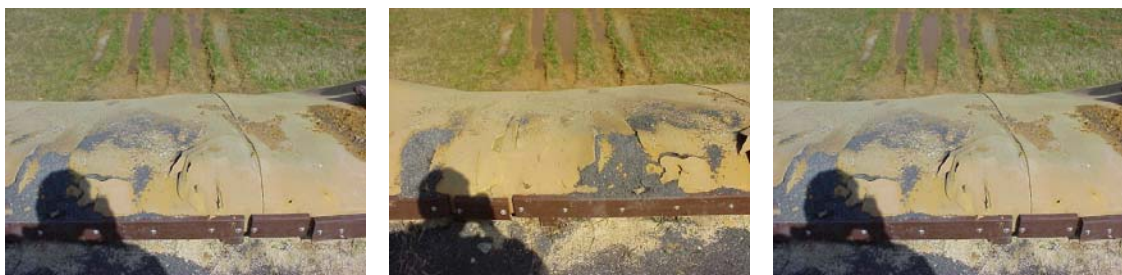
The top of the Bullet Catcher had severe damage to the upper portion of the top rubber cover (See Figures 38, 39, and 40).

**Figures 38, 39, and 40. Damage to the Upper Portion of the Top Rubber Cover of the Range 5 Bullet Catcher.**

The bullets hit the top portion of the Bullet Catcher because of the long distance between the firing point and the Bullet Catcher (approximately 271'). This large distance allows bullets to "travel" to the edges of the Bullet Catcher and beyond. Bullets that impact the Bullet Catcher at or near the edges are not able to penetrate the Bullet Catcher properly and therefore cannot be appropriately retained. The top portion of the Bullet Catcher, where it becomes flat, showed the most damage. Bullets that were fired at an upward angle or from the prone position caused this damage. When the bullets finally reach the Bullet Catcher they have traveled roughly 271' and have had the opportunity to "climb". The bullet then lightly penetrates the flattened out portion of the Bullet Catcher and simply skims the top rubber cover, tearing it as it passes. This damage is not due to a malfunction or inadequacy of the Bullet Catcher to perform, but is a direct result of the range design. Perhaps if the Bullet Catcher had been designed and constructed several feet taller this damage would not be an issue.

The top portion of the Bullet Catcher was patched. Steps taken to repair the damaged area were the same as for the smaller patches. Two large repair patches were needed for this top portion. Approximately 25-30 minutes were required to repair the entire top portion of the Bullet Catcher.

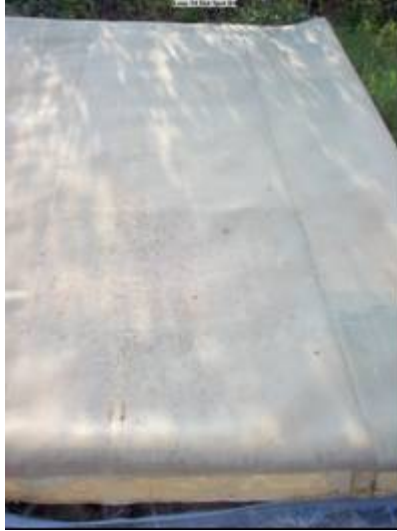
The bullets that impacted the Bullet Catcher on Range 4 were confined to “hot spots.” In this instance a hot spot is an area with a high concentration of bullets/entry marks. Each lane had a hot spot approximately 70” (height) x 50” (width) located towards the lower section of the Bullet Catcher (Figure 46).

**Figure 46. Range 4, Lane 54 Hot Spot.**

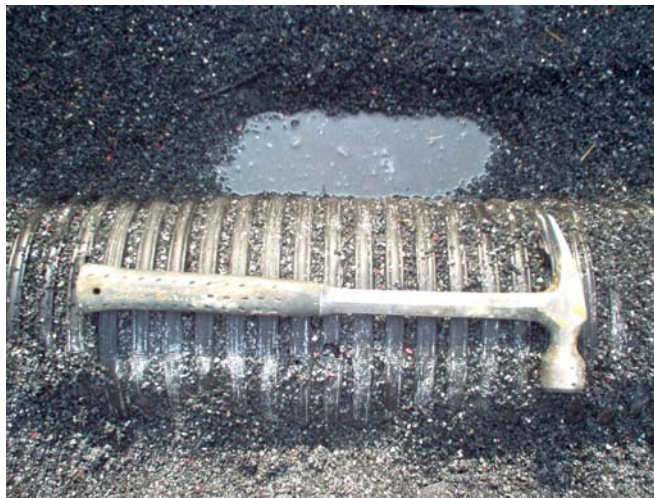
After the granular rubber was removed, it was noticeable that there was some water accumulation in the Bullet Catcher. A puddle of water, roughly one-half gallon, was lying next to the water collection pipe at Lane 53 (See Figure 50). This was an indication that precipitation had entered the Bullet Catcher, which would be sampled, analyzed, and properly disposed of.

**Figure 50. Puddle of Water at Lane 53.**

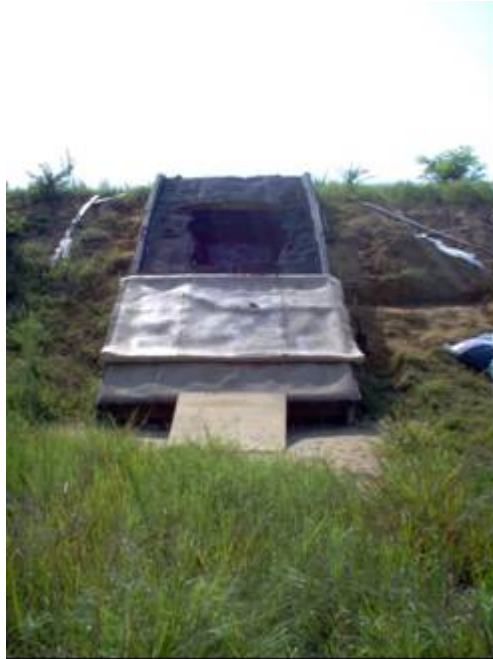
At roughly 6:00am on 20 August 2004 Clean Harbors began the sifting process on Range 5. The hot spot on Range 5 was slightly larger than the hot spots on Range 4. The Range 5 hot spot was roughly 80 inches (length) x 55 inches (width) Figure 52 shows the hot spot with the top rubber cover pulled down and the granular rubber removed.

**Figure 52. Range 5 Hot Spot.**

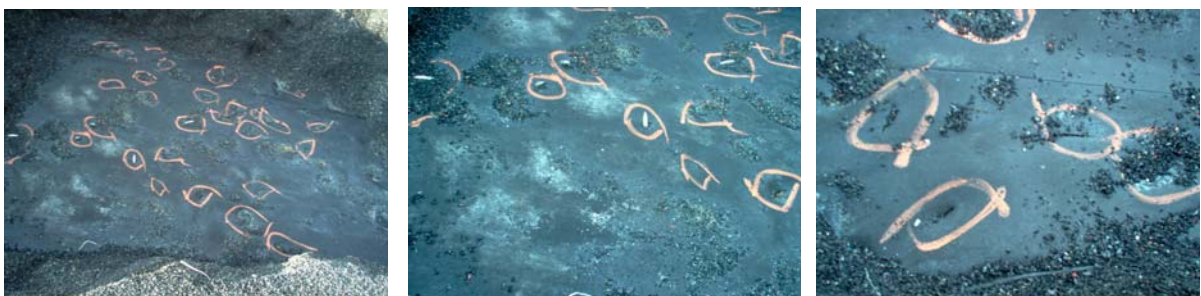
Again, Clean Harbors chose to utilize the STAPP-sifter during the sifting process. Range 5 had bullets throughout the depth of the granular rubber. Once the granular rubber was removed from the hot spot, the bottom rubber liner was visually inspected. Upon inspections it was noted that there were roughly thirty holes/tears in the bottom rubber liner caused by bullets penetrating beyond the depth of the granular rubber. Some of the holes/tears had bullets protruding from them with several facing away from the bottom rubber liner. For more detail please see Figures 53, 54, and 55.

**Figures 53, 54 and 55. Holes/Tears (circled) in Bottom Rubber Liner of the Range 5 Bullet Catcher.**

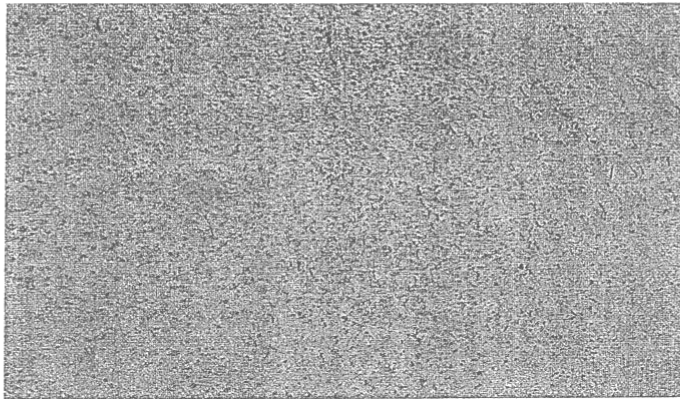
Repair Necessary

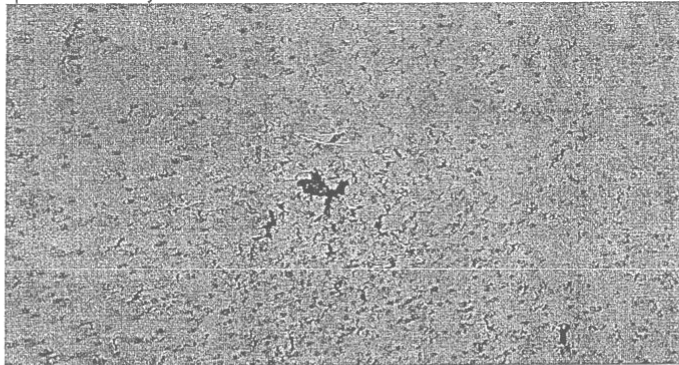
Damage is insignificant and local. Repair may soon be needed to prevent penetration of bullets up- and water down- through opening(s), and to protect against ricochets. CA-glue is recommended when mending.

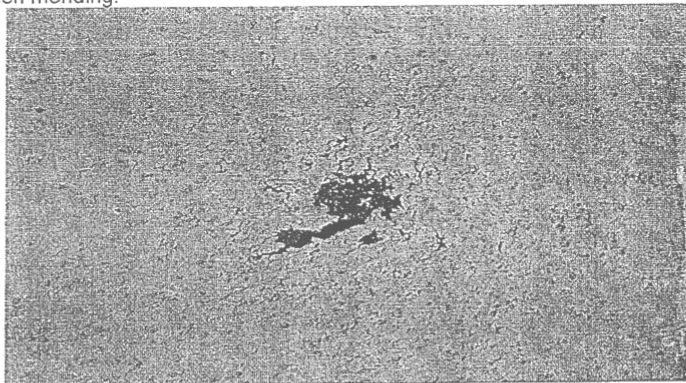
Bullet Catcher is saturated after intensive shooting with low-energy impact, large-bore rounds. Repair is imminent. It is recommended that upper rubber granules be replaced with new. Mend using CA-glue (alternative 1) or vulcanized-tape, (alternative 2).
