**AFRL-ML-WP-TR-2007-4145**

**QUICK REACTION EVALUATION OF  
MATERIALS AND PROCESSES**

**Delivery Order 0010: Bonded Boron Patch  
Repair Evaluation**

**Final Report for 01 March 2005 – 01 September 2006**

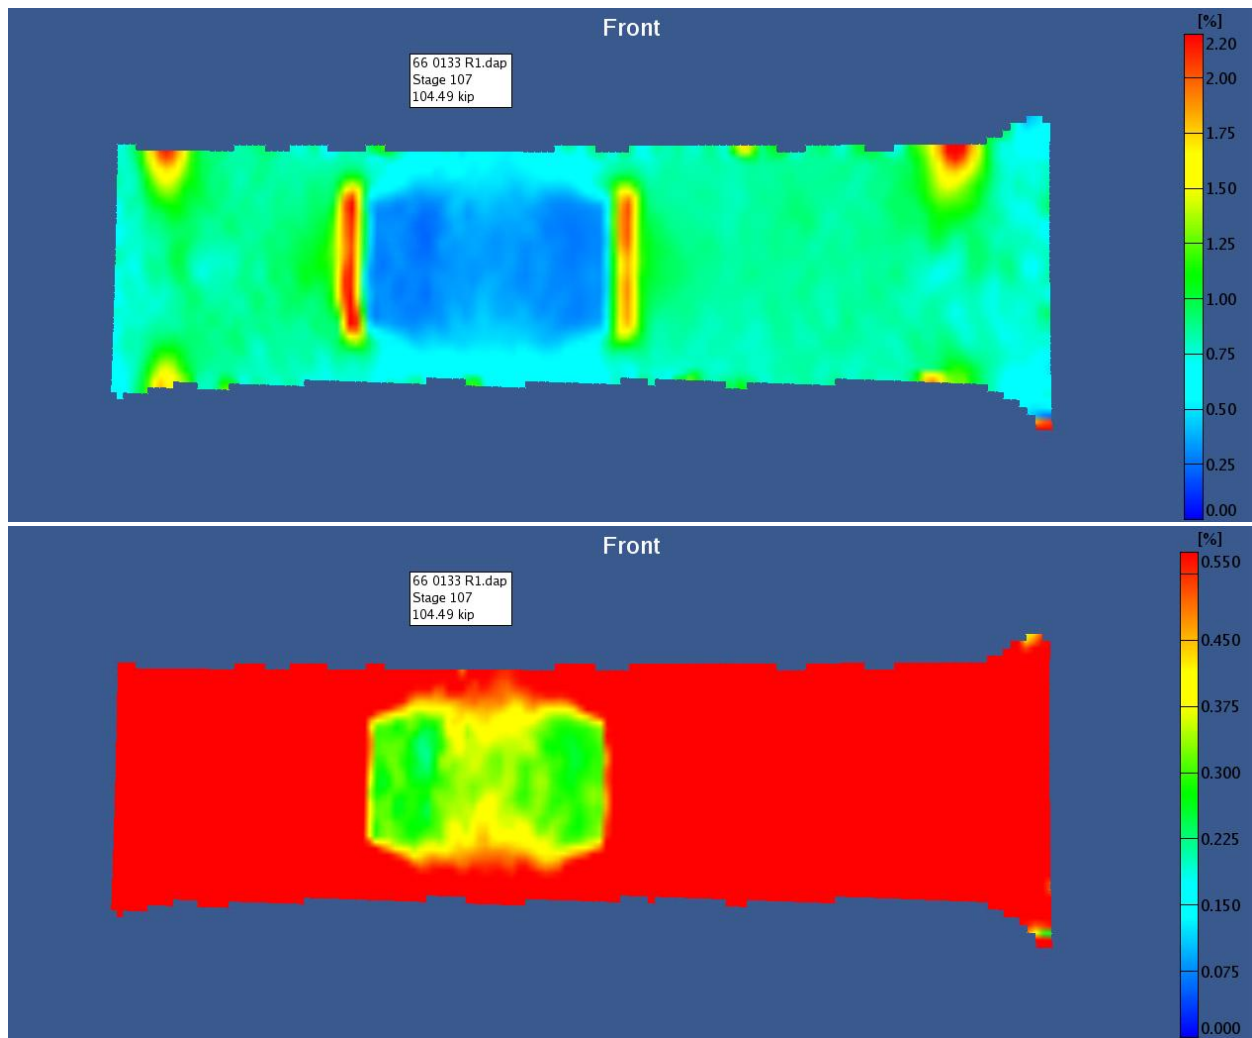
**Figure 23. Typical SO Response of Original Repairs (top = high scale, bottom = low scale).**

The majority of the original repairs sustained no patch related failures. These specimens generally failed in the gage (reduced) section of the aluminum away from the patch. For these typical cases, the SO results were checked to confirm there were no delaminations or other patch events, and then saved for future use. For brevity, only a representative SO response is presented in this report, rather than listing each individual specimen. Figure 23 displays a typical SO response for an original repair, with the strain scale changed from high to low scale to better illustrate the surface strain through the specimen and the OML patch. In this case, the original repair was a square edge patch design.

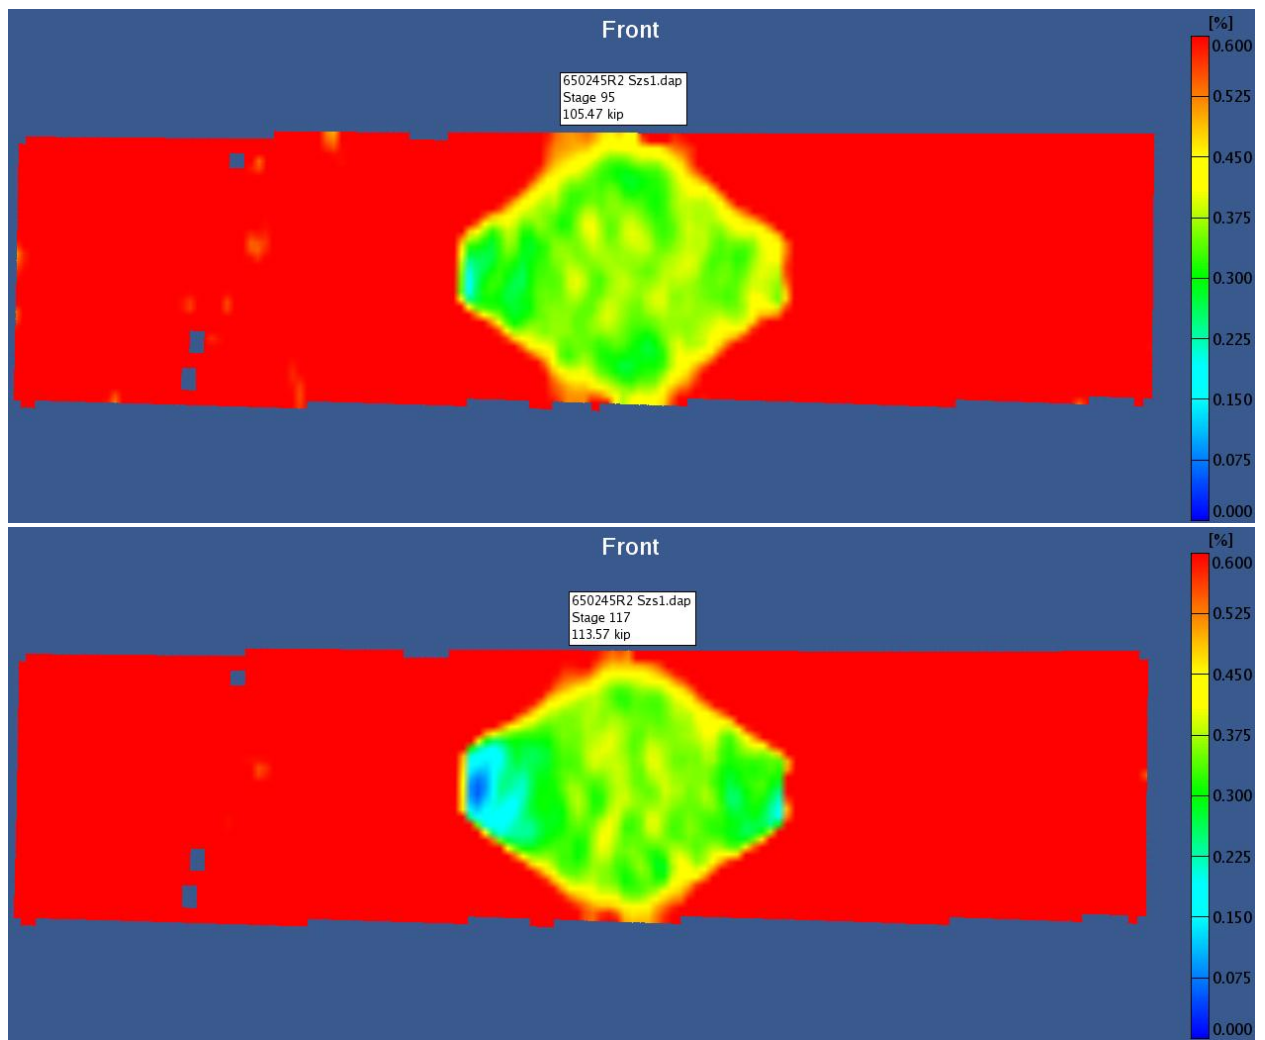
**Figure 24. OML Patch Delamination; Repair 65-0245 R 2.**

Specimen number 65-0245 R 2 had a patch with a clipped edge, aligned OML patch (TI repair) that began to delaminate at the corner of the patch at approximately 77 ksi. The delamination/disbond grew under increasing load across the edge of the specimen, then increasing in size under the skin with increasing load. The specimen failed at 83.1 ksi. Figure 24 shows the strain field of the patch failure at the first detectable occurrence as well as the final maximum extent of the delamination, just prior to sample failure. Note that the scale used in the figure has been reduced to more clearly show the patch failure. The OML patch became completely disbonded upon failure and separated from the specimen.

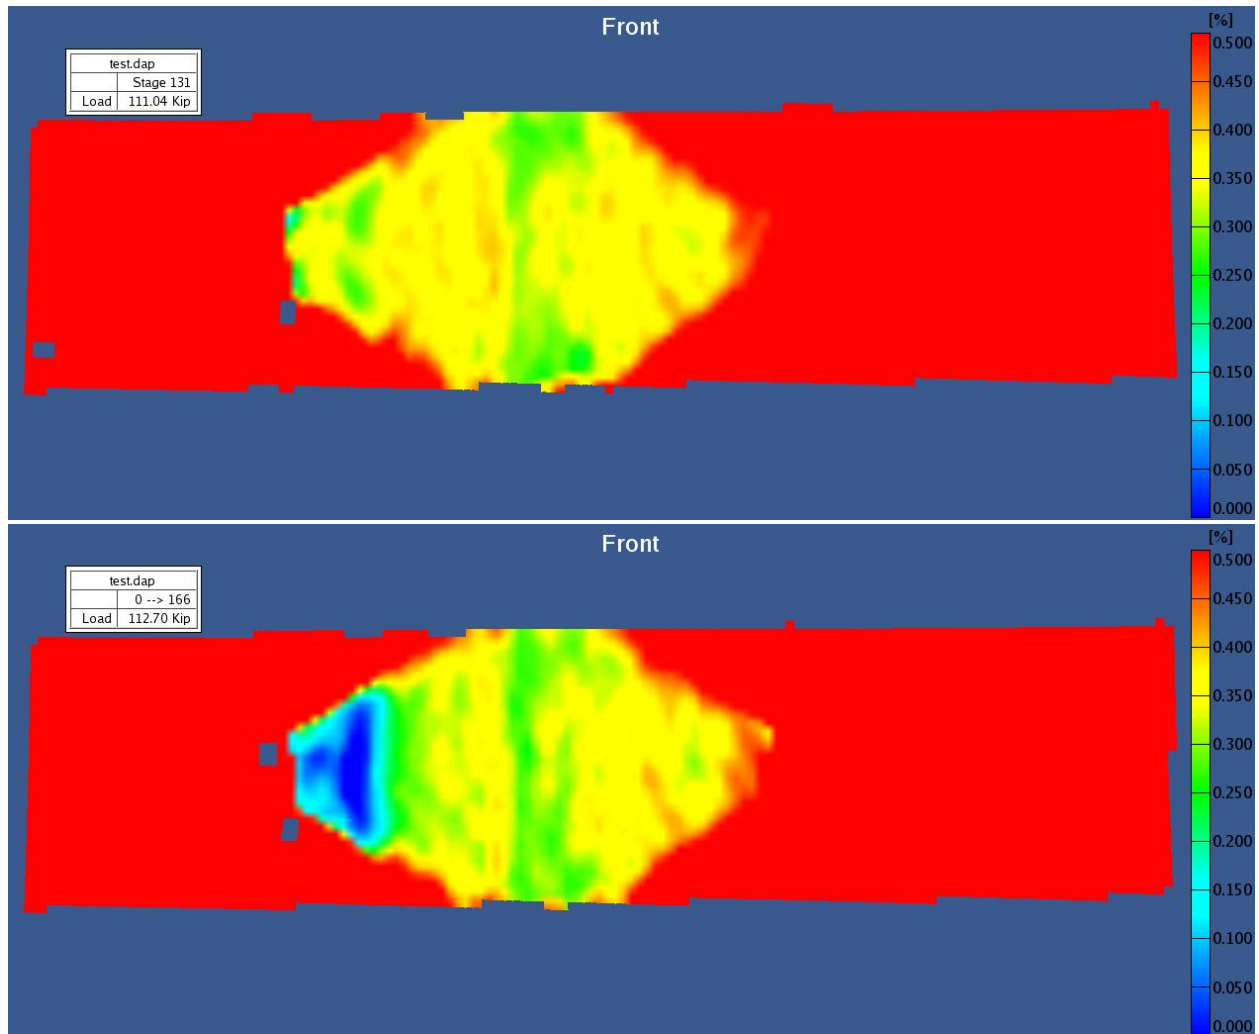
**Figure 25. OML Patch Delamination; Repair 66-0168 R 1.**

Specimen number 66-0168 R 1 had a clipped edge, aligned OML patch (TI repair) that began to delaminate at the corners of the patch at approximately 84 ksi. The delaminations grew under increasing load across the edge of the specimen, eventually joining into a single delamination and growing under the skin with increasing load. The specimen failed at 86.3 ksi. Figure 25 shows the strain field of the patch failure at first detectable occurrence as well as the final maximum extent of the delamination, just prior to substrate failure.

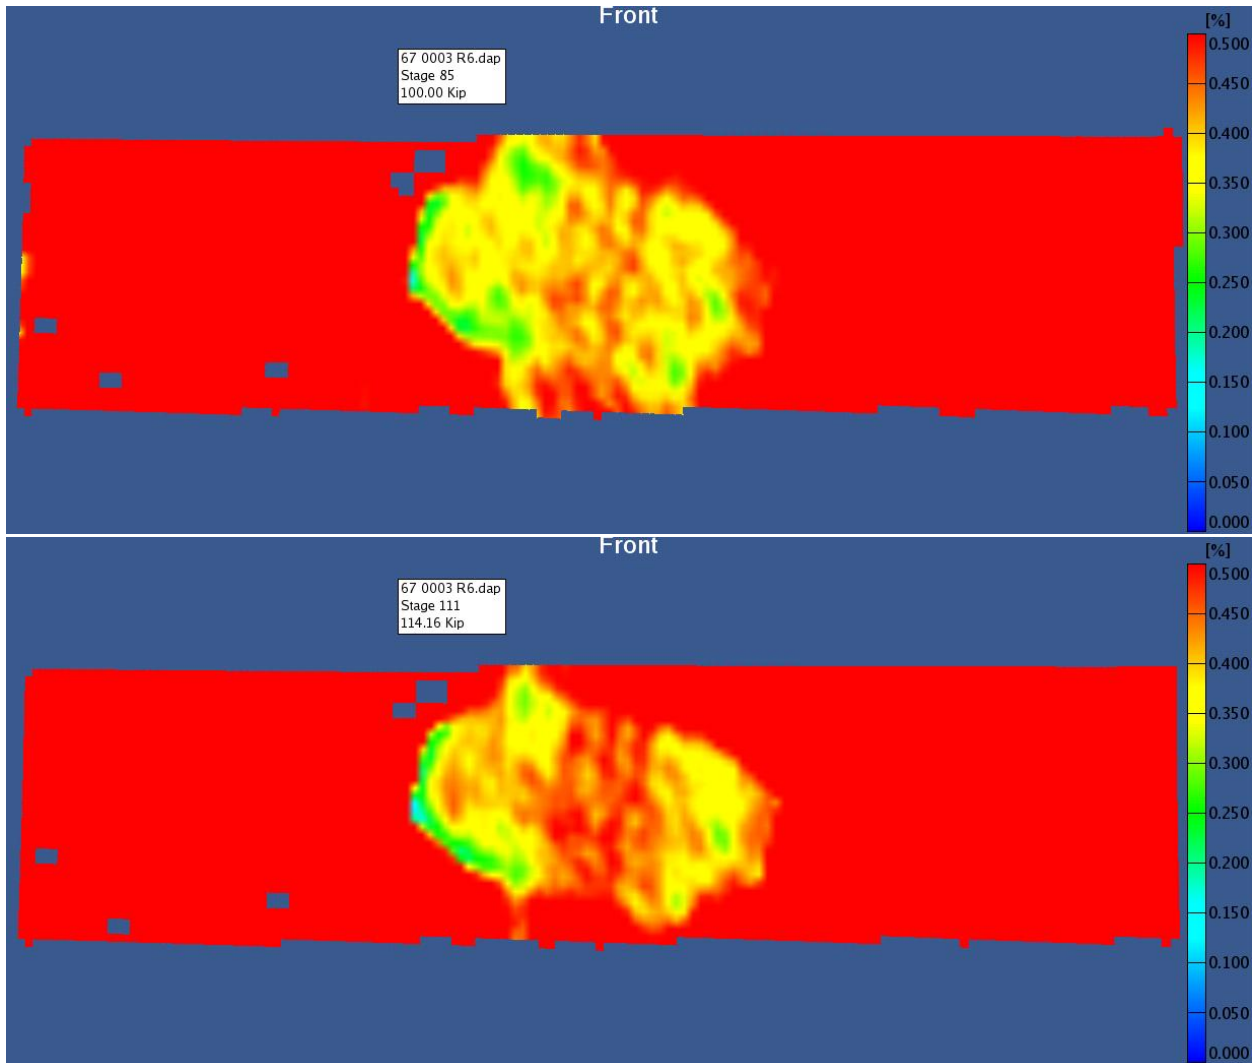
**Figure 26. OML Patch Delamination; Repair 67-0003 R 6.**

Repair number 67-0003 R 6 had a clipped edge, angled OML patch (CTI repair) that began to delaminate at central tip of the patch at approximately 75 ksi. The delamination grew slightly under the patch with increasing load. The specimen failed at 79.9 ksi. Figure 26 shows the strain field of the patch failure at first detectable occurrence as well as the final maximum extent of the delamination, just prior to substrate failure.

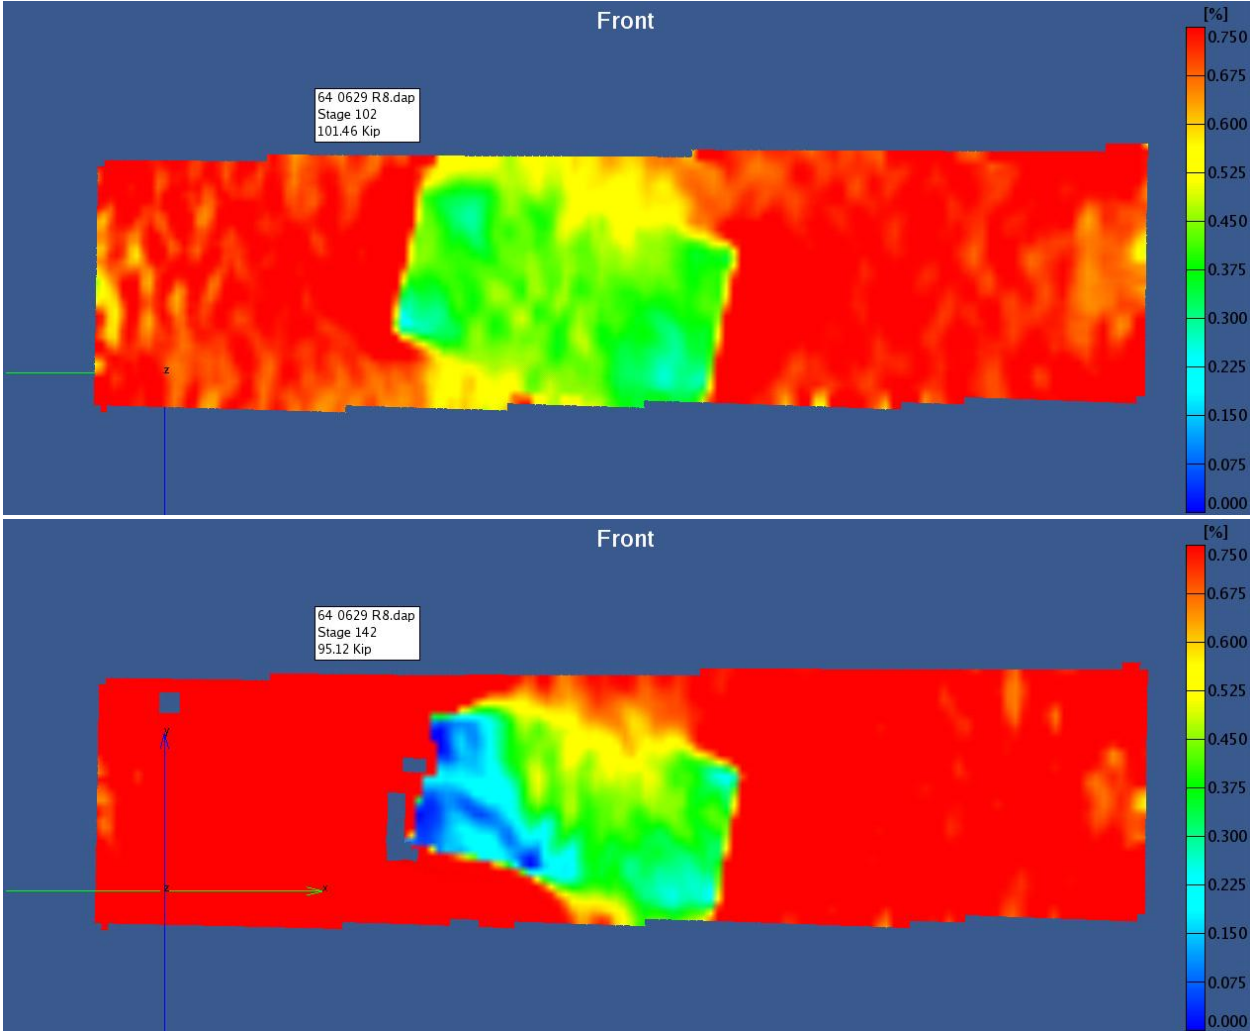
**Figure 27. OML Patch Delamination; Repair 64-0629 R 8.**

Repair number 64-0629 R 8 had a square edge, angled OML patch (CTI repair) that began to delaminate at central tip of the patch at approximately 73 ksi. The delamination grew extensively under the patch with increasing load. The specimen failed at 81.1 ksi. Figure 27 shows the strain field of the patch failure at first detectable occurrence as well as the final maximum extent of the delamination, just prior to substrate failure.

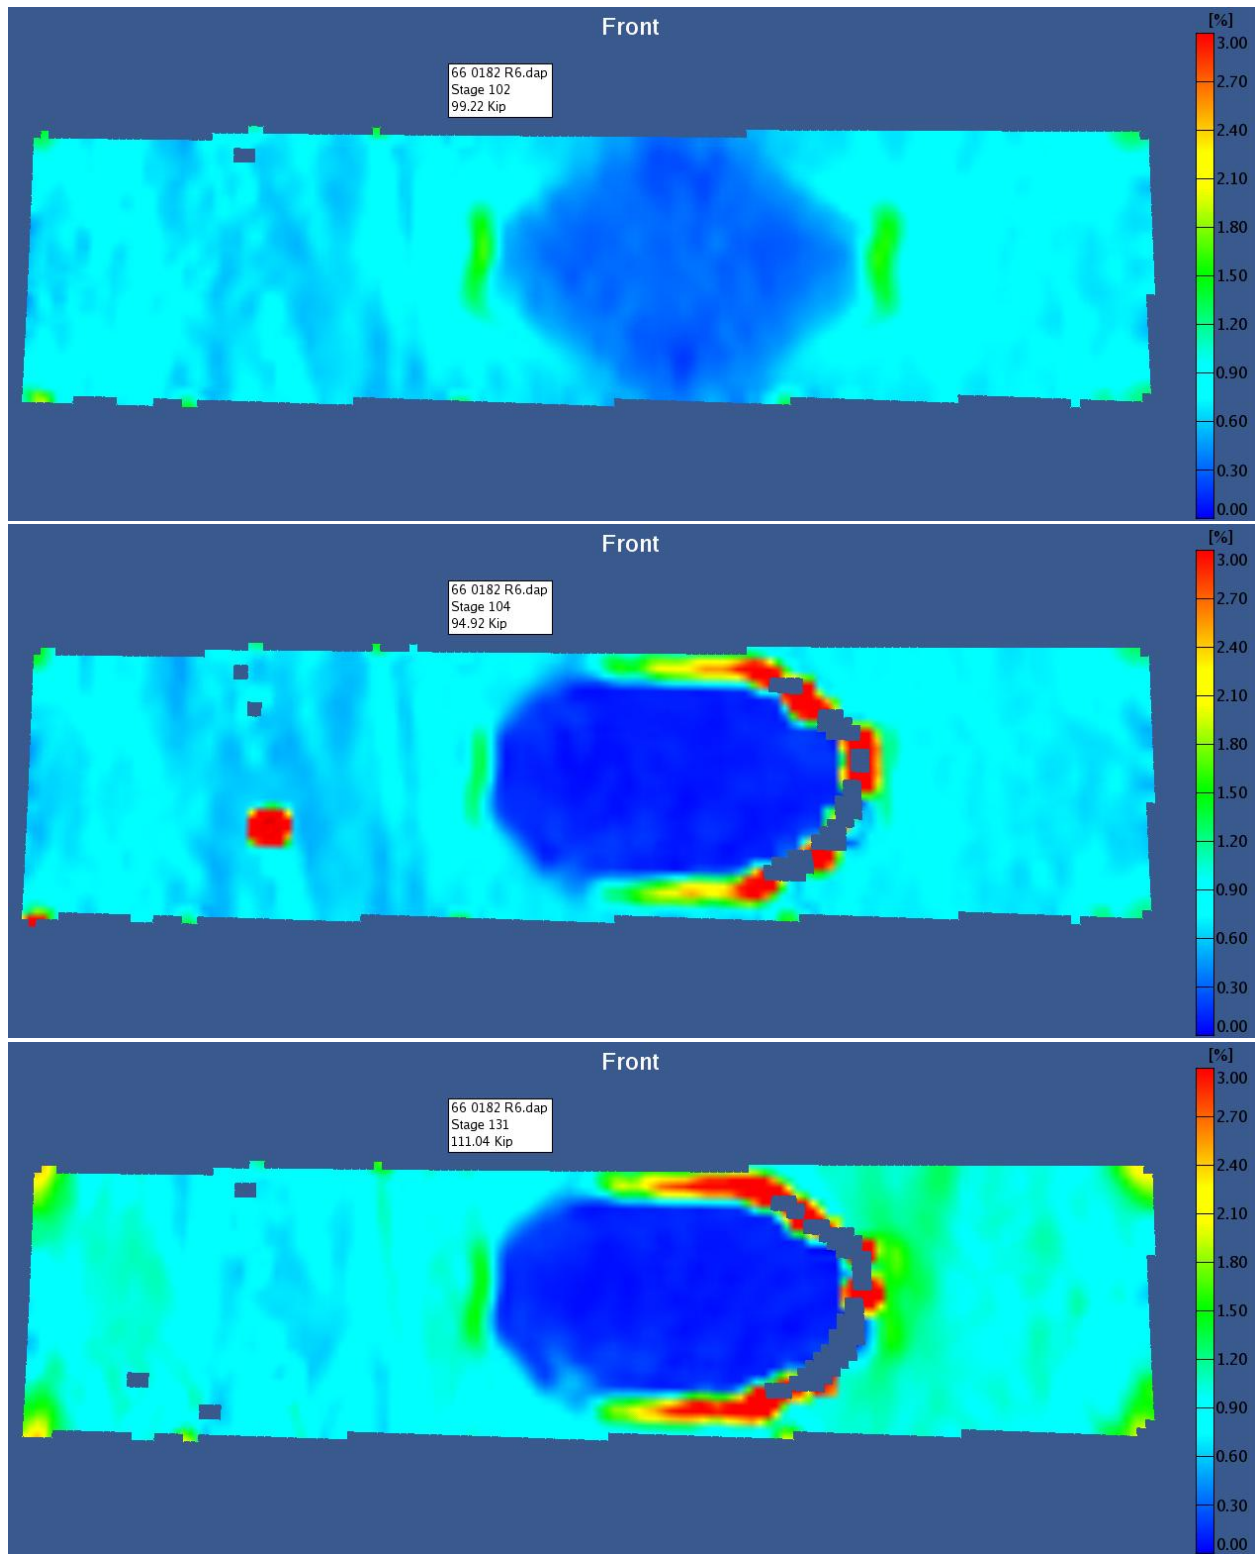
**Figure 28. OML Patch Failure Disbond: Repair 66-0182 R 6.**

Repair number 66-0182 R 6 had a clipped edge, aligned OML patch (TI repair) that appeared to become disbonded from the substrate at approximately 75.6 ksi. The load dropped simultaneously with the disbond event, indicating that the load carried by the patch was released. The load dropped approximately 5,000 lbs (to a stress of 71.6 ksi). The specimen continued loading from that point to the ultimate stress of 82.8 ksi. Figure 28 shows a progression of SO results displaying the patch strain field just to the disbond event, after the disbond event, and at the ultimate load of the specimen. Note the patch is “cold” after the disbond event, indicating little to no strain being carried through the patch. The area to the right of the patch appears to be at high strain, but this is actually a large crack in the sealant that the SO system incorrectly interpreted as high strain (speckles moved far apart). The OML patch became completely disbonded upon substrate failure and separated from the specimen.

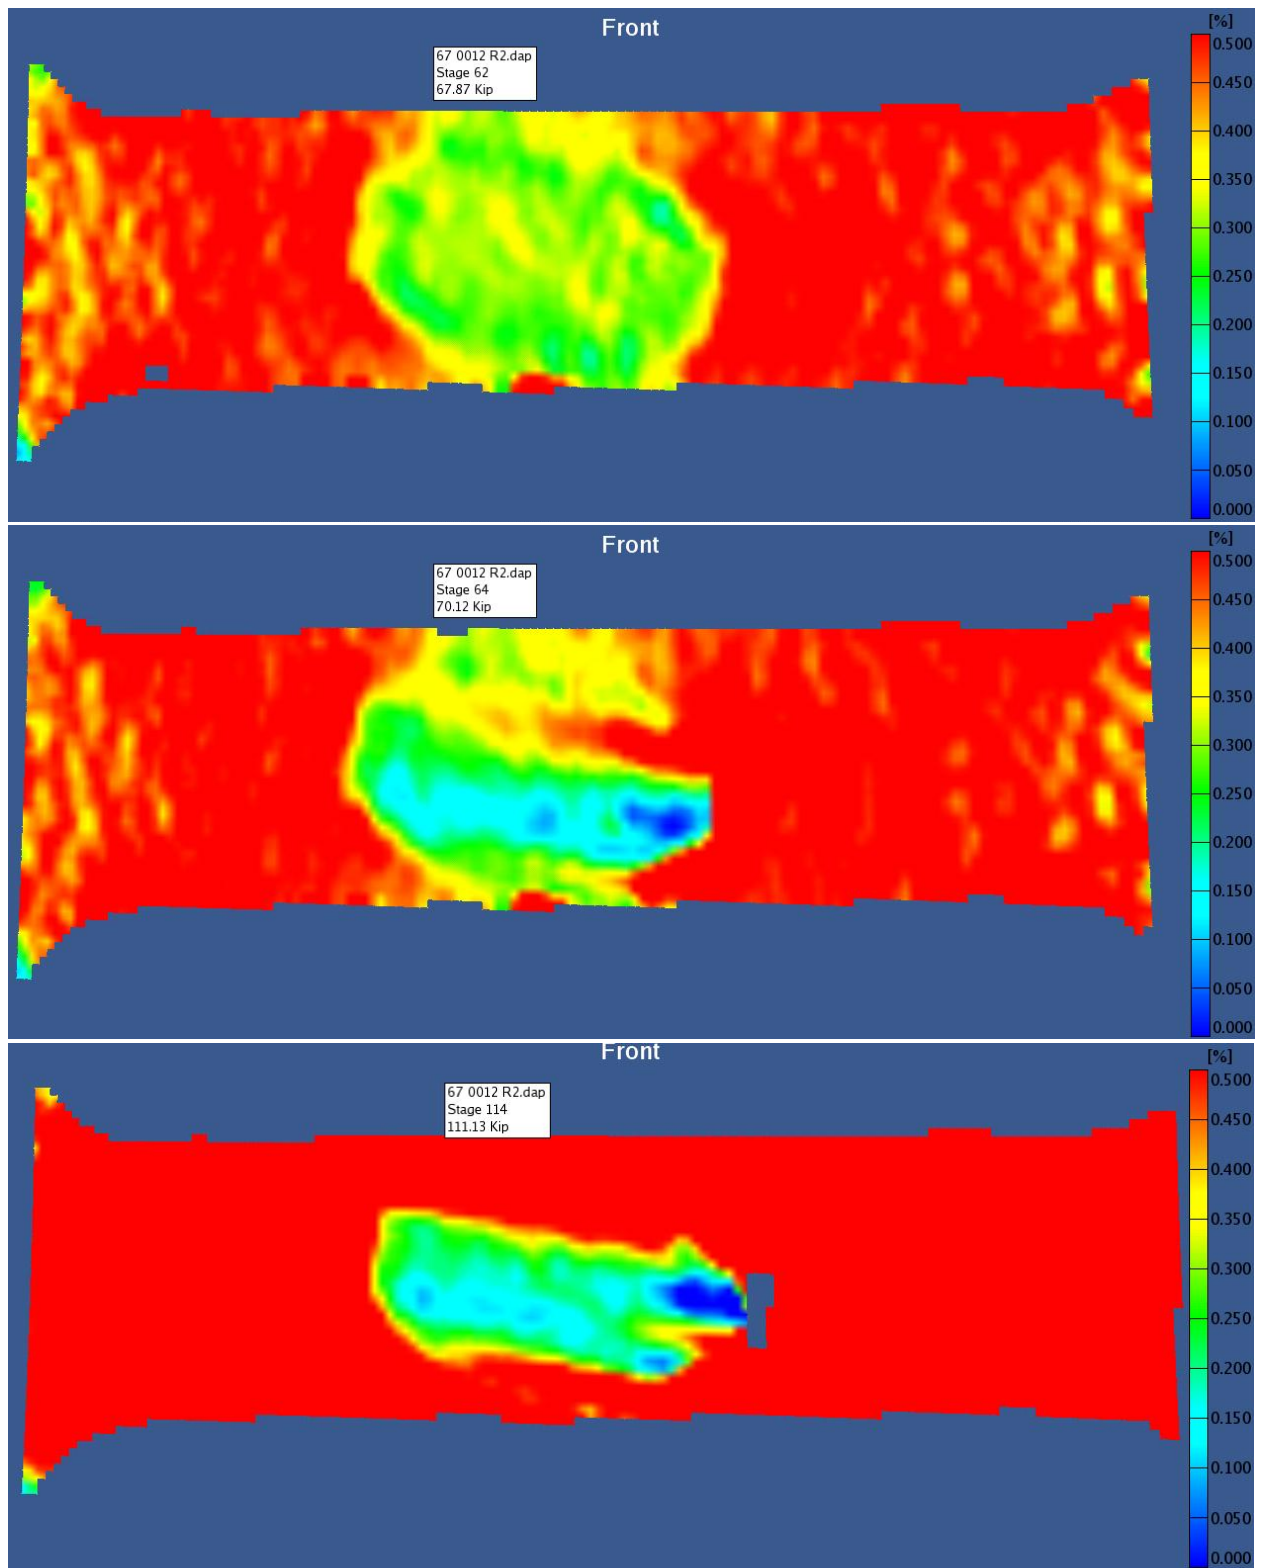
**Figure 29. OML Patch Failure Delamination: Repair 67-0012 R 2.**

Repair number 67-0012 R 2 had a clipped edge, angled OML patch (CTI repair) that delaminated or disbonded at the lower edge of the patch at approximately 52 ksi. The delamination grew slightly under the patch with increasing load. However, the SO surface strain data surrounding the patch indicated that the patch continued to attract and carry load after the delamination event, indicating that the delamination was in the outermost plies and only affected surface strain. The specimen failed at 83.5 ksi. Figure 29 shows the strain field of the patch just prior to the failure (top), just after the failure at first detectable occurrence (middle), as well as the final maximum extent of the delamination (bottom) just prior to substrate failure. Note that the scale used in the figure has been reduced to more clearly show the patch failure. The specific failure mode of this specimen is further described in reference #AFRL/MLS 06-091.

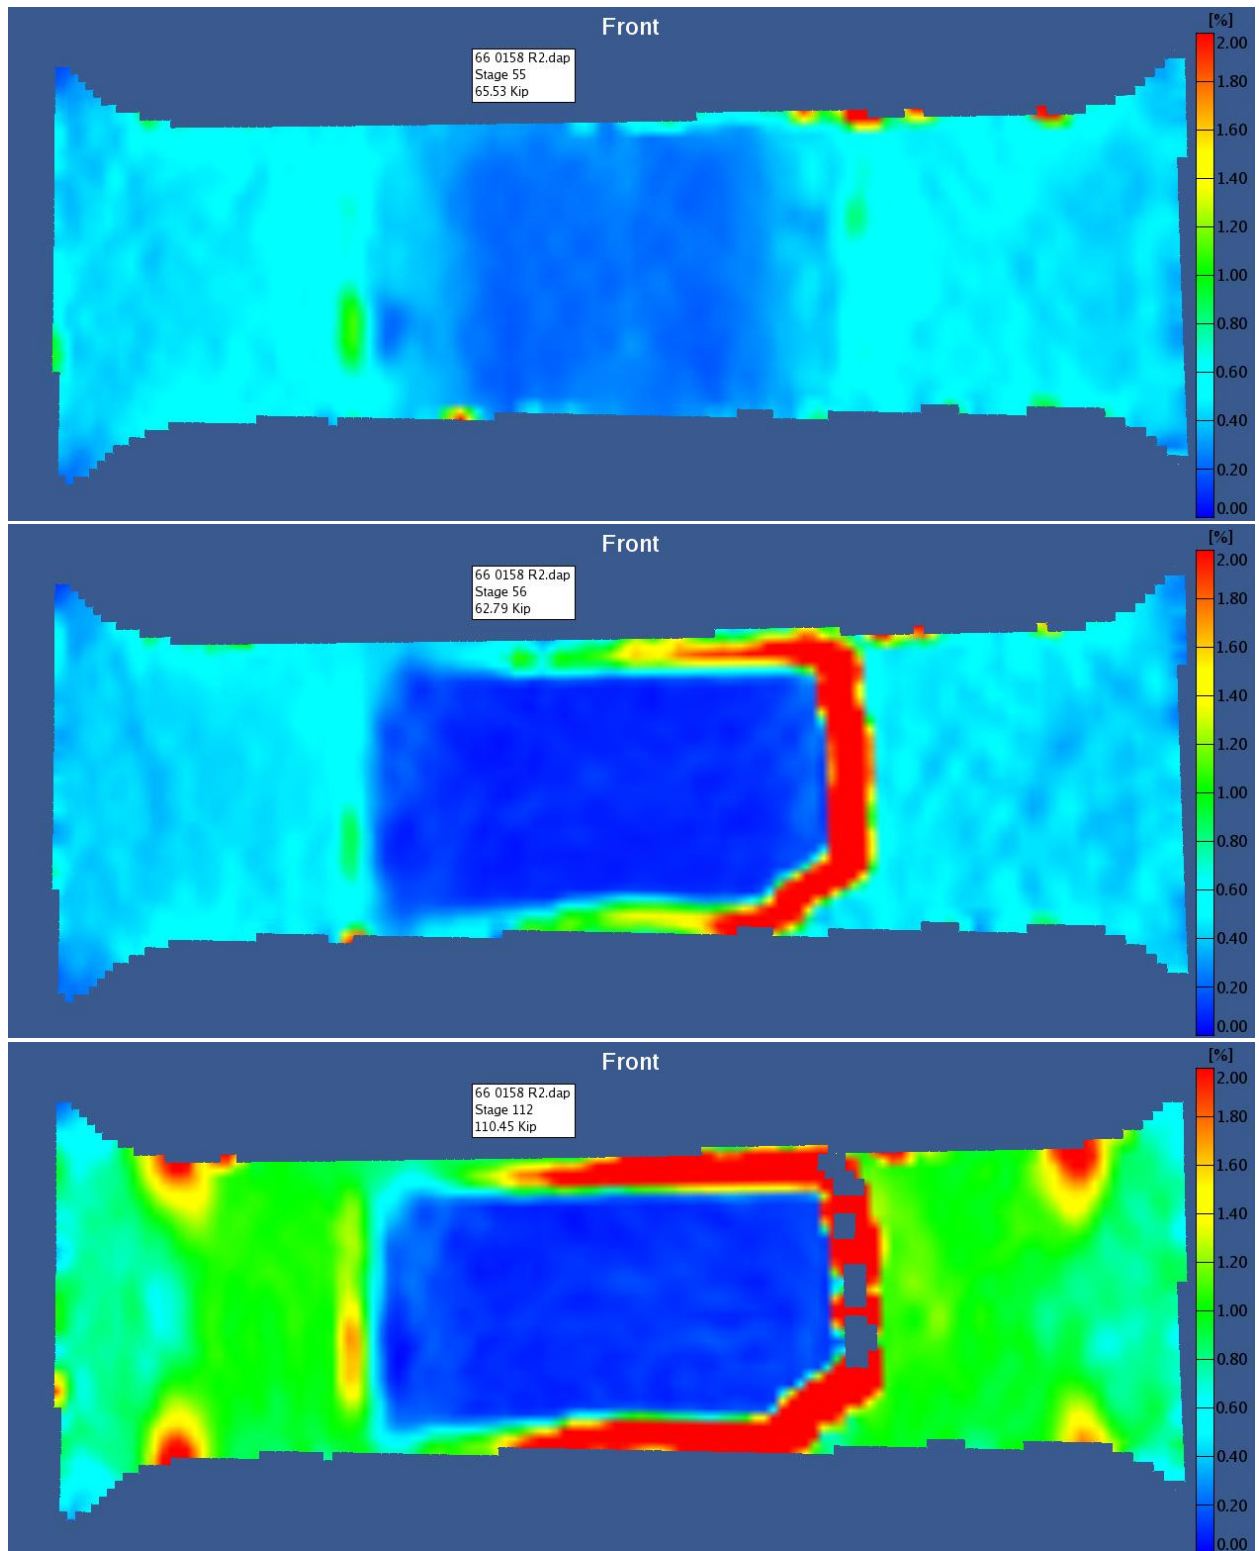
**Figure 30. OML Patch Failure Disbond; Repair 66-0158 R 2.**

Repair number 66-0158 R 2 had a square edge, aligned OML patch (TI repair) that began to appear to become disbonded from the substrate at approximately 50 ksi. The load dropped simultaneously with the disbond event, indicating that at least some of the load carried by the patch was released. The load dropped approximately 3,800 lbs (to a stress of approximately 47 ksi). The specimen continued loading from that point to the ultimate stress of 84.2 ksi. Figure 30 shows a progression of SO results displaying the patch strain field prior to the disbond event, after the disbond event, and at the ultimate load of the specimen. Note the patch is “cold” after the disbond event, indicating little to no strain being carried through the patch. The area to the right of the patch appears to be at high strain, but this is actually a large crack in the sealant that the SO system is incorrectly interpreting as high strain (speckles displaced farther apart than surrounding speckles). The OML patch became completely disbonded upon substrate failure and separated from the specimen (reference #AFRL/MLS 06-091).

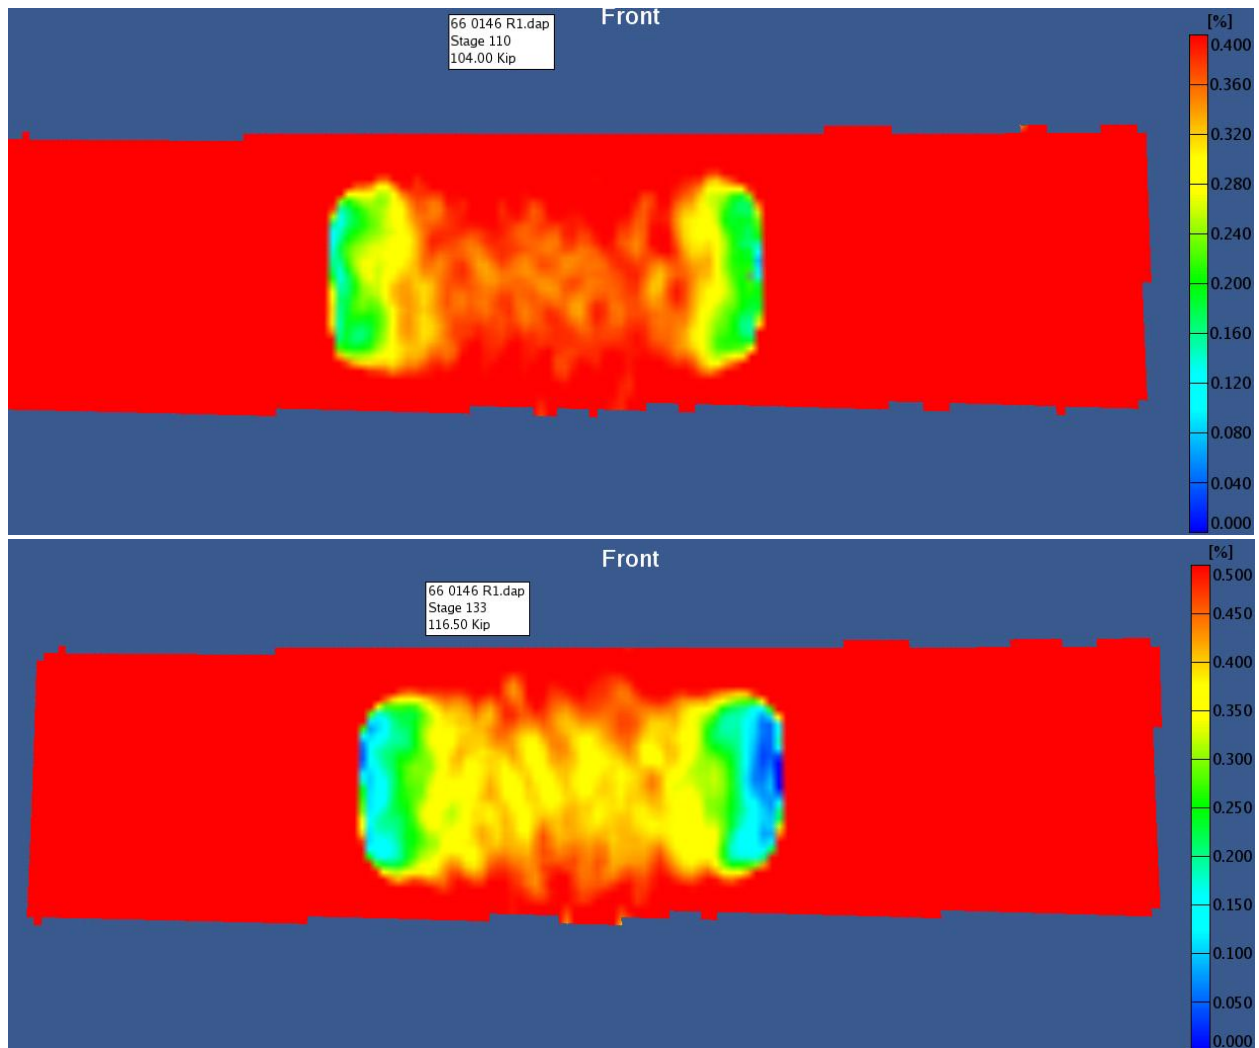
**Figure 31. OML Patch Failure Delamination; Repair 66-0146 R 1.**

Specimen number 66-0146 R 1 had a square edge (with rounded corners), aligned OML patch (Lockheed repair) that began to delaminate at both edges of the patch at approximately 73 ksi. One of the delaminations grew under the skin of the specimen, parallel to the edge, with increasing load. The specimen failed at 87.2 ksi. Figure 31 shows the strain field of the patch failure at first detectable occurrence as well as the final maximum extent of the delamination, just prior to substrate failure. Note that the scale used in the figure has been reduced to more clearly show the patch failure.

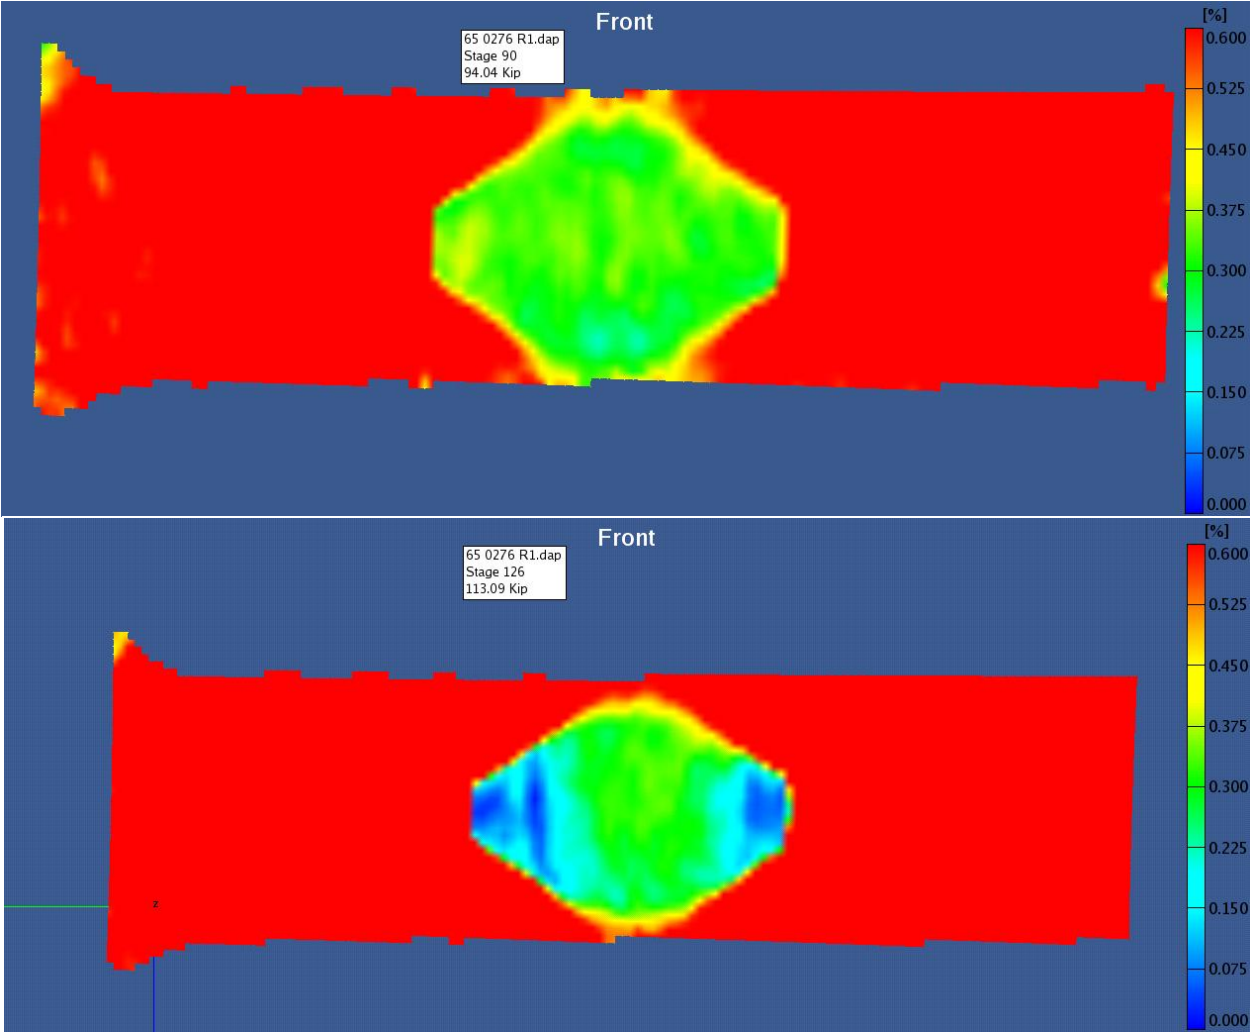
**Figure 32. OML Patch Failure Delamination; Repair 65-0276 R 1.**

Specimen number 65-0276 R 1 had a clipped edge, aligned OML patch (TI repair) that began to delaminate at both edges of the patch at approximately 77 ksi. One of the delaminations grew under the skin of the specimen, parallel to the edge, with increasing load. The specimen failed at 87.2 ksi. Figure 32 shows the strain field of the patch failure at first detectable occurrence as well as the final maximum extent of the delamination, just prior to substrate failure. Note that the scale used in the figure has been reduced to more clearly show the patch failure.
