## Task Order 2 Enhanced Preliminary Assessment

DEFENSE MAPPING AGENCY (DMA)  
HERNDON, VIRGINIA

December 1989

Roy F. Weston, Inc.  
West Chester,  
Pennsylvania 19380

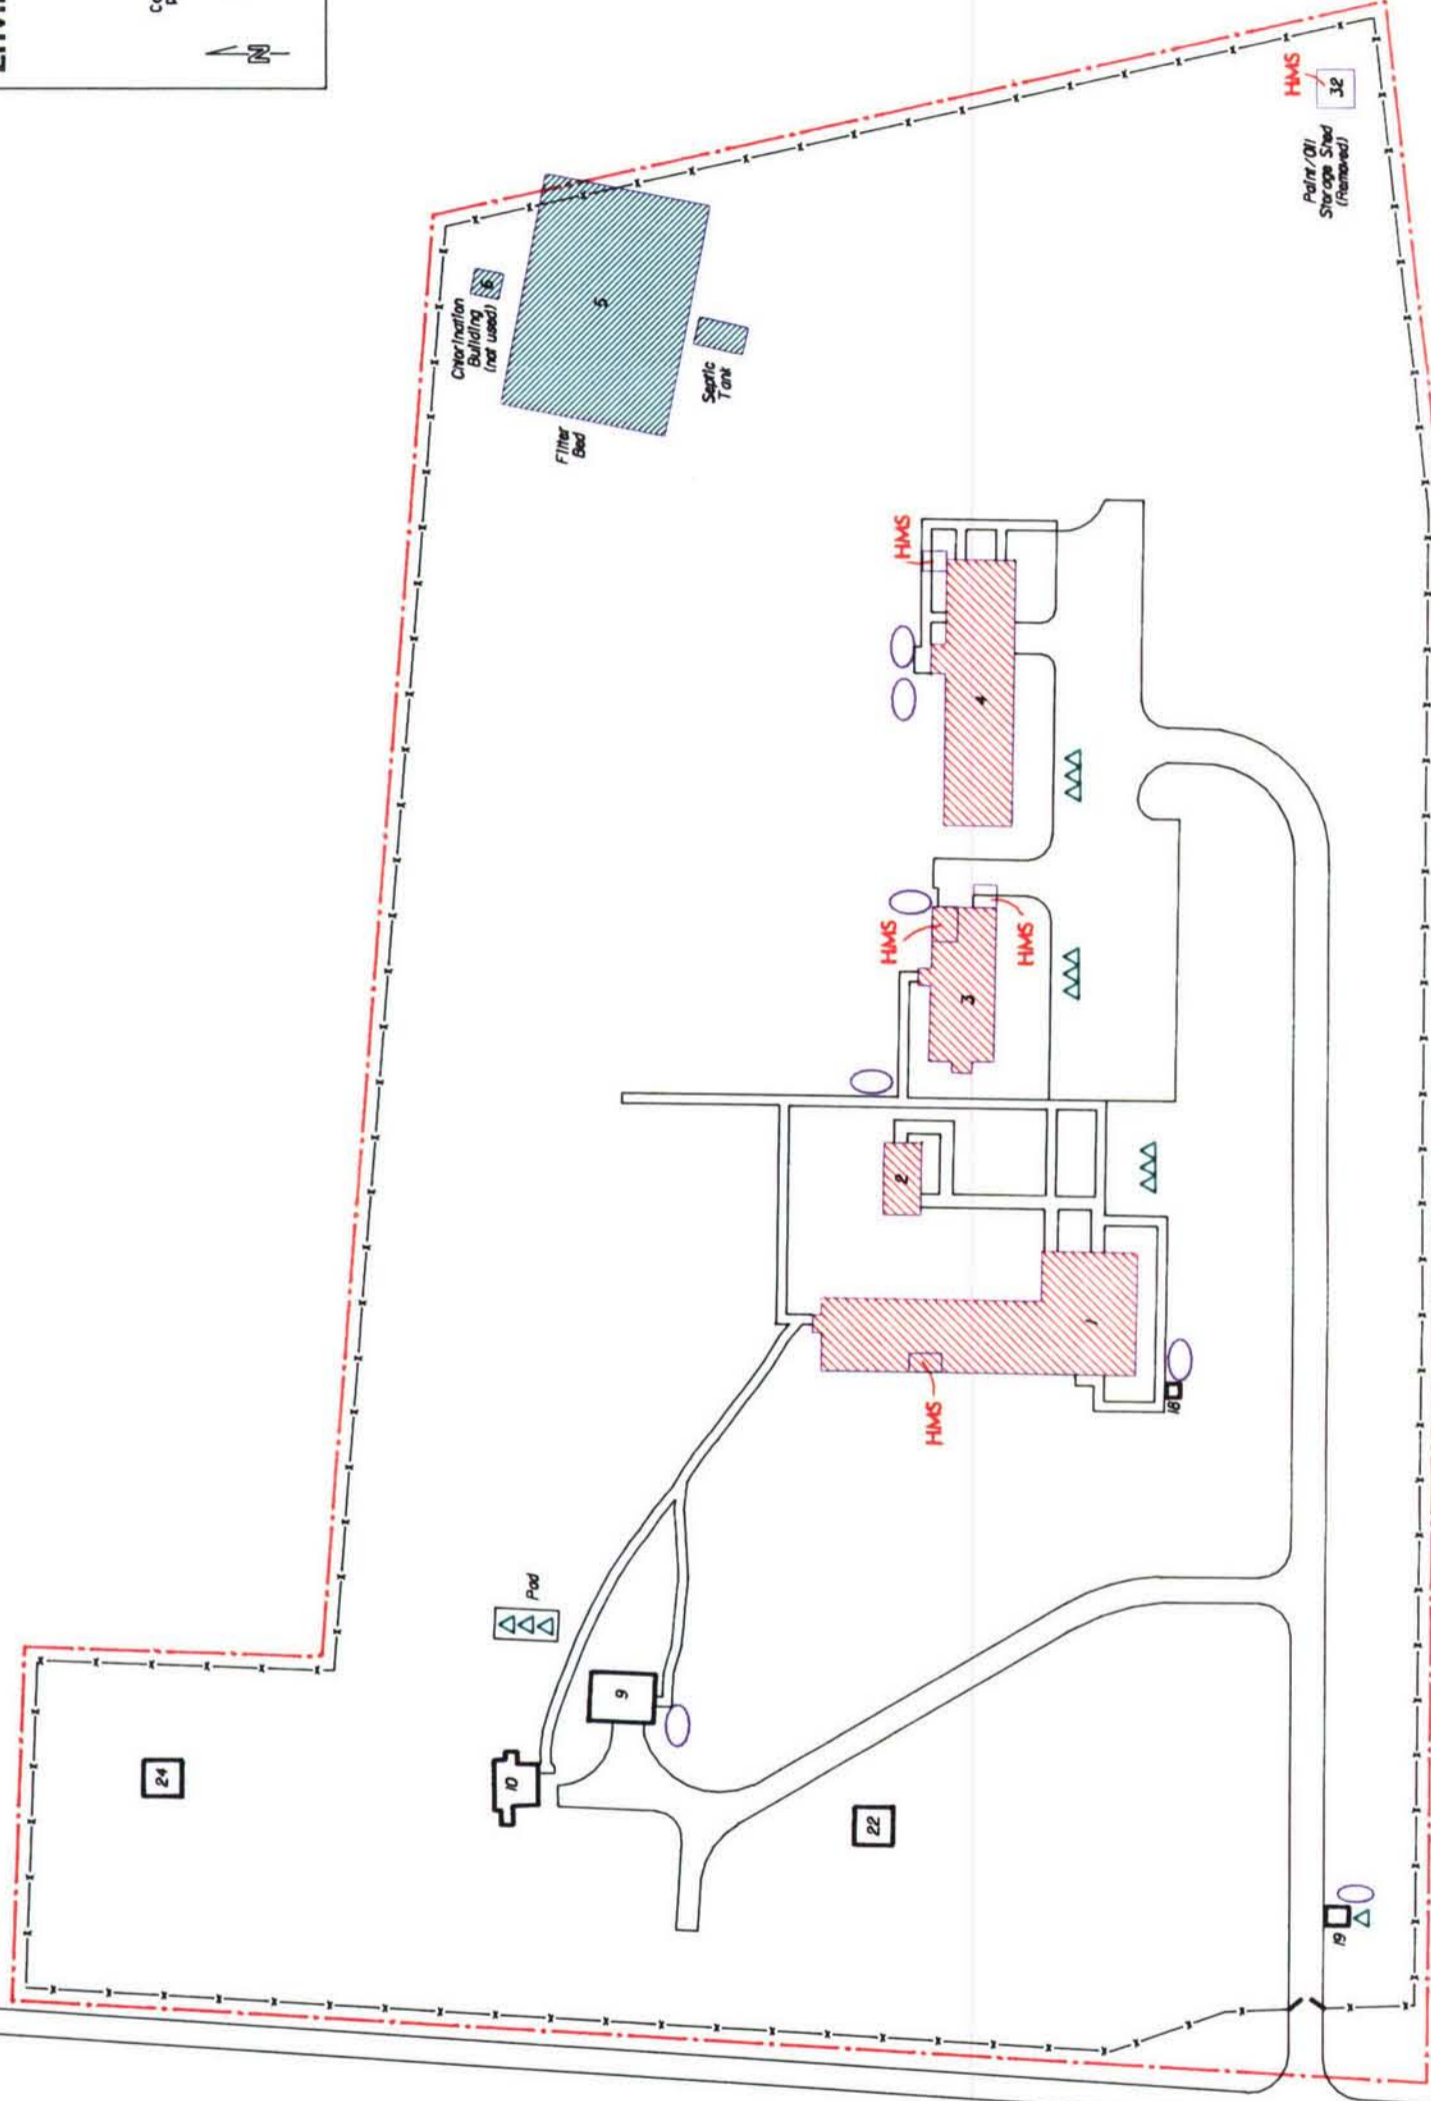
**ENVIRONMENTALLY SIGNIFICANT OPERATIONS**

The two tanks at Buildings 3 and 4 could not be effectively leak tested and there was some breakage or corrosion associated with the fill pipes. Accordingly, there is a possibility that underground storage tanks on the facility may have released some of their contents to soils.
