FIGHTING VEHICLES  
RESEARCH & DEVELOPMENT  
ESTABLISHMENT

REPORT No. T.R. 57.

BELLY ATTACK BY ANTI-TANK MINES Mk 7  
AGAINST  
CENTURION TANK TARGETS.

PROJECT NO: G1/F/311

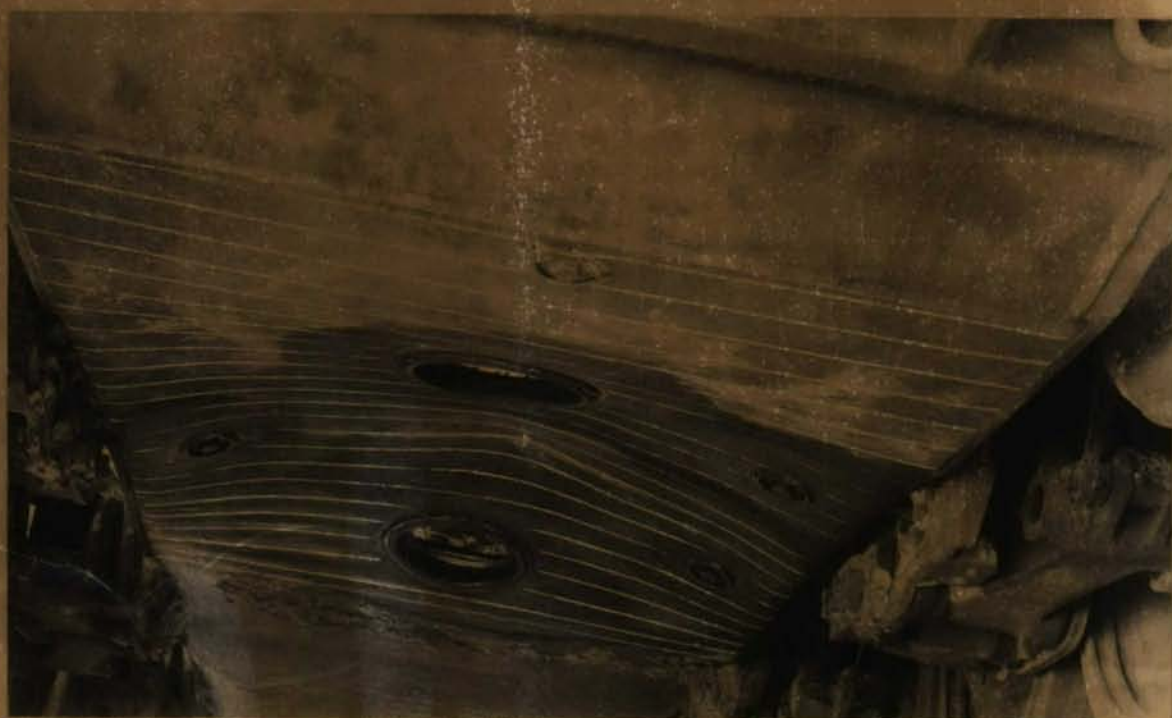
FIG. NO. 2.

- A Hull floor plate bulged inwards, max. 7 in, total bulged area 72 in x 60 in floor width. Floor plate and welds remained intact without fracture.
- B1 Access cover - Oil pump, dislodged outwards - partially held by 2 bolts.

SHOWING DISTORTION OF THE FLOOR PLATE AFTER ATTACK M2.  
MAXIMUM DISPLACEMENT = 7 IN. CHALK LINES INDICATING  
CURVATURE 4 IN SPACING.

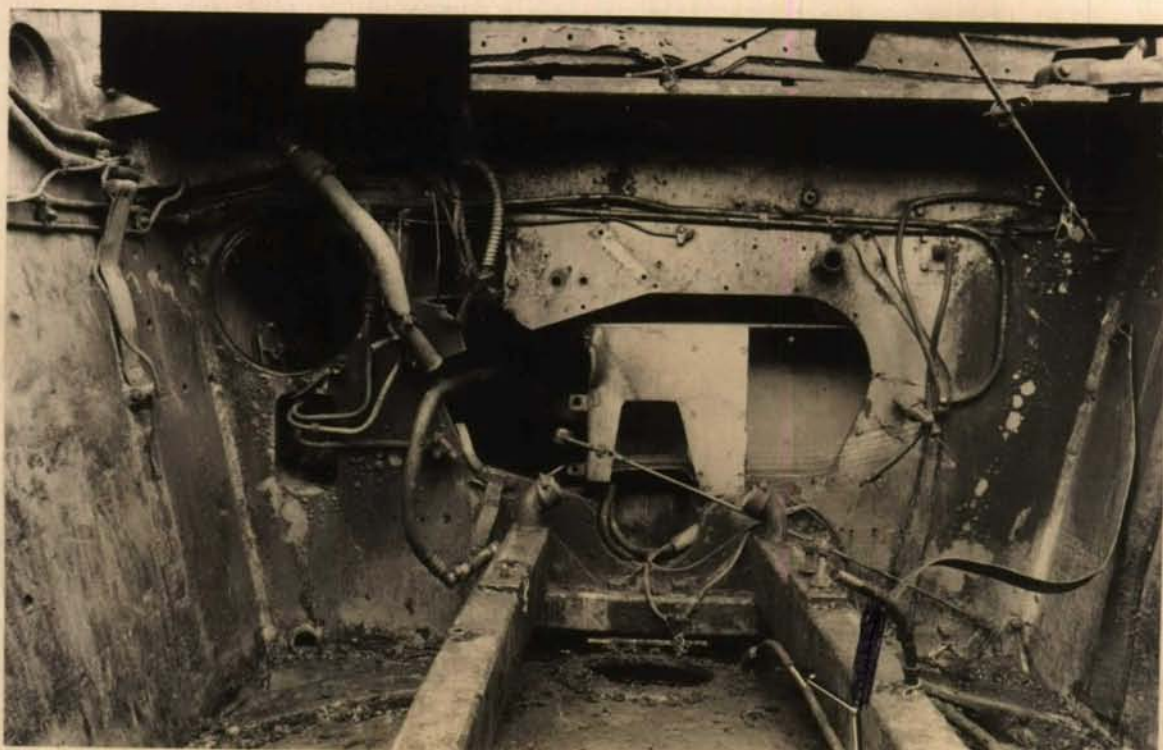
FIG. NO.3.

- I, J & K Clutch, Steering and Gear Change control rods severely bent and put out of adjustment. Right and Left steering rod bell-cranks on gearbox fractured.

DRIVER'S CONTROL RODS

ATTACK M2. ENGINE COMPARTMENT AFTER ATTACK  
WITH INTERNAL COMPONENTS REMOVED SHOWING FLOOR  
DISPLACEMENT AND DISTORTED CONTROL RODS.

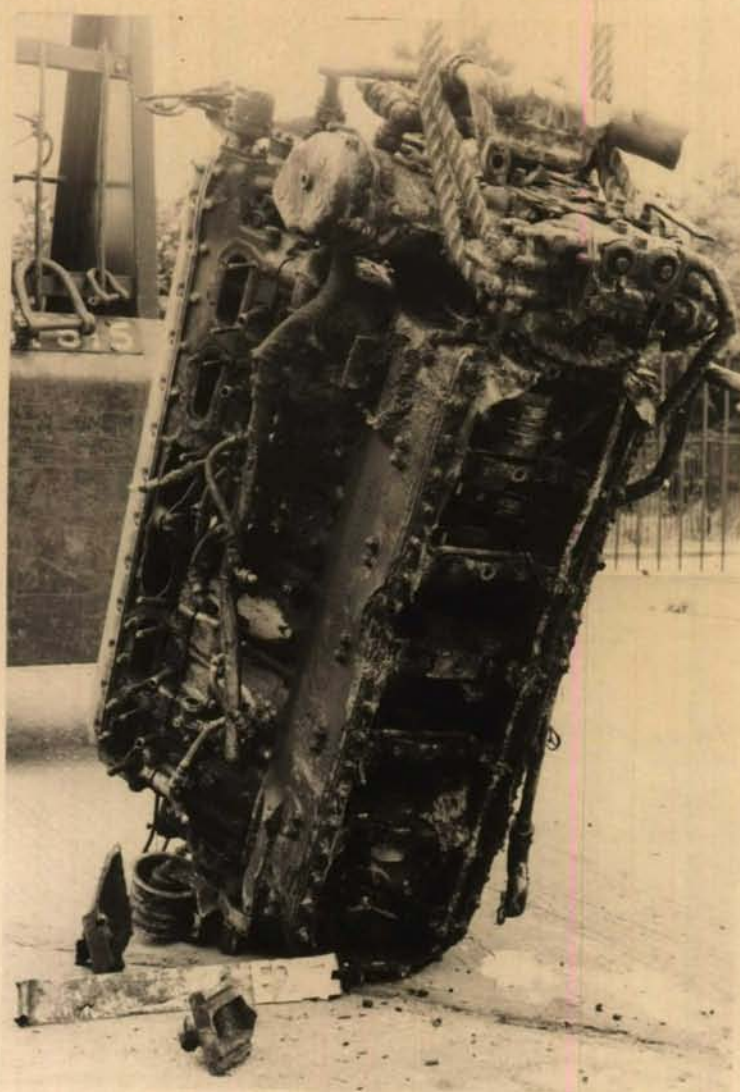
FIG. NO.4.

- E5 Engine sump shattered.
- E6 Engine crankcase sump face crushed and sides cracked.
- E7 & E8 Exhaust manifolds fractured and cylinder head fixtures damaged.

ATTACK M2. SHOWING CONDITION OF CRANKCASE  
AND SUMP AS FOUND WHEN ENGINE WAS REMOVED.

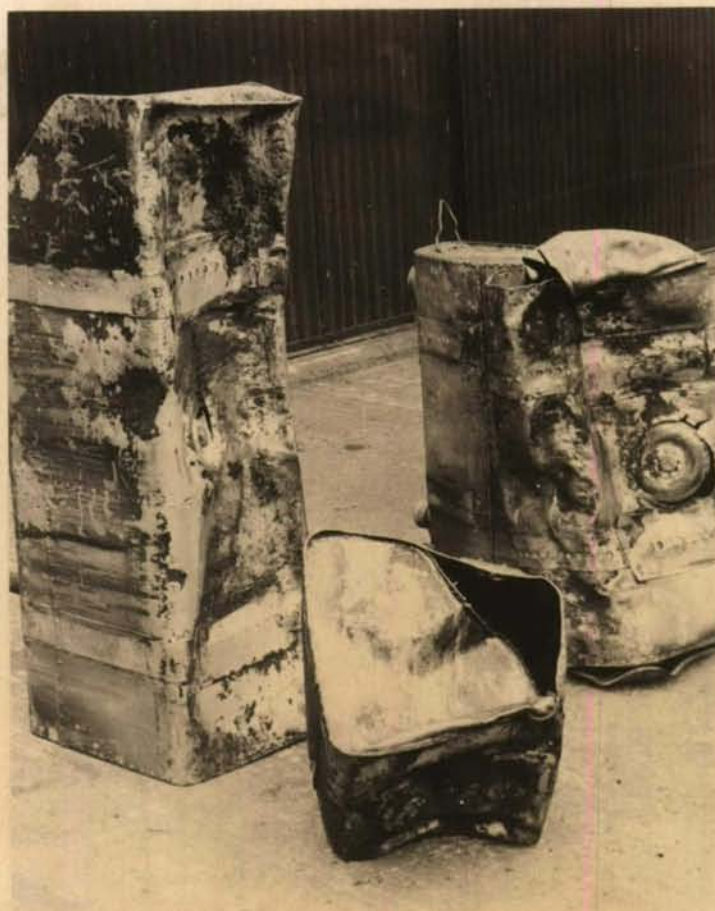
FIG. NO. 5.

- F Oil cooler severely bent - no oil leakage.
- G1 & G2 Right and Left petrol tanks severely buckled and seams split open - all fuel lost.
- H Oil tank severely buckled and seam split open - all oil lost.

ATTACK M2. SHOWING DAMAGE TO  
FUEL AND ENGINE OIL TANKS.

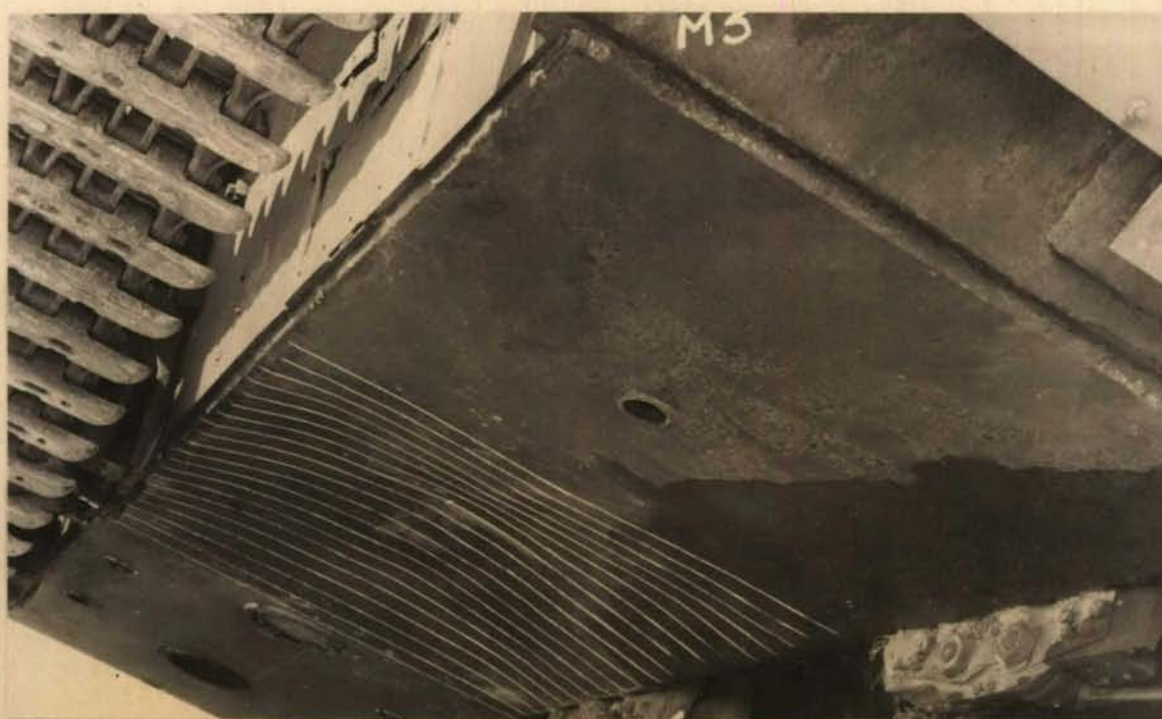
FIG. NO.9.

- A Hull floor plate bulged inwards, max. 4½ in, total bulged area 80 in x 60 in floor width - floor plate and welds remained intact without fracture.
- B Rotary Base Junction completely dislodged from floor and forced up 8 in.

SHOWING DISTORTION OF FLOOR PLATE AFTER ATTACK M3.  
MAXIMUM DISPLACEMENT WAS  $4\frac{1}{2}$  IN. CHALK  
LINES INDICATING CURVATURE 4 IN SPACING.

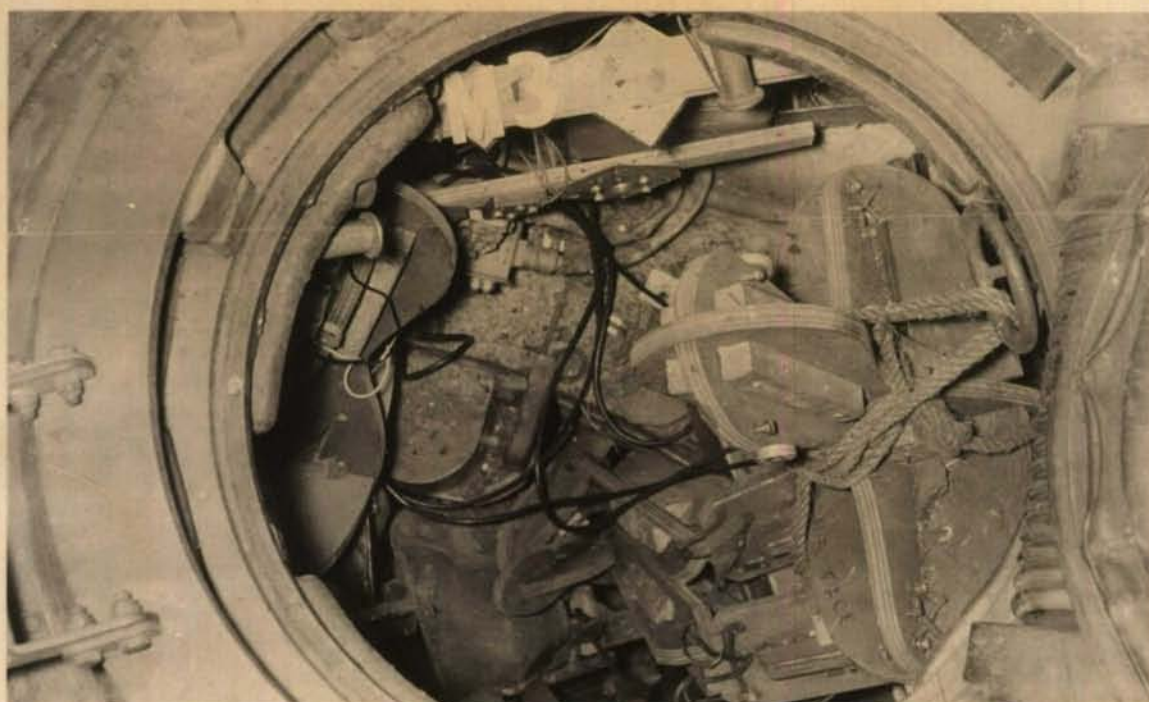
FIG. NO.10.

VIEW THROUGH COMMANDER'S HATCH AFTER ATTACK.

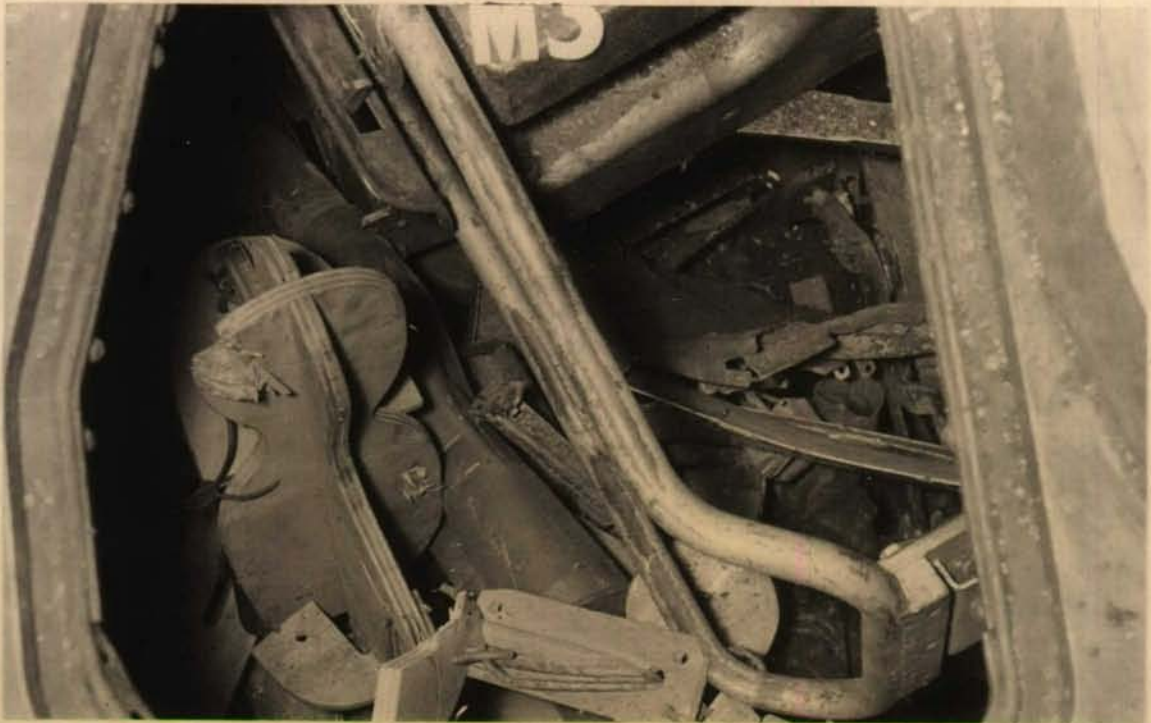
FIG. NO.11.

- N Commander's Dummy - foot damage.
- O Gunner's Dummy - right arm off and shoulder broken.
- P Loader's Dummy - severe leg and right shoulder damage. Head severe dent.

VIEW THROUGH LOADER'S HATCH AFTER ATTACK M3  
SHOWING DAMAGE TO LOADER'S DUMMY AND  
DISRUPTED FLOOR STOWAGE.

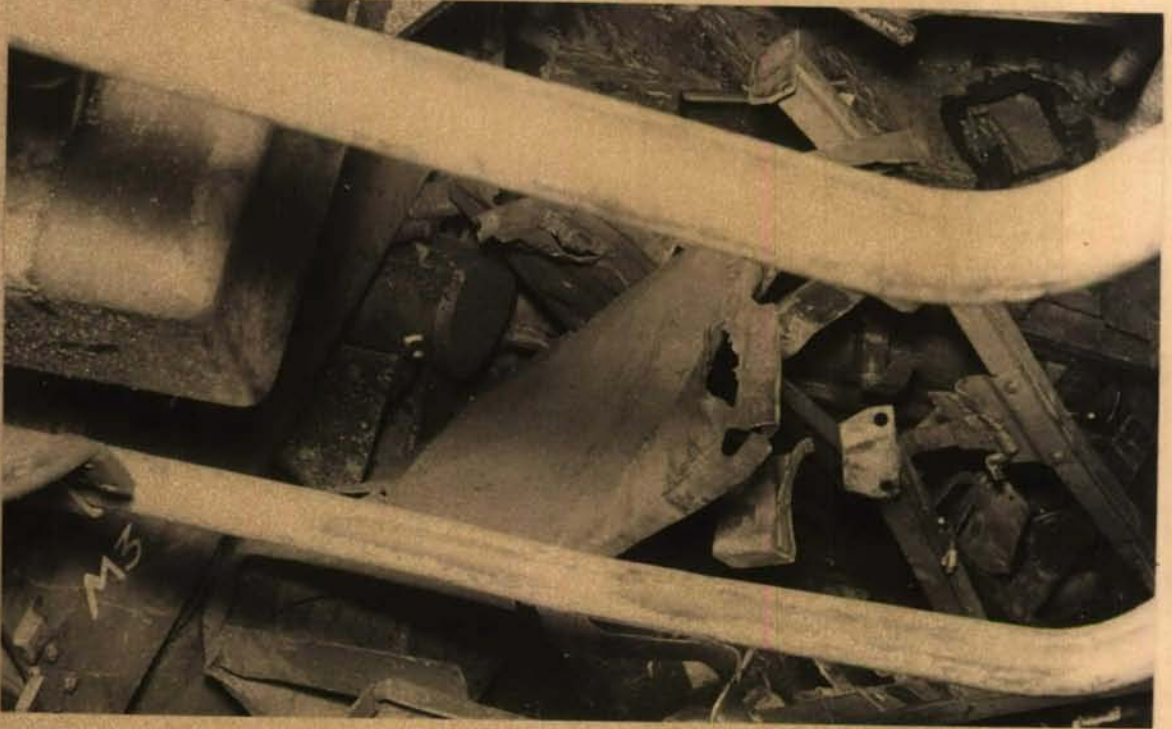
FIG. NO.13.

- G4-G9 Floor stowage bins - bin flaps detached and stowed ammunition ejected and damaged.
- H1 & H2 Batteries shattered - electrolyte and fragments dispersed over whole of the fighting compartment - bin flaps removed.

ATTACK M3.SHOWING DISRUPTED AMMUNITION FLOOR STOWAGE BINS.

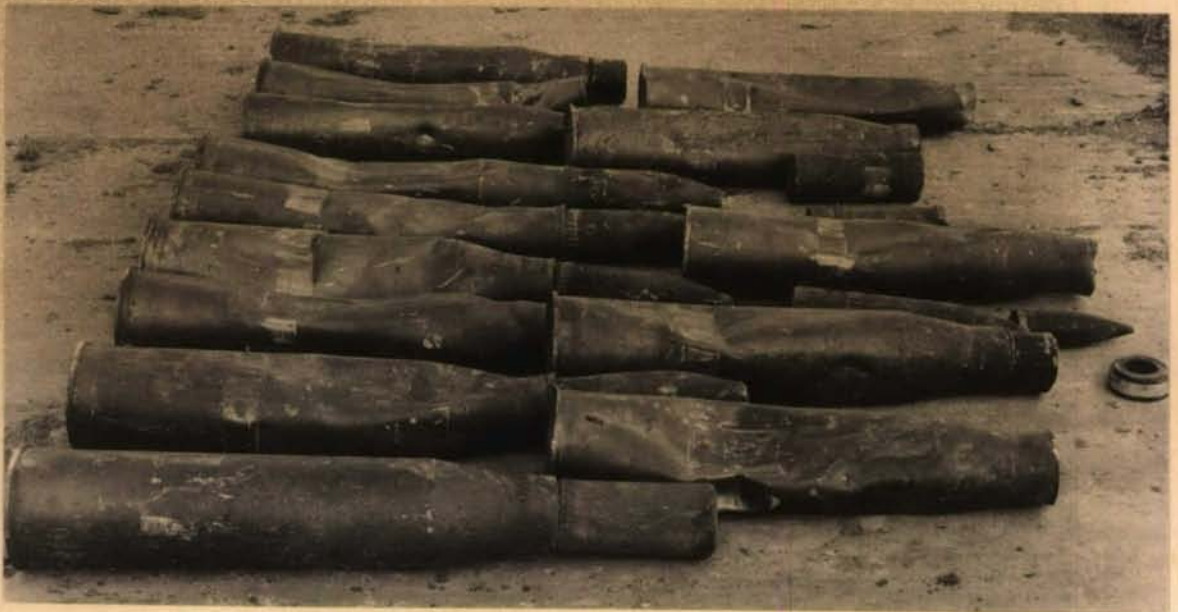
FIG. NO.14.

Ammunition stowed in the floor bins was unfit for firing, all the cartridge cases being squashed to a varying degree. Several rounds were recovered loose in the fighting compartment having been projected out of the bins. Floor bin flaps and other components were wrenched from their hinges and fixtures; the batteries were shattered and pieces scattered over the whole compartment.

ATTACK M3.SHOWING DAMAGE TO AMMUNITION STOWED IN THE FLOOR BINS.
