**FIGHTING VEHICLES  
RESEARCH AND DEVELOPMENT  
ESTABLISHMENT**

REPORT No. F.T. 2239.

MINE DAMAGED TRACKS.

MINE DAMAGED TRACK

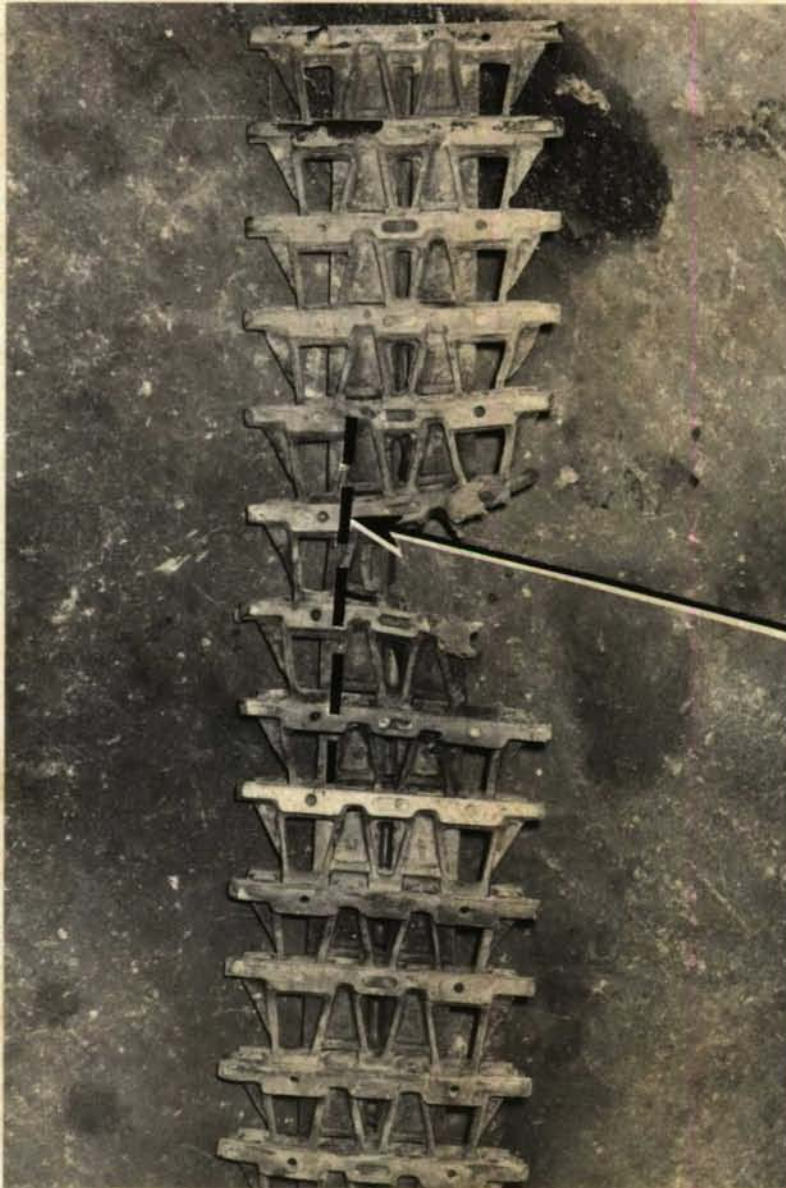
SECTION AA

- 3.2. For this light track assembly No. FV.337635 the following design criteria were determined based on the arbitrary conditions given in 2.4.
- 3.2.1. When track is not severed beyond section 'AA' indicated in the figure attached to this cover sheet No 'kill' will be recorded.

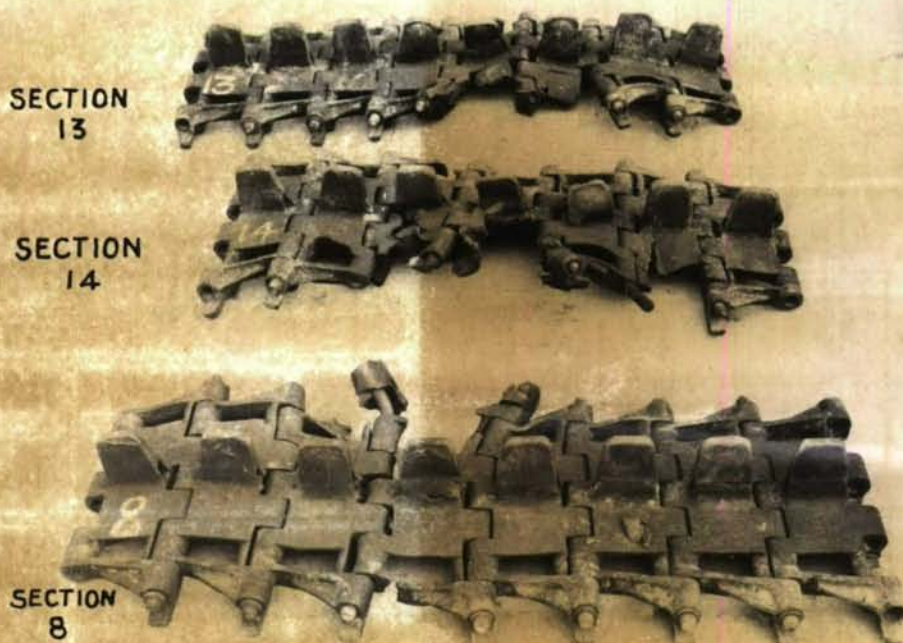
FIG. 1

3.2 Track Sections. Ten sections of dry pin metal tracks, as received from R.A.R.D.E. are shown in Fig. 1-3. These sections were each identified by the number painted on them by R.A.R.D.E. (Ref. report SXR/457/01). Drawing No. of link FV.351283.

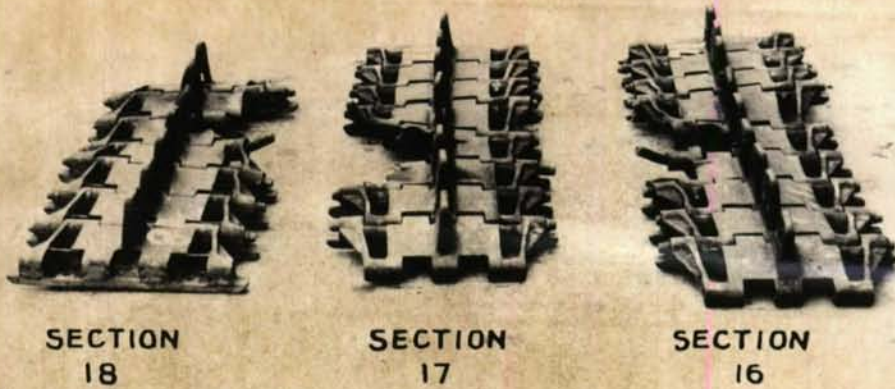
FIG. 7

6.1 The condition of the track sections after removal is shown at (Fig. 7-9).

- 7.1 The course was level, easy going and considered to represent normal light cross country.
  - 7.2 The horns bent by mine blast tended to foul the road wheels and it was evident that consequential damage to components would be caused by prolonged running.
  - 7.3 The sprocket engagement holes damaged by the mine blast caused the track to ride up on the sprocket teeth and resulted in very rough running. Where damage across the track was extensive there was some slight tendency for the links to open under driving tension. However this did not affect running with the loadings sustained in this trial.
  - 7.4 No instance of track shedding occurred during the trial.
8. The Officer i/c of Trial was - Major R. W. E. Day R.E.
