ERDC/CRREL TN-08-1

Ice Jam at the Rio Blanco Diversion Weir on the White River in Colorado

A Case Study of In-Stream Structures and Ice

February 2008

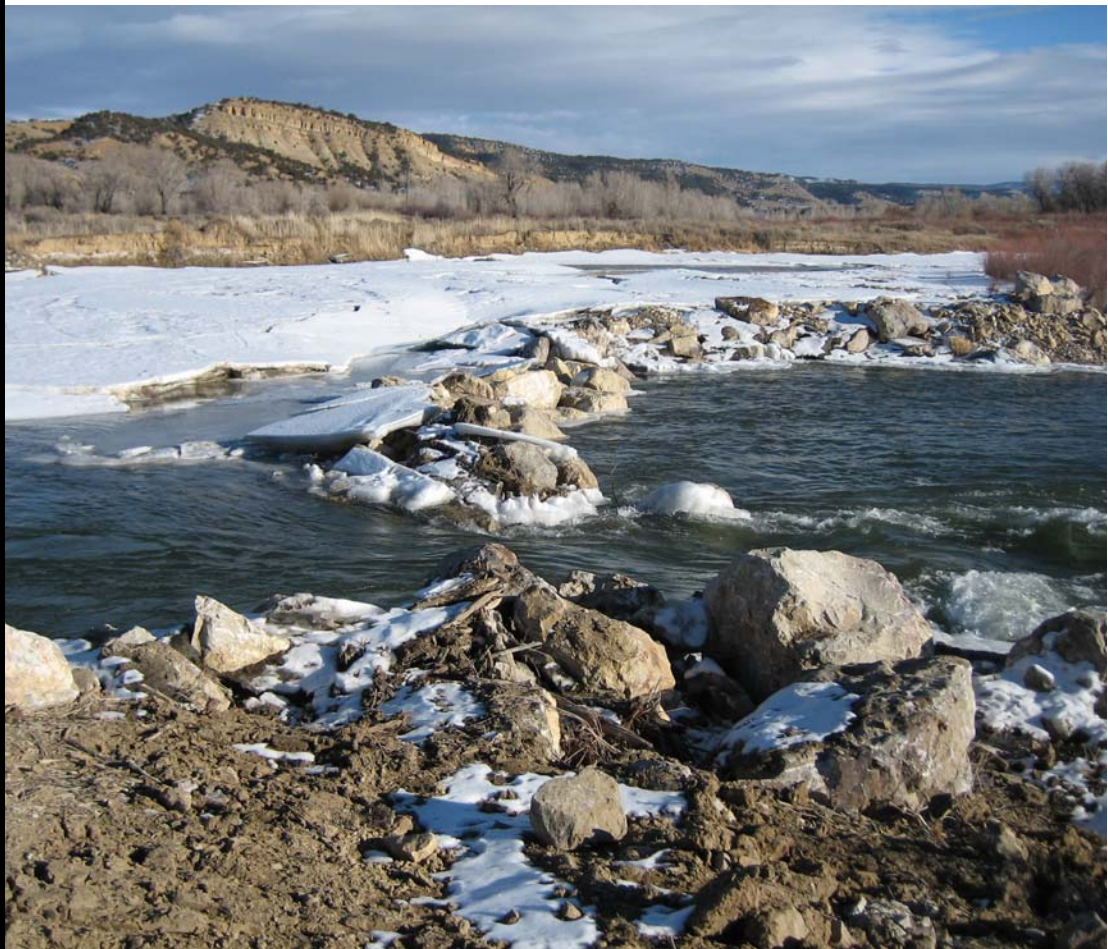
COVER: Breached rock weir on Colorado's White River, about 18 miles south of Meeker.

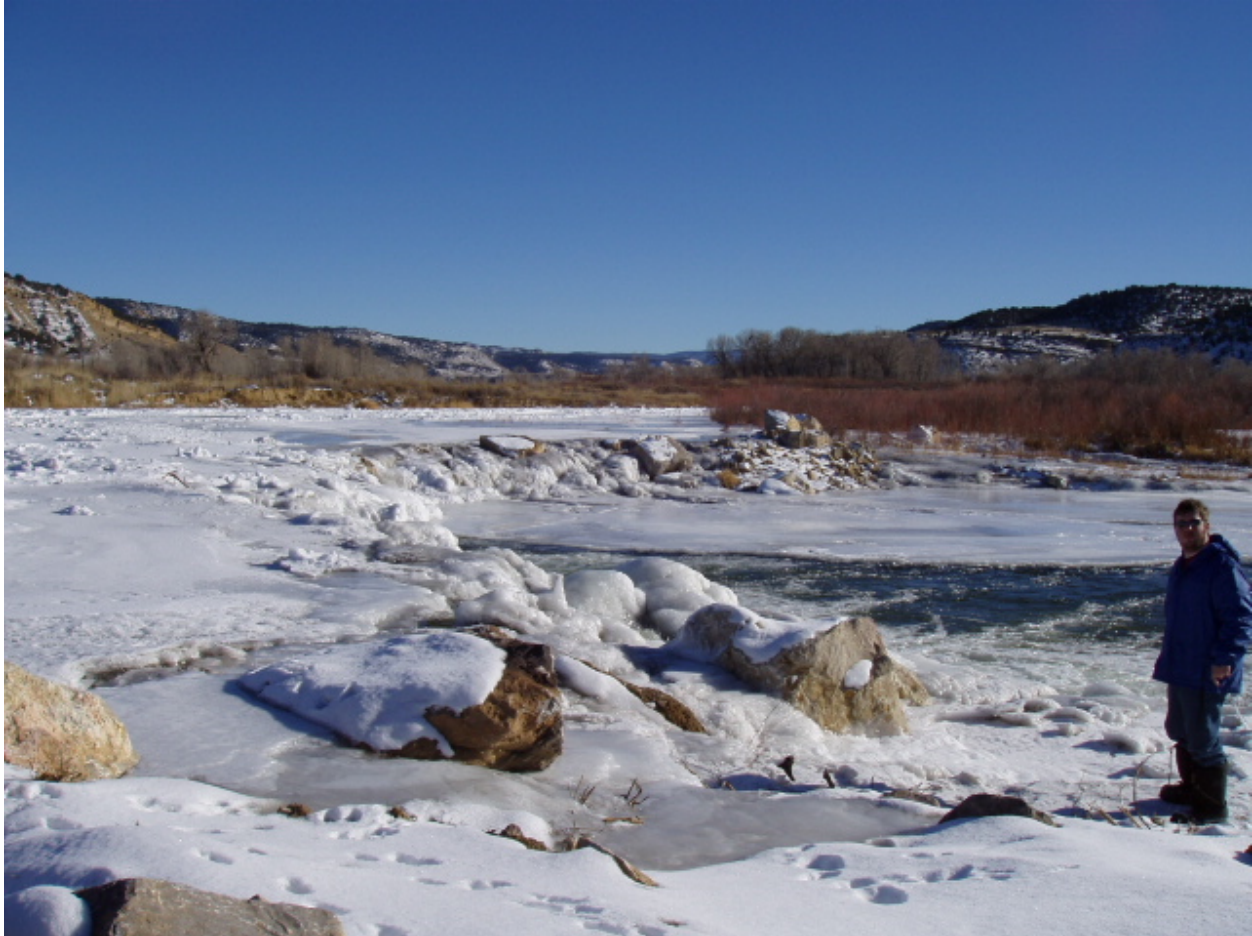
Figure 4. Ice jam at CDOW weir on 15 December 2005.

The freezeup ice jam formed during an early December cold snap at the rock weir structure that diverts water to Rio Blanco Lake. Figure 4 shows the jam at the structure on 15 December 2005.

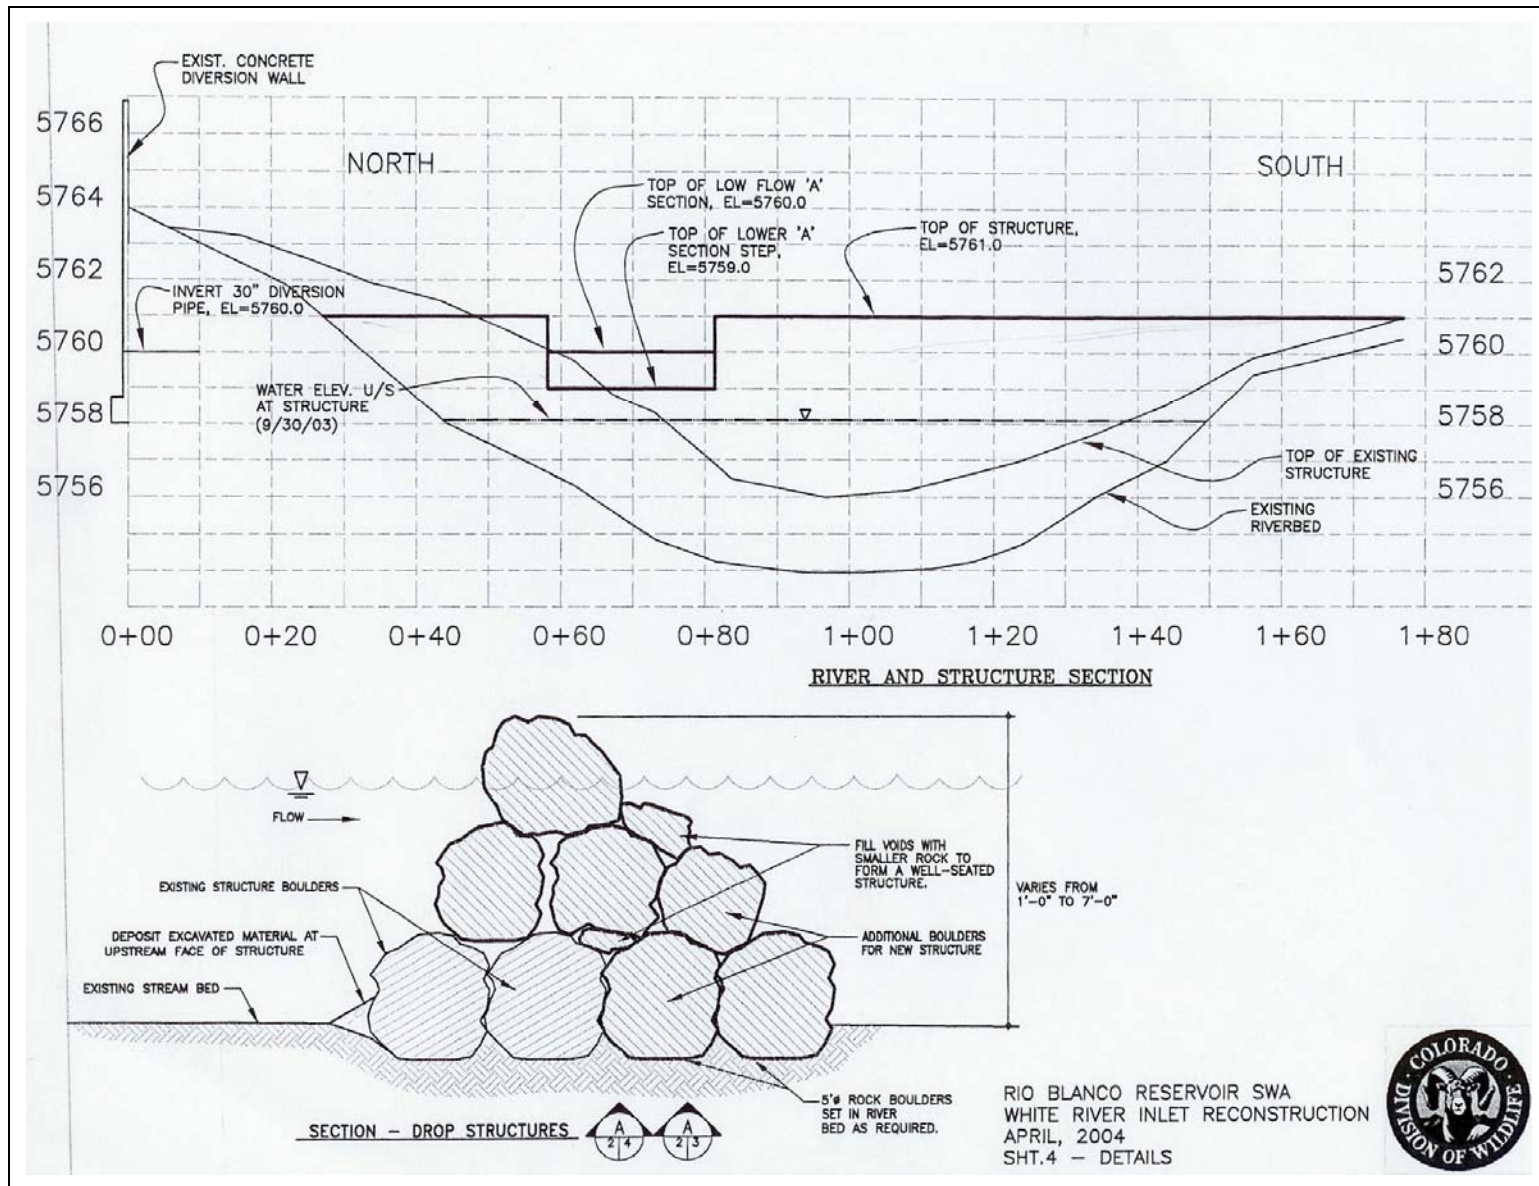
Figure 5. Section views of CDOW rock weir.

In the fall of 2005, the weir had been redesigned and heightened about 4 ft to better divert flow into the Rio Blanco Lake. Figure 5 shows before and after cross sections of the weirs. The new weir had a level crest with a lower 25-ft-wide spillway section, whereas the previous weir was more U-shaped, conforming to the natural riverbed cross section. Under low flow, open water conditions, the design change resulted in a water level rise at the weir of about 2 ft.

Based on the CDOW weir cross sections (Fig. 5), water velocities on the pool upstream of the weir were calculated assuming an average winter baseflow of 350 cfs. Three cases were considered: 1) a no-weir case, 2) a pre-2005 weir case, and 3) a 2005 and after weir case.

- 1) For the no-weir case, assuming a top width of 70 ft and an average depth of 1.5 ft, the average velocity would be 3.3 ft/s. Under these conditions, one would expect the frazil floes to pass the pool and the 70-ft weir opening without problems as they do in the upstream river channel between the town of Meeker and the Rio Blanco weir.
- 2) For the pre-2005 weir case, with a top width of about 60 ft and an average upstream depth of about 2.5 ft, the approach velocity would be 2.3 ft/s, which would still favor ice passage rather than retention.
- 3) For the 2005 weir, with an upstream top width of about 130 ft and an average upstream water depth of 4 ft, the upstream approach velocity would be about 0.7 ft/s. This is slow enough for the frazil ice floes to stall in the upstream pool independent of the 30-ft gap width at the weir (which would probably cause arching).

Based on these observations, to ensure against ice jam formation, it would probably be necessary to lower the pool elevation by about 2 ft (close to pre-2005 conditions) and maintain a gap width of at least 60 ft.

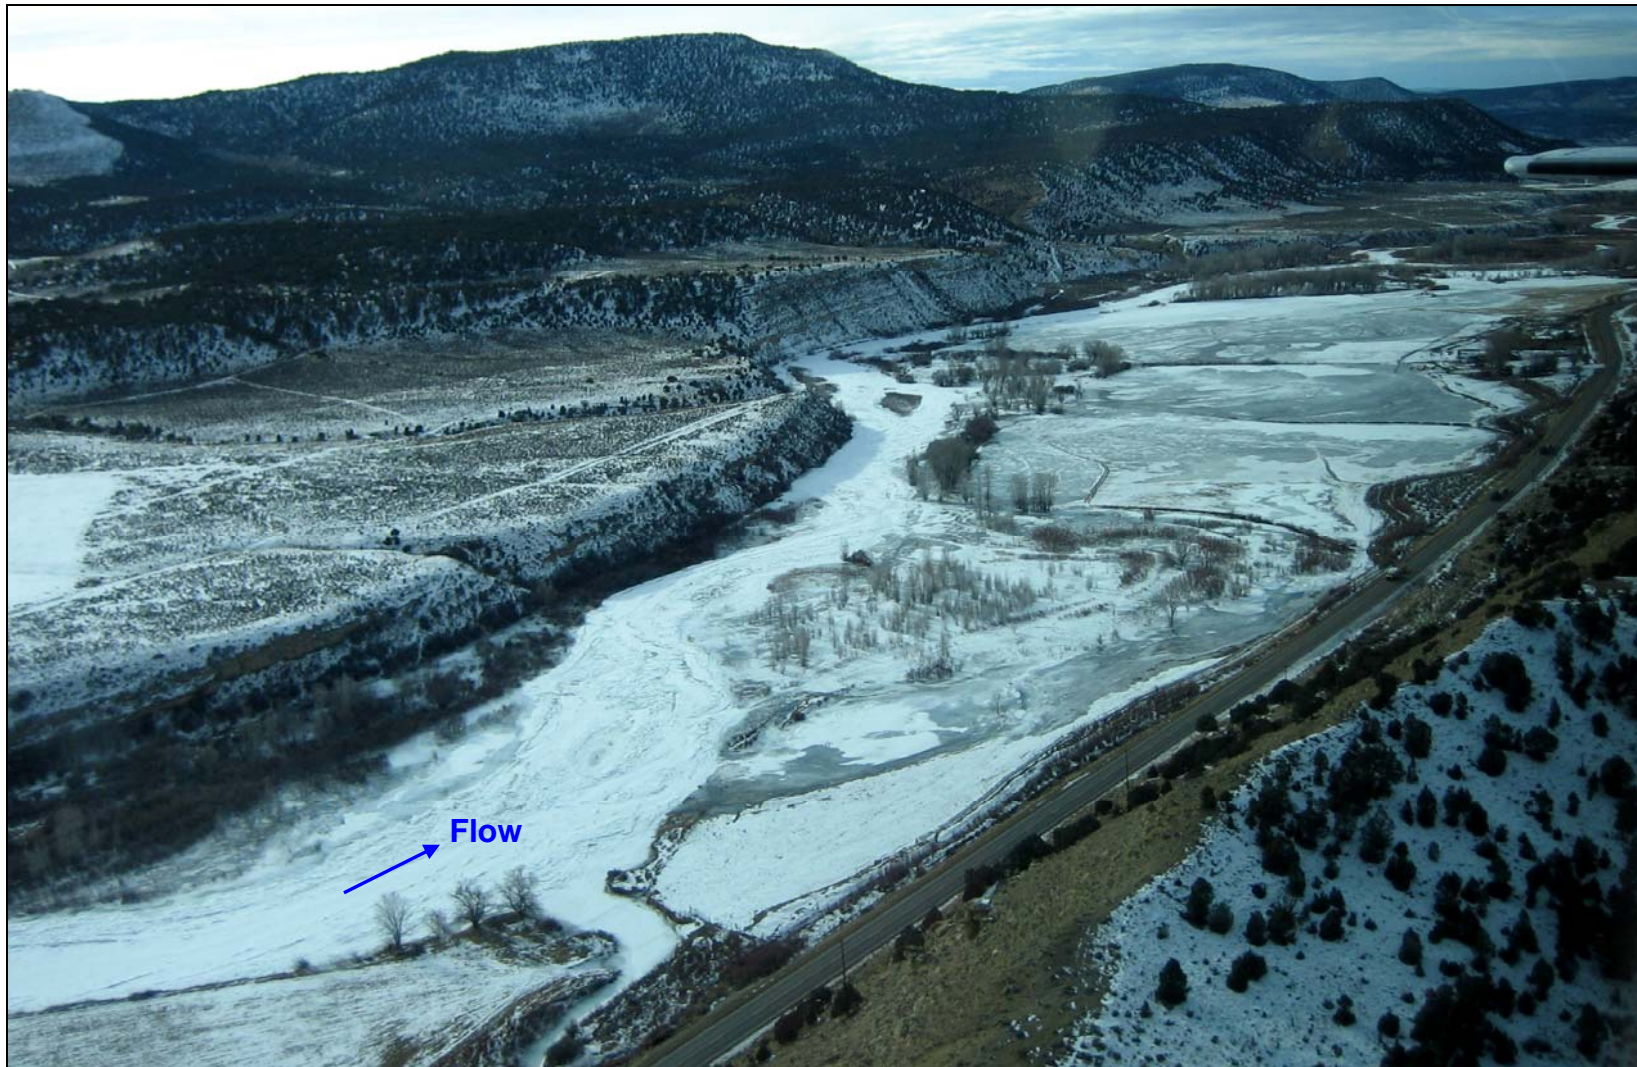
Within a week of its formation, the jam had progressed about five miles upstream of the weir, forcing nearly all flow from the main river channel across the alfalfa fields of a working cattle ranch owned by Sam Love of Meeker. At that time, an ice cover had formed on much of the White River upstream as far as Meeker. Figures 6–8 are aerial photos of the jam and

Figure 6. Looking downstream on 17 January 2006, showing ice jam filling main channel on left, forcing flow across Love property on right.

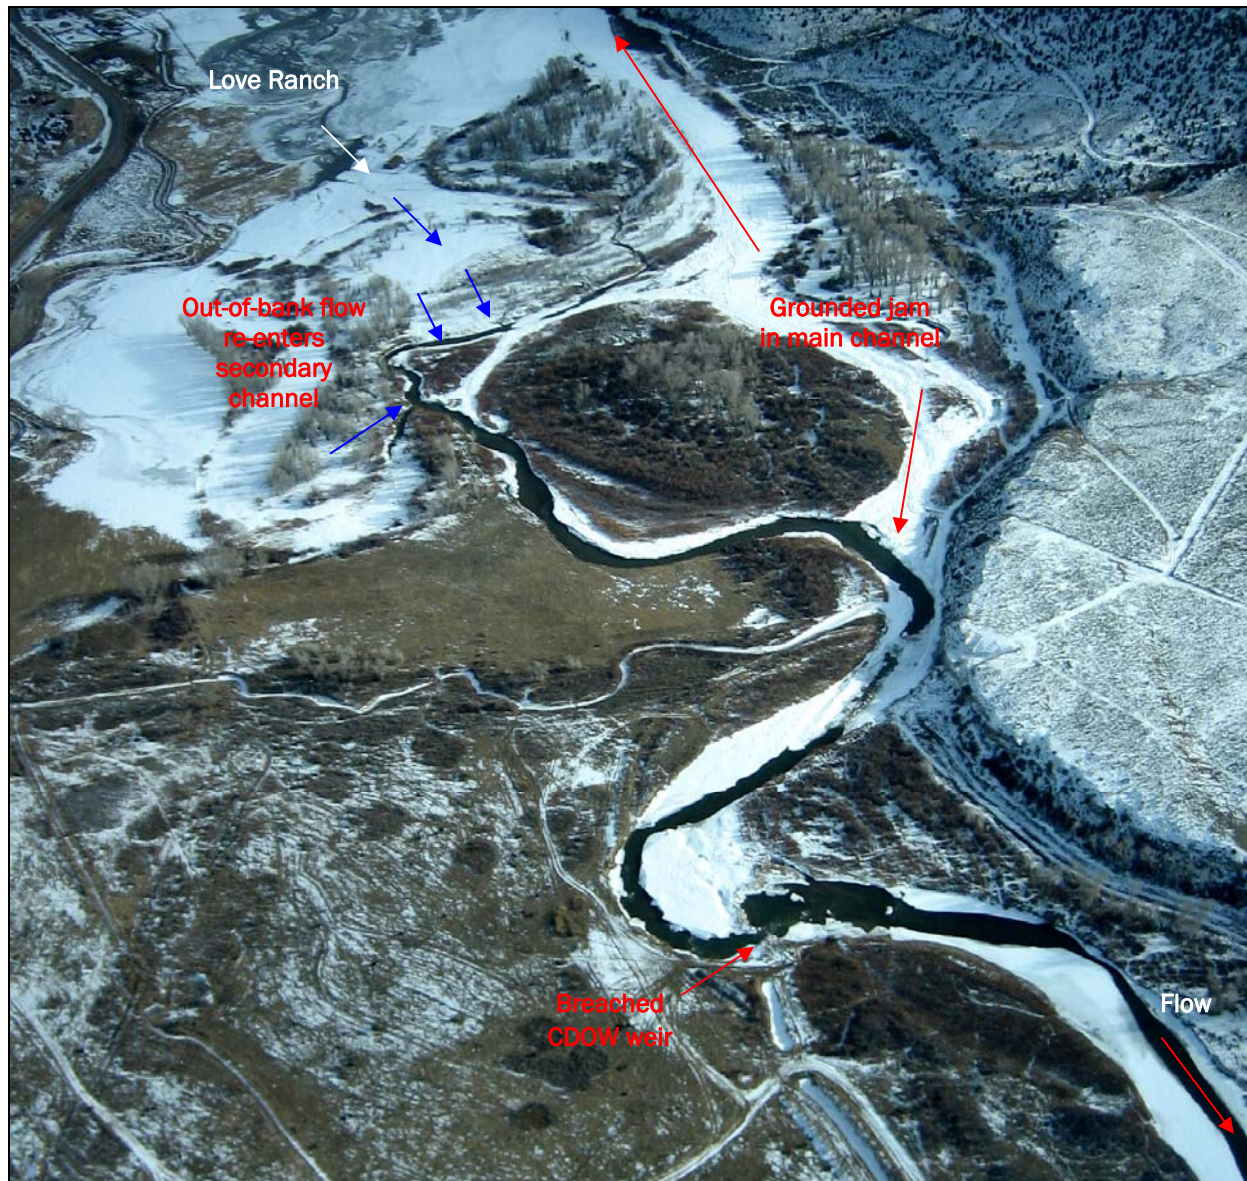
Below the Love property, the out-of-bank flow entered a wetland, which drained into a secondary channel that then conveyed nearly all the flow (Fig. 7). Because almost no flow passed beneath the grounded jam in the main channel, very little melting had taken place by mid-January, even though the air temperatures had been moderate (Fig. 10 and 11). Records from the USGS gage below Meeker indicate that an ice cover existed at the gage site, eight miles upstream of the CDOW weir, from 29 November to 30 December 2005 (Fig. 3). Whether this ice cover in the vicinity of the gage retained or passed frazil ice from upstream is uncertain. By mid-

Figure 7. White River downstream of Love property, 17 January 2006.

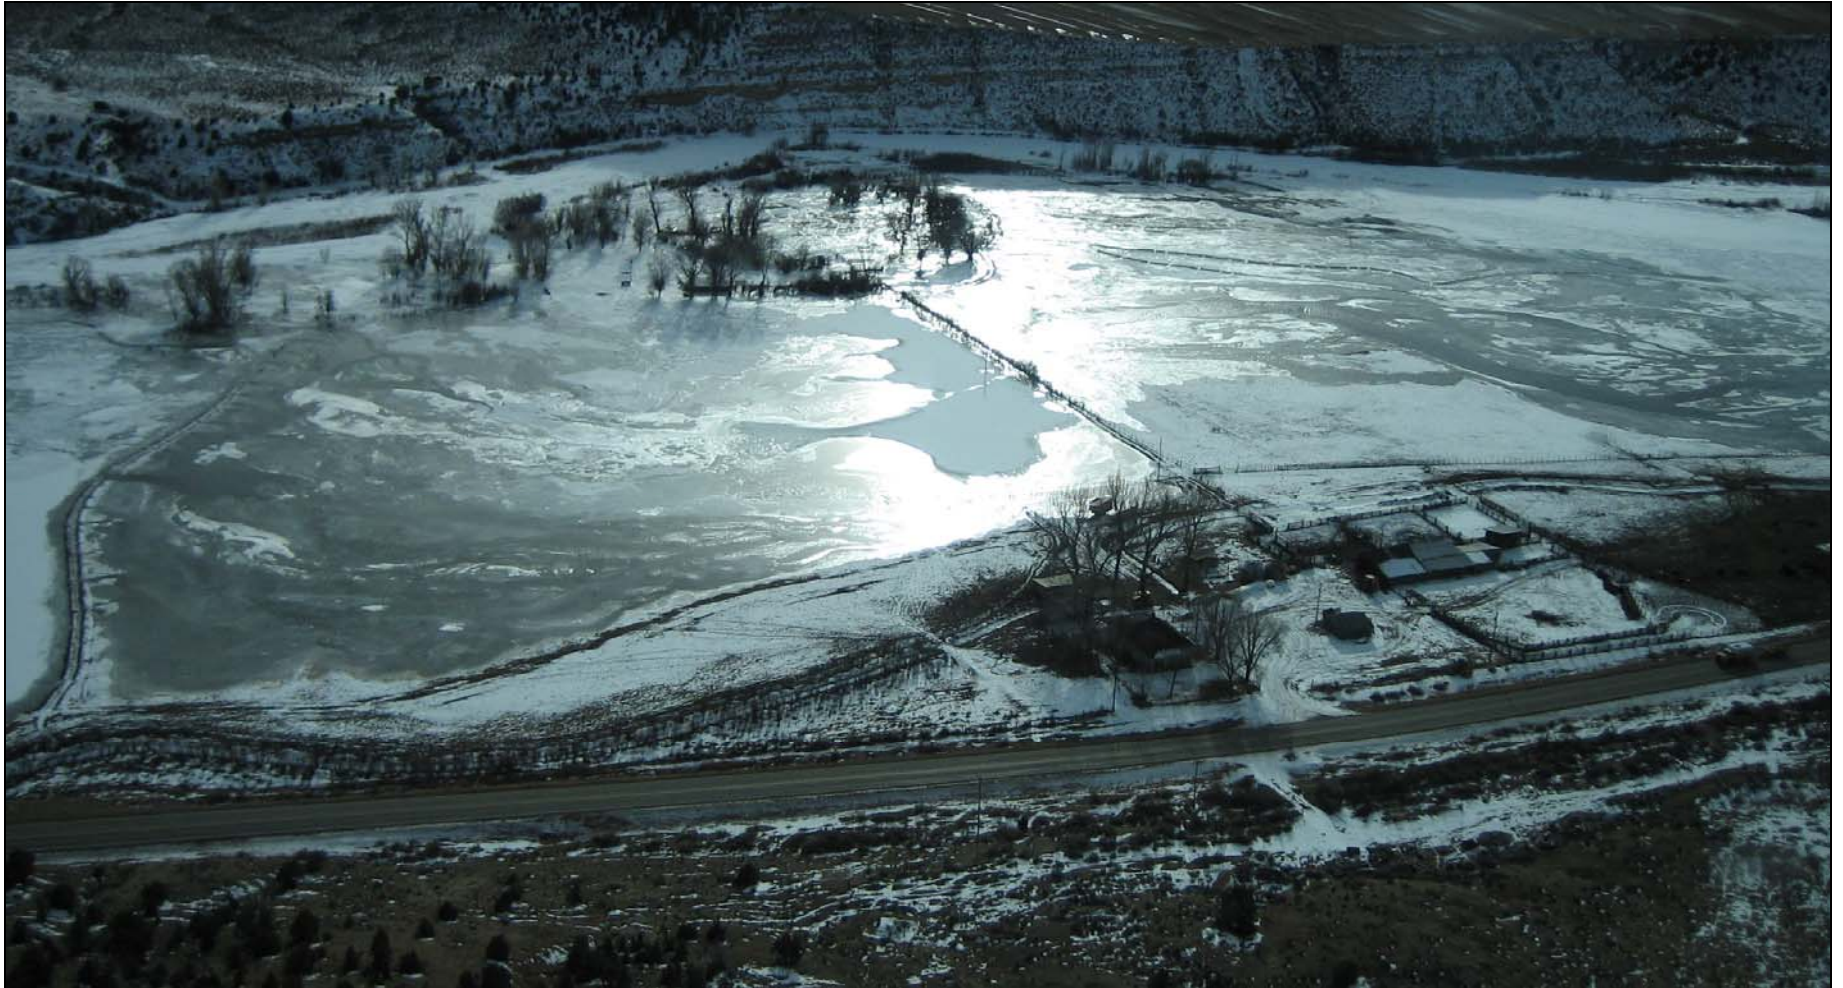
Figure 8. Flooded fields at Love property on 17 January 2006. Ice jam fills main channel in background.

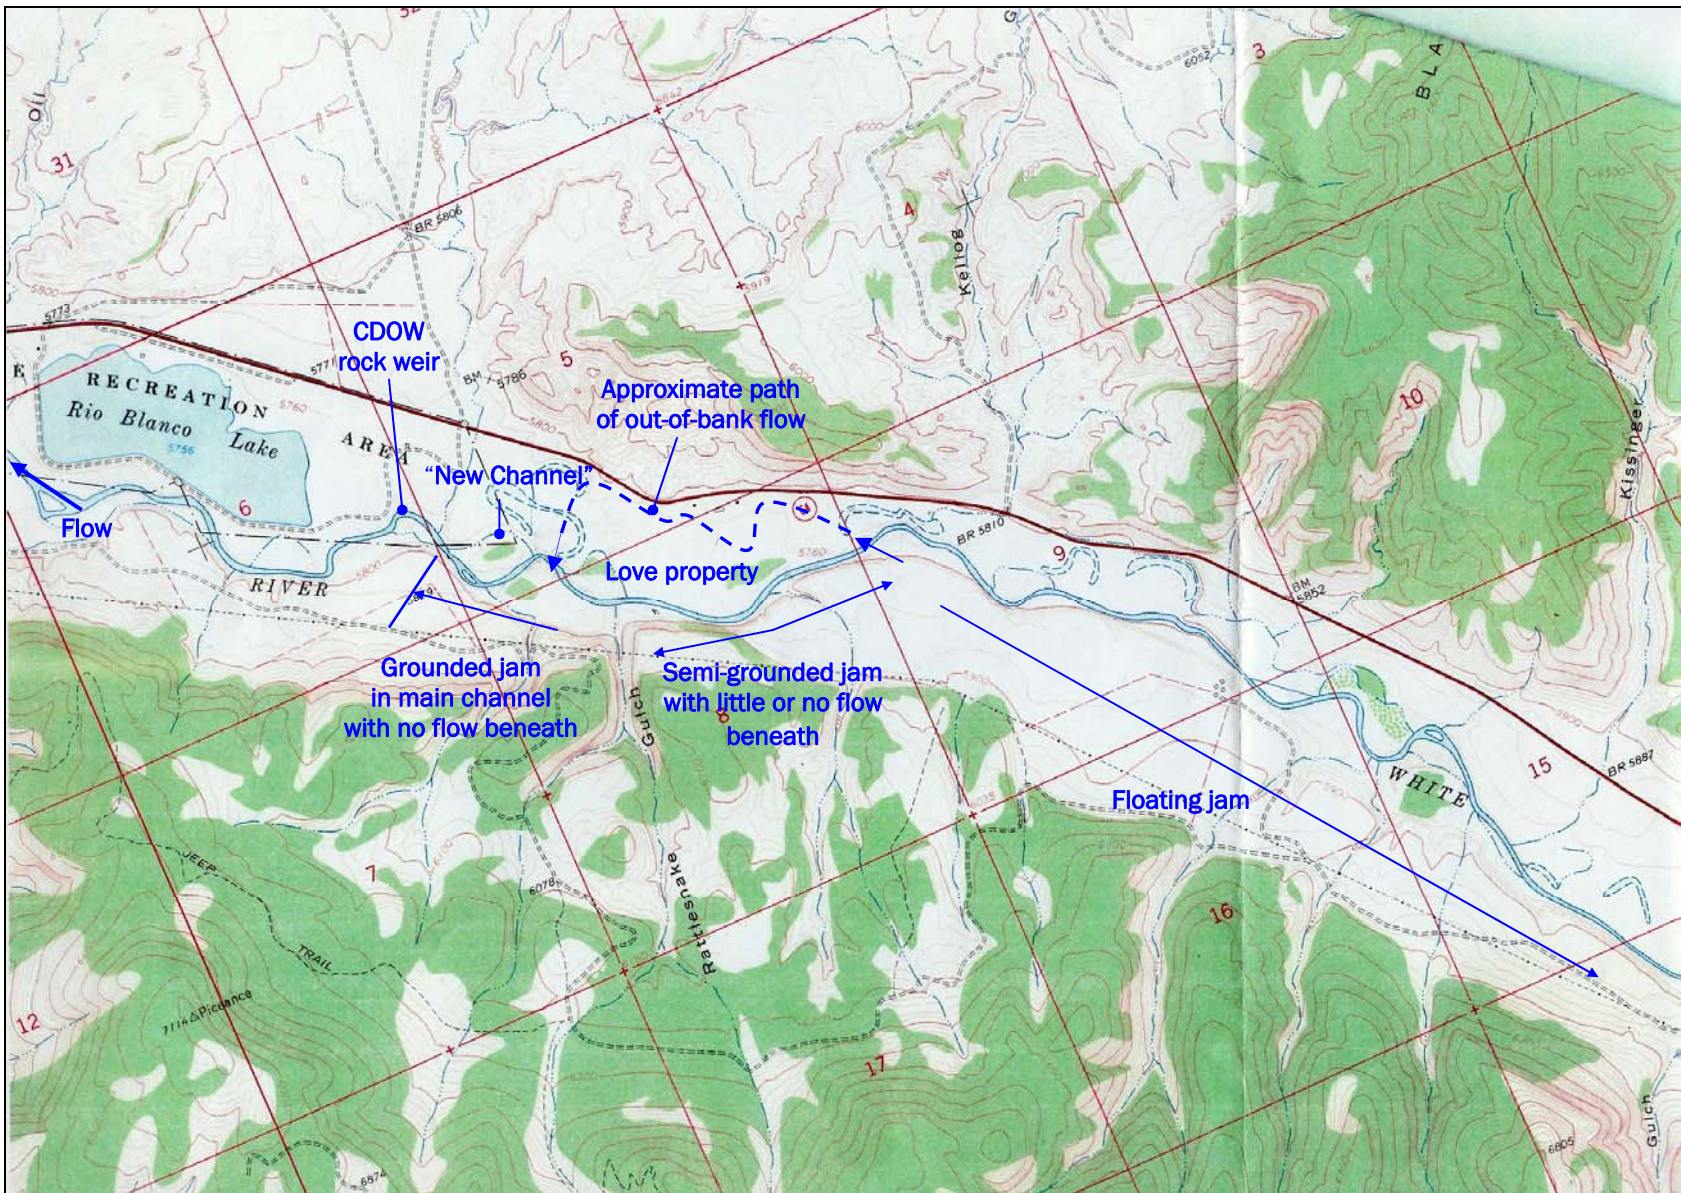
Figure 9. Ice jam problem area on White River.

flooded fields owned by Love, and Figure 9 is a general site map. The floodwaters and frazil ice deposits isolated the ranchers' winter hay supply and calving yard. About one mile upstream, the ice jam threatened a steel bridge also owned by Love. Also, thousands of feet of cattle fencing and numerous irrigation structures were inundated and frozen in, the degree of damage unknown until spring.

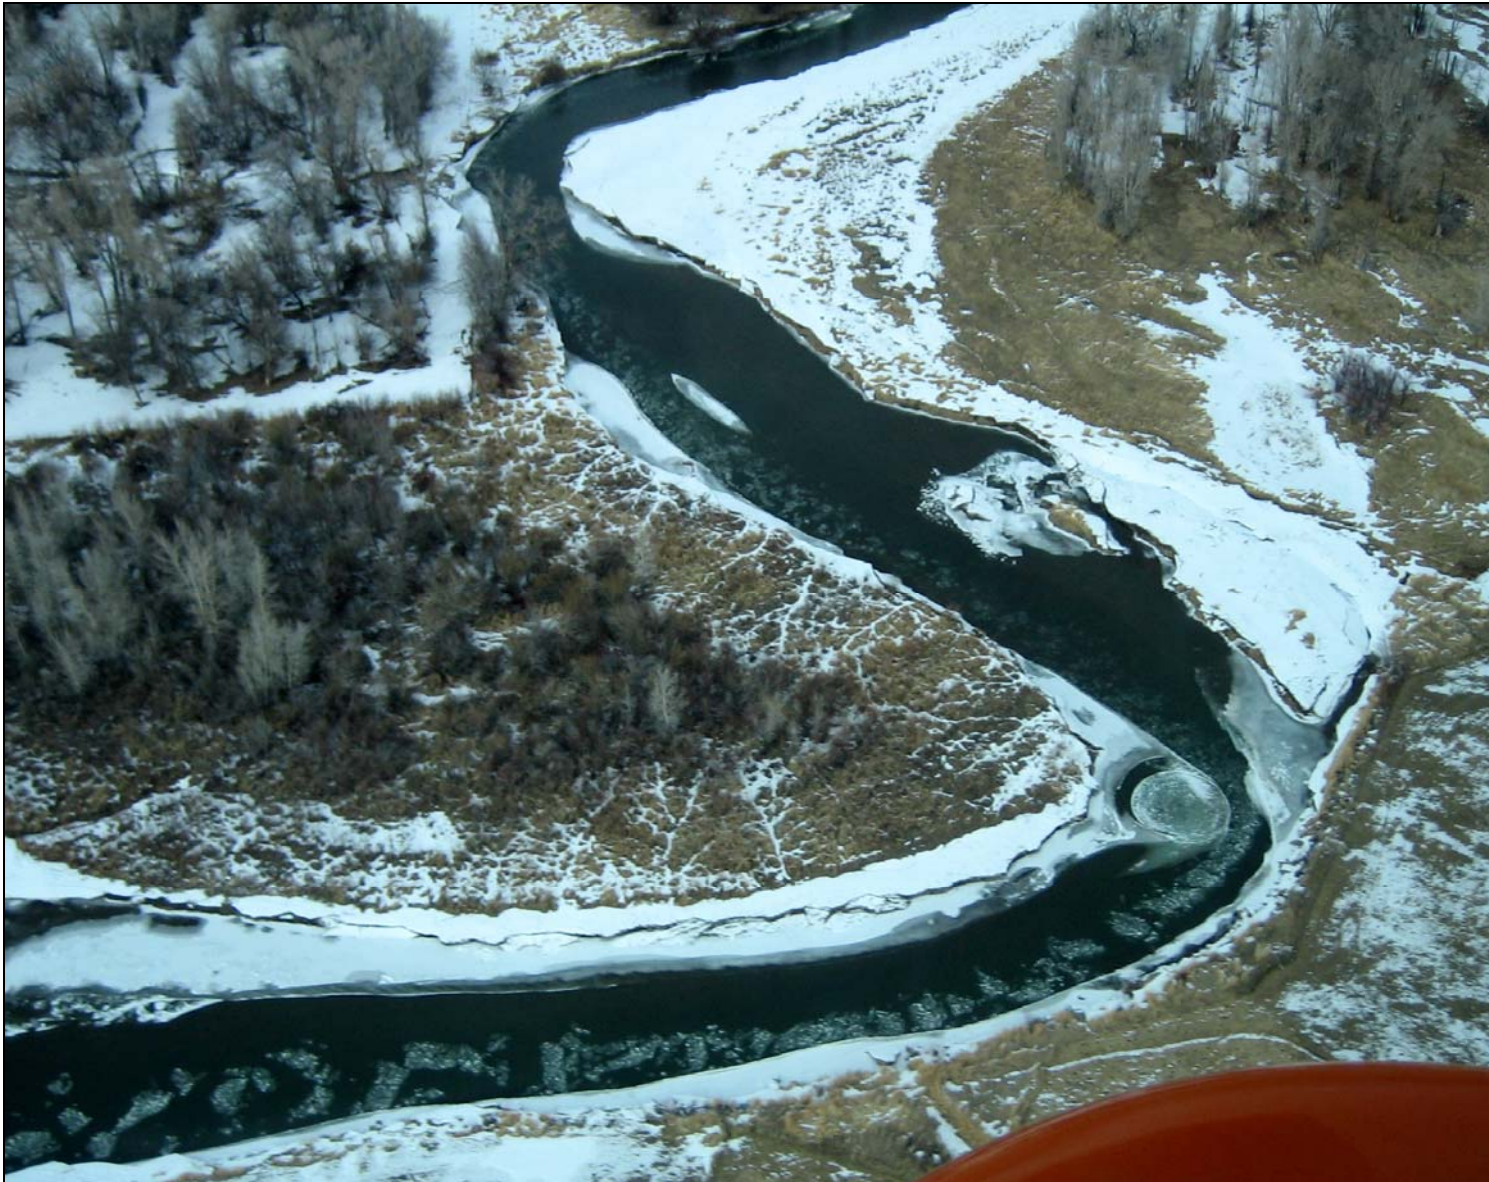
On the afternoon of 17 January, CRREL contracted Coulter Aviation to photograph the river from Meeker downstream past the jam. Except for a few minor sections of ice cover, the White River was open from above Meeker to the head of the ice jam. Total ice jam length was about 3.5 miles. Although air temperatures were in the 20s, the previous night had been cold and the river was carrying frazil floes at a surface concentration of about 10 percent (Fig. 12).

Figure 12. Drifting frazil ice upstream of ice jam on 17 January 2006. Flow direction is right to left.

Theory developed through experiments by Calkins and Ashton (1975) predicts that, for surface ice concentrations greater than about 30%, ice floes will arch across a gap if average floe diameter is more than one quarter of the gap width. Based on discussions with locals and photos of the river (e.g., Fig. 12), floes moving through this section of the White River can be at least 15 ft in diameter and surface ice concentrations can exceed 30%. According to ice arching theory, gap width should therefore be at least 60 ft.

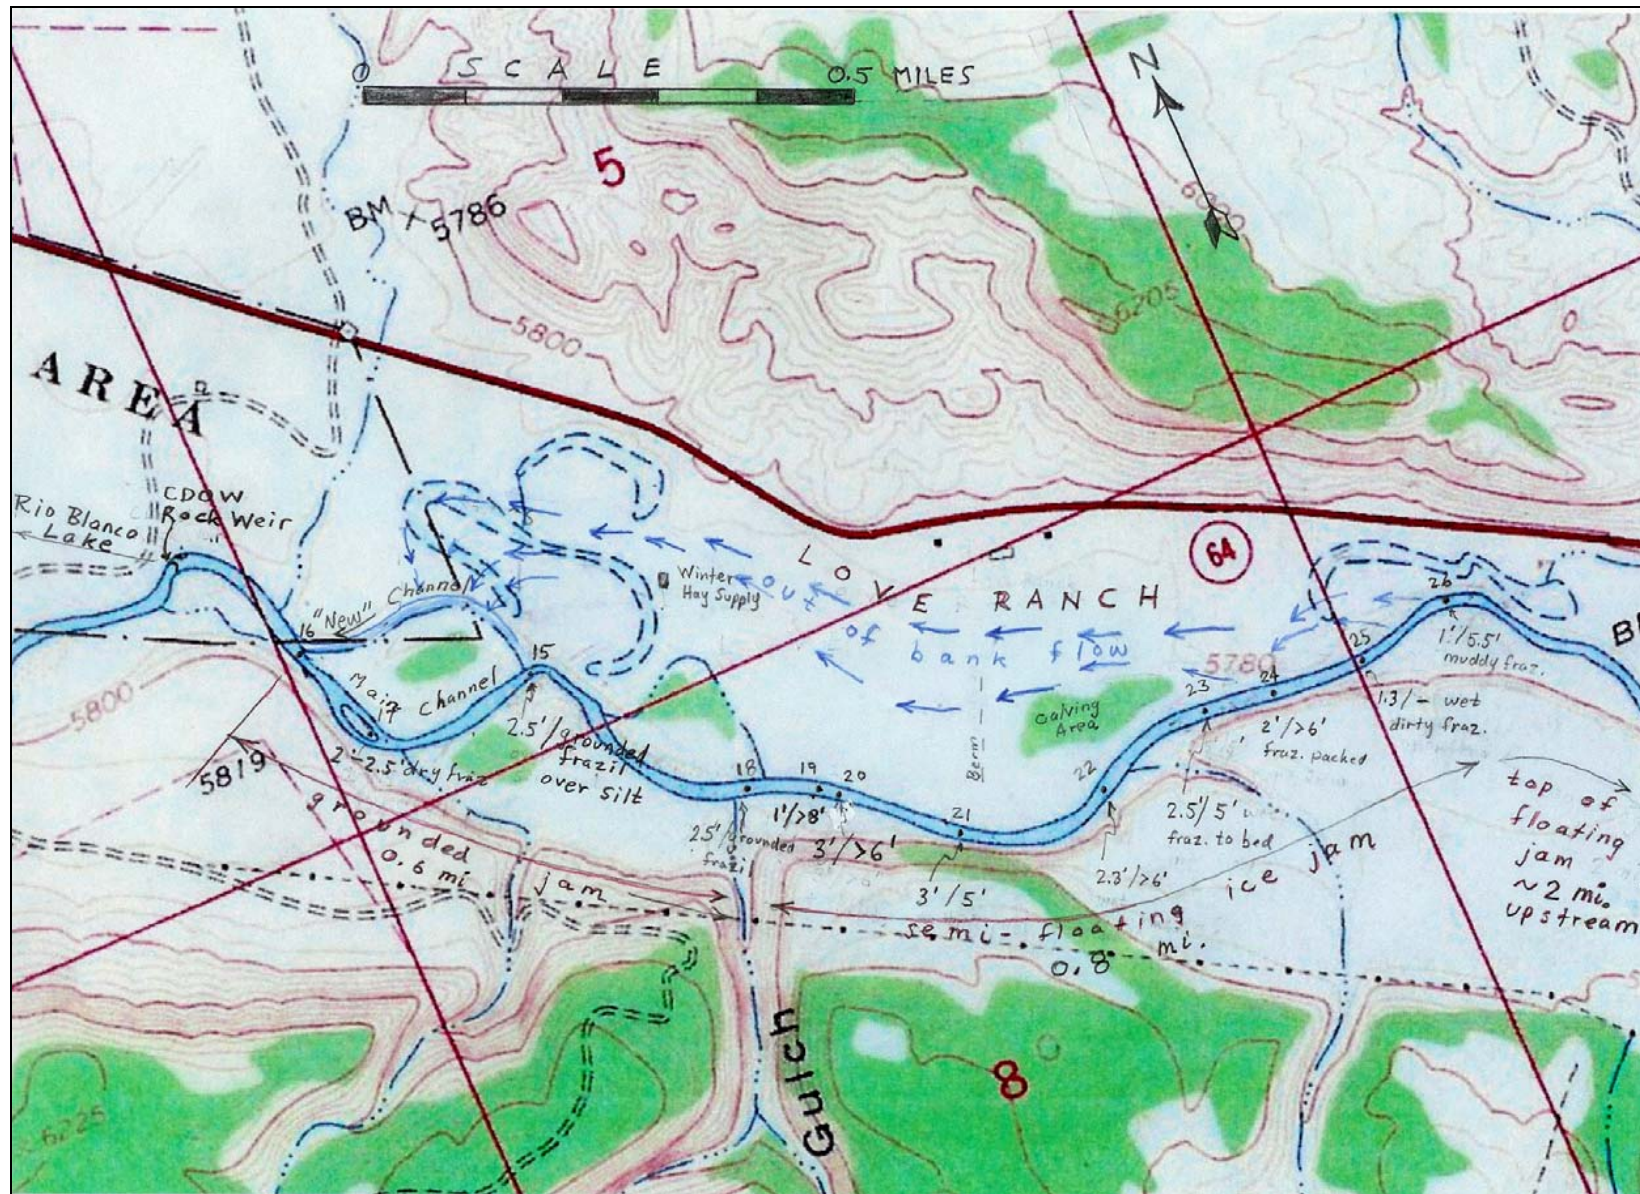
Figure 13. Ice jam thickness measurements.

On 18 January, Sam Love and CRREL accessed the jam in the main channel from the west (Waypoint 15, Fig. 13), finding a grounded, dry frazil accumulation about 2.5 ft thick, resting on a silt layer. This silt had apparently deposited under the ice jam, as the river in this area is known to be gravel and cobble-bedded. Looking to the north, overland flow could be seen spilling into the new channel from the fields on the north side of the river.

On the afternoon of the 18th and the morning of the 19th, CRREL accessed the frozen jam on foot to make a series of ice thickness measurements (shown in Figure 13). Ice conditions are described from downstream to upstream. From the CDOW weir to the outlet of the new channel (Waypoint 16), the river was about half-covered by decaying frazil ice, with the full flow of the river passing beneath the ice and within banks. The entire new channel was open, with exposed silty cut banks along the outside of the bends. These eroded banks did not look entirely new, suggesting that this secondary channel captured by the ice jam flood outflow also conveys flow during open-water season high-discharge events. At the upstream end of the new channel, overland flow could be seen re-entering the river at

multiple locations along the right bank over a length of about 600 ft. A grounded jam filled the lowermost 1500 ft of the main channel (Waypoints 16 and 15) and the dry frazil ice accumulation appeared to be draped over the channel bed topography. The ice was 2–2.5 ft thick, with no signs of flow beneath. In the area abeam the Love Ranch buildings (Waypoints 19 and 20), solid frazil 2.5–3 ft thick overlay still, muddy water 6–8 ft in depth.

This semi-floating ice jam condition continued from Waypoint 19 upstream for about a mile to Waypoint 26. At many locations in this section of the main channel, water and loose muddy frazil ice were found beneath the 2- to 3-ft-thick solid frazil layer, but no appreciable water currents were observed. Although it was difficult to discern exactly, flow appeared to be escaping the main channel and into the fields of the Love Ranch for about 1000 ft, between Waypoints 23 and 26. The solid frazil layer probably represented an initial floating ice cover formed of juxtaposed frazil floes. The loose frazil was probably drawn beneath the solid cover and deposited there to thicken the jam. The continued deposition of this frazil, and possibly silt, plugged the flow paths beneath the jam, forcing the river flow out of bank and onto the Love property.

On about 23 January, Love contracted a high-track D-8 Cat to attempt to excavate a 20-ft-wide channel through the grounded and semi-grounded portions of the ice jam from Waypoints 16 to 26. It was hoped that this would cause the river flow to return to the main channel, alleviating the

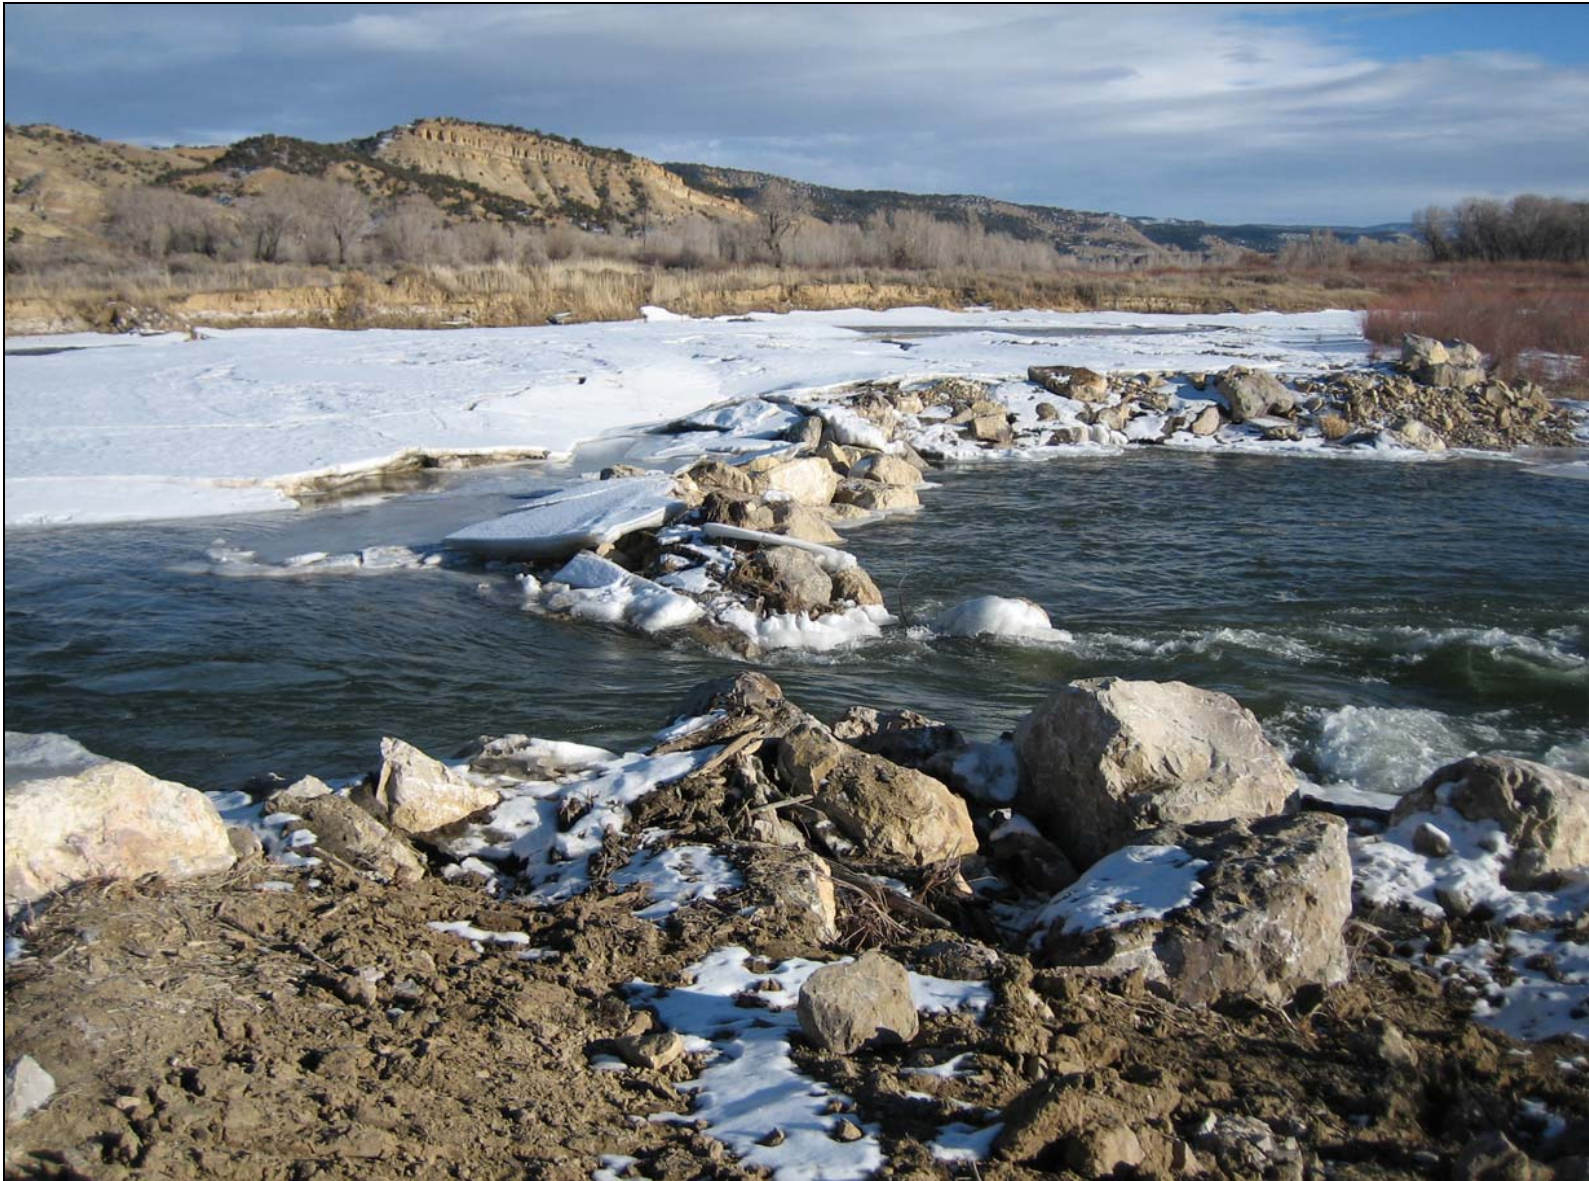
Figure 14. Breached CDOW rock weir, 17 January 2006.

On 10 January, USACE and CDOW allowed Love to remove a section of the weir using a large excavator (Fig. 14). This action, combined with the effect of more moderate air temperatures, caused most of the ice cover to melt out for about one mile above the weir (Fig. 7). The ice jam in the main channel adjacent to the Love Ranch remained in place, however, and continued to divert nearly all the river flow across the Love property.
