# Structural Health Monitoring of a Bonded Composite Patch Repair on a Fatigue-Cracked F-111C Wing

DSTO-RR-0335

A large fatigue crack in the wing skin of an Australian Defence Force F-111C aircraft was repaired with an adhesively bonded boron/epoxy fibre composite patch. The patch prevented further growth of the crack for 670 flying hours.

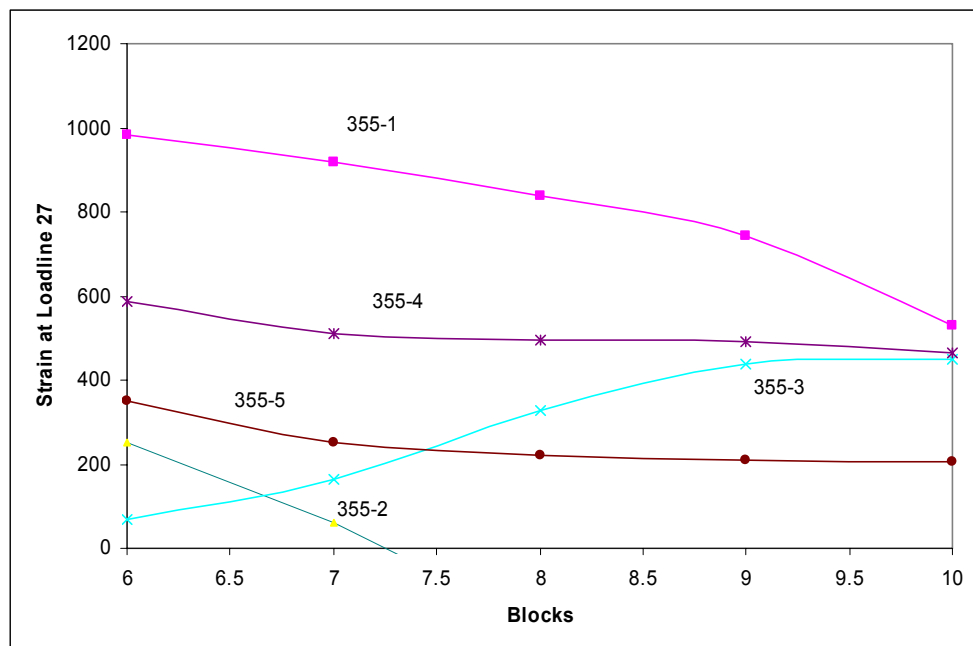
Results for strip-gauge 355-1, 4 and 5, provided in Figure 25 indicate a gradual growth of the pre-existing disbonds; gauges 355-2 and 355-3 exhibit anomalous behaviour. Figure 15 shows the corresponding NDI indications in this region at Block 10.

Figure 25: Strain versus block number for strip-gauge 355 for Blocks 6 to 10; the skin gauge location is 361 and the patch gauge positions are as indicated in Figure 20
