# Structural Health Monitoring of a Bonded Composite Patch Repair on a Fatigue-Cracked F-111C Wing

DSTO-RR-0335

A large fatigue crack in the wing skin of an Australian Defence Force F-111C aircraft was repaired with an adhesively bonded boron/epoxy fibre composite patch. The patch prevented further growth of the crack for 670 flying hours.

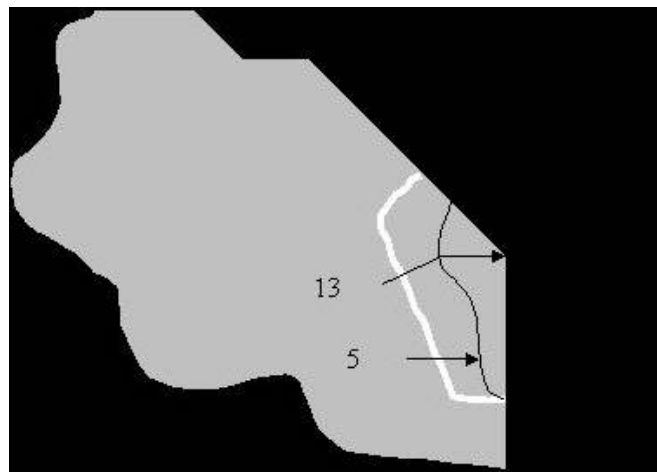
The wing was then transferred to DSTO for inspection prior to the fatigue test. Using a Novascope 4000 (not then available to RAAF) one of the disbond areas was reinspected with the result shown in Figure 9. This inspection confirmed the presence of one of the disbonds noted by RAAF but shows it to be significantly smaller than indicated in the RAAF report.

In the DSTO measurements a loss of 50% in signal height was taken to be an indication of a disbond; thus, in addition to the influence of probe size, various interpretations of disbond size are possible depending on definition of what measurement constitutes a disbond and the calibration of the NDI system.

*Figure 9: Sketch of the disbond region, top right Figure 8, showing in white outline the disbond area noted by RAAF and in black line the region noted at DSTO using a Novascope 4000 pulse echo instrument*

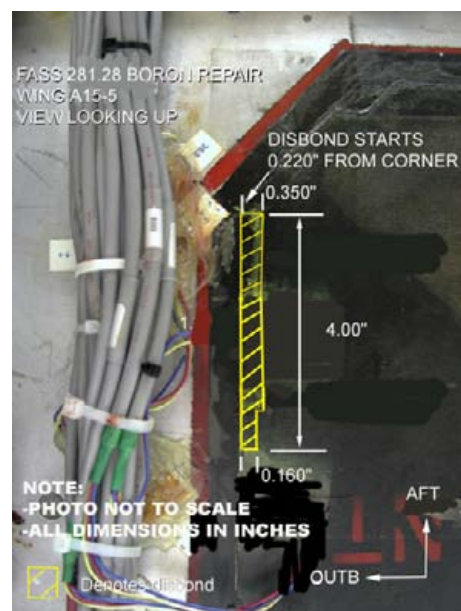
Figure 14: NDI indications of disbonds between the patch and substrate material at 10572 SFH, Block 10 in the region between skin gauges 363 and 361. Later at Block 12 patch gauges 802

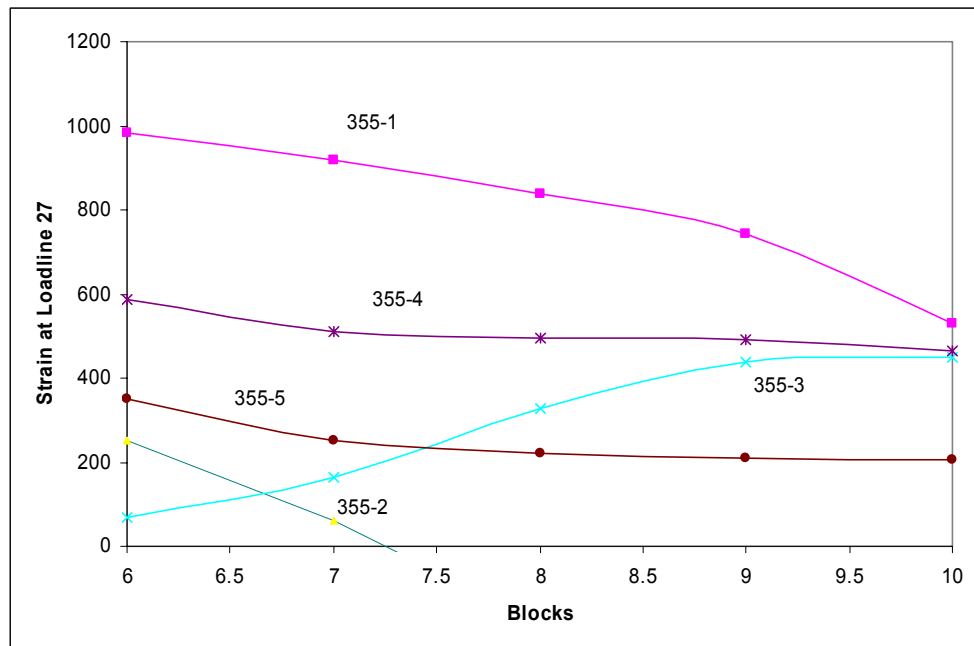
Results for strip-gauge 355-1, 4 and 5, provided in Figure 25 indicate a gradual growth of the pre-existing disbonds; gauges 355-2 and 355-3 exhibit anomalous behaviour. Figure 15 shows the corresponding NDI indications in this region at Block 10.

Figure 25: Strain versus block number for strip-gauge 355 for Blocks 6 to 10; the skin gauge location is 361 and the patch gauge positions are as indicated in Figure 20

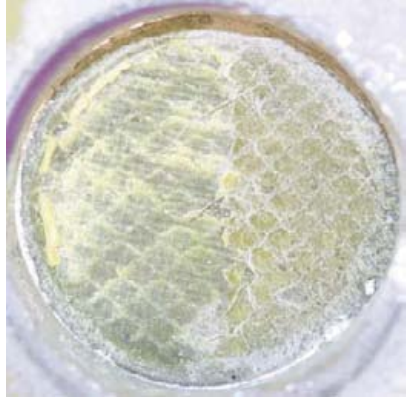
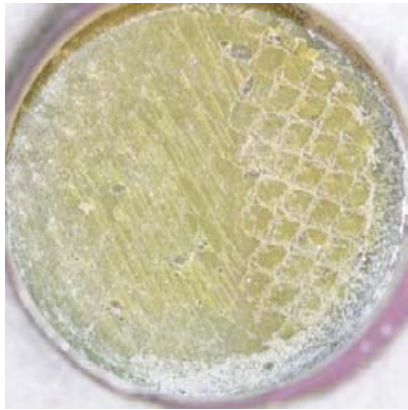
Figure 35 Photographs of fracture surfaces produced by the bond test, showing the main failure modes, as indicated
