## **Evaluation of Minimum Asphalt Concrete Thickness Criteria**

Haley P. Bell and L. Webb Mason

October 2008

Final report

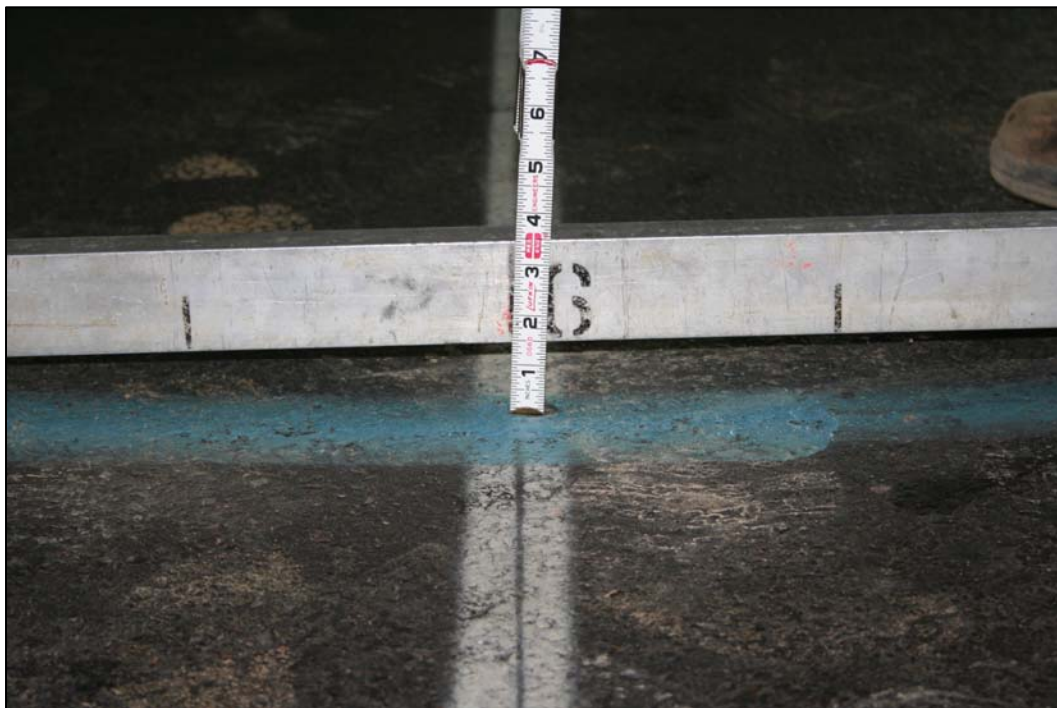
The only surface distress noted from Item 1 was rutting (Figure 28). Item 1 was trafficked with the C-17 wheel until 776 passes when about 2 in. of rutting had occurred. Failure with an average of 1 in. of rutting occurred around 234 passes. Rutting is a load related distress caused by an accumulation of vertical compressions (Collop et al. 1995). The presence of rutting indicated that a permanent deformation occurred in one or more of the layers of the pavement structure. The vertical stresses that occurred under the loaded wheel caused compression of the pavement materials. Figure 29 shows an overall view of Item 1 after trafficking was complete.

Figure 28. Item 1 centerline rutting after 302 passes.

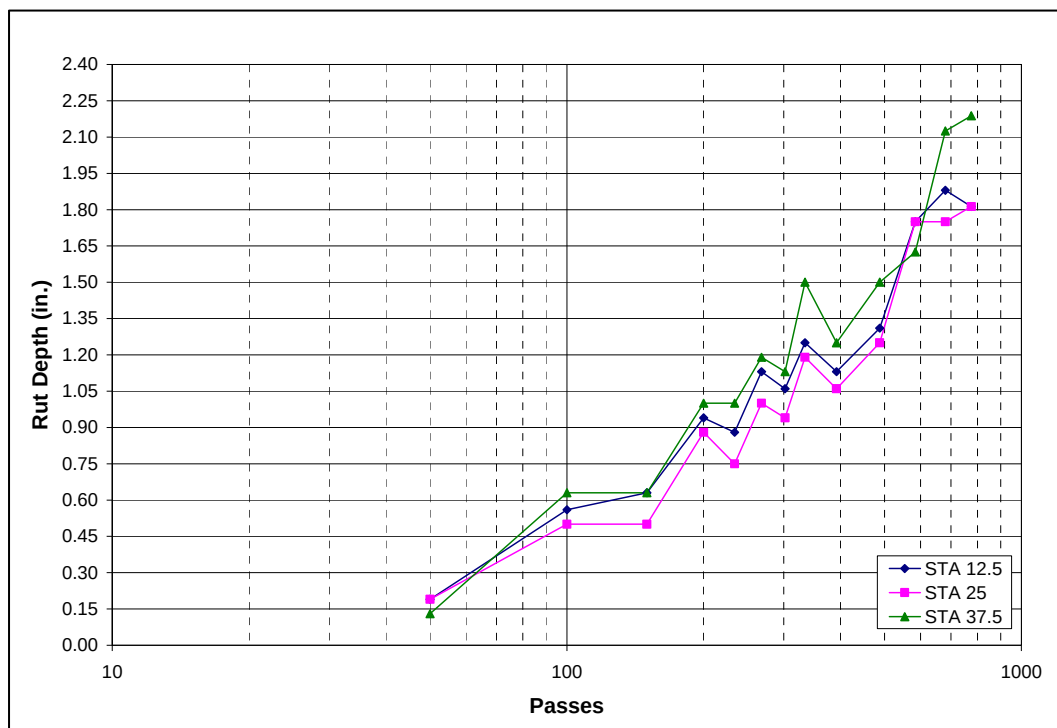
Figure 34 shows the rut depth measurements versus increasing pass level for Item 1. Item 1 failed around 234 passes. Failure was determined by averaging the rut depths across the traffic lanes at Stations 12.5, 25, and 37.5. The rut depth measurements in Figure 34 show that the rut depths did not consistently increase with pass level. The occasional decrease in rut depth was dependent upon the side of the lane the wheel was on when trafficking stopped. If the wheel stopped trafficking on the east side of the traffic lane, then the west side of the traffic lane may have had a decrease in rut depth from the previous measurement. This was due to the loaded wheel shoving the asphalt concrete (and/or possibly underlying material) from side to side.

Figure 34. Item 1 rut depth measurements west of the centerline.

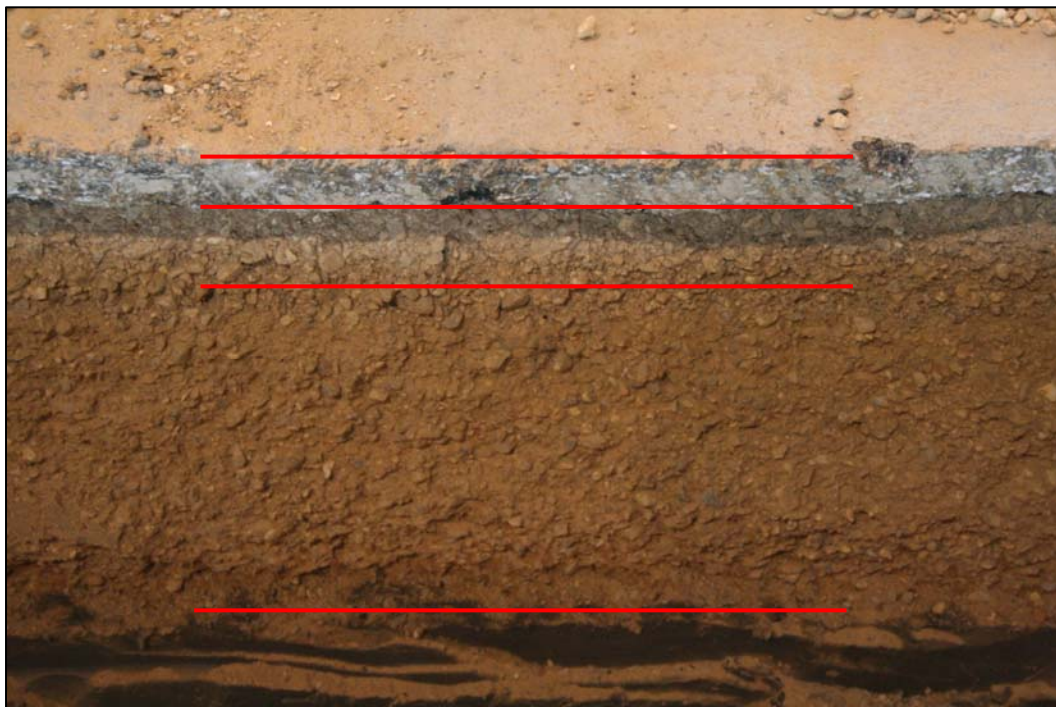
Failure location in the pavement structure of any of the items was not clear based on visual inspection alone. The items were not trafficked to catastrophic failure, so it was difficult to visually pinpoint which layer or layers may have had movement. Visual inspection did show that there was no evidence of subgrade pumping in Item 1 because the subbase was not contaminated with clay. Figure 38 shows a profile view of Item 1 after trenching. The picture is of the center of the rut. From the picture, it is difficult to distinguish between the base and subbase material, so red lines were drawn to show each layer.

Figure 38. Item 1 trenched profile view.

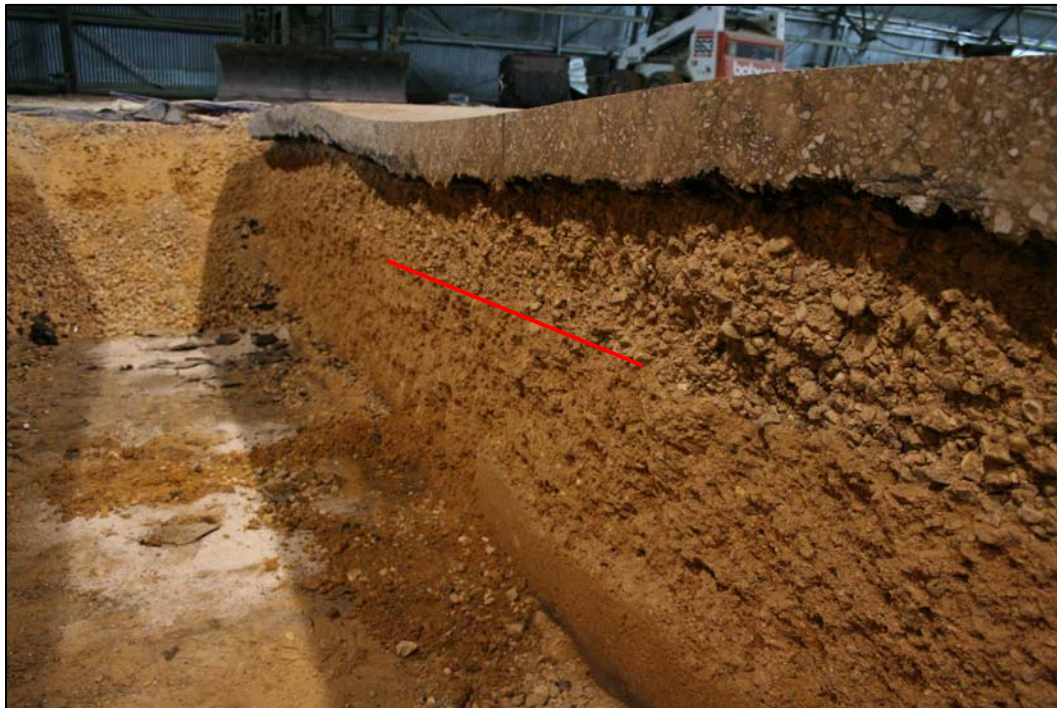
The manual profile results showed that the asphalt concrete thickness remained constant at 3.5 in., so the pavement did not fail as a result of the asphalt concrete. As expected, the underlying layers were more difficult to assess. The base course thickness for Item 2 was relatively constant, although it seemed a little low compared to the pre-test data (approximately 0.20 in. lower). This was somewhat unexpected because the density measurements indicated that there was no densification of the base course layer. Based on the profile measurements, movement seemed to be in the base, subbase, and subgrade. Nonetheless, it appeared as though most of the movement occurred in the subgrade, most likely as a result of shear flow.

Figure 50. Item 2 trenched profile view.

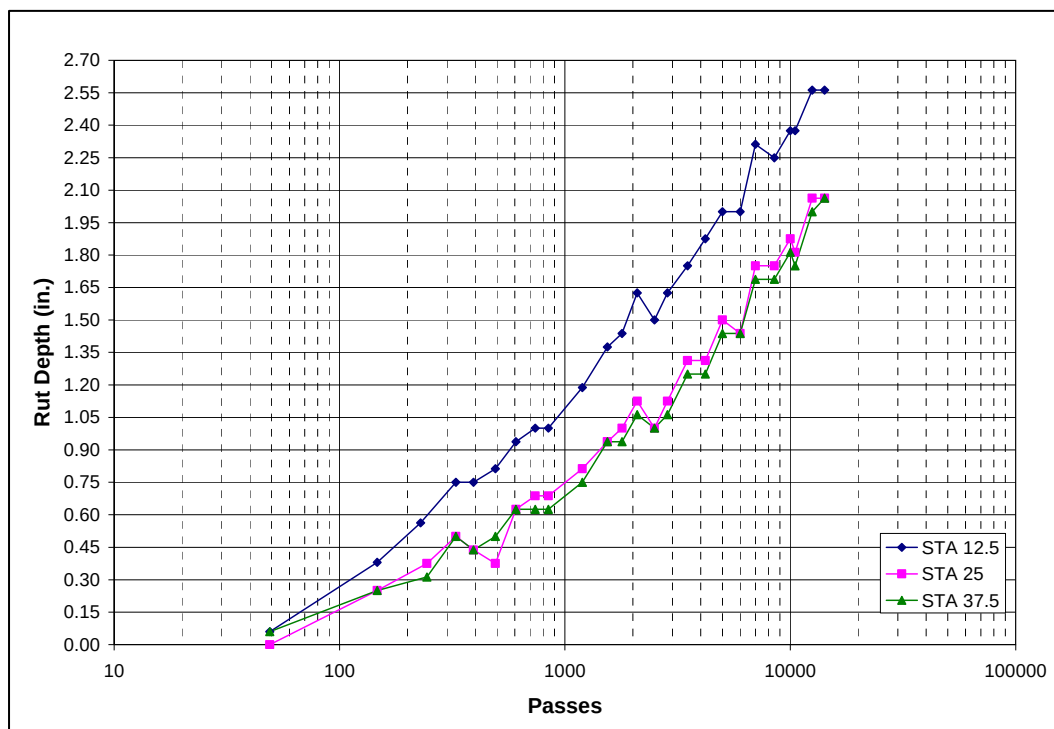
Figure 58 shows the rut depth measurements versus increasing pass level for Item 3. Item 3 failed around 2,850 passes. Again, failure was determined by averaging the rut depths across the traffic lane at Stations 12.5, 25, and 37.5. Figure 58 also shows that the pavement structure at Station 12.5 was slightly weaker than the other stations. This is most likely due to an inconsistent compaction effort across the item. The pre-traffic DCP data at Station 12.5 for Item 3 showed that the base course material was slightly weaker than at Stations 25 and 37.5. This inadequate compaction effort possibly resulted in a more rapid failure rate at Station 12.5. However, this greater rate of rutting was also seen at Station 12.5 for Items 4 and 6. During trafficking, the HVS-A wheel appeared as though it may have been “pushing off” at Station 5 every time the machine started a

Figure 58. Item 3 centerline rut depth measurements.

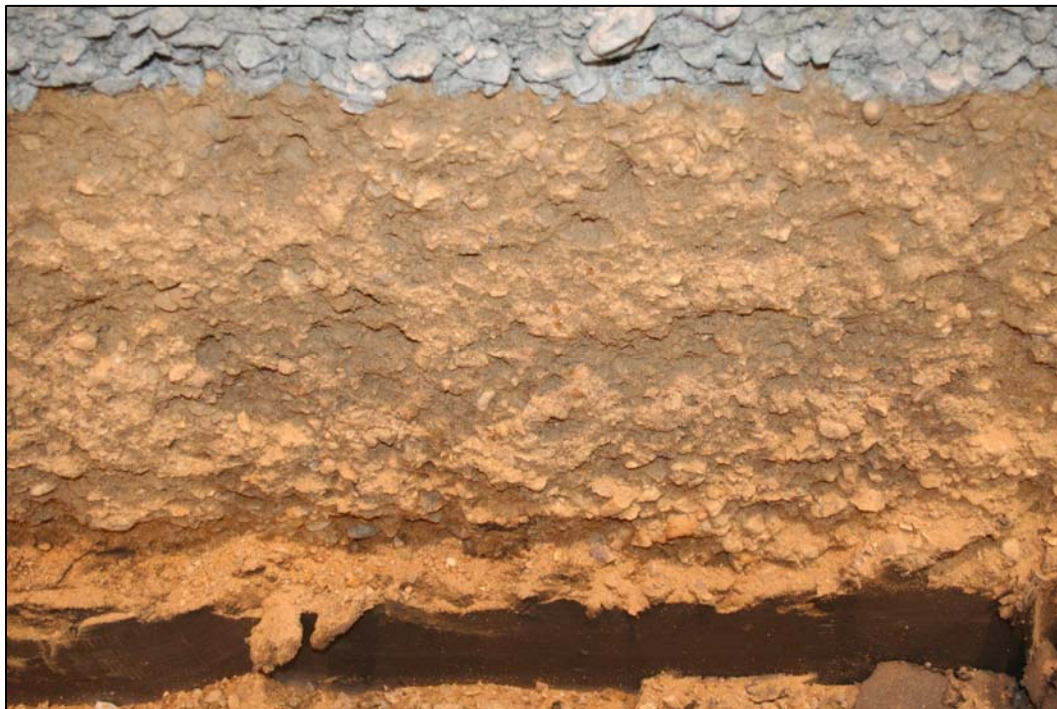
Visual inspection did not reveal any evidence of subgrade pumping in Item 3. Figure 61 shows a profile view of Item 3 after trenching. The picture shows part of the base and subgrade and all of the subbase. Figure 62 clearly shows how difficult it was to assess each item. The interfaces of each layer within each item visually appeared to be level across the traffic lane.

Figure 62. Item 3 trenched profile view.

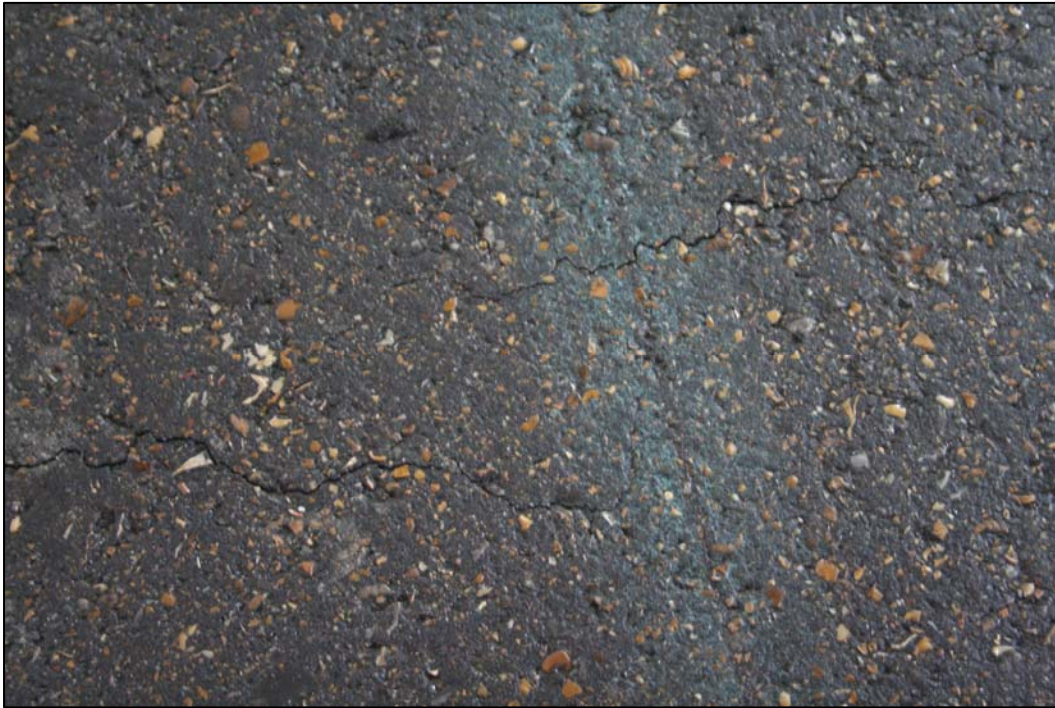
Figure 63. Item 4 polished aggregate and cracking at failure (42,881 passes).

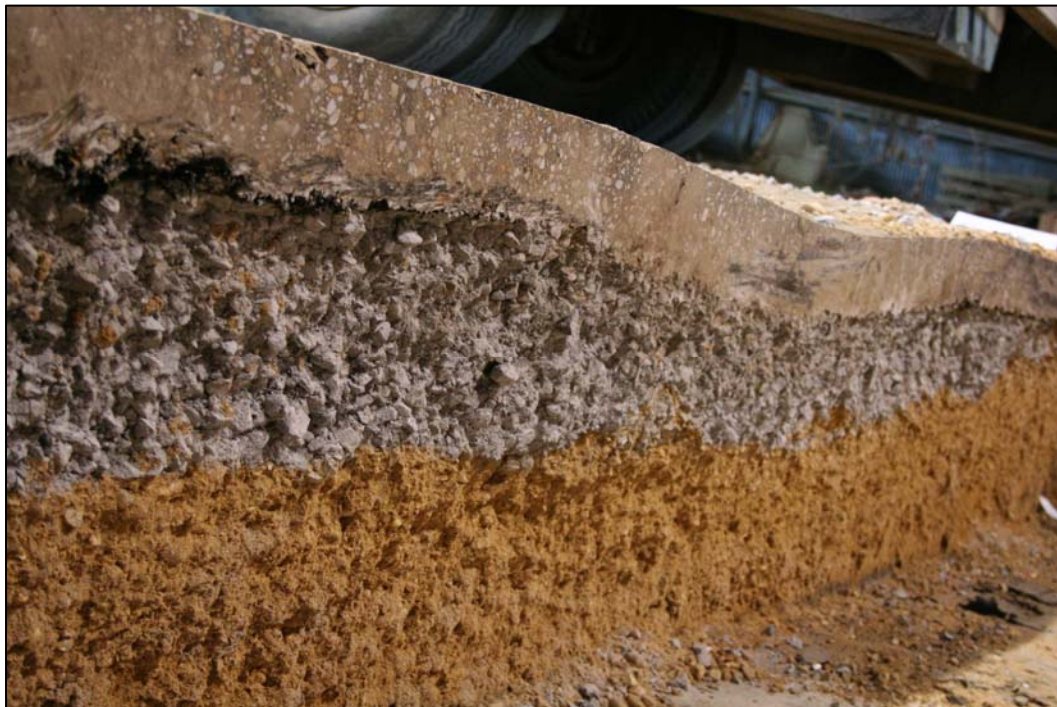
Visual inspection did not reveal any evidence of subgrade pumping in Item 4. Figure 72 shows a profile view of Item 4's surface, base, and subbase after trenching. The extreme right side of Figure 72 shows the transition zone into Item 6.

Figure 72. Item 4 trenched profile view.

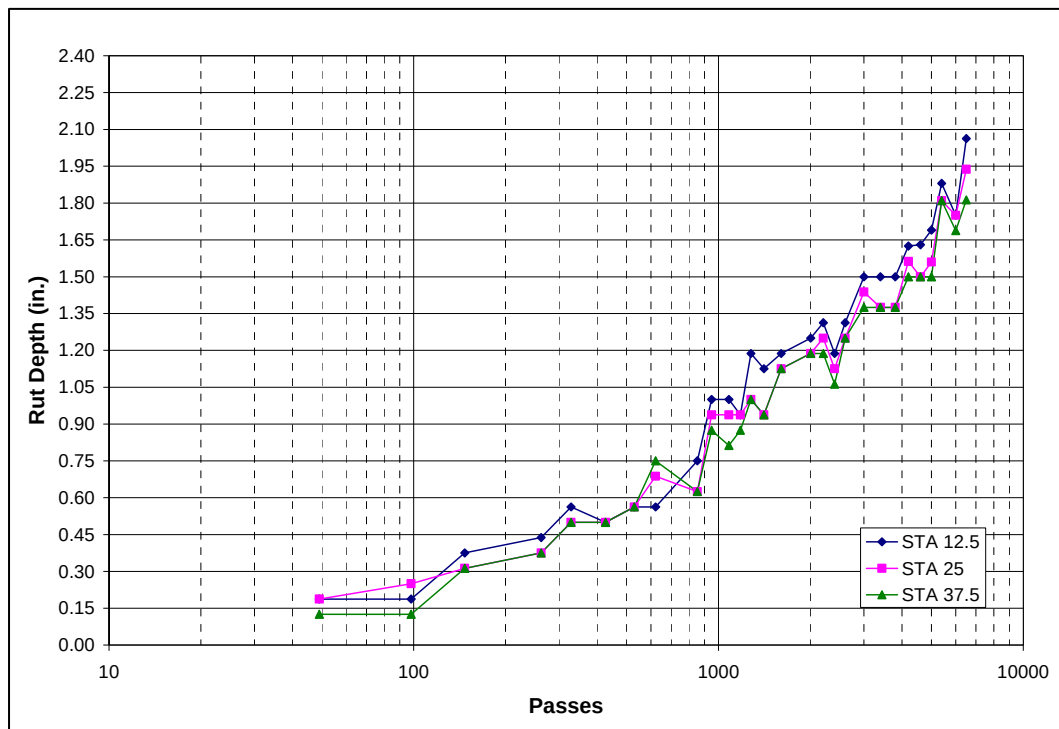
Figure 79 shows an overall steady increase in rut depth with each pass for Item 5. Item 5 failed around 1,278 passes. An average of 2 in. of rutting occurred around 6,500 passes.

Figure 79. Item 5 centerline rut depth measurements.

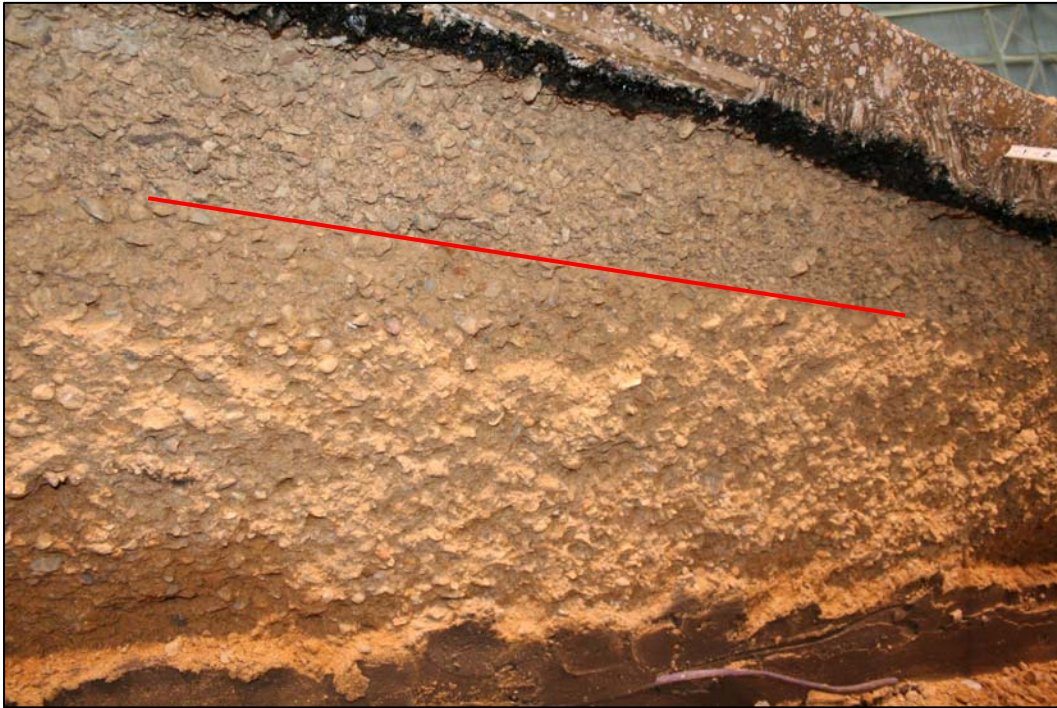
Figure 83. Item 5 trenched profile view.

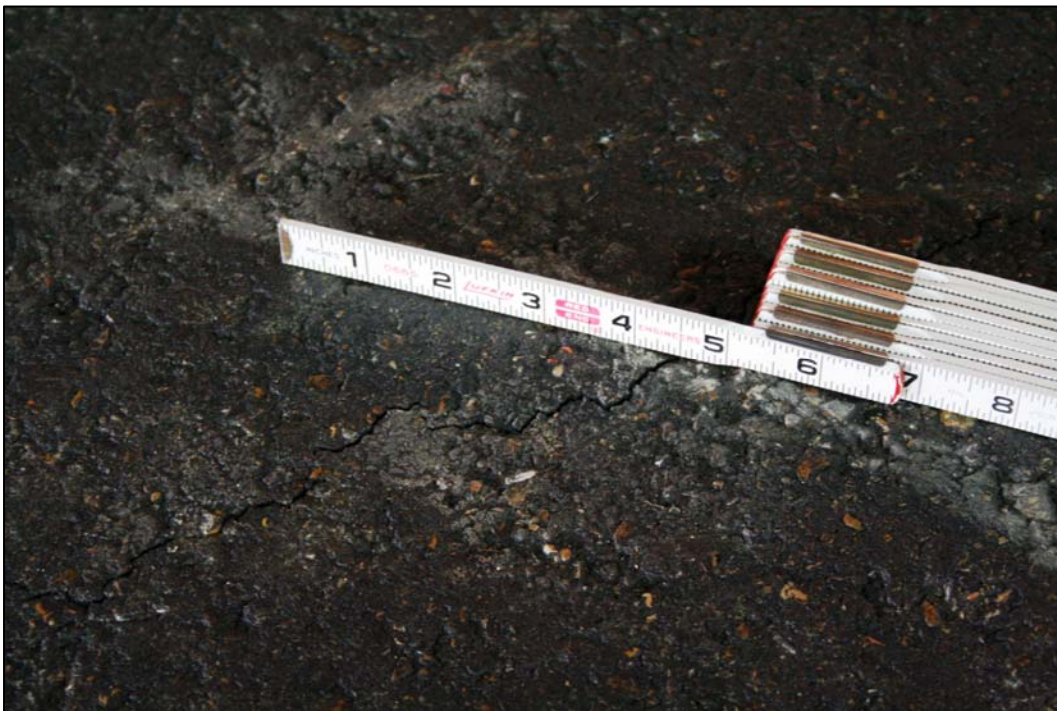
Figure 84. Item 6 cracking after 16,500 passes.

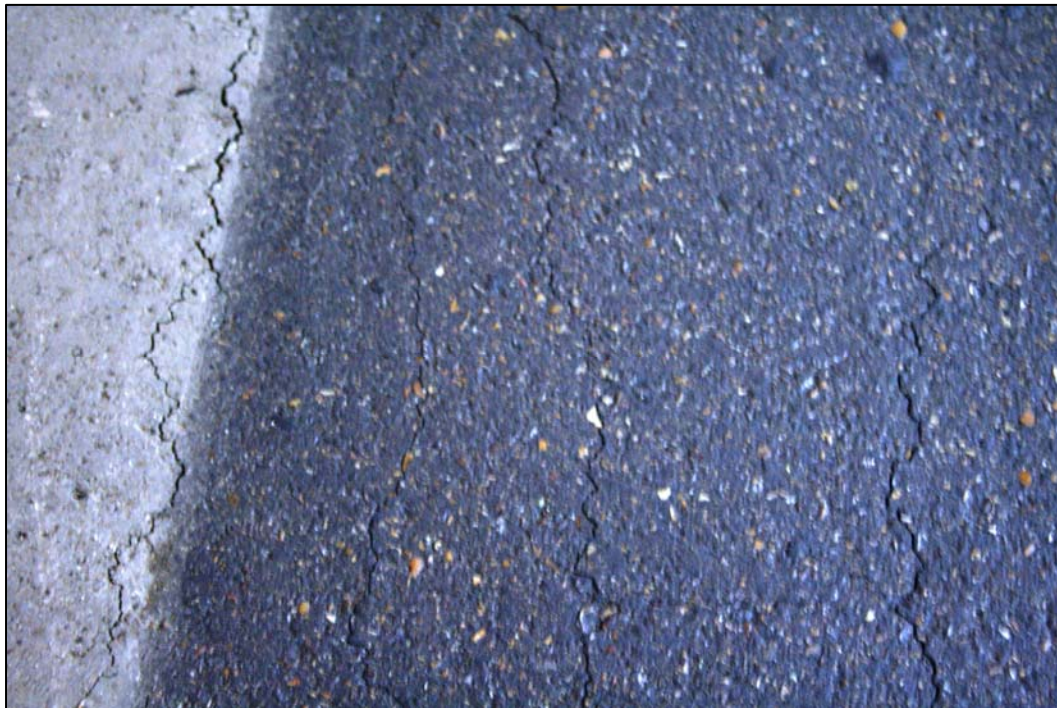
Figure 85. Item 6 cracking inside and outside of the traffic lane after 43,000 passes.

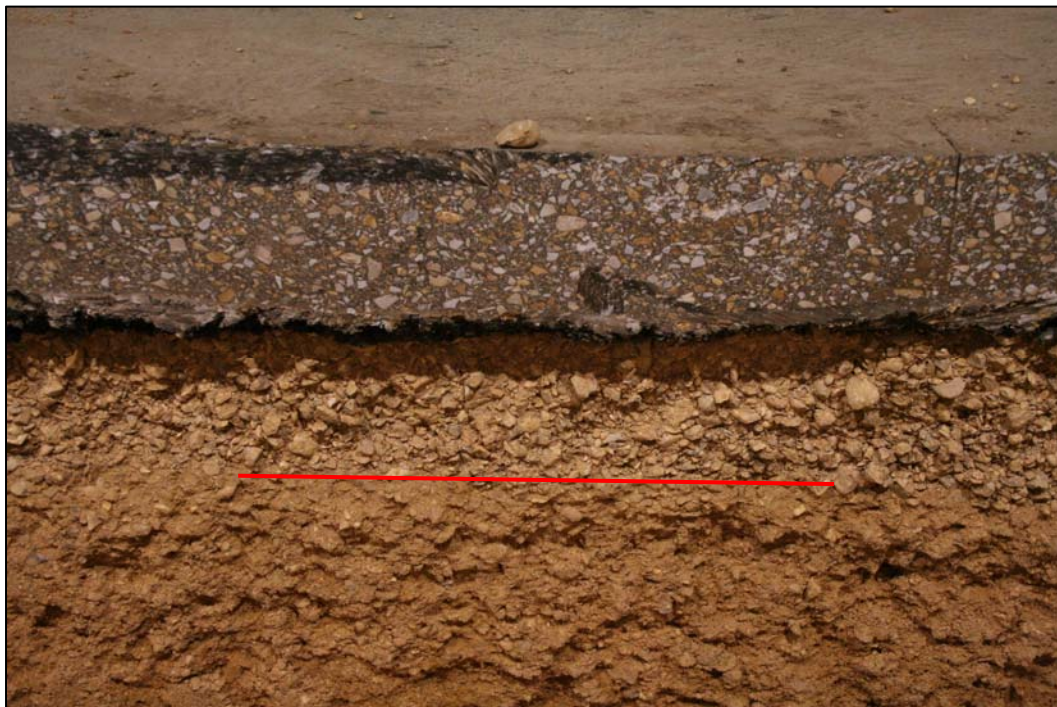
Figure 94. Item 6 trenched profile view.
