IRAQI CIVIL DEFENSE
HEADQUARTERS
BAGHDAD, IRAQ

SIGIR PA-06-090
APRIL 26, 2007

SUBJECT: Report on Iraqi Civil Defense Headquarters, Baghdad, Iraq (Report Number
SIGIR PA-06-090)

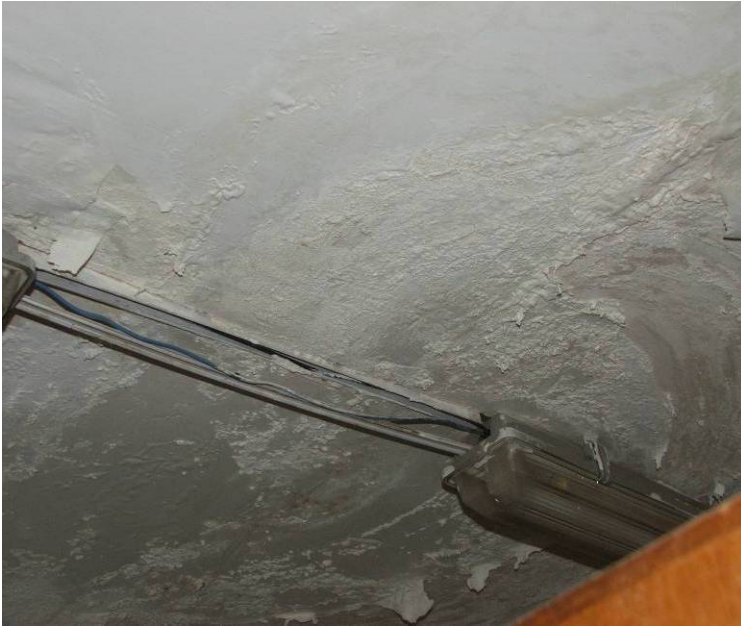
During our site visits, we identified water damage within the ICD HQ bathrooms (Site Photos 7 and 8). Our observations, coupled with discussions with ICD HQ personnel and review of daily QA reports, suggest the bathroom plumbing installation did not adhere to the standards of the IPC.

**Site Photo 7. Water damage to ceiling of 1st floor bathroom
(Photo courtesy of the USACE)**

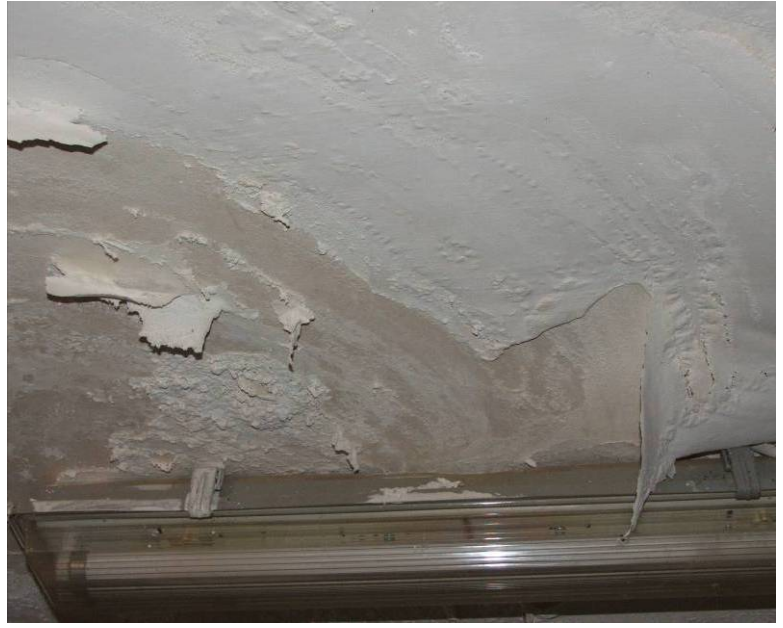
**Site Photo 8. Additional view of water damage to ceiling
(Photo courtesy of the USACE)**

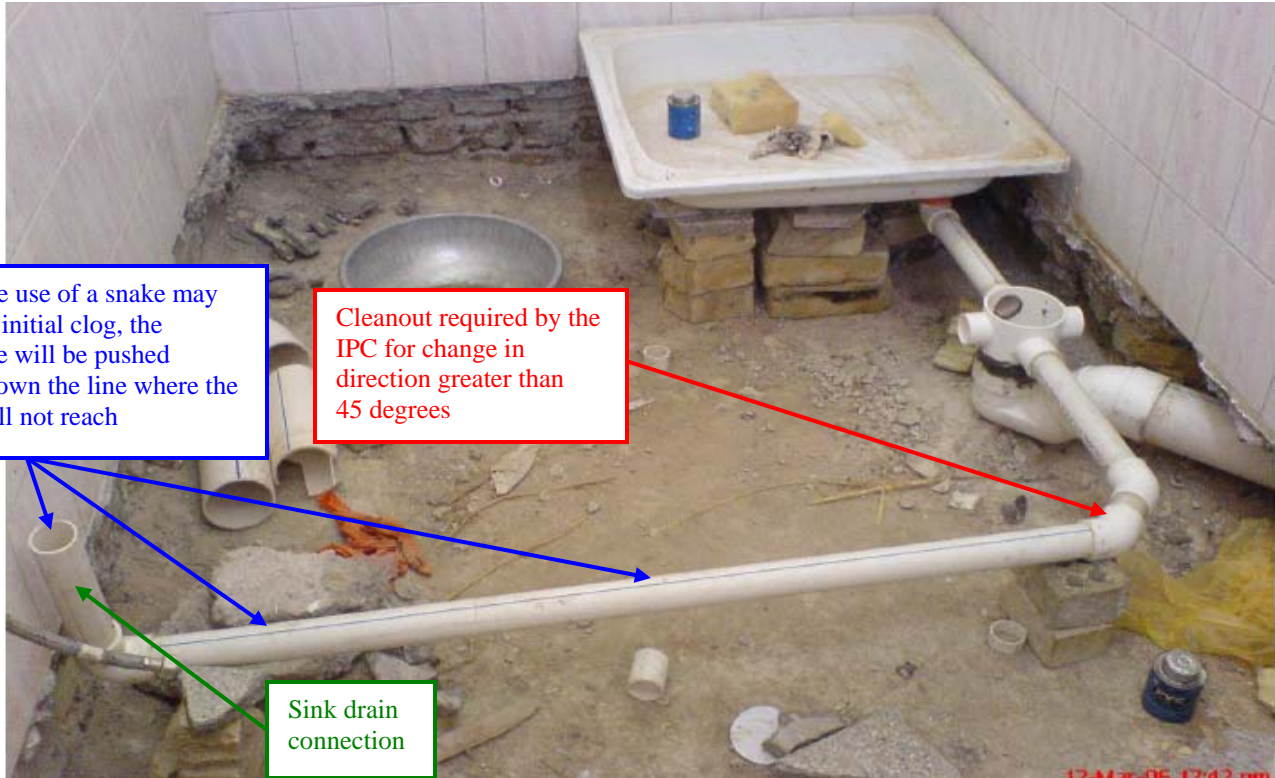
The as-built drawings for the ICD HQ bathrooms indicate cleanouts were only used at the far end of a straight run of soil pipe, not for every toilet trap and change of direction (Figure 7). Since the 30% and 60% design drawings were unavailable for our review, we cannot determine whether the government engineers reviewing the bathroom design drawings failed to detect and identify the lack of sufficient number of cleanouts and traps at the correct locations. However, the government design reviews do not mention the absence of cleanouts and traps at the correct locations as a deficiency.

Site Photo 9. Plumbing installation techniques used by the subcontractor – specifically, a lack of required cleanouts (Photo courtesy of the USACE)

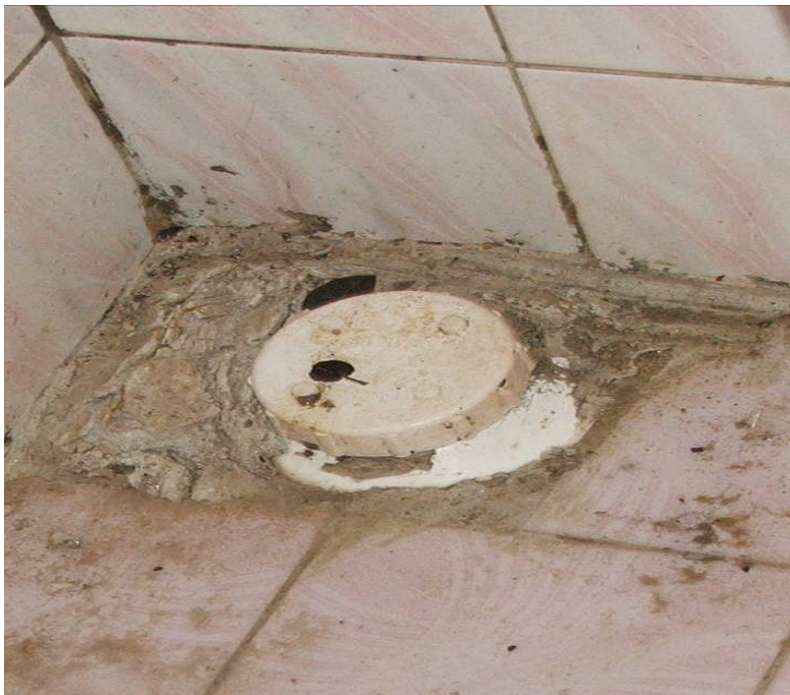
In addition, GRD representatives stated that having a single cleanout at the end of a straight run of soil pipe was adequate. However, we identified instances where the subcontractor used poor installation techniques for the single cleanout (Site Photo 10). The top has been cemented and will not come off to allow access to the cleanout, which rendered this cleanout useless for any type of maintenance and/or repair purposes.

Site Photo 10. Cleanout at the end of a straight lateral run of 6-inch sewer pipe. Poor installation resulted in the cleanout being unusable.

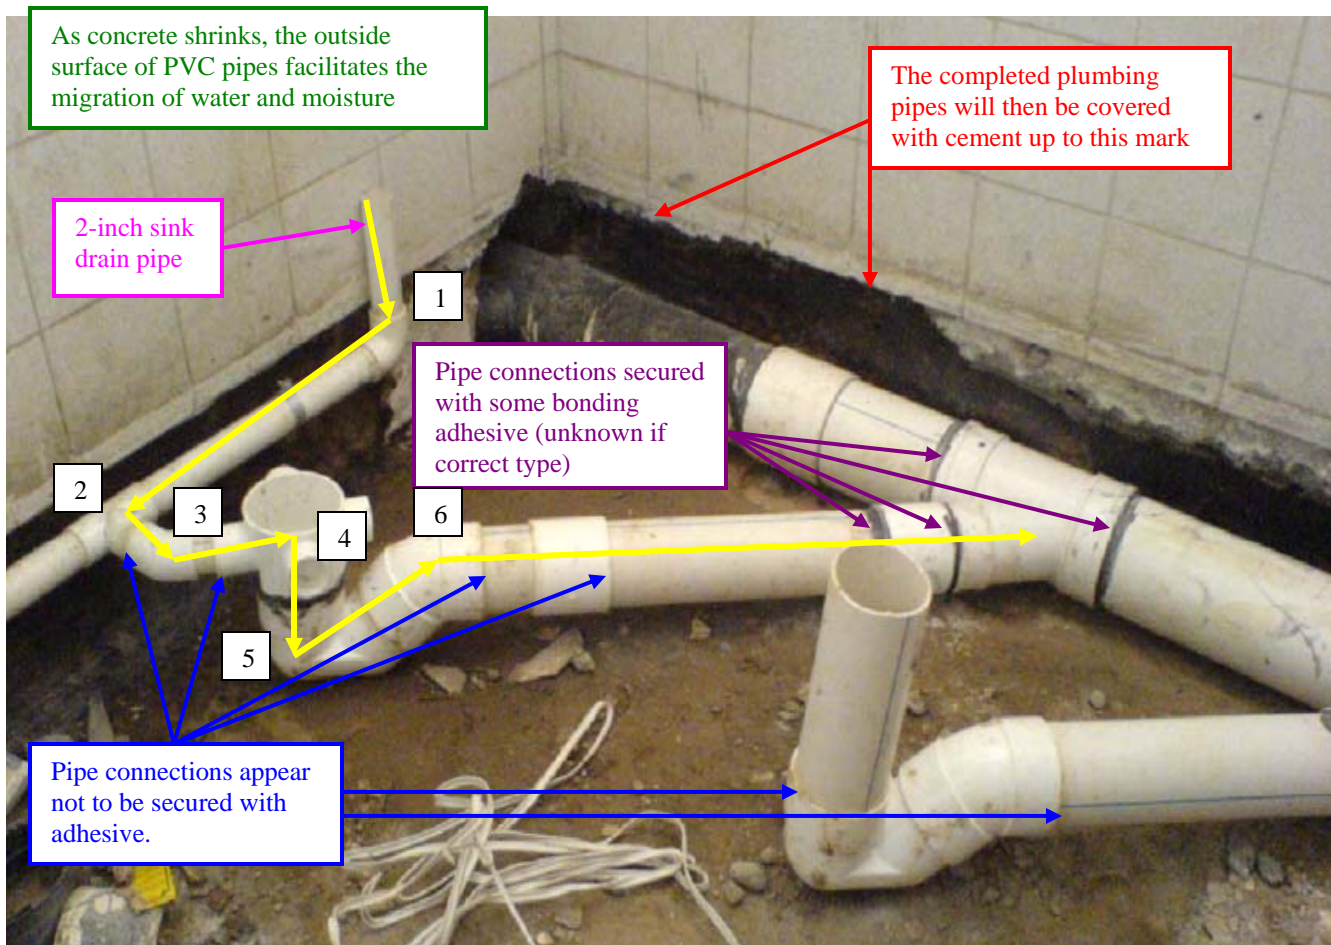
Finally, Site Photo 11 illustrates another design and installation problem with the bathroom plumbing. The photo shows a 2-inch sink drain pipe, which needs to make 6 turns in order to flow into the main 6-inch sewer line. These unnecessary numbers of connections exponentially increases the chances of sentiment clogs and leaks.

Site Photo 11. Subcontractor's bathroom plumbing assembly prior to pouring cement (Photo courtesy of the USACE)

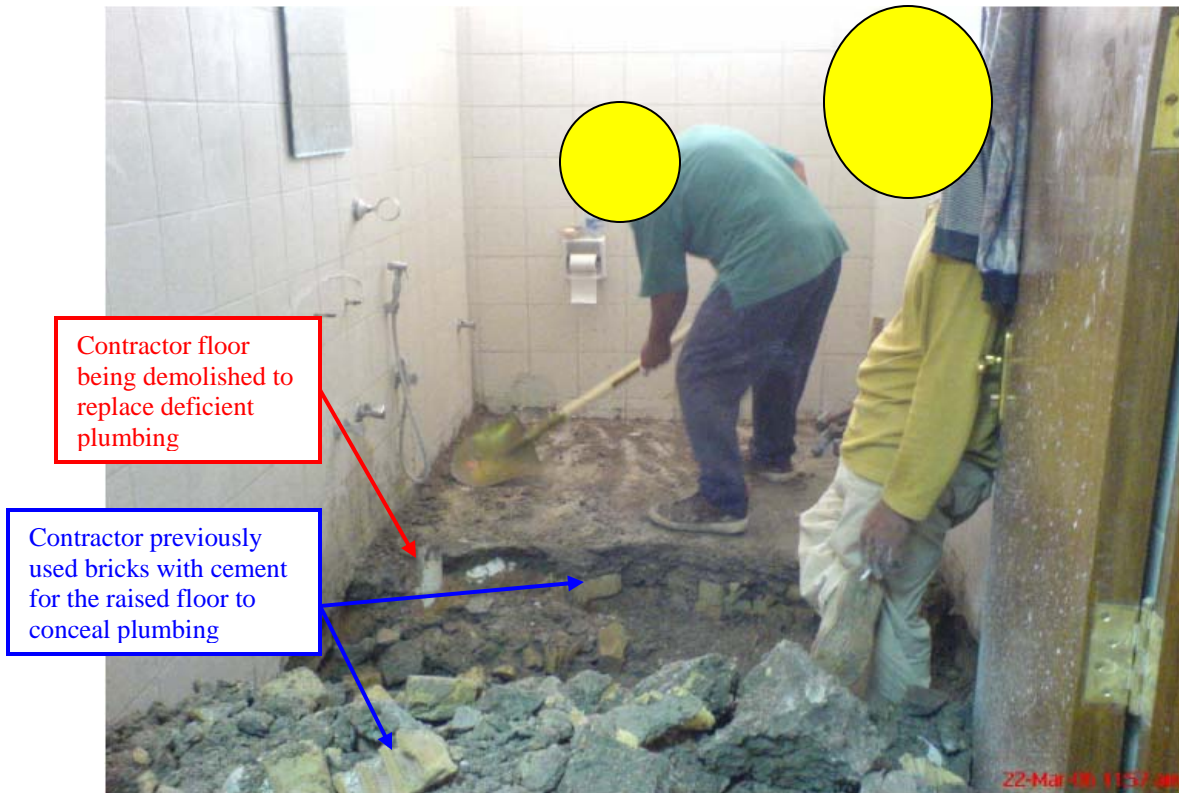
Site Photo 13. Burying the plumbing pipes required demolishing the floor to correct poor installation techniques (Photo courtesy of the USACE)

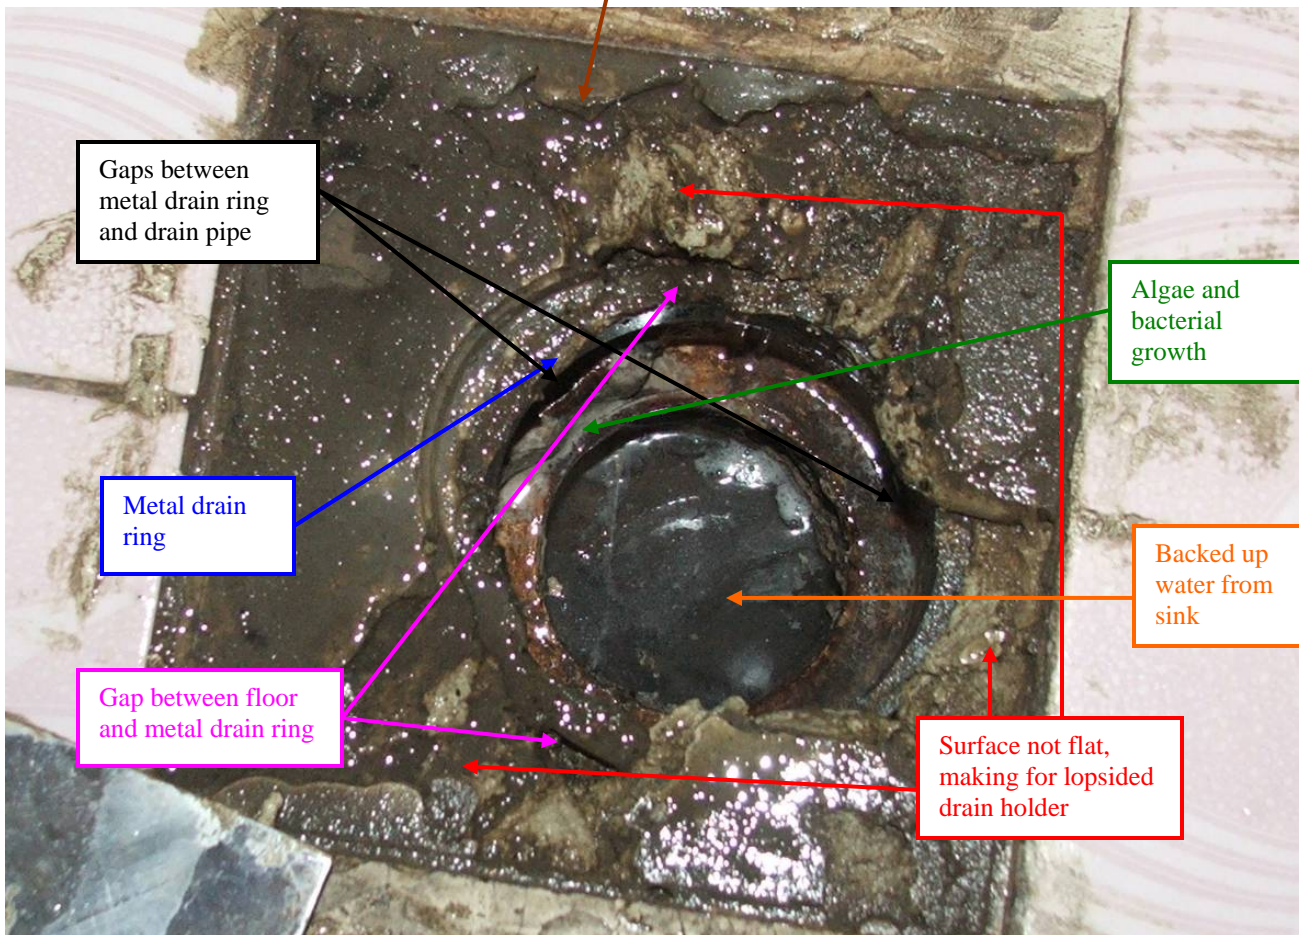
During our site visit, we lifted a drain cover, which exposed a pooling of sewer water and germs collecting underneath. The contractor did not properly seal the drain cover into the mortar, allowing water to seep underneath, which facilitated the growth of algae. We found cracks, voids, holes, and openings around the drain pipe in the floor. These

Site Photo 17. Close-up view of first floor drain with cover removed

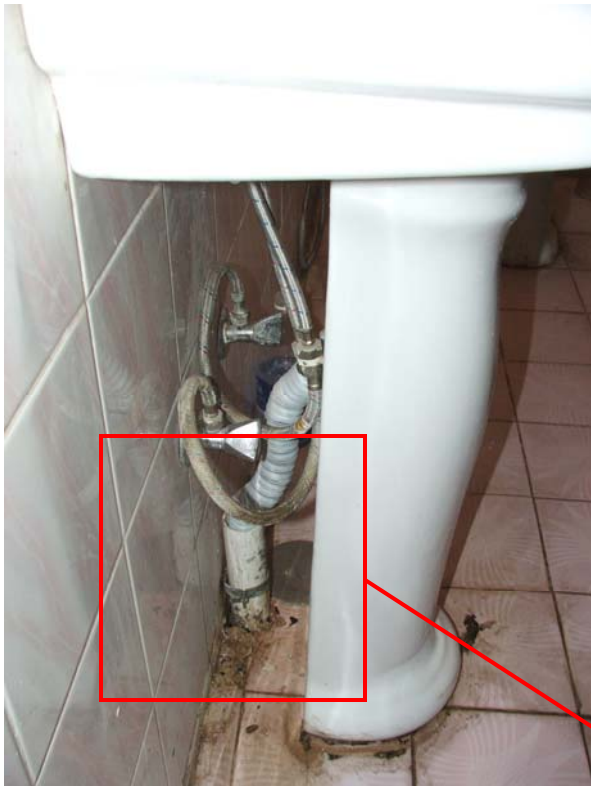
**Site Photo 18. Poor installation workmanship
(floor not completely waterproofed)**

Gap resulting from cement not adhering to PVC pipe. Water from a leaking sink, overflowing toilet, or for cleaning the floor will run down opening and onto the ceiling of floor below.

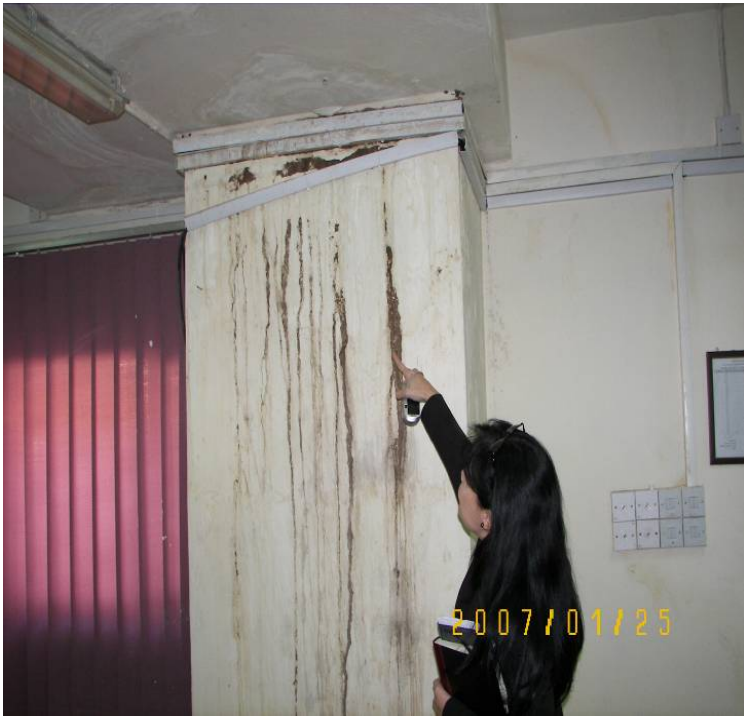
However, according to discussions with ICD HQ personnel, the water leaks resulted from poor construction techniques, specifically the subcontractor’s failure to follow the TO required IPC standards. The ICD HQ personnel stated that the dark stain on the pillar is from sewer water, and they are currently dealing with the potential for environmental and health hazards within the room by limiting its use as the designated Operations Room.

Site Photo 20. Water damage in ground floor Operations Room

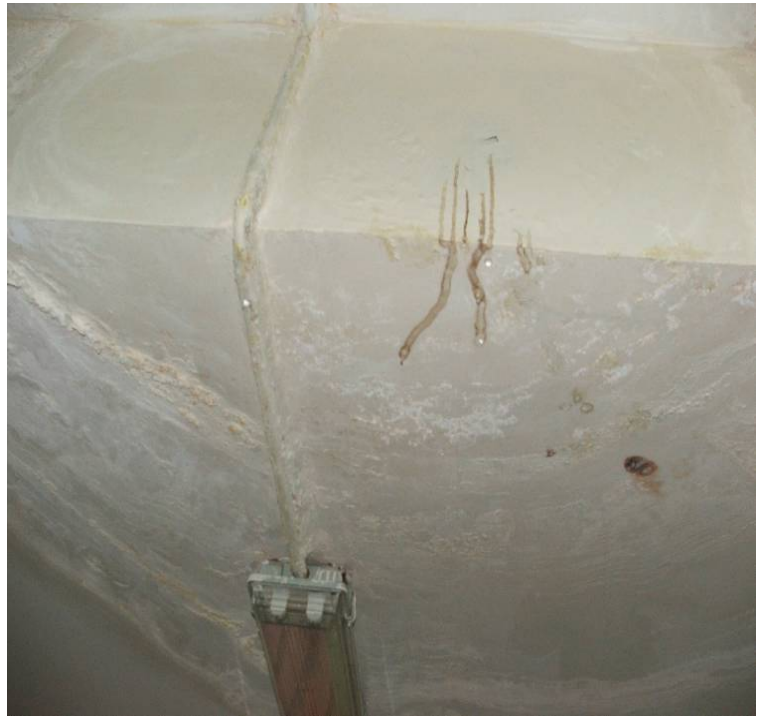
Site Photo 21. Close up view of water damage on ceiling

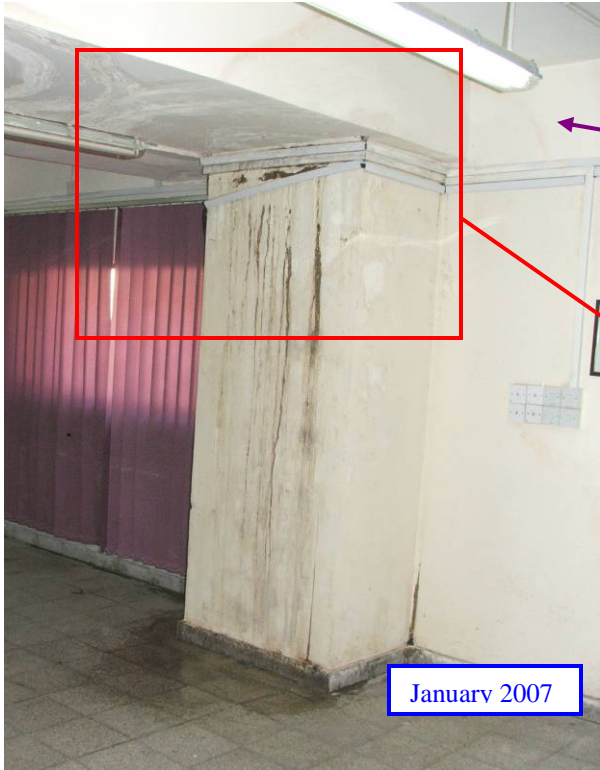
Site Photo 23. Water damage within the ground floor Operations Room from our first site visit

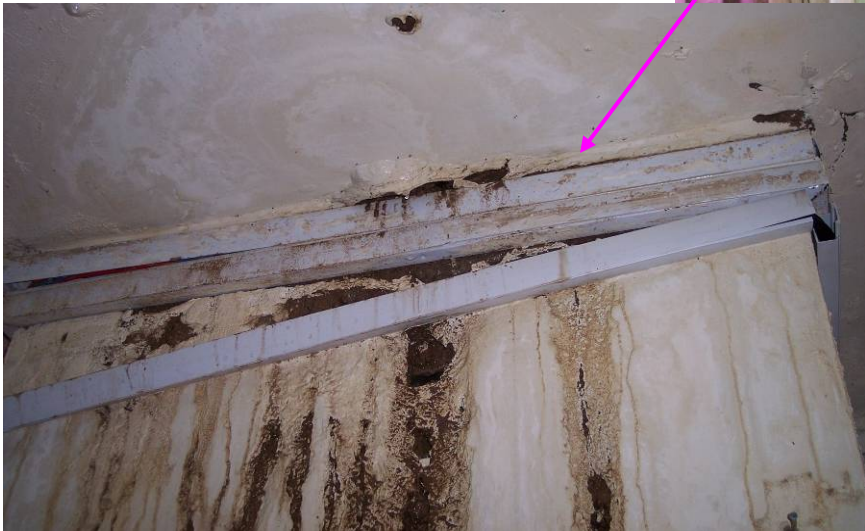
Site Photo 25. Close-up view of water damage

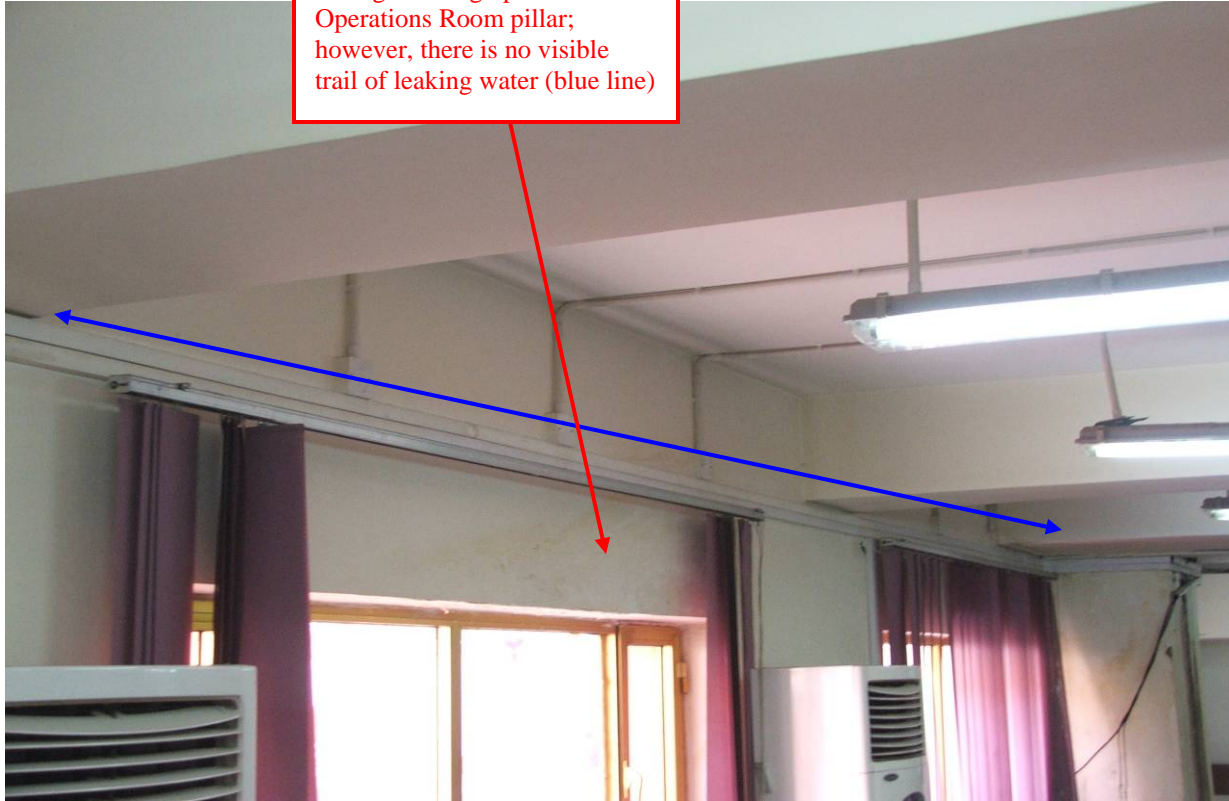
Existence of some water damage leading up to the Operations Room pillar; however, there is no visible trail of leaking water (blue line)

Site Photo 27. View of limited water damage on the ground floor Operations Room ceiling

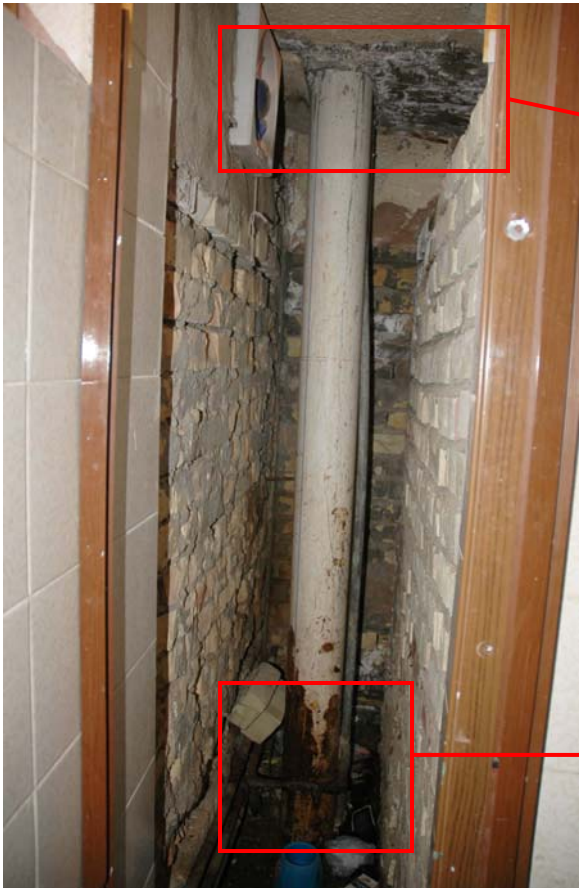
Finally, during our last site visit, in an effort to confirm GRC's theory of water leaking from the first and second floors on the left all the way down to the ground floor Operations Room pillar and beam on the right, we thoroughly inspected the ground floor ceiling. We noticed water damage at various points in the Operations Room; however, these water spots appeared to be old and dried out (Site Photos 36 and 37), while water was still dripping from the ceiling slab of the Operations Room (the slab connected to the pillar) (Site Photo 38). This appeared to disprove GRC's theory that water traveled approximately 37' from left to right within the Operations Room. The more likely scenario is the significant water damage resulted from leaks within the two first floor bathrooms directly on top of the Operations Room beam.

Site Photo 32. Water damage within the first floor bathroom chase

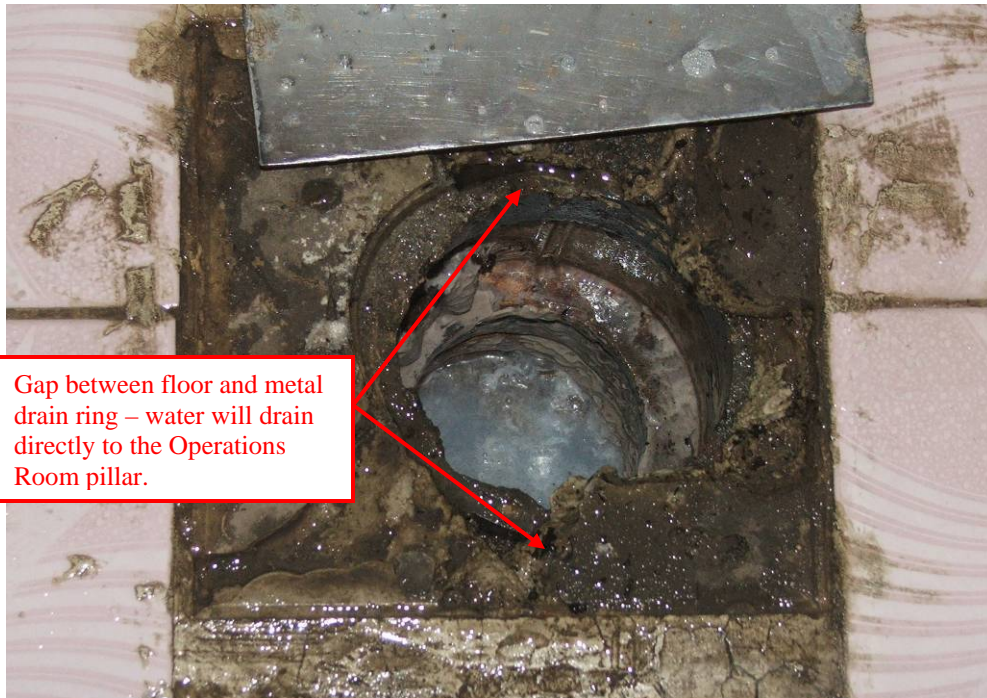
Site Photo 35. Poorly installed floor drain in the first floor bathroom

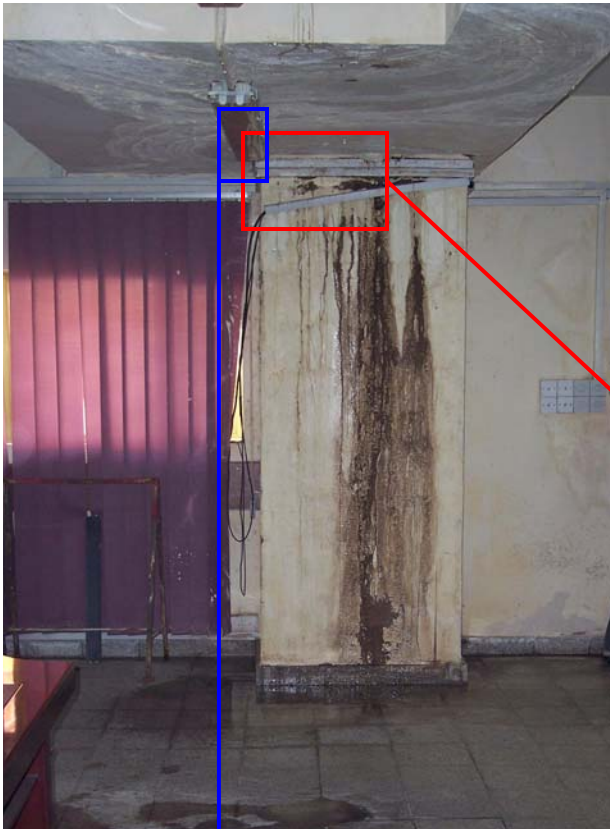
Site Photo 39. Water damage to ground floor Operations Room

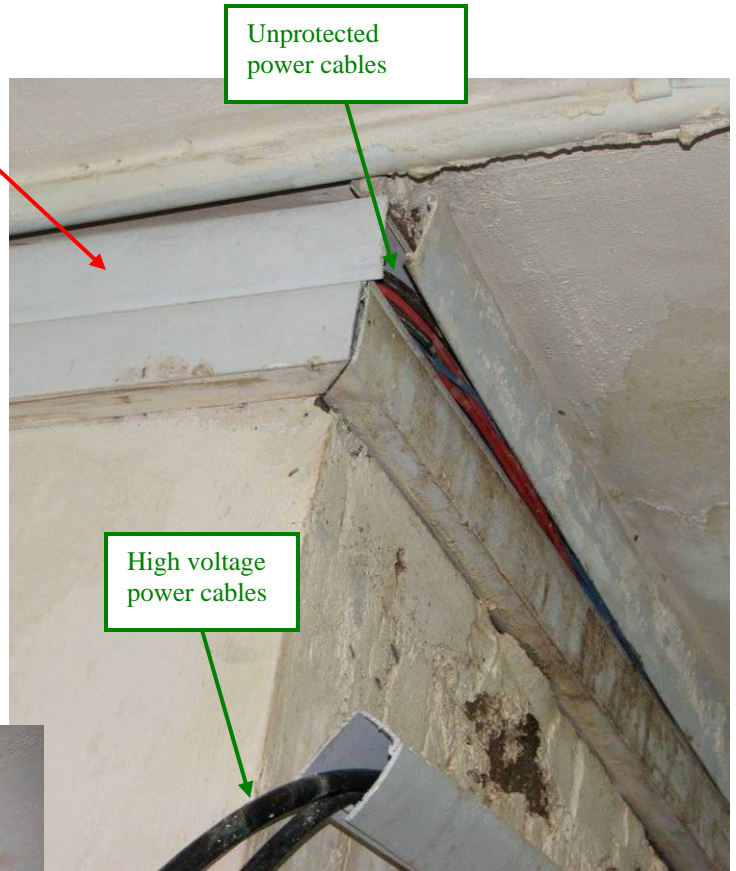
Site Photo 40. Unprotected live wires exposed to leaking water

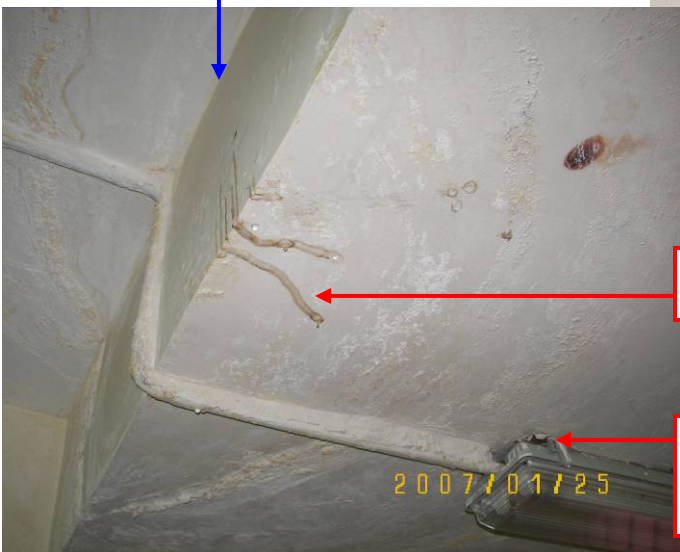
Site Photo 41. Leaking water on the ceiling and open area of light fixture

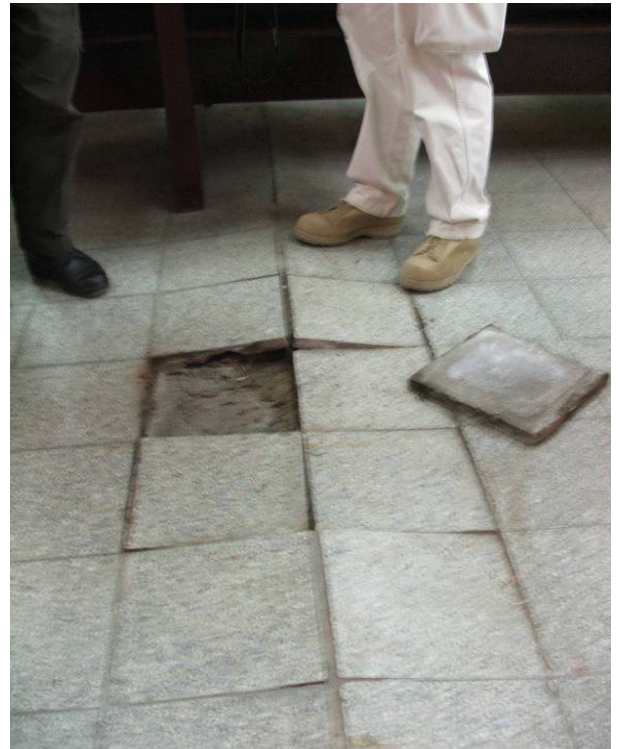
Site Photo 43. Additional view of tile buckling

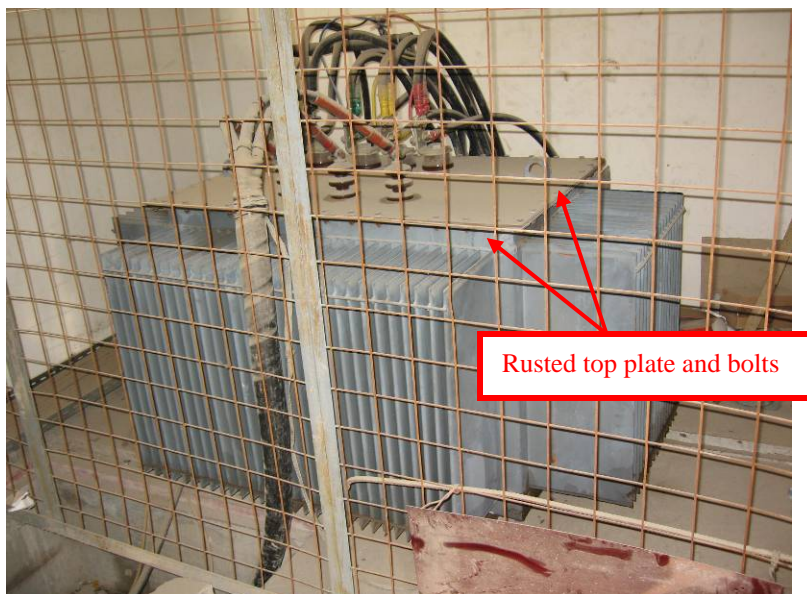
The ICD HQ personnel asserted that the faulty transformer resulted in power surges, contributing to the electrical fires. This theory does not appear to be the reason of the electrical fires. The transformer provides electrical power for the entire ICD HQ facilities, including light fixtures, ceiling fans, outlets, and computers. However, the ICD HQ personnel reported no problems with either ceiling fans or computers. Considering the amount of electrical power they draw, power surges would have a significant effect upon computers.

Site Photo 46. ICD HQ personnel believe this is a used transformer because of its used look (rusted top plate and bolts)

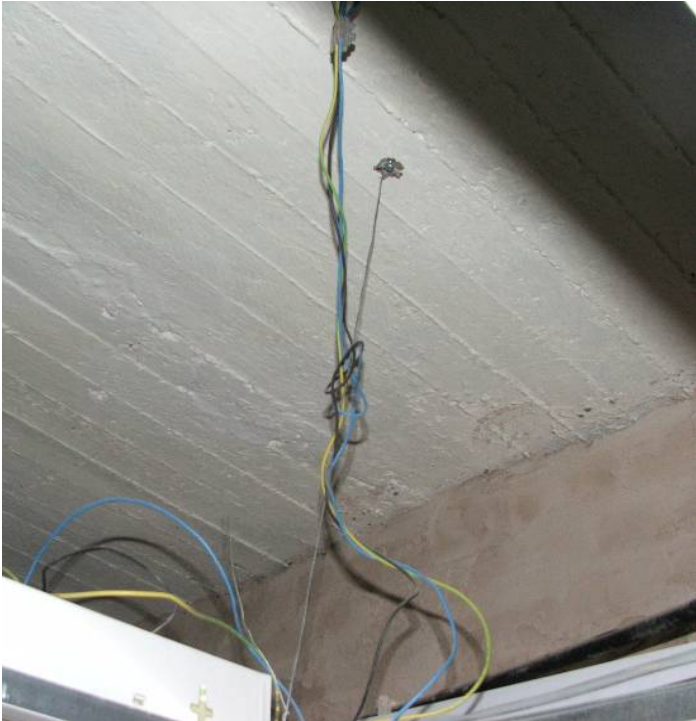
Site Photo 47. Poor electrical installation technique (allowing wires to dangle freely from the ceiling slab)

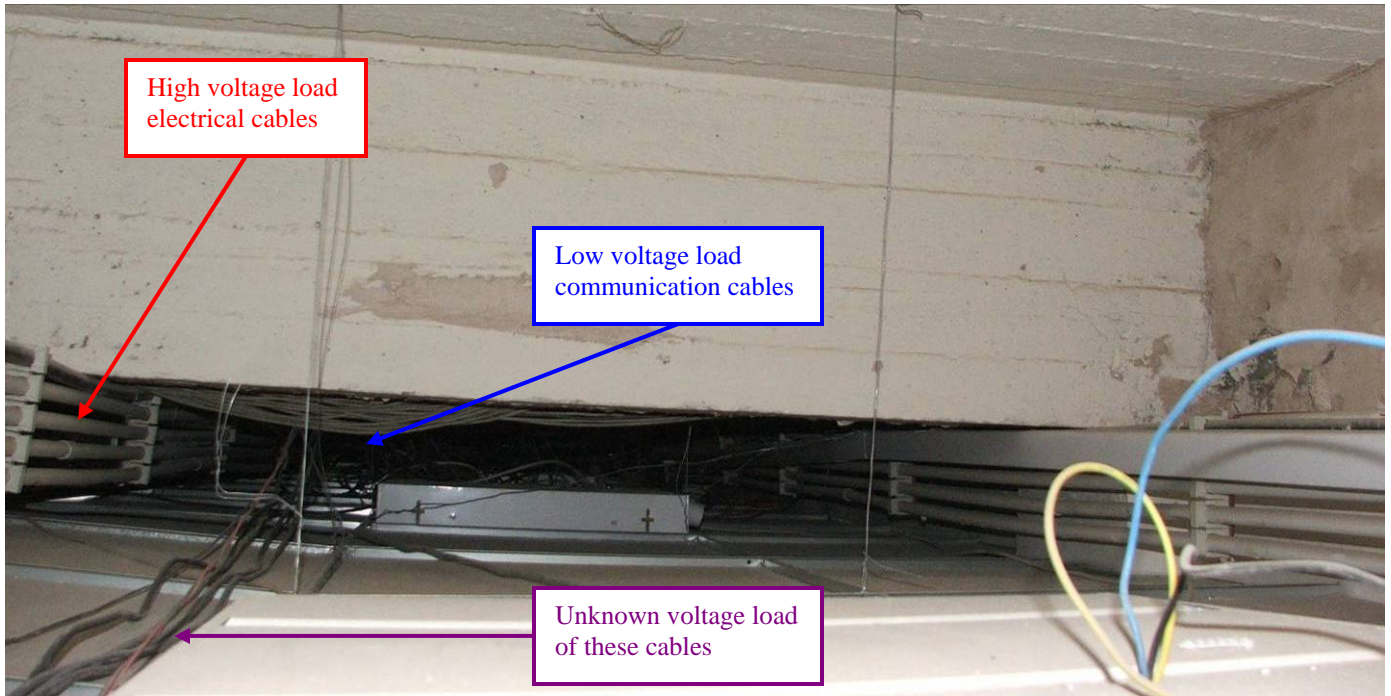
Site Photo 49. Electrical wires carrying varying voltage loads dangerously close to each other

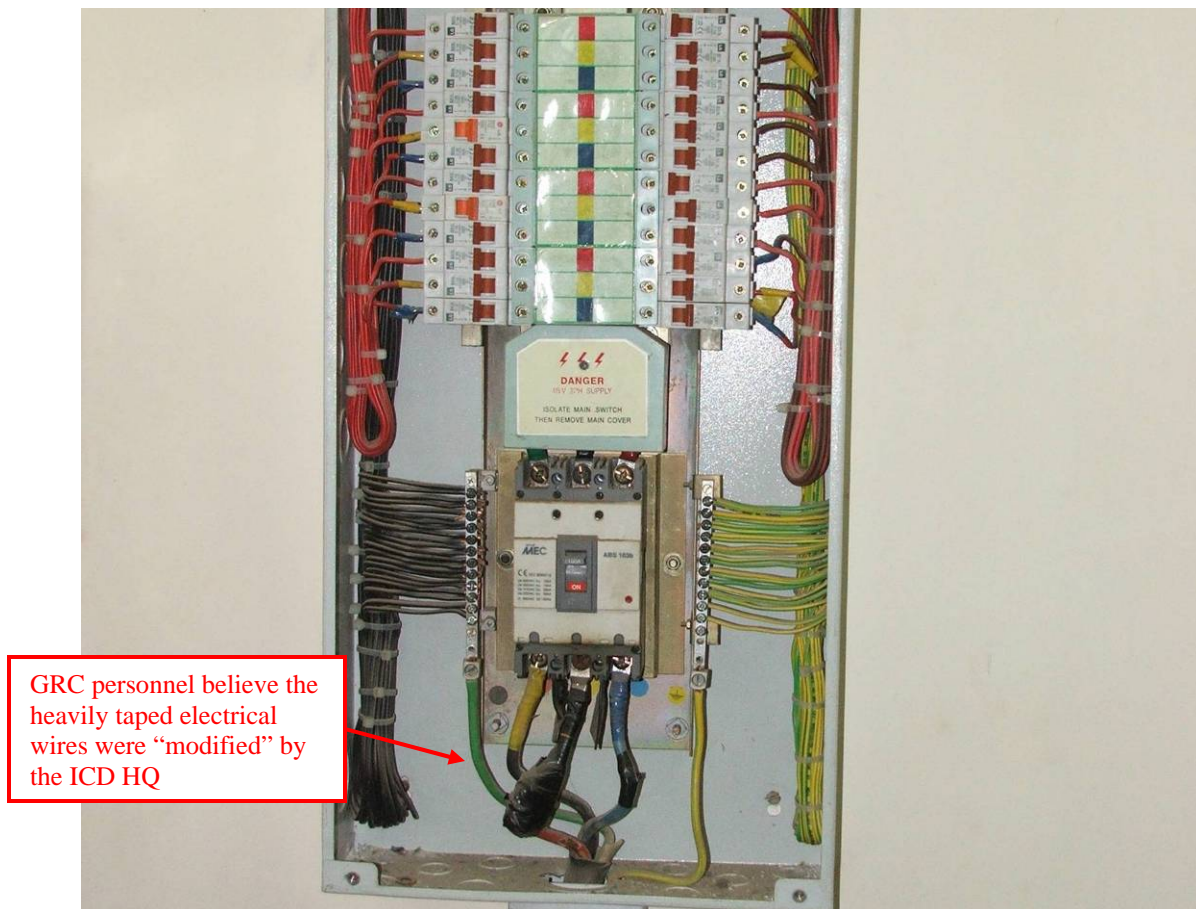
Site Photo 50. Electrical panel GRC believes ICD HQ personnel modified

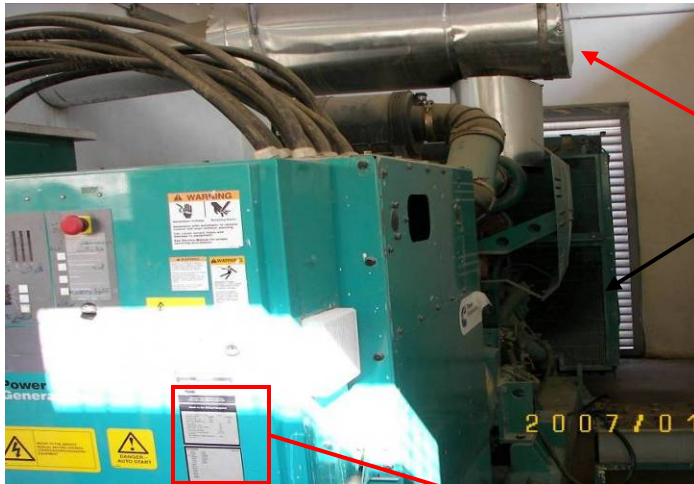
The ICD HQ personnel stated the generator overheats after approximately 1-2 hours of normal use. This deficiency has been documented in several punch-list agreements between Parsons and GRD. The ICD HQ attempted to fix the problem by adding an exhaust vent and radiator to the generator to effectively cool the generator (Site Photos 51 and 52). According to ICD HQ personnel, these add-ons have helped marginally, but the generator still has to be shut down because it will overheat. To date, according to ICD HQ personnel, the problem still has not been adequately addressed by Parsons or GRD and the ICD HQ does not have adequate power to operate essential life safety systems.

Exhaust system (red arrow) and radiator (black arrow) added to the generator in an effort to cool it down. While this has helped, the generator still suffers from overheating.

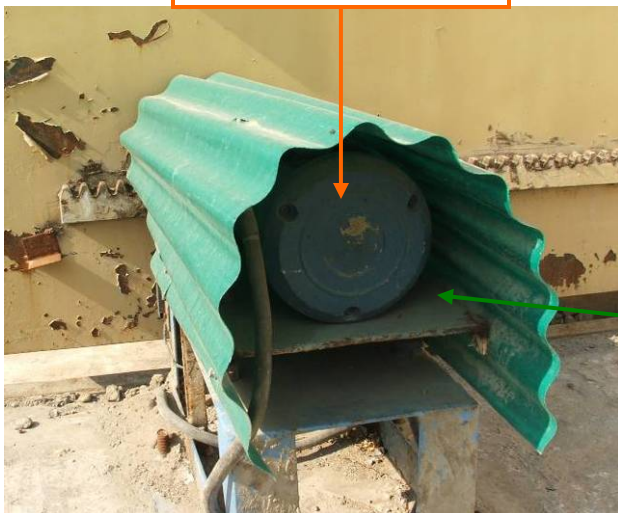
Inadequate size motor – does not produce enough torque to move the gate

Site Photo 53. Enlargement of Sally Port gate motor

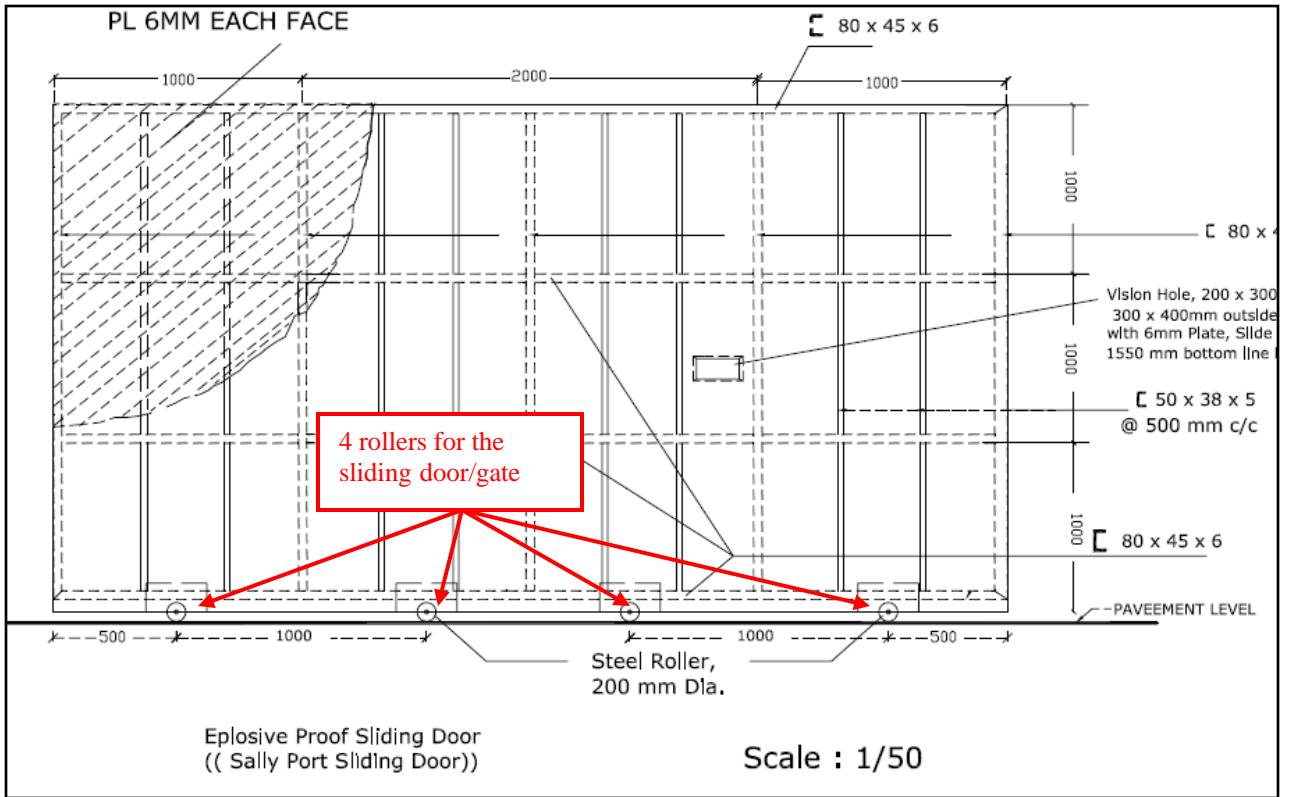
The as-built drawings for the Sally Port sliding gate indicate that each gate has four rollers/wheels and one vision hole (Figure 19). However, during our site visits, we identified that each gate had only two rollers/wheels and at least one gate had no vision hole (Site Photo 60). The lack of two additional rollers means the weight of the anti-explosive gate is distributed over two fewer wheels, resulting in additional stress on the two rollers. The vision hole is critical to enable the sliding gate guard to identify those attempting to enter the ICD HQ compound. Without a vision hole, the guard will have to partially open the sliding door in order to identify anyone approaching; this significantly increases the danger to the guard and the compound.

Figure 19. Sliding door fabrication detail (from as-built drawings)

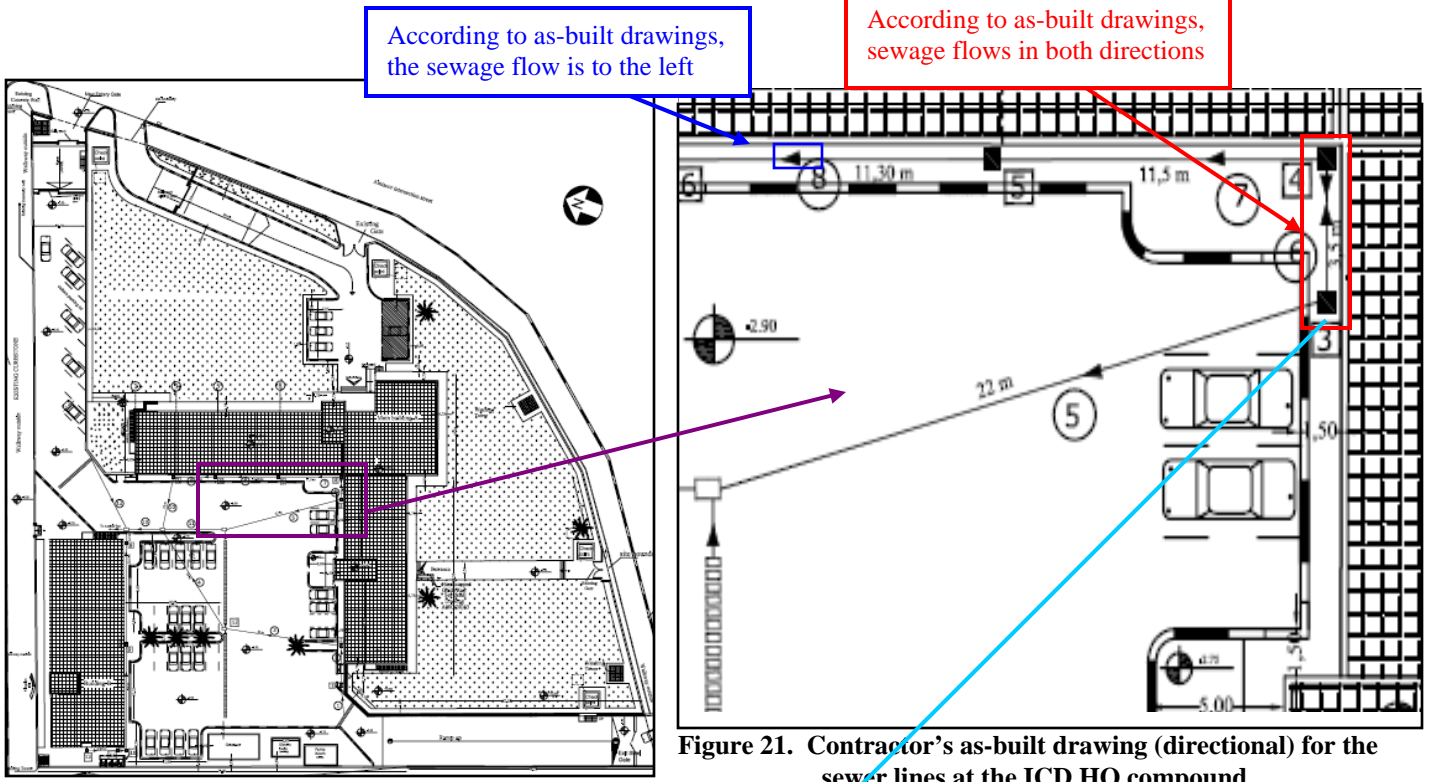
The sewage line site plan as-built drawings for the ICD HQ main building does not provide a correct sewage flow diagram (Figure 20). For example, in one instance sewage appears to flow in opposite directions (Figure 21), which is not possible considering the sewage lines run directionally by gravity. We lifted the manhole cover (Site Photos 61 and 62) and determined that the sewage actually flowed from Box 4 to Box 3. In another instance, the direction of the sewage flow is not correct. Figure 21 shows sewage directional flow running from Box 4 to the left toward Box 5; however, when we lifted the manhole cover, we determined the flow of the sewage line was running from Box 5 to the right to Box 4 and then downward to Box 3 (Figure 22 shows the correct directional flow of sewage lines).

Figure 20. ICD HQ compound

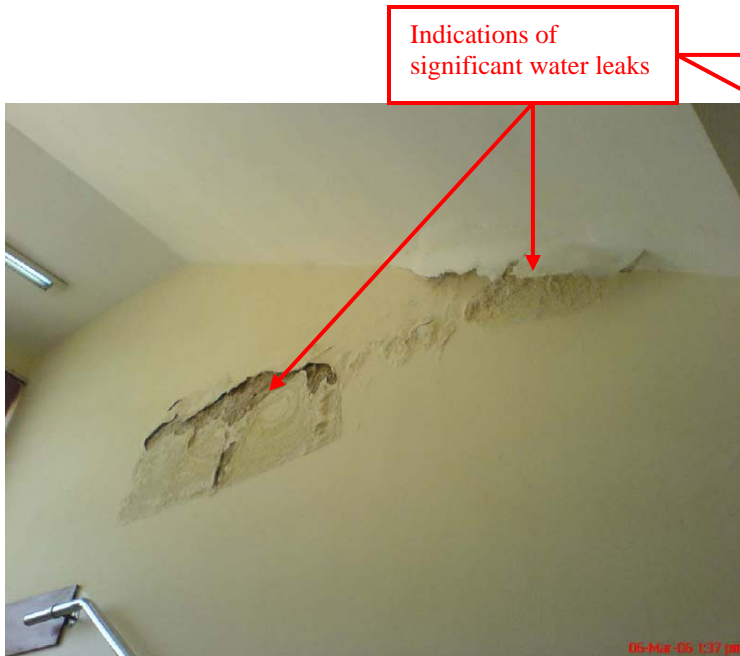
**Site Photo 63. Water damage identified in previous QA reports
(Photo courtesy of USACE)**

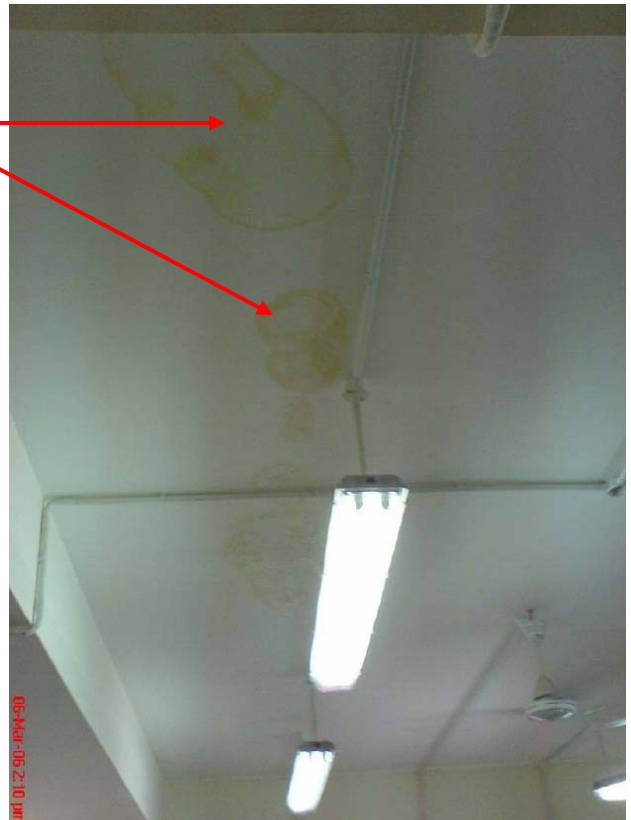
**Site Photo 64. Water damage identified in previous QA reports
(Photo courtesy of USACE)**

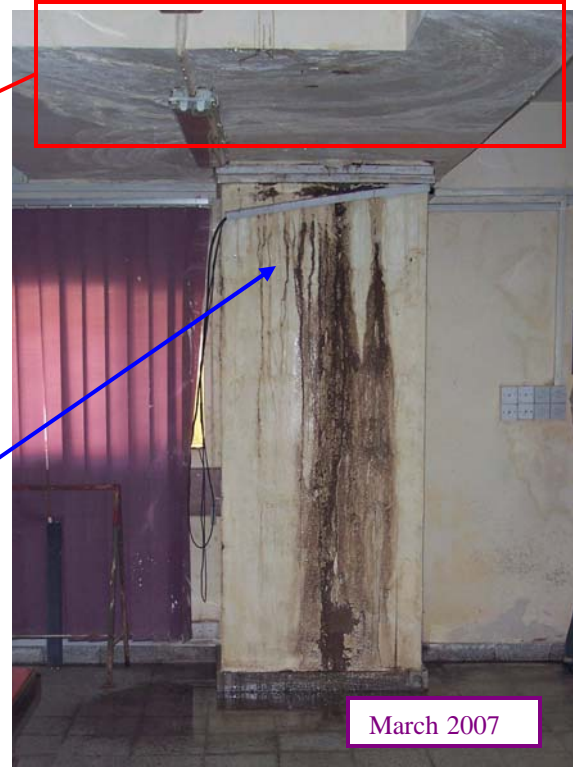
Site Photo 66. Water damage one year later
