## **Pythian Powerhouse and Laundry**

Historic Building Survey

## **Final Report**

(Building No. 503)

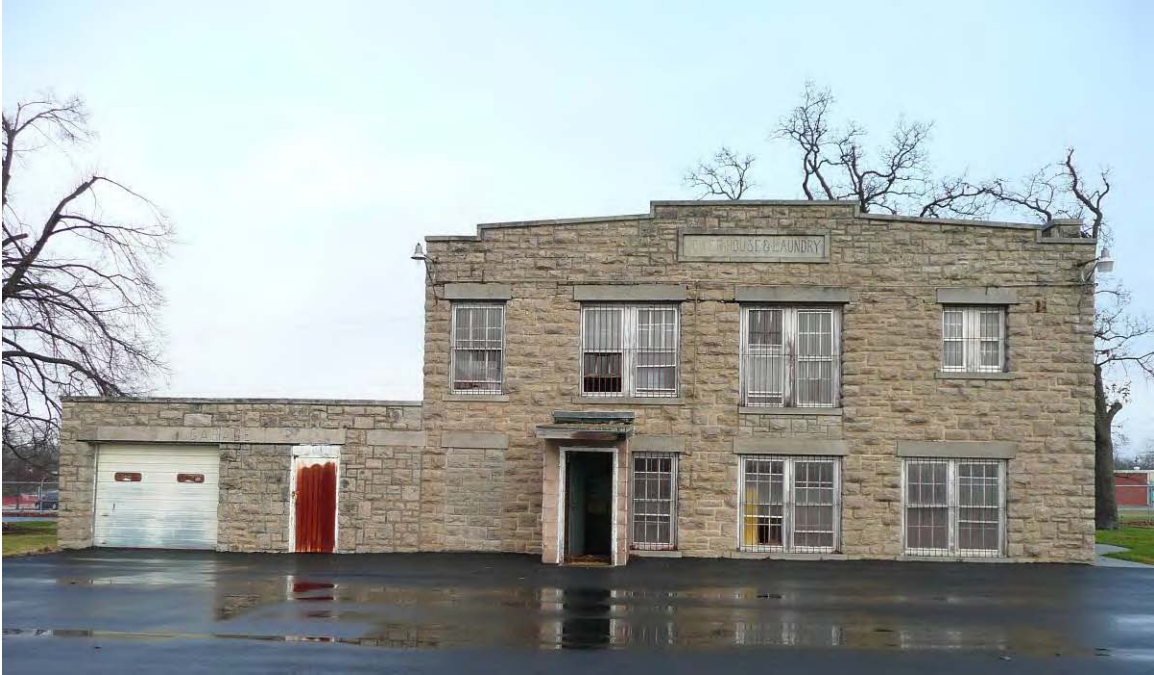
The south elevation (Photo 1) is the main elevation of the building that faces an open, paved parking lot and the rear of the Pythian Home. The south elevation is two different heights. The left side of the elevation is one-story and houses what use to be the garage space (Photo 2). This portion is covered with a sloped roof and a straight parapet with concrete capping. A metal replacement overhead garage door provides access into the one-story interior space. A replacement single metal entry door is located to the right of the garage door opening. This door is showing signs of severe rust damage. A concrete lintel stretches across the garage door opening and is located above the replacement metal door and the letters "GARAGE" are etched into the concrete (Photo 3). To the right of the door on the one-story portion of the exterior wall, an original window has been removed and the opening has been filled in with stone. The concrete lintel remains above the filled opening (Photo 4). The right side of the south elevation is two stories in height and is dominated by several paired wood double-hung windows. This portion of the building is covered with a sloped roof defined by a stepped parapet with concrete capping. There is one single window opening that has been filled in with stone. This window is located on the first floor and to the right of the other filled opening described above. The concrete lintel is intact. To the right of this filled window is a vestibule addition (Photo 5). A small wood structure has been constructed in front of the original single entry door. The vestibule is clad with asbestos cement siding and has a shed roof covered with asphalt shingles. Adjacent to the vestibule is a single six-over-six wood double-hung window (Photo 6). Two sets of paired six-over-six wood double-hung windows are located on the right side of the first floor. The second floor of the exterior wall contains a single six-over-six wood double-hung window, two sets of paired six-over-six wood double-hung windows, and a set of smaller paired four-over-four wood double-hung windows. Located above the windows in the center of the wall is a concrete sign. Etched in the sign are the letters "POWER HOUSE & LAUNDRY" (Photo 7). Two decorative light fixtures are located at the top edges of the exterior wall (Photo 8).

**Photo 1 – south elevation; overall view**

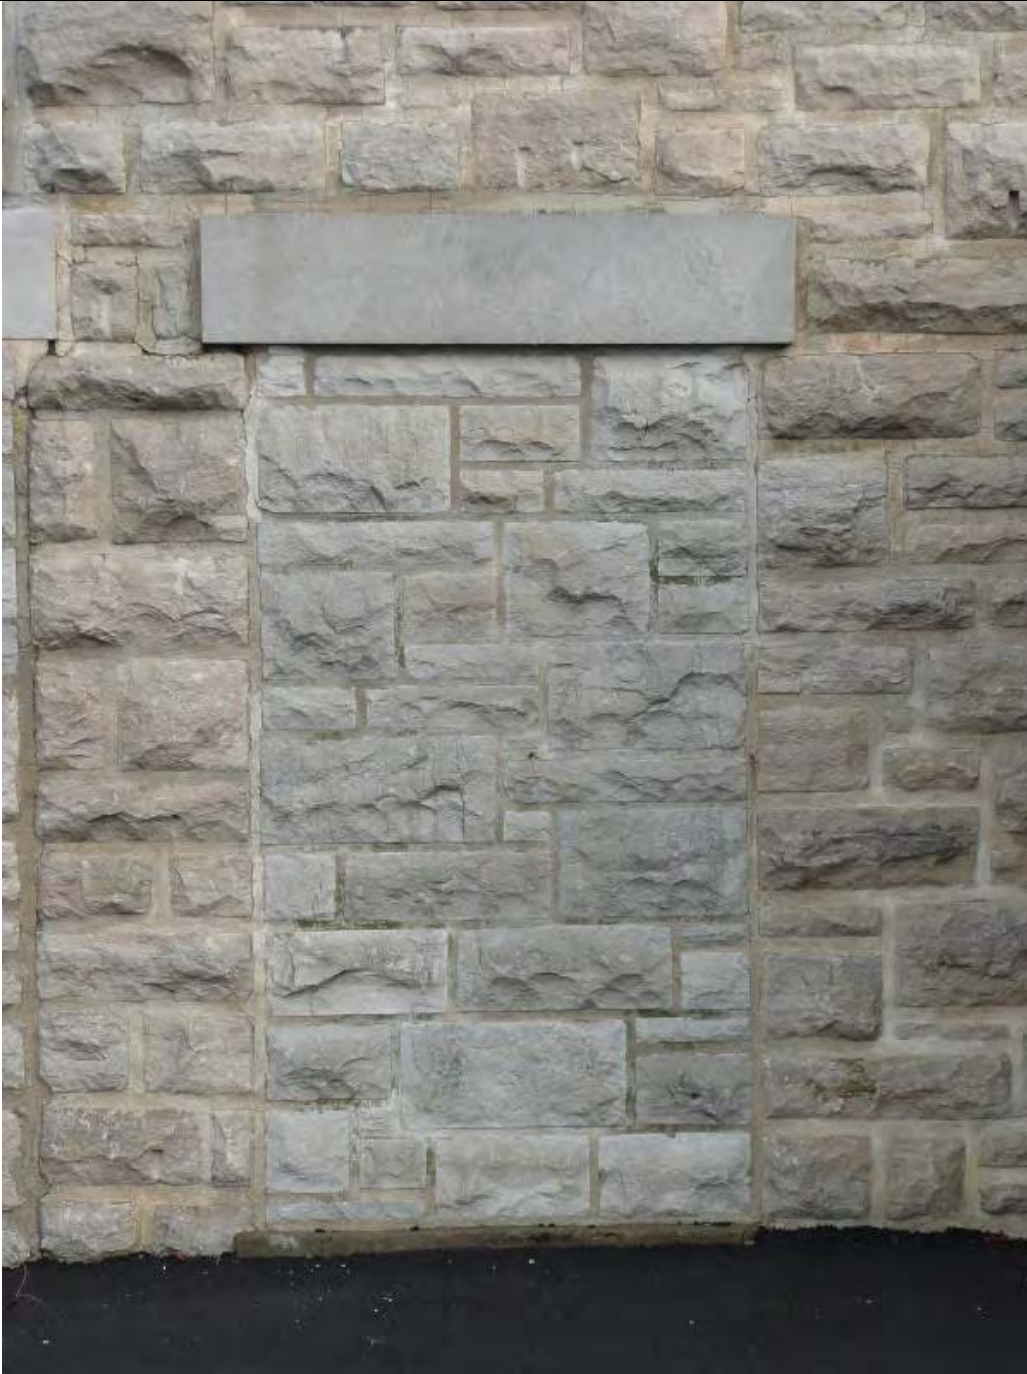
It is unknown if the one-story garage on the west side of the two-story Powerhouse and Laundry building was original to the design or if it was added at a later date. Also there is a window modification on the south elevation second floor. It is believed that the paired windows in the middle of the second floor replace a door opening (Photo 21). This door opening would have been added during World War II to provide access to the laundry area on the second floor. The windows that currently fill in the door opening are slightly larger than the other paired wood double-hung windows found on the building and the limestone located below the opening is slightly different in texture and in color.

**Photo 4 – view of modified filled window opening on south elevation**

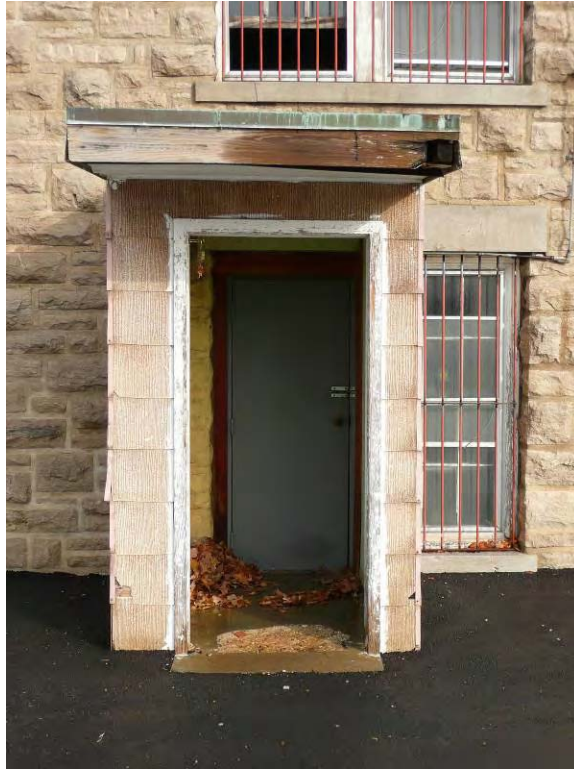
**Photo 6 – close-up of window modification  
near vestibule addition on south elevation**

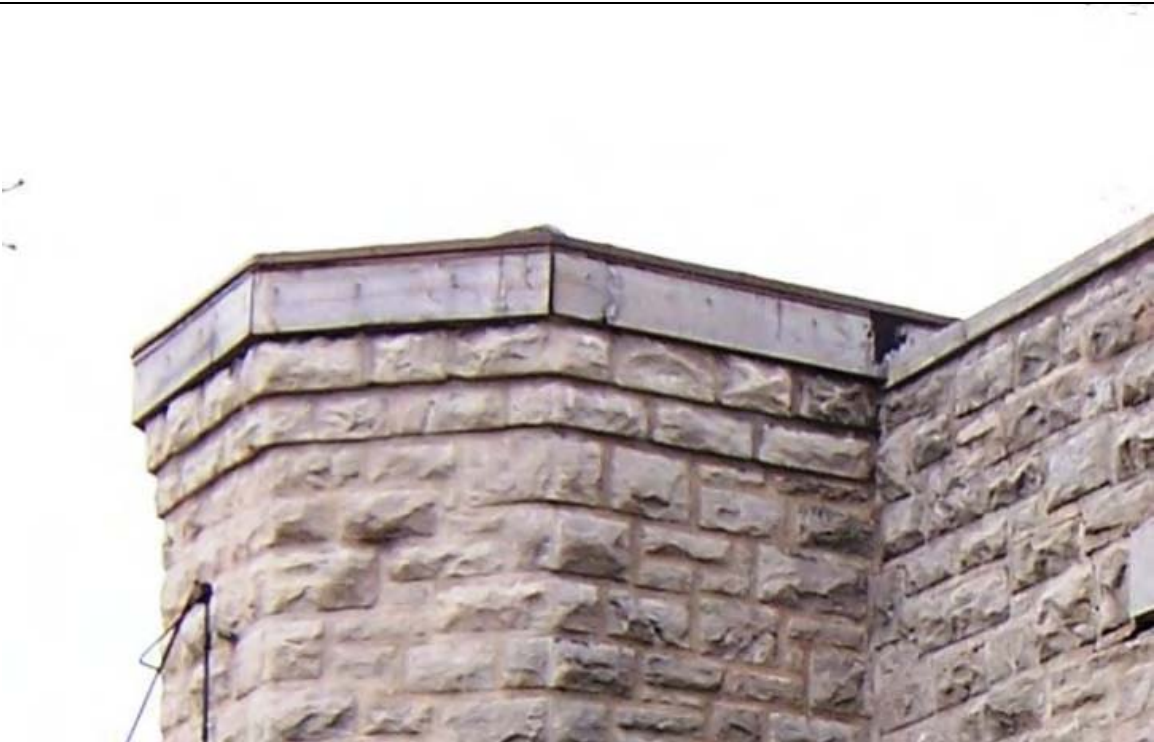
The east elevation (Photo 9) is where the original chimney stack was located. A majority of the stack is intact; however, the top portion of the stack that extended above the two-story roof height has been removed and has been capped off (Photo 10). The chimney is located in the center of the elevation and is five-sided. There are two sets of paired wood double-hung windows on the first floor; one on each side of the chimney. One single six-over-six wood double-hung window is to the right of the chim-

**Photo 10 – close-up of chimney stack modificaiton**

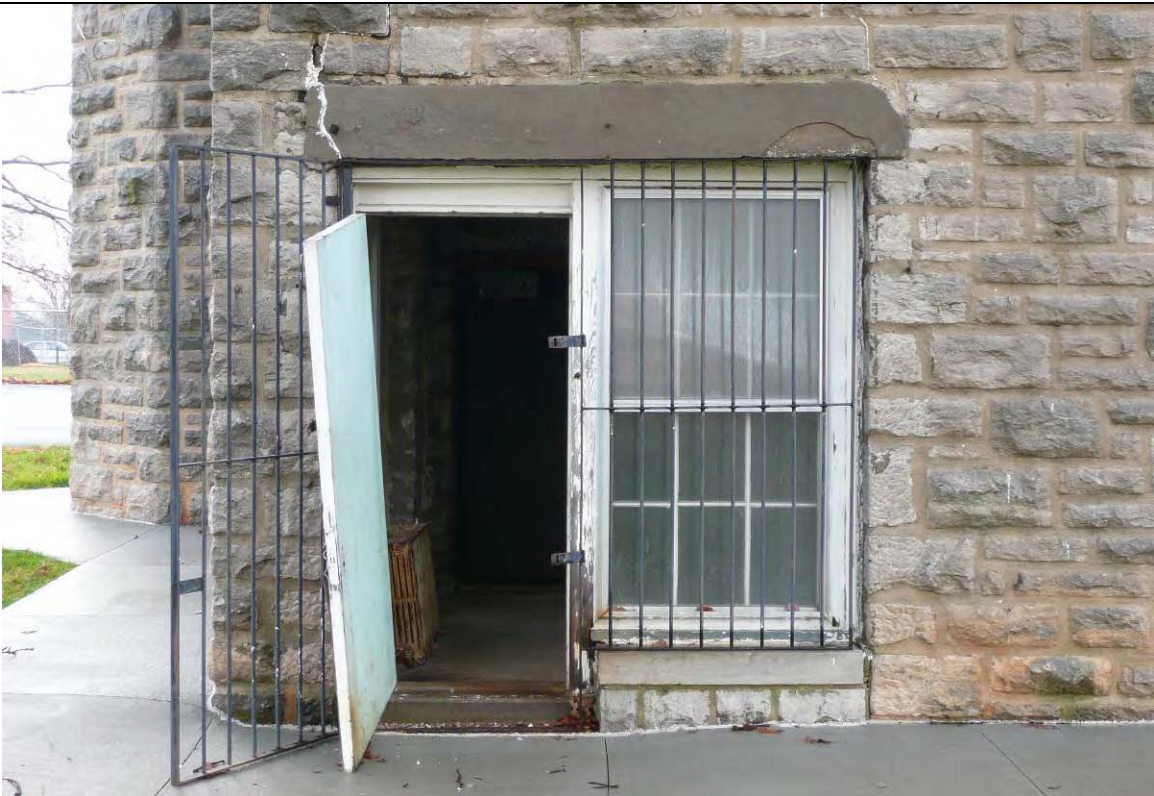
The north elevation (Photo 11) is defined by several window openings. The majority of the elevation is two-stories tall. The first floor of the two-story exterior wall has a window opening modified with one window and a replacement door (Photo 12), one set of paired six-over-six wood double-hung windows, a modified window opening that has been filled in with stone, and one single six-over-six wood double-hung window. The second floor consists of four evenly spaced single six-over-six wood double-hung windows. All of the windows have concrete windowsills and lintels and are covered with metal security bars. The right side of the north elevation is recessed from the two-story portion. The right side is one-story tall and has one smaller three-pane wood awning window with a concrete windowsill and a small single-pane fixed window without a concrete windowsill (Photo 27).

**Photo 12 – close-up of window modification on north elevation**

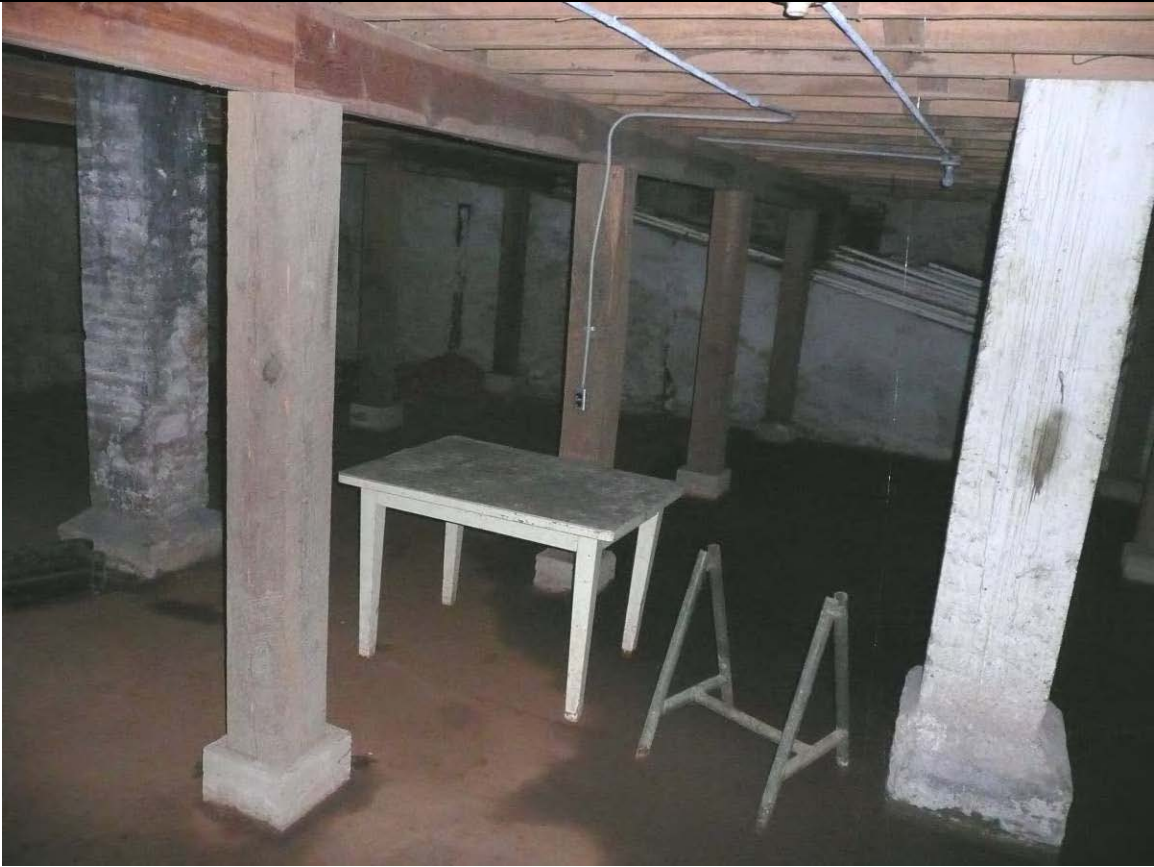
4. Structural System, Framing: The building has a simple structural system. The exterior walls are approximately 1'-10" thick cut limestone. Two concrete columns are located in the two-story space that extends from the lower level (basement) up through the second floor. These 1'-0" by 1'-0" columns are set within a concrete pier. Each column base measures 1'-6" by 1'-6". The columns are located 24'-0" from the east wall and 12'-2" and 24'-10" from the south wall (Photo 14). Newer 0'-8" by 0'-8" wood columns are spread throughout the basement to support the wood floor addition above. These columns are set within concrete foundations (Photo 15).

**Photo 15 – view of added wood columns used to support first floor**

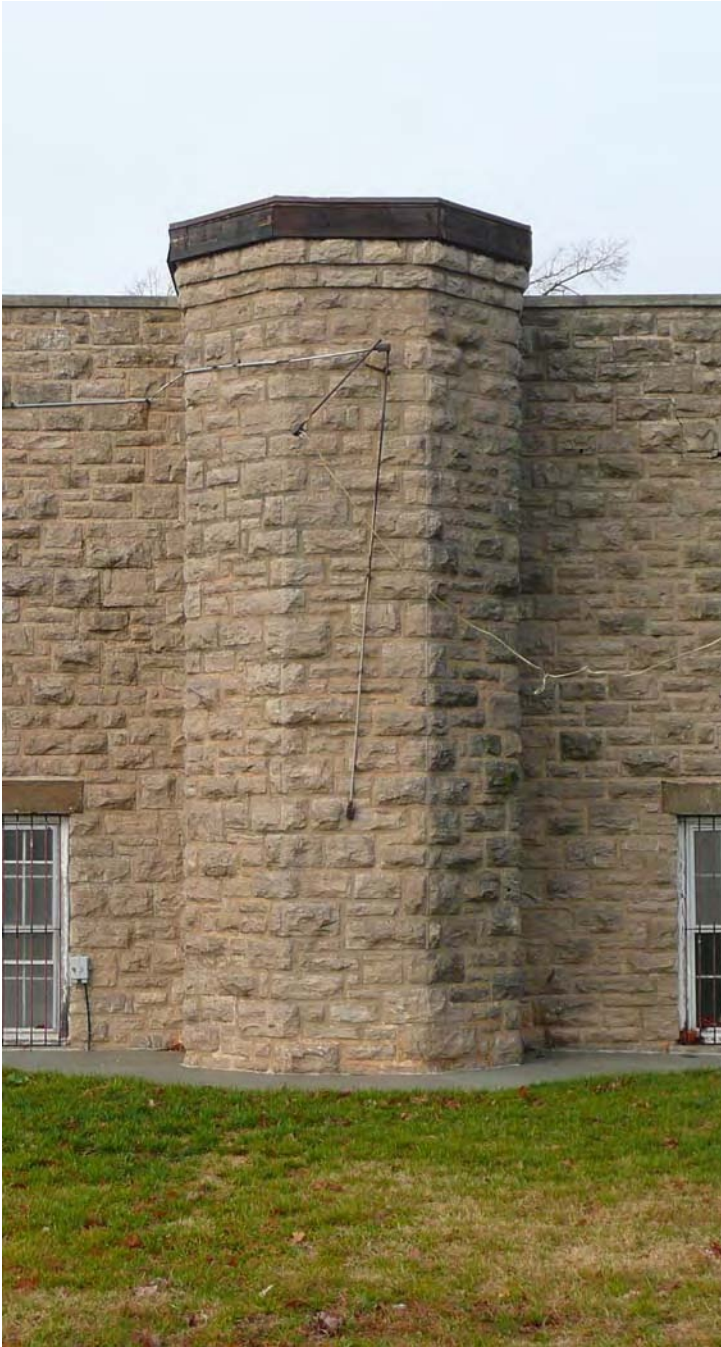
6. Chimneys: A five-sided chimney is located on the exterior of the east wall (Photo 16). The chimney is constructed of the same cut limestone. The original stack has been removed and the remaining portion of the chimney has been capped. The chimney width is 10'-0" across. The five sides measure 4'-6", 3'-8", 3'-10", 3'-8", and 4'-6". The current height of the chimney is 22'-0".

**Photo 16 – overall view of modified chimney on east elevation**
