RUBIDIUM AND CESIUM FREQUENCY STANDARDS
STATUS AND PERFORMANCE ON THE GPS PROGRAM
HARRY BETHKE, DALE RINGER AND M. VAN MELLE

Rockwell International
Satellite System Division
Seal Beach, California

13. SUPPLEMENTARY NOTES Proceedings of the Sixteenth Annual Precise Time and Time Interval (PTTI) Applications and Planning Meeting, Greenbelt, MD, 27-29 Nov 1984

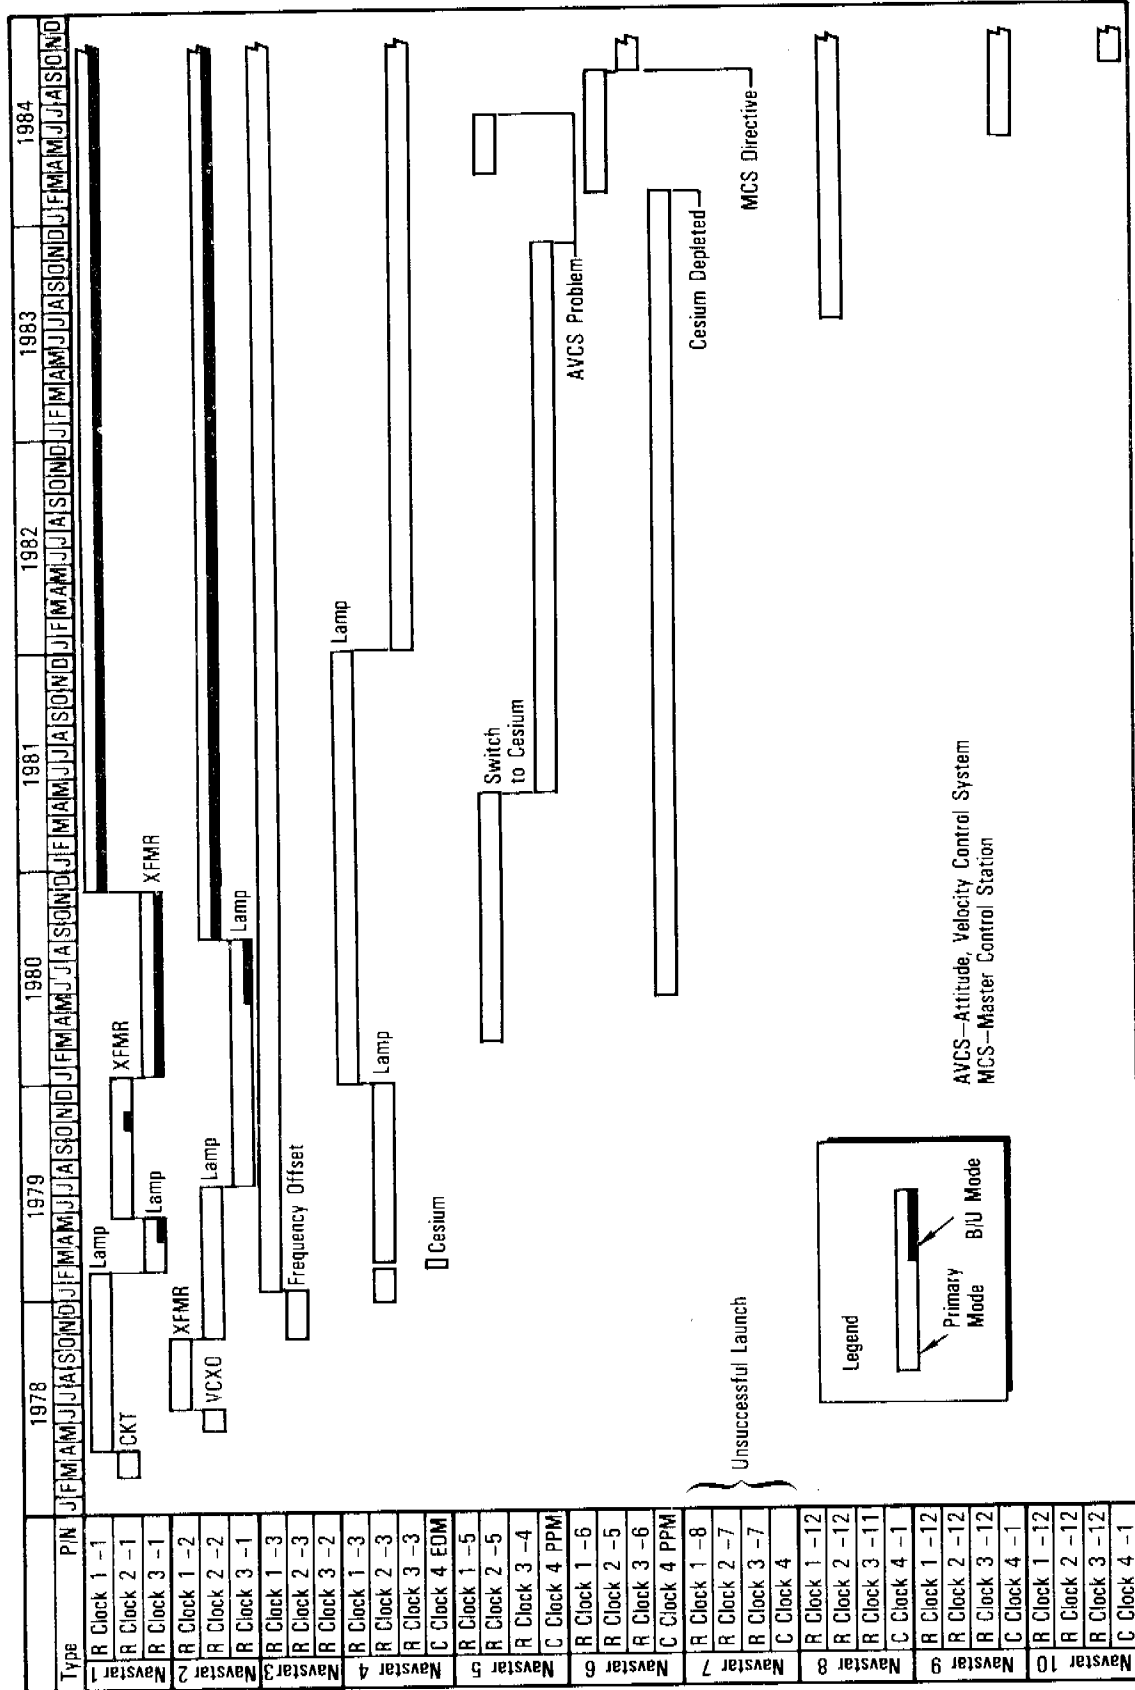
Figure 1. Navstar Clock Operating History

The evolution of the Rb frequency standards (RFS) on the GPS program started with the Block I concept validation program beginning with a proposal program in 1973, followed by the (GPS 1-8) prototype space vehicle contract in 1974. The full scale developmental (GPS 9-11) models, contracted in 1978, provided both navigation and nuclear detection capability. The production qual vehicle (GPS-12) was contracted in 1980, and the production vehicles (GPS 13-40) in 1982. During the proposal phase of this program, the on-board frequency standards were considered the most critical item within the GPS navigational system for achieving user position accuracy. Therefore, a considerable amount of effort was devoted to the frequency standards. To minimize the risk to the GPS program on this critical item, the initial GPS vehicles (GPS 1 through 3) incorporated three Rb frequency standards, each with a backup mode. This was achieved by operating a high performance VCXO without Rb reference. This design concept resulted in the redundancy potential of six frequency standards per vehicle. Later space vehicles, starting with GPS 4, included an additional cesium frequency standard, also with a backup VCXO mode. This extended redundancy was deemed necessary in lieu of the more conventional dual redundancy. The actual on-orbit GPS frequency standard operating history, shown in Figure 1, illustrates the results of this hardware implementation.

On-orbit operation data of GPS Rb frequency standards started with Navstar 1 in March, 1978, followed by Navstar 2 in May, 1978. The original Dash 001 part number clocks were used in Positions 1, 2, and 3 on Navstar 1 and in Positions 3 on Navstar 2. Dash 002 clocks were used in Positions 1 and 2 and Navstar 2. The only difference in the Dash 002 from the Dash 001 clocks was a time constant change in the servo control loop. As shown in Figure 1, three types of problems were experienced:

1. Power supply transformer failures
2. Lamp failures
3. Low frequency oscillation of the VXCO heater control

The new transformer was installed in all Dash 003 and subsequent clocks. Results of this change are very apparent from the data shown on Table 1. A total of 186 months (15.6 years) of on-orbit operation have accumulated with no transformer failures. Referring to Figure 1, note that Frequency Standard 1 on Navstar 3 has been operating continuously for 70 months (approximately six years); this provides a very high degree of confidence that the transformer problem has been corrected.

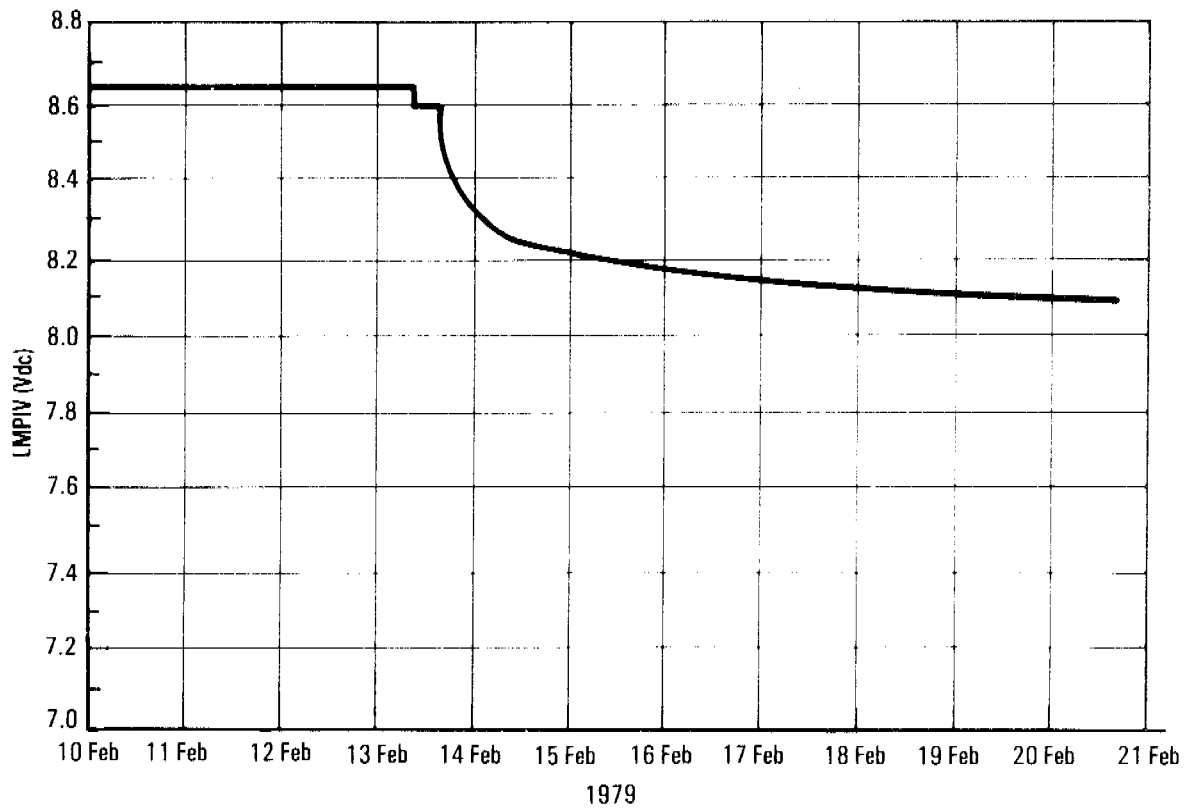
Figure 2. Navstar 1 Frequency Standard No. 1 LMPIV Anomaly

The Rb lamp failures were perhaps the most critical on-orbit problem encountered on the early space vehicles. To investigate the problem, a team was assembled that consisted of representatives from Rockwell, the National Bureau of Standards, Duke University, the USAF, Aerospace Corporation, and Efratom. Once the clock failure was established to be the lamp, a plan was initiated to duplicate the on-orbit failures in the laboratory. Lamps were prepared with an intentionally low Rb fill, installed into the physics packages, and subsequently installed into several frequency standards. Laboratory testing on these standards duplicated the on-orbit lamp failures. All units exhibited the same lamp voltage decay characteristics symbolic of the suspected lamp failures as illustrated in Figure 2.

To determine the amount of Rb in the lamps, a three-fold corrective plan of action was instituted:

1. For Rb lamps already built, the fill would be determined by neutron activation.
2. The fill of newly fabricated lamps would be determined by sampled destructive analysis.

3. A calorimetric measurement utilizing a differential scanning calorimeter is now used.

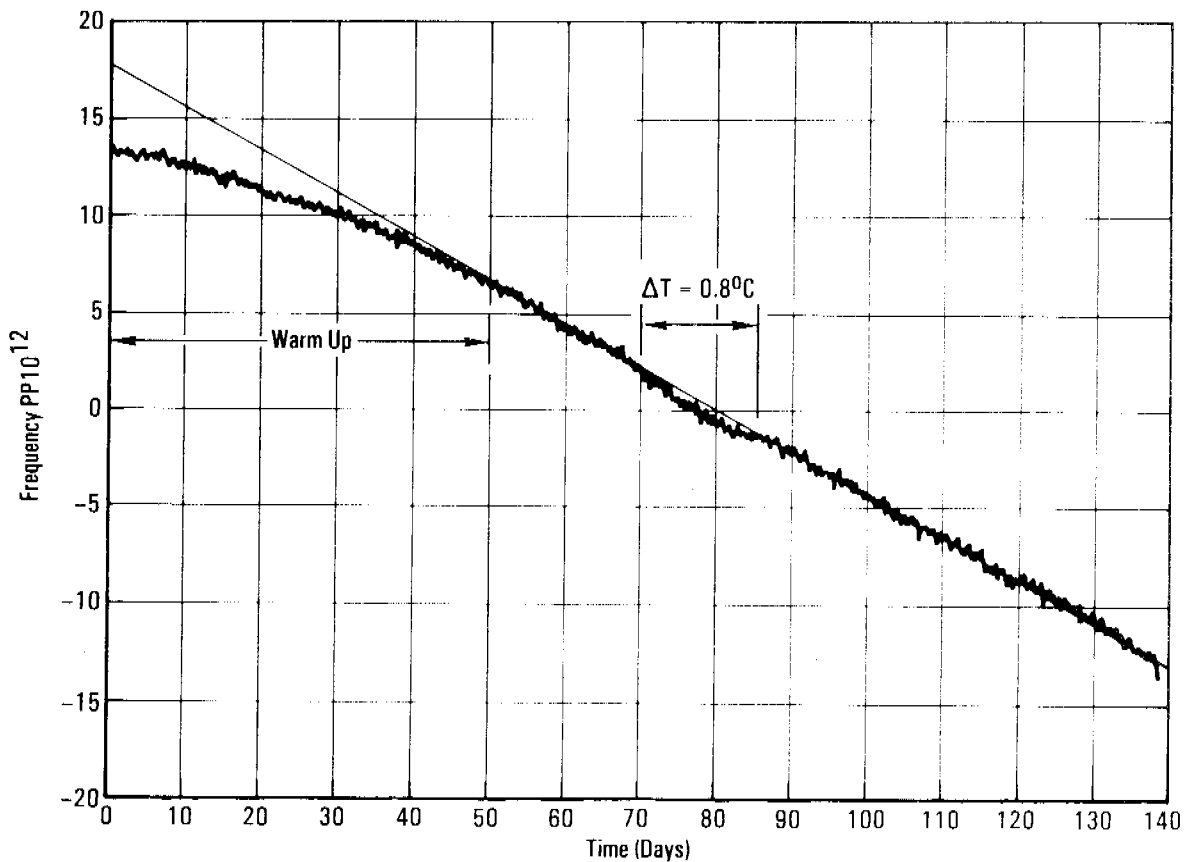
Figure 3. GPS 140-day Rb Stability Test

The beat frequency, $\Delta f/f$, is shown in Figure 3. The frequency was calculated from 1,000-second period average data, which was then averaged over 10 data points to conform to computer storage requirements. Examination of the entire 140-day period shows an initial "warmup" period of about 50 days, during which the drift changes from about minus $6 \times 10^{-14} \Delta f/f/\text{day}$ to minus $2 \times 10^{-13} \Delta f/f/\text{day}$. The frequency drift is relatively constant from Day 50 to Day 140, except for a dip from Day 70 to Day 86. This dip correlates to a drop the clock baseplate temperature of about 0.8°C . This points out the critical role that temperature stability plays with frequency and time prediction error.

It was seen from the baseplate temperature that a 0.8°C temperature plateau resulted in a small frequency shift. For a 15-day period, this gave a 600 to 700-nanosecond offset. This period influenced longer data length prediction intervals before, during, and after the occurrence of the plateau. All subsequent RFS's now are being controlled to $\pm 0.1^\circ\text{C}$ by a temperature controller.

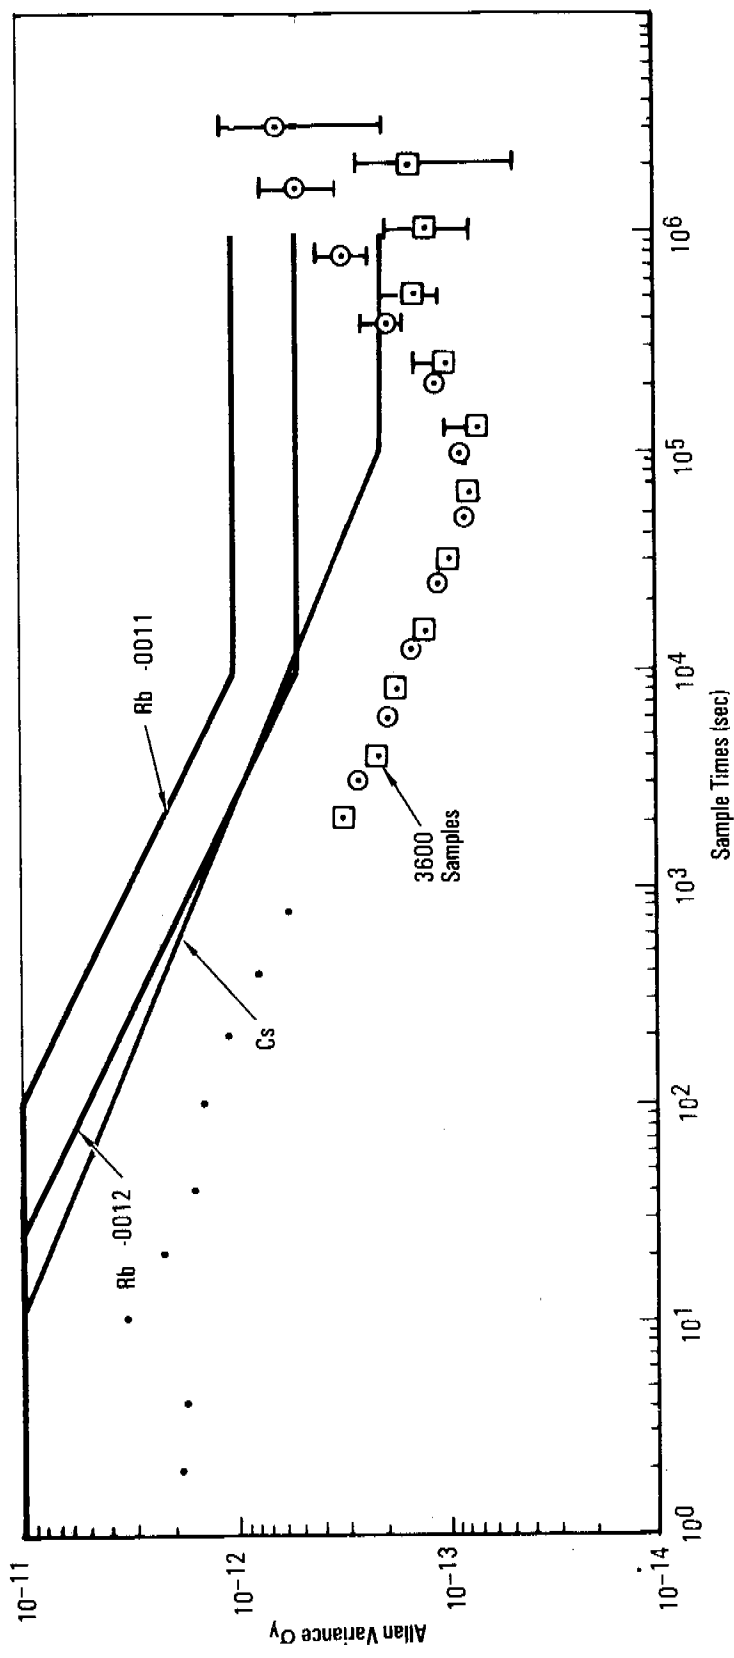
Figure 4. IR&D Time Error 140-day Stability Test Rb Frequency Standard No. LQX0001

The Allan variance, σ_y , can be calculated both with and without the warmup period data. It can be seen in Figure 4 that the main effect of the behavior is on the long-term values or the "random walk." The total data σ_y represents the usual RFS Allan variance signature; whereas, the day 50-150 σ_y values are better in terms of random walk. If μ is the slope of the random walk portion of the Allan variance plot where $\sigma_y \sim t\mu$ for large t , then $\mu = 0.7$ for Day 0 to Day 140 data, and $\mu \approx 0.1$ for Day 50 to Day 140 data.

- 1,10,100 sec Date: Day 1
- ⊙ 1000 sec Date: Day 2 To Day 140; Drift/Day = -2.00075×10^{-13}
- ⊠ 1000 sec Date: Day 50 To Day 140; Drift/Day = -2.16956×10^{-13}
