# **A BRIEF DISCUSSION OF A RECENT EXPLOSIVE ACCIDENT AT THE NAVAL SURFACE WARFARE CENTER**

M. M. Swisdak, Jr.  
Naval Surface Warfare Center/Indian Head Division

**28<sup>th</sup> DoD Explosives Safety Seminar  
August 1998**

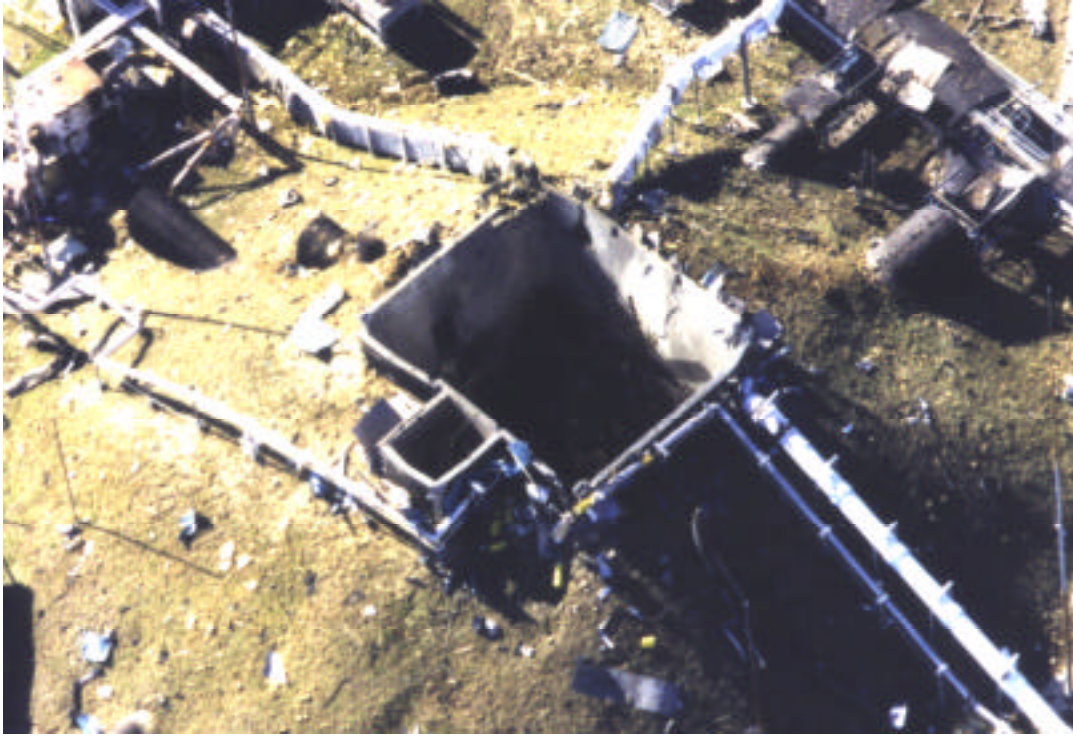
**FIGURE 3. AERIAL VIEW OF BUILDING**

The event caused the top of the walls of the structure to deflect outward about 3.7 feet. This deflection began at a hinge point located 13.3 feet below the top of the wall. The mezzanine and first floors were blown down to the ground floor of the structure. Figures 3 and 4 show two views of this damage.

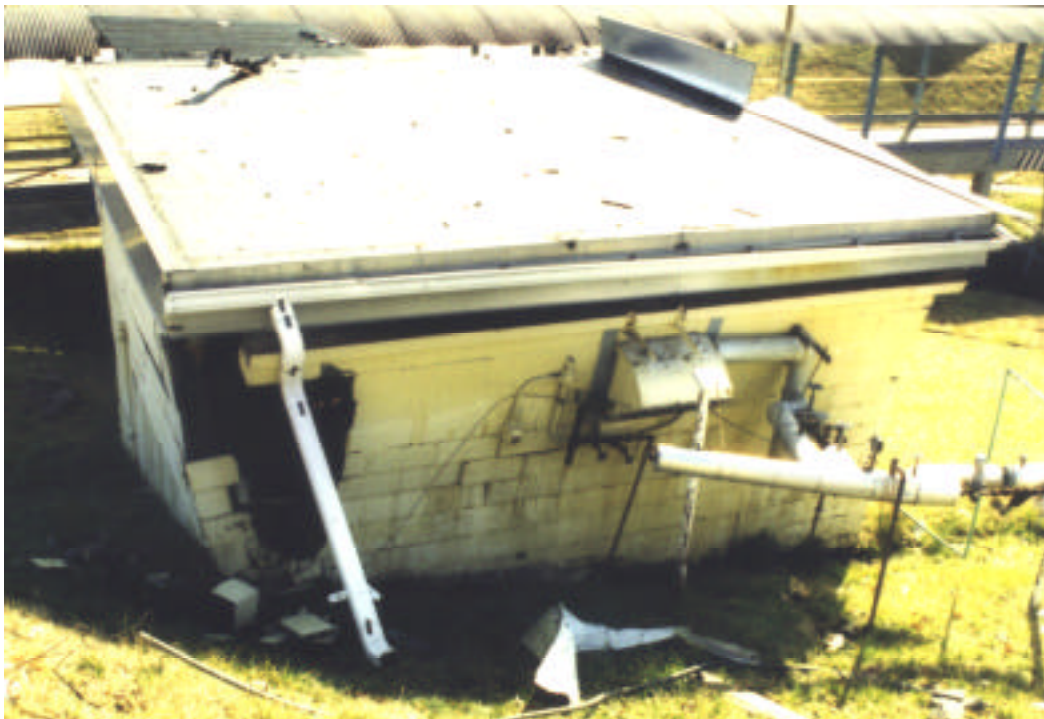
The damage that was observed in the surrounding structures appeared to be directional rather than being symmetrical centered on the structure. This is attributed to the numerous tunnel entrances to the building. Under normal circumstances, the airblast from this type of event would be symmetrical. This phenomenon has been studied by NCEL (Naval Civil Engineering Laboratory, now Naval Facilities Engineering Service Center (NFESC)) and is described as airblast from a four wall, vented cubicle<sup>1</sup>. In our situation, however, another event is superimposed on this airblast. That is the highly directional airblast that is directed out each of the tunnels. It is this non-classical, directed-flow airblast that causes the majority of the observed damage to the surrounding structures<sup>2</sup>. The following figures (Figure 5 through Figure 9) show some of this damage.

**FIGURE 5. DAMAGE TO NEARBY CONCRETE BLOCK STRUCTURE**

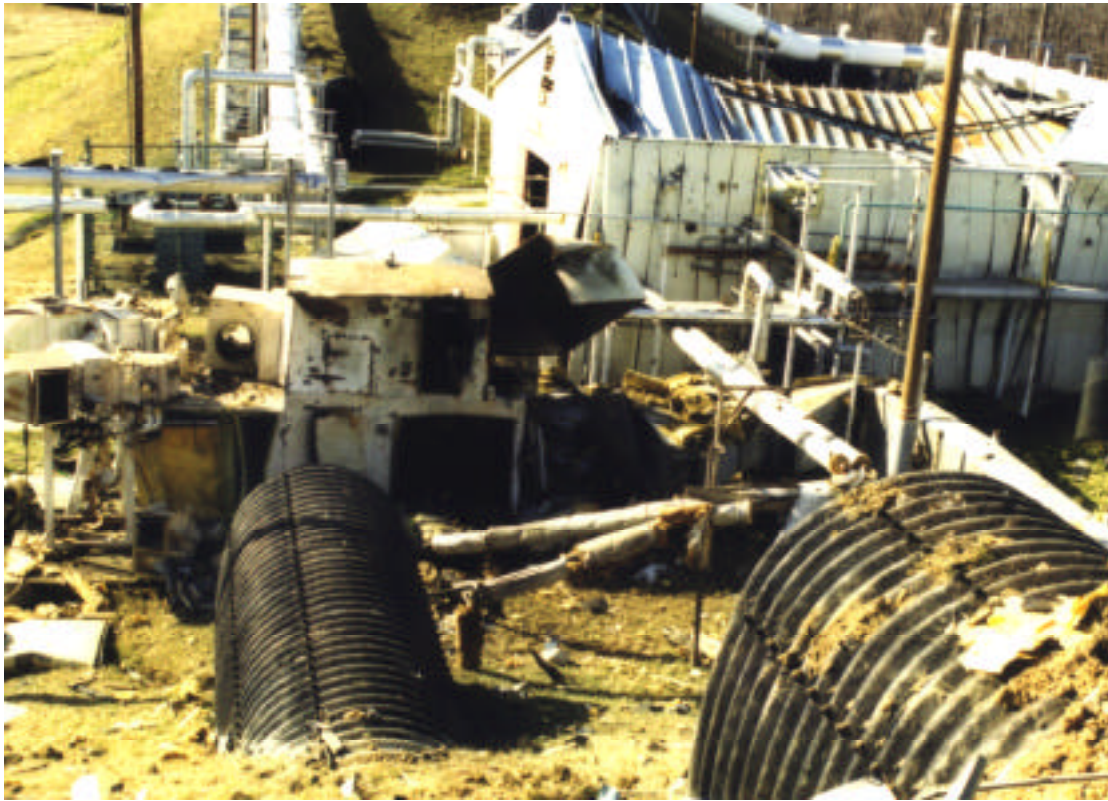
**FIGURE 6. VIEW FROM TUNNEL ENTRANCE**

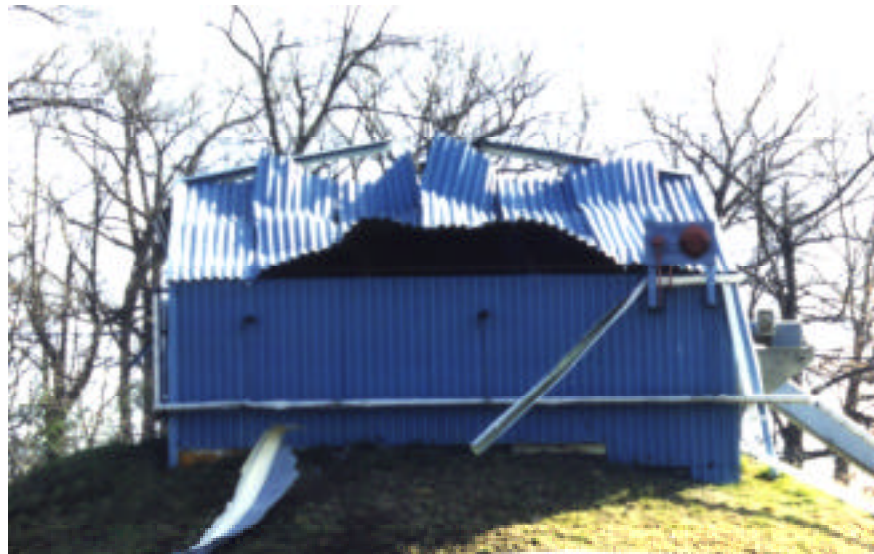
**FIGURE 7. TYPICAL DAMAGE**

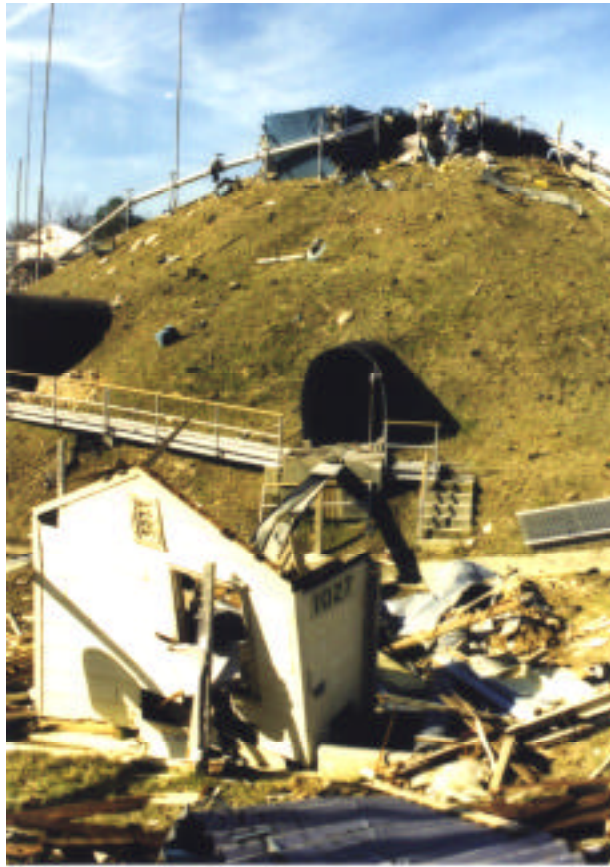
**FIGURE 8. EXTERNAL DAMAGE**

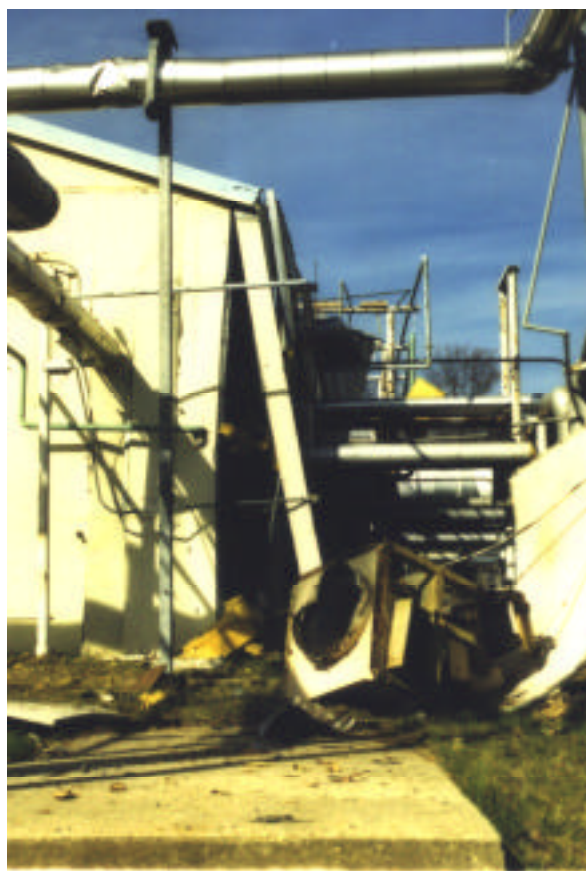
**FIGURE 9. DAMAGE TO NEARBY EQUIPMENT BUILDING**
