# **Lipari Landfill Piping Network Corrosion Condition Assessment and Service Life Prediction Analysis**

December 2008

Final report

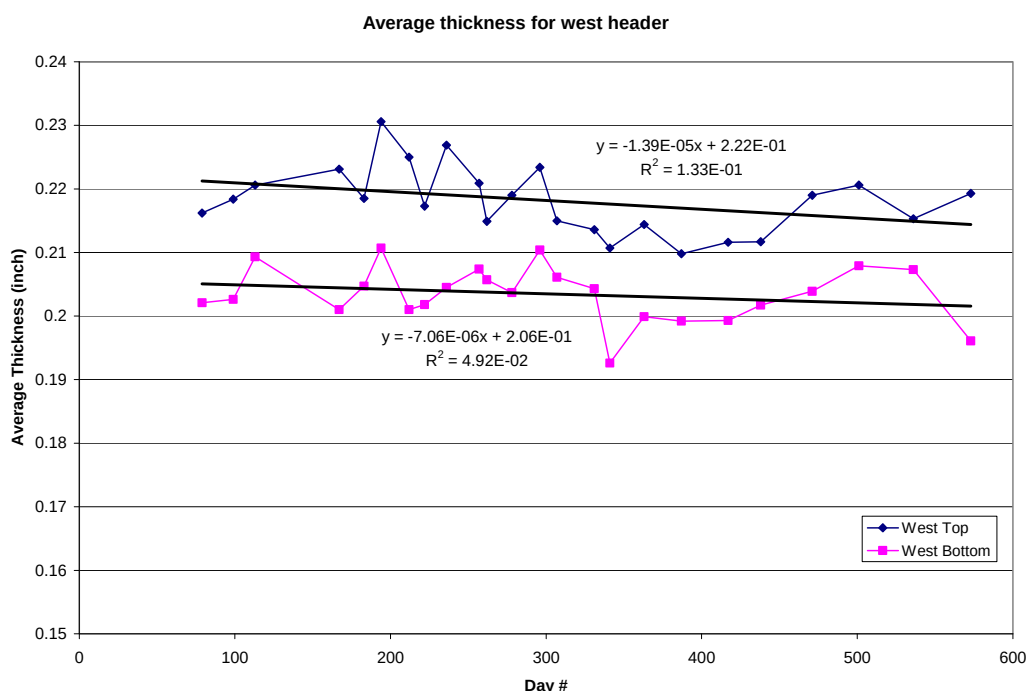
Figure 4. Average thickness measurements for west header during 15-month current condition assessment.

The data show some interesting trends. For the west header, both top and bottom thickness measurements show a decreasing trend. This would indicate a wall thickness that is thinning during the measurement period. For the central header, the top measurements show a decreasing trend, while the bottom measurements show a very slight increasing trend. This might indicate a loss of wall material near the top of the pipe and an accumulation of corrosion products at the bottom of the pipe. For the east header, both top and bottom measurements show an increasing trend. This might be due to an accumulation of corrosion products on the entire inside surface of the pipe. While this last trend may be an indication of the most excessive corrosion of the three pipes, we have to use the decreasing trend lines as an indication of material loss and hence a corrosion rate. The corrosion rates based on the decreasing trend lines are given in Table 2.

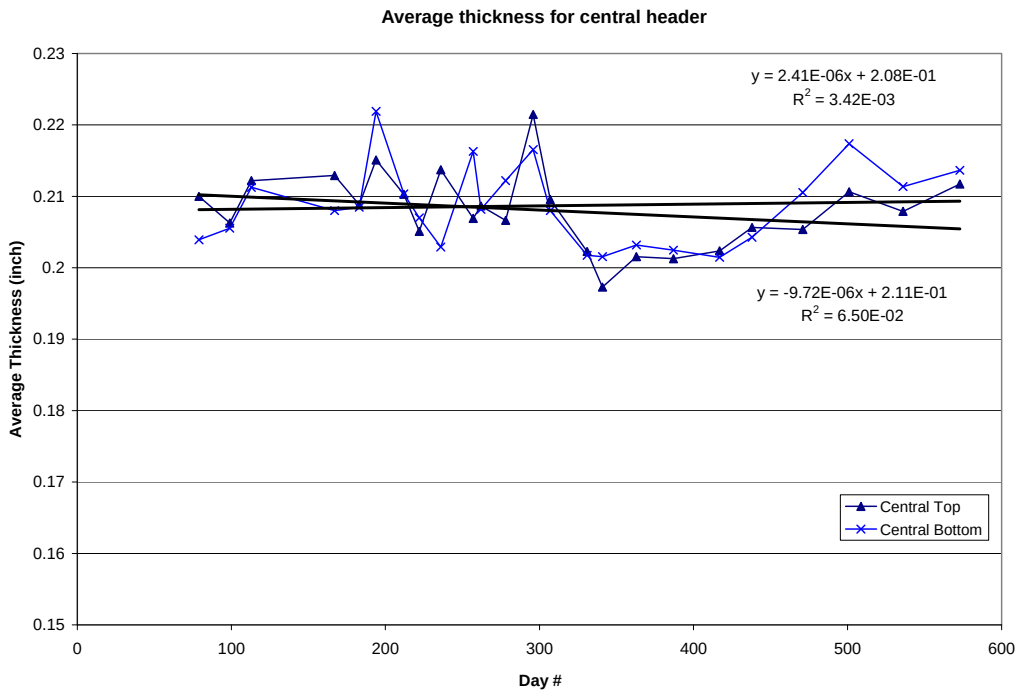
Figure 5. Average thickness measurements for central header during 15-month current condition assessment.

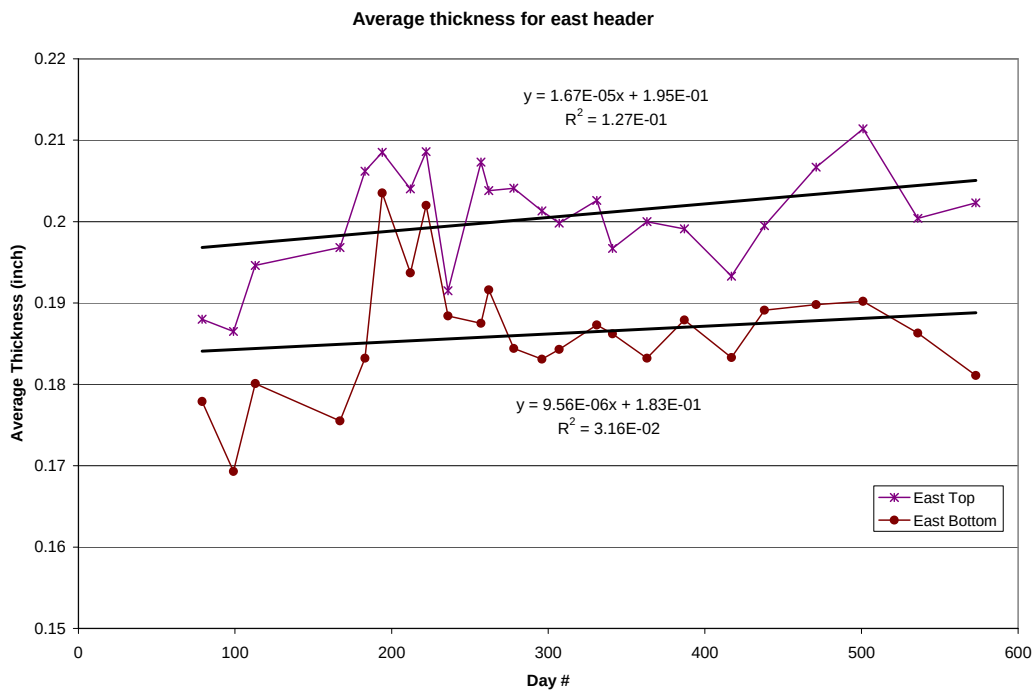
Figure 6. Average thickness measurements for east header during 15-month current condition assessment.

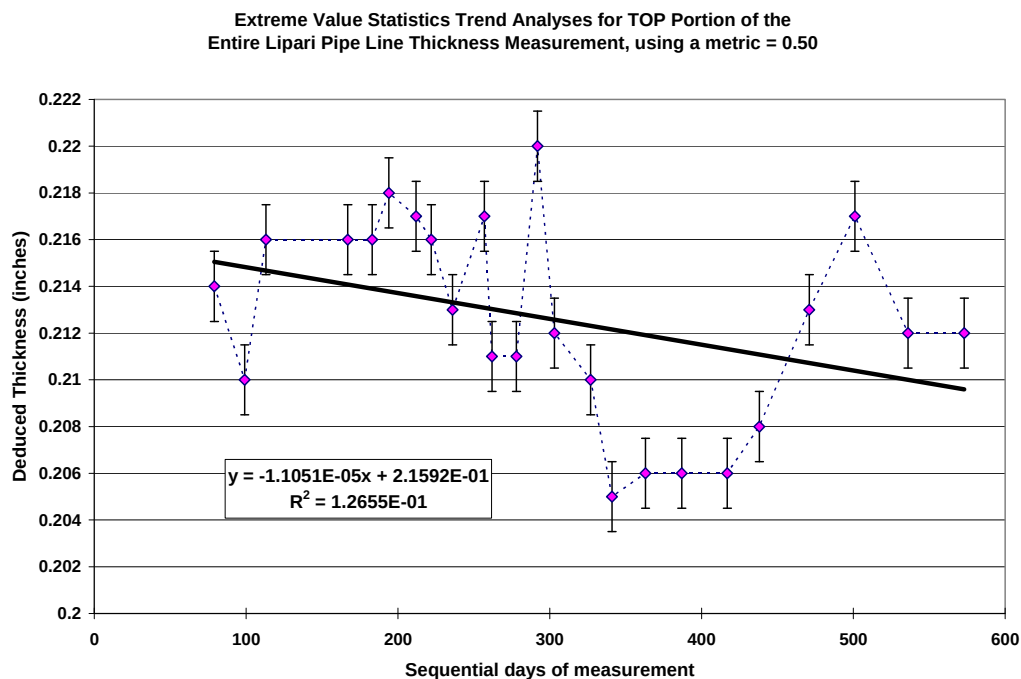
Figure 14. EVS trend for all top ultrasonic thickness measurements for the duration of the assessment period using a metric of 0.50.

The random scatter in this actual data is substantial. Even so, the statistical method extracts a systematic thinning of the original 0.237 in. thick steel carrier pipe. Using the analytic equation derived from the least squares fit of the data in Figure 14, a characteristic corrosion rate for the top of all pipes was calculated to be 4.03 mpy. Using the analytic equation derived from the least squares fit of the data in Figure 15, a characteristic corrosion rate for the bottom of all pipes was calculated to be 2.63 mpy.

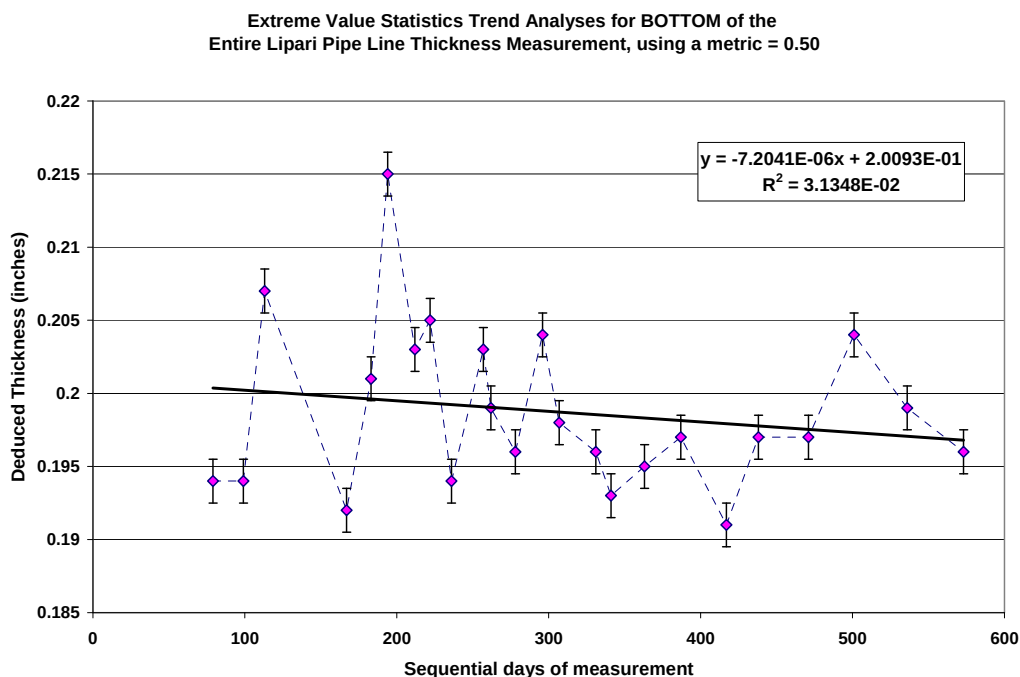
Figure 15. EVS trend for all bottom ultrasonic thickness measurements for the duration of the assessment period using a metric of 0.50.

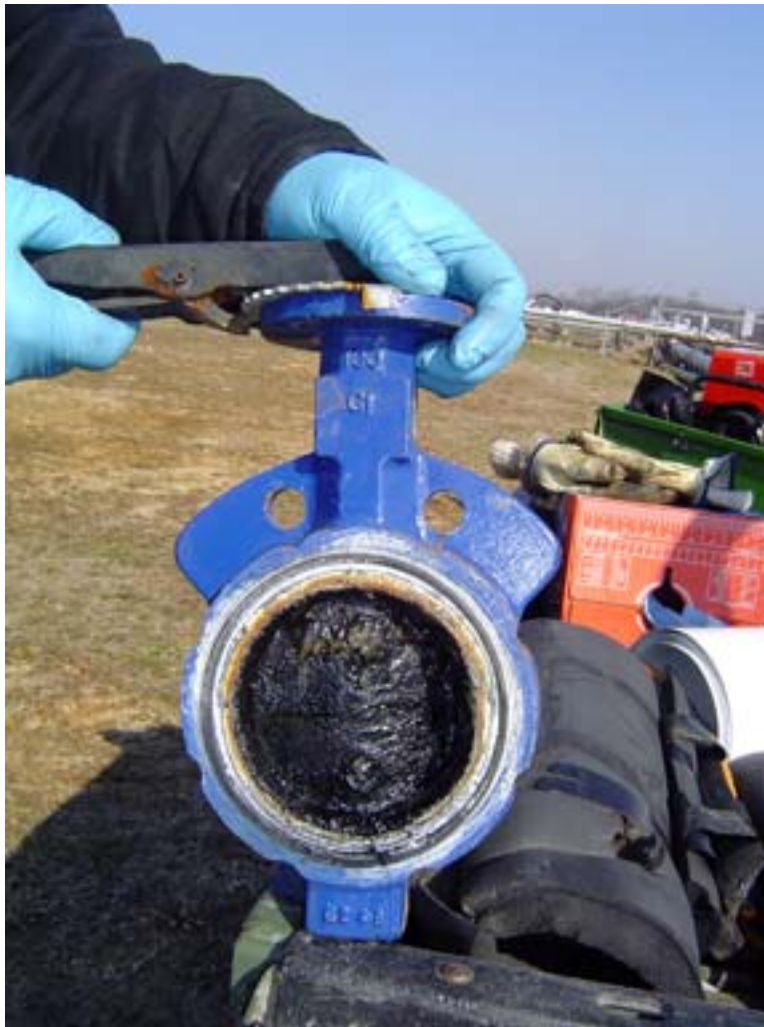
Figure 23. Photograph of the test coupon after 6 months in the west header.

The corrosion product on the coupon when removed from the pipe was black, as shown in Figure 23 and Figure C12 (see Appendix C). By the time the coupon reached the lab, the corrosion product was the common hematite rust color, as shown in Figures C13 and C14, which is typical of aerobic corrosion. This indicates that the pumped water had minimal dissolved oxygen to support complete corrosion. The corrosion product was loosely attached to the surface of the steel and was easily washed away. This may have allowed for fresh coupon material to be exposed to the corrosive action of the water while in the pipe and caused an accelerated corrosion rate.

Using the ASM (2003) standard method of calculating the corrosion rate from test coupon data, the corrosion rate was calculated to be 9.57 mpy. Additionally, a corrosion rate calculation based on initial and final average thickness measurements returned a value of 15.07 mpy.

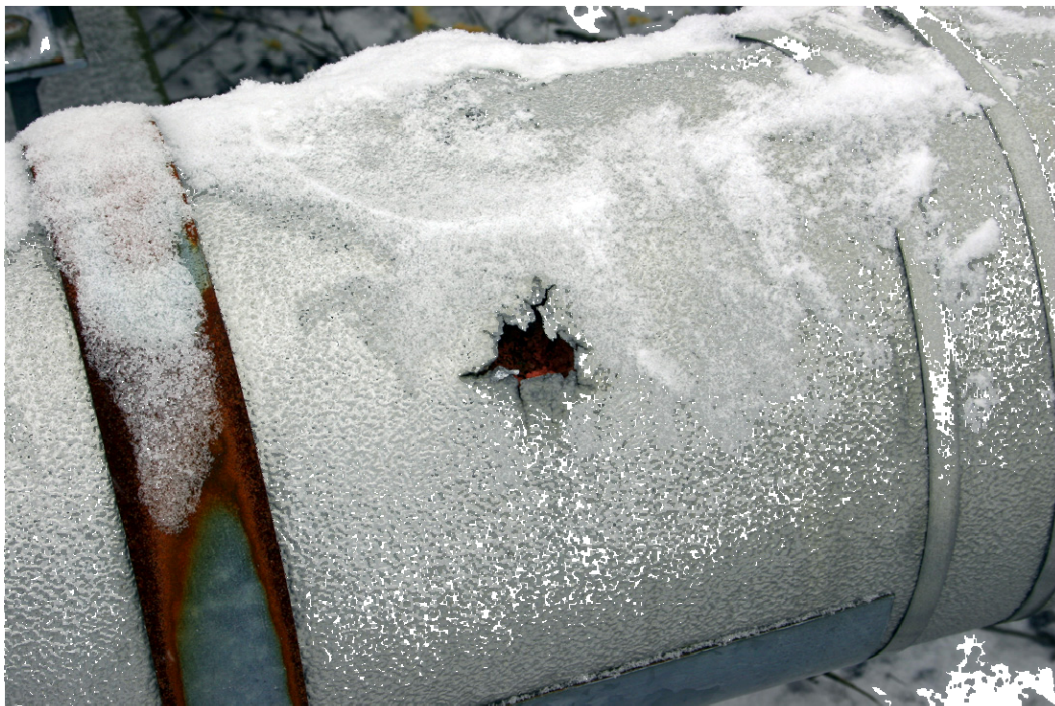
Figure C4. Photograph of the aluminum weather cover on header showing a hole possibly caused by general corrosion.

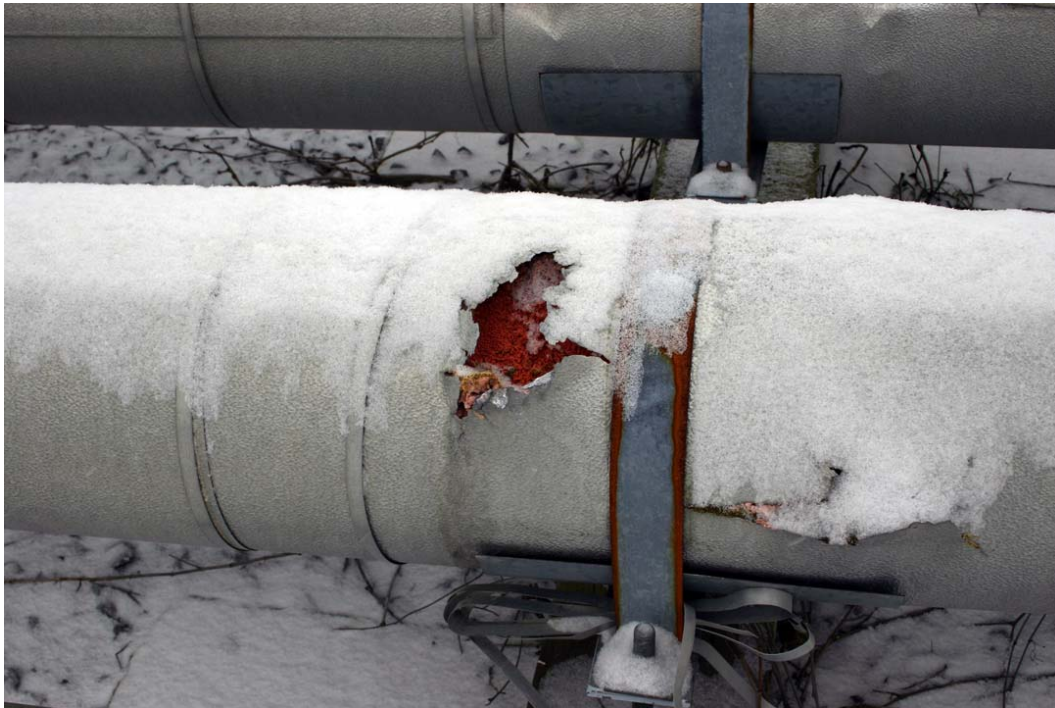
Figure C5. Photograph of another hole in aluminum weather cover.

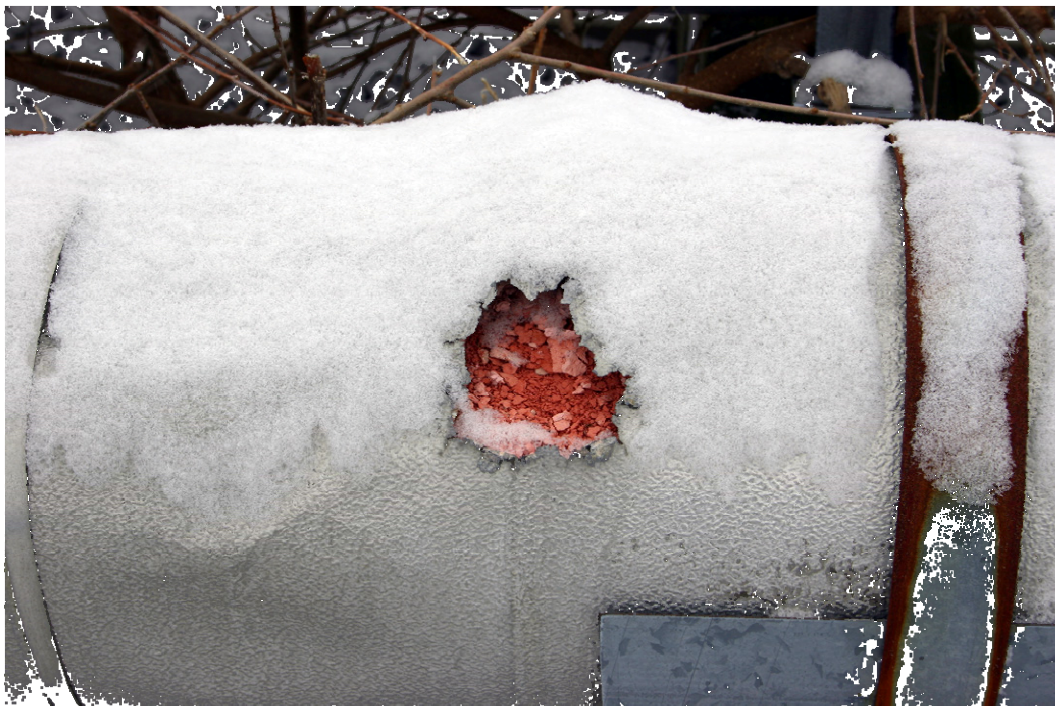
Figure C6. Photograph of another hole in aluminum weather cover on the header.

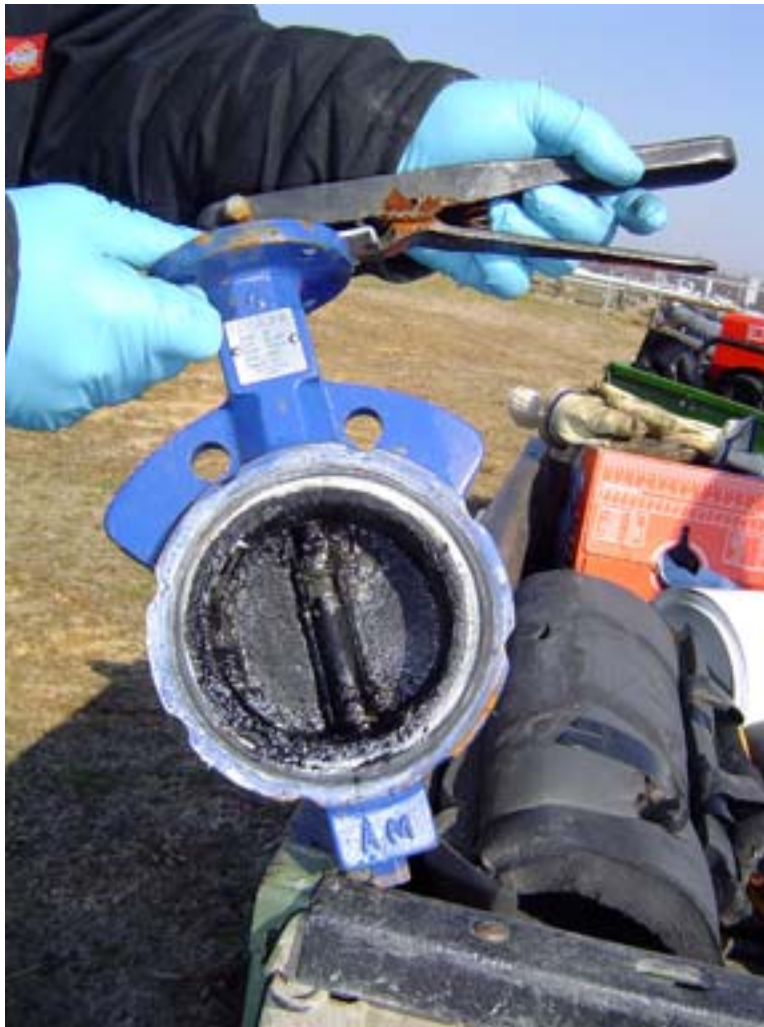
Figure C12. Photograph of the test coupon valve stem side after 6 months in the west header.

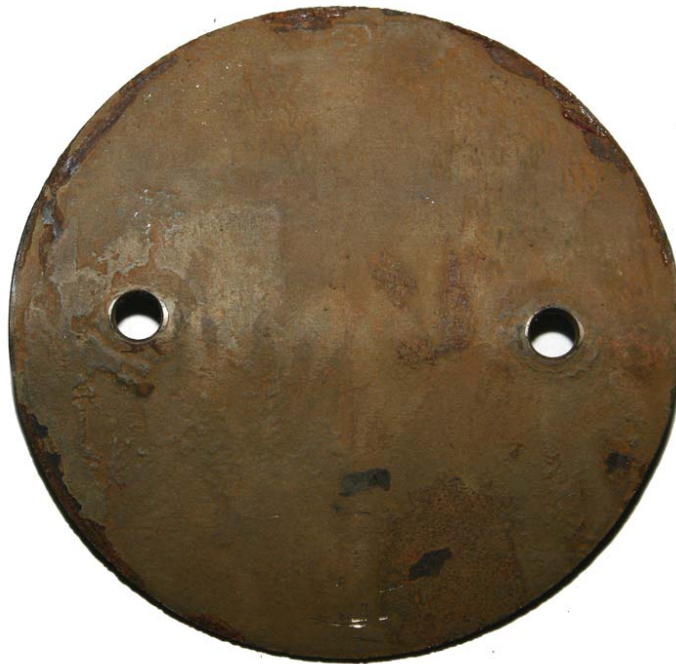
Figure C13. Test coupon after cleanup, showing the extent of general surface corrosion.

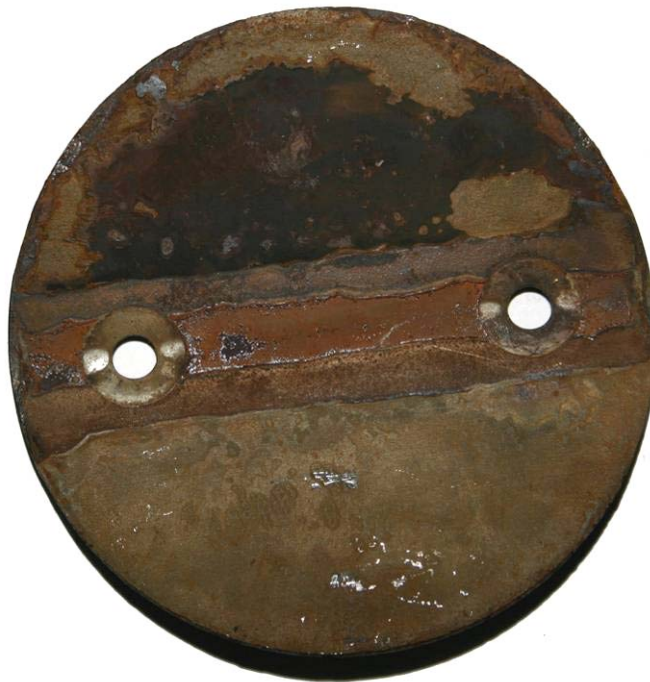
Figure C14. Test coupon stem side after cleanup, showing the extent of general corrosion.
