**MISSAN SURGICAL HOSPITAL**  
**UNDER THE ECONOMIC SUPPORT FUND**  
**AL AMARAH, IRAQ**

**SIGIR PA-08-165**  
**SIGIR PA-08-167**

**JULY 16, 2009**

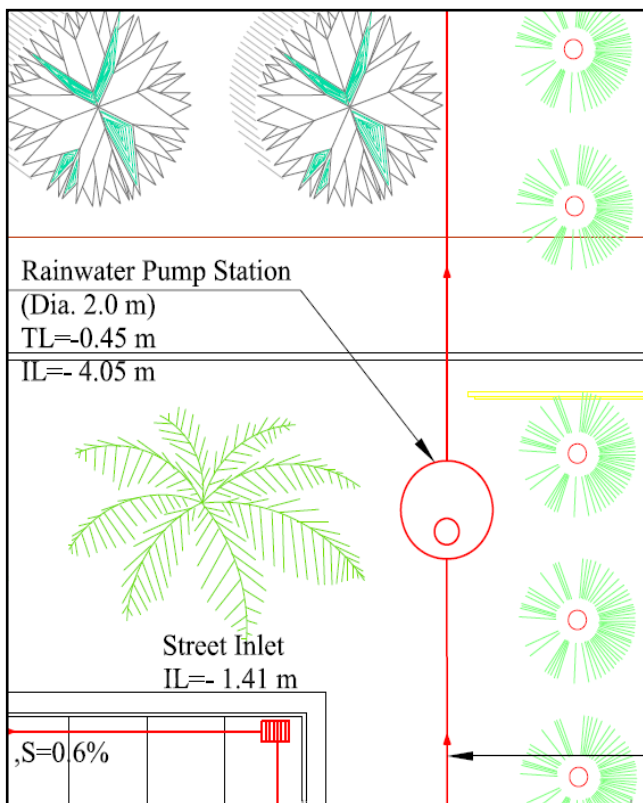
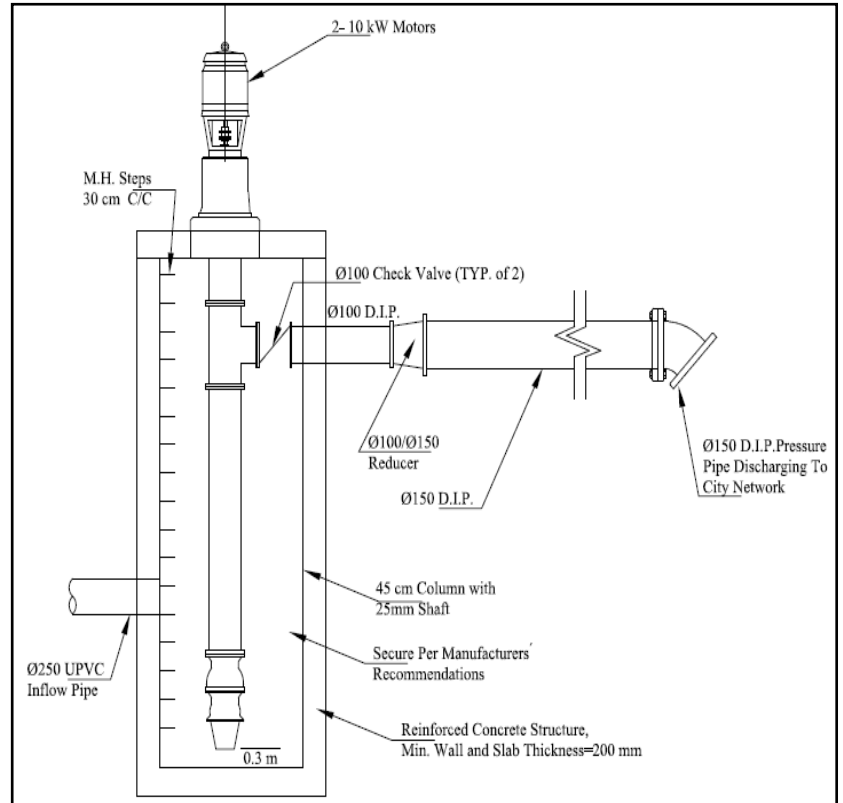
The contractor's plans lacked adequate information for SIGIR to determine how the pumps are controlled or how they will address low-flow conditions. SIGIR is concerned that the high capacity of the pumps combined with the small size of the wet well may result in a rapid cycling of the pumps leading to overheating and premature pump failure.

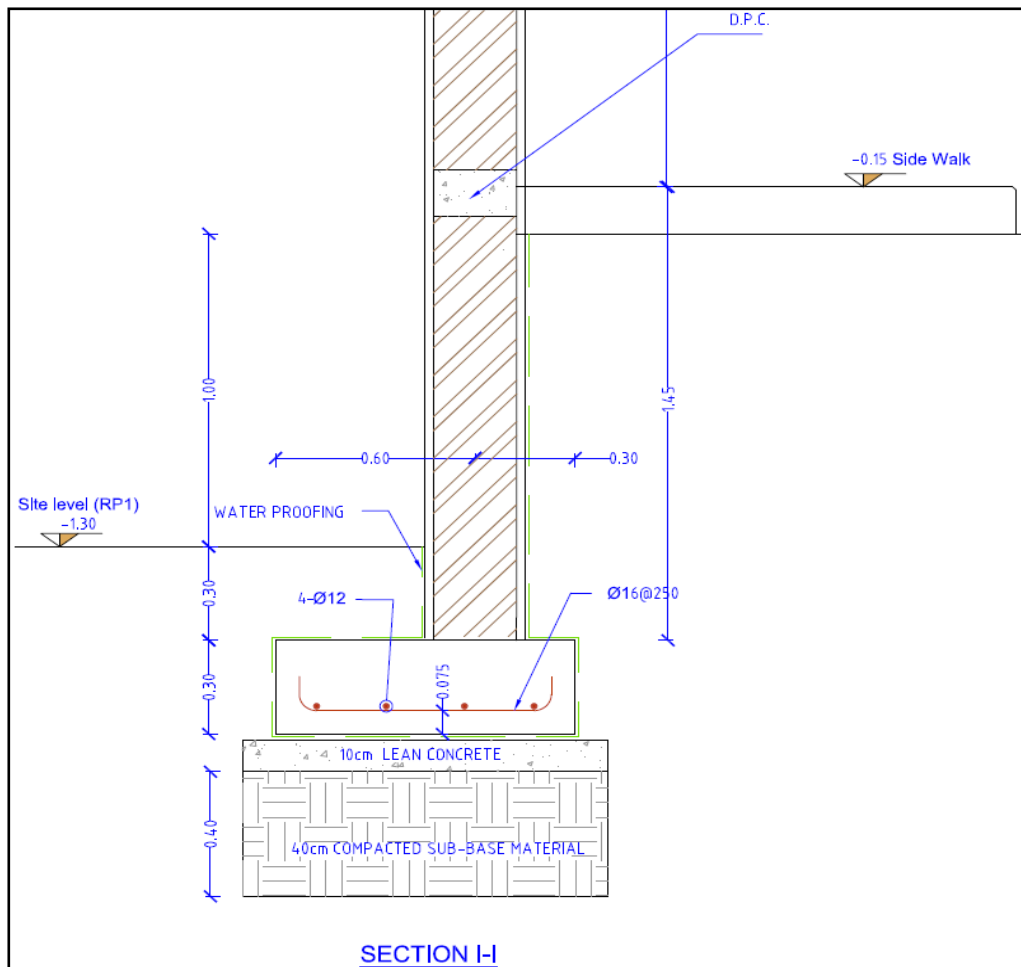
**Figure 8. Perimeter retaining wall section**

The contractor's design plan detailed the perimeter fence along the north edge of the project site. The plan indicated the application of waterproofing to the portion of the wall below grade (Figure 8). However, the application of waterproofing without the integration of subsurface drainage behind the wall may allow for the buildup of hydrostatic pressure against the wall and possible localized failure of the brick infill.

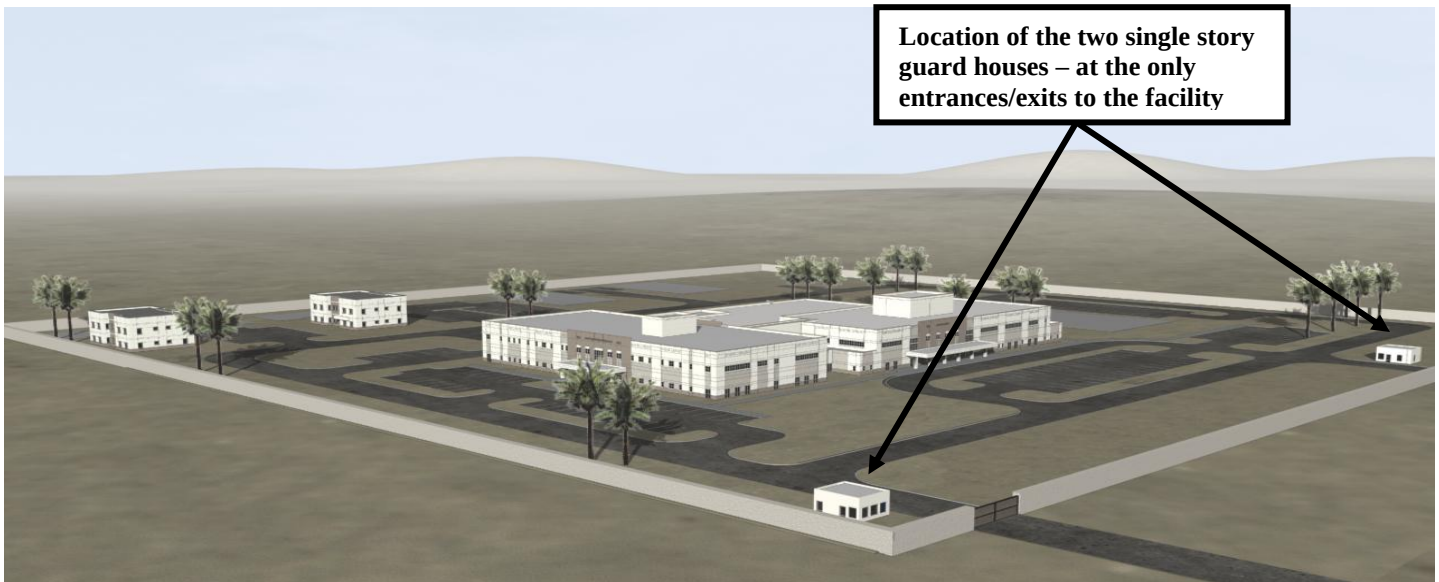
from the guard house, additional guard houses and elevated guard towers are necessary to provide adequate security.

**Figure 9. Location of the two guard houses for the MSH (Courtesy of GRS)**

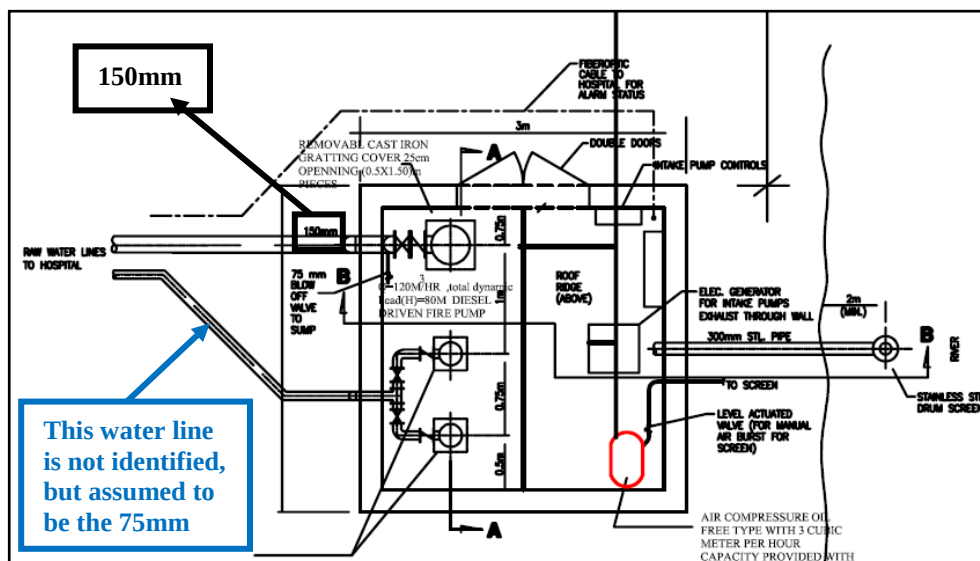
Figure 10. Contractor’s river intake detail design (Courtesy of GRS)

Of particular concern to SIGIR is the lack of the defined route from the river intake to the hospital. According to GRS, the current plan is to place the river intake near the intersection of the Tigris and Al Kahla Rivers and then run the water lines to the hospital site. However, this would require the contractor to excavate and lay two pipe lines a total of 3.1 km through a significant portion of the city of Al Amarah (Figure 13). In a previous SIGIR Inspections report of the Falluja Wastewater Treatment Plant, SIGIR documented significant delays and serious security issues due to the fact the contractor had to excavate and lay pipe through the city.

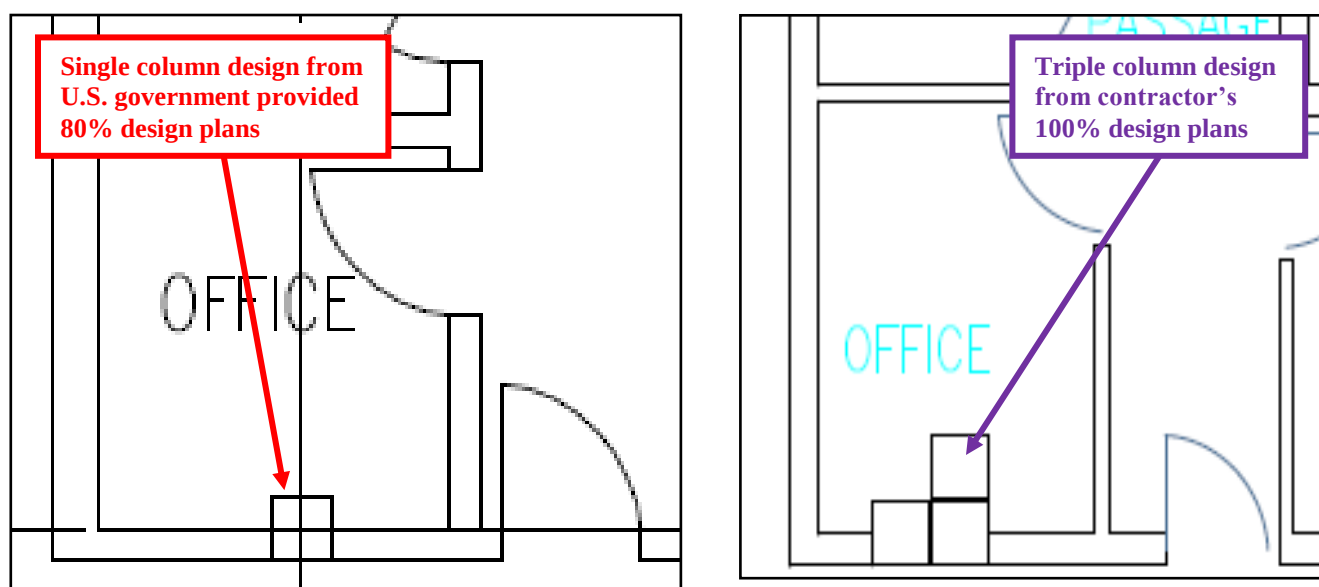
The design drawings include a structure layout with additional columns to accommodate expansion joints in the building. While the floor plans were adjusted to accommodate the additional columns, there appeared to be spatial conflicts in several of the rooms. For example, Figure 15 is the original floor plan (80% design), which allocated a 0.5 m x 0.5 m column in this office; while Figure 16 is the contractor's re-design, which added the expansion joint and two additional 0.5 m x 0.5 m columns for the same office. Although the contractor made the office larger to compensate for the undesirable use of space, the additional columns render the office less efficient and aesthetic than if the floor plan was modified to place the columns in less obtrusive locations. SIGIR observed this in several locations.

**Figures 15 and 16. The contrast between the 80% design single column configuration (left) and the contractor's triple column configuration (right). The triple column configuration is less efficient space wise and less aesthetically pleasing. (Courtesy of GRS)**

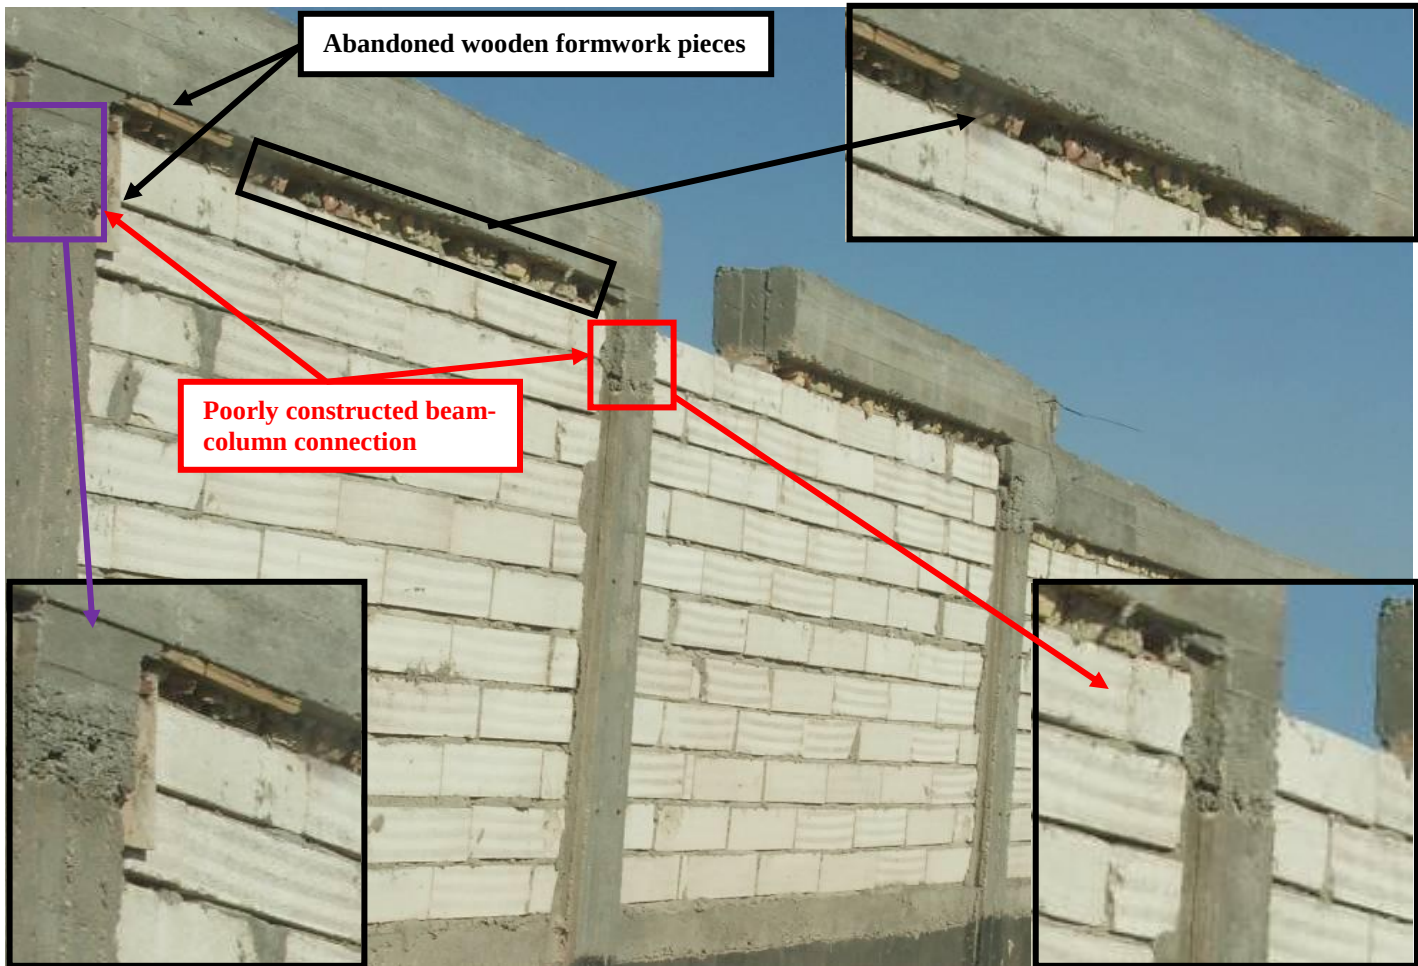
At the time of the site visit, the perimeter wall appeared adequate as a deterrent to anyone attempting to unlawfully enter the compound; however, the concerns identified by SIGIR regarding the wall's construction will ultimately affect the wall's long term sustainability.

Site Photo 3. Perimeter security wall construction

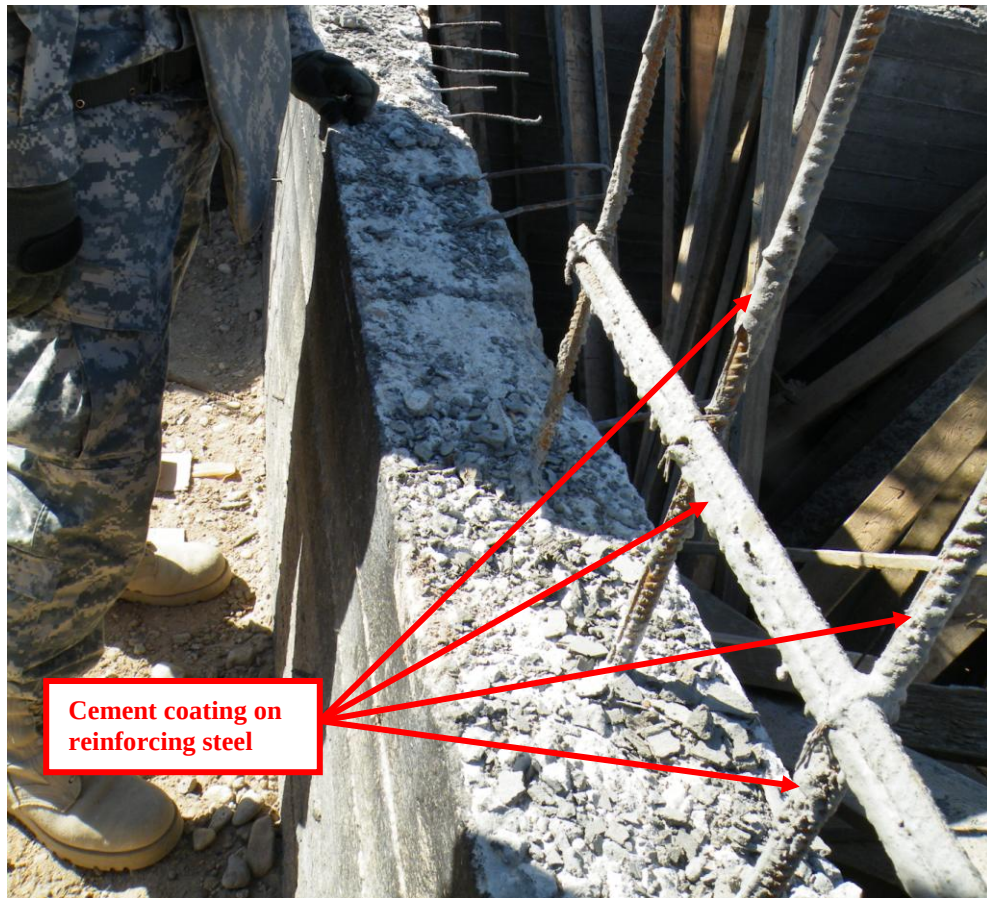
Due to time limitations on site, SIGIR did not have the opportunity to analyze the reinforcing steel inside the formwork to determine if this issue was being rectified prior to concrete pouring operations.

**Site Photo 4. Cement coating on reinforcing steel**

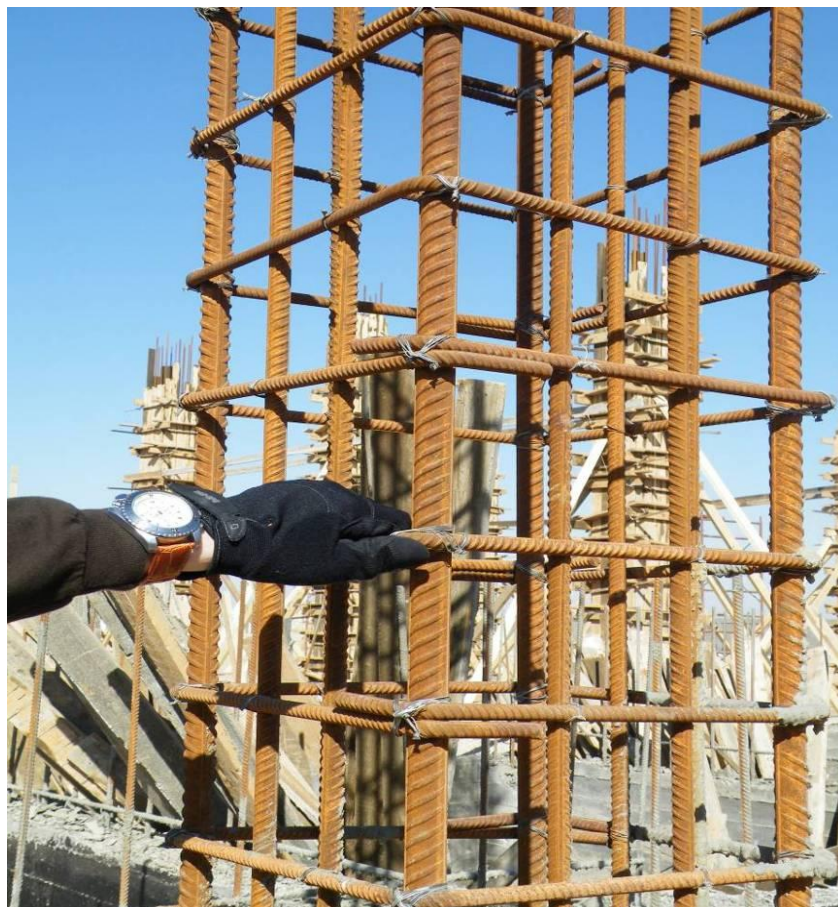
In addition, SIGIR noted that the reinforcing configuration used in the construction of the reinforced concrete columns varied from the configuration specified in the design drawings. Figure 17 clearly illustrates the difference between the design drawing and actual construction of the reinforcing configuration. The design drawing required three separate pieces of reinforcement bar along with two ties (primary and intermediate). The primary ties a steel bar around the perimeter of the vertical reinforcement bars; while the intermediate ties a steel bar from the middle reinforcement bar of one side to the other. However, the contractor opted to use four vertical pieces of reinforcement bar along with a primary tie around the perimeter.

**Site Photo 5. Example of constructed column section**

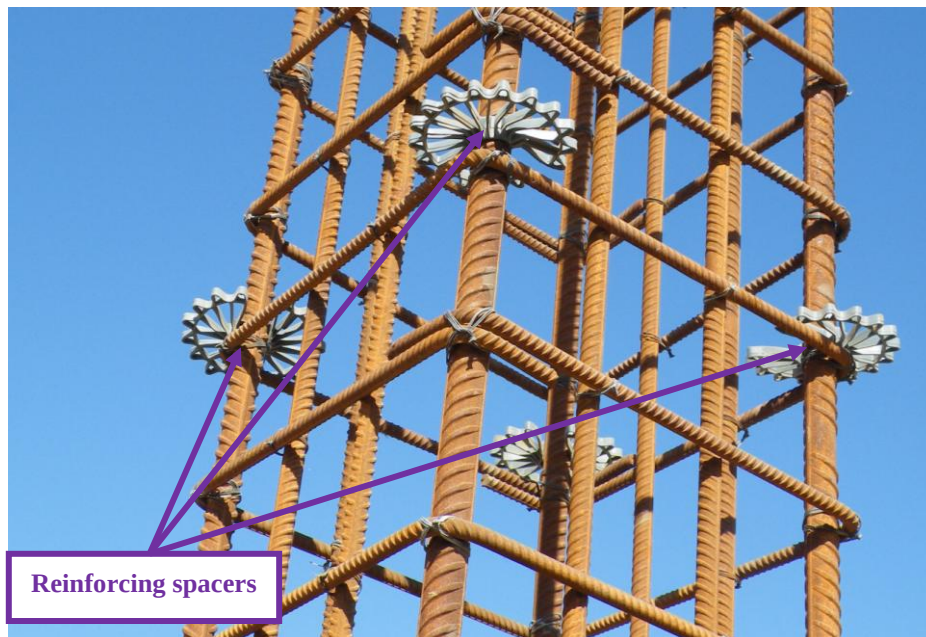
Upon review of the reinforcing steel for the columns, SIGIR noted a wheel type of spacer used in the construction of the reinforcing cage (Site Photo 6). In general, the use of spacers to maintain adequate concrete cover over the reinforcing steel is a good construction practice. However, the configuration of the spacers SIGIR observed may prove to be problematic. Specifically, the contractor utilized spacer with radial spokes between the reinforcing bars and the outer edge of the spacer. The distance between the radial spokes appeared to be smaller than the maximum possible dimension of the aggregate in the concrete mix. During pouring operations, the spokes may become clogged, preventing concrete from completely filling the corners of the column below the spacer, which would result in voids and/or honeycombing at the corners of the columns.

**Site Photo 6. Column reinforcing cage and form spacers**

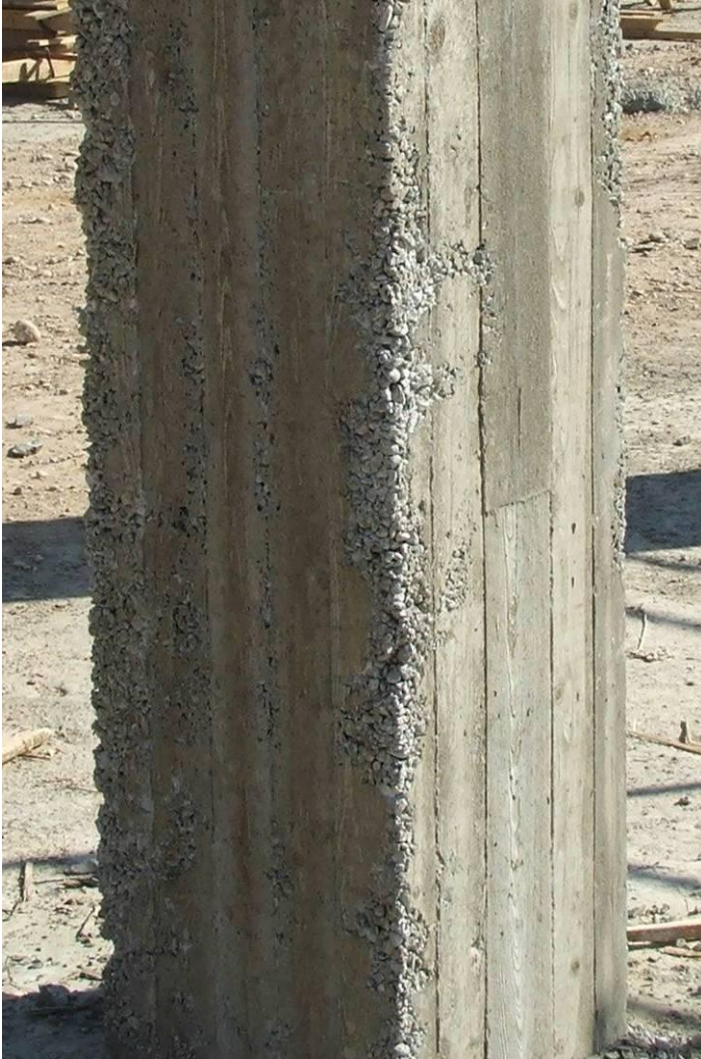
SIGIR identified several examples, from slight to moderate to severe, of honeycombing of the reinforced concrete members (Site Photos 7 and 8). This construction deficiency appeared to be most prevalent at construction joints between successive pours and along the corners of the reinforced concrete members.

**Site Photos 7 and 8. Typical examples of slight to moderate concrete honeycombing in columns**

Due to time limitations on site, SIGIR could not assess the extent and severity of the honeycombing, which may require limited destructive testing to ascertain. However, SIGIR did observe, in at least one location, exposed primary reinforcing steel (Site Photo 9). The full extent of the honeycombing should be assessed and appropriate remedial measures taken based upon the impact to each member.

3. Require the contractor to remove all defective concrete and replace it with a suitable repair material.
4. Require the local national on-site quality assurance representatives to closely monitor and ensure that the contractor removes and replaces deficient concrete.

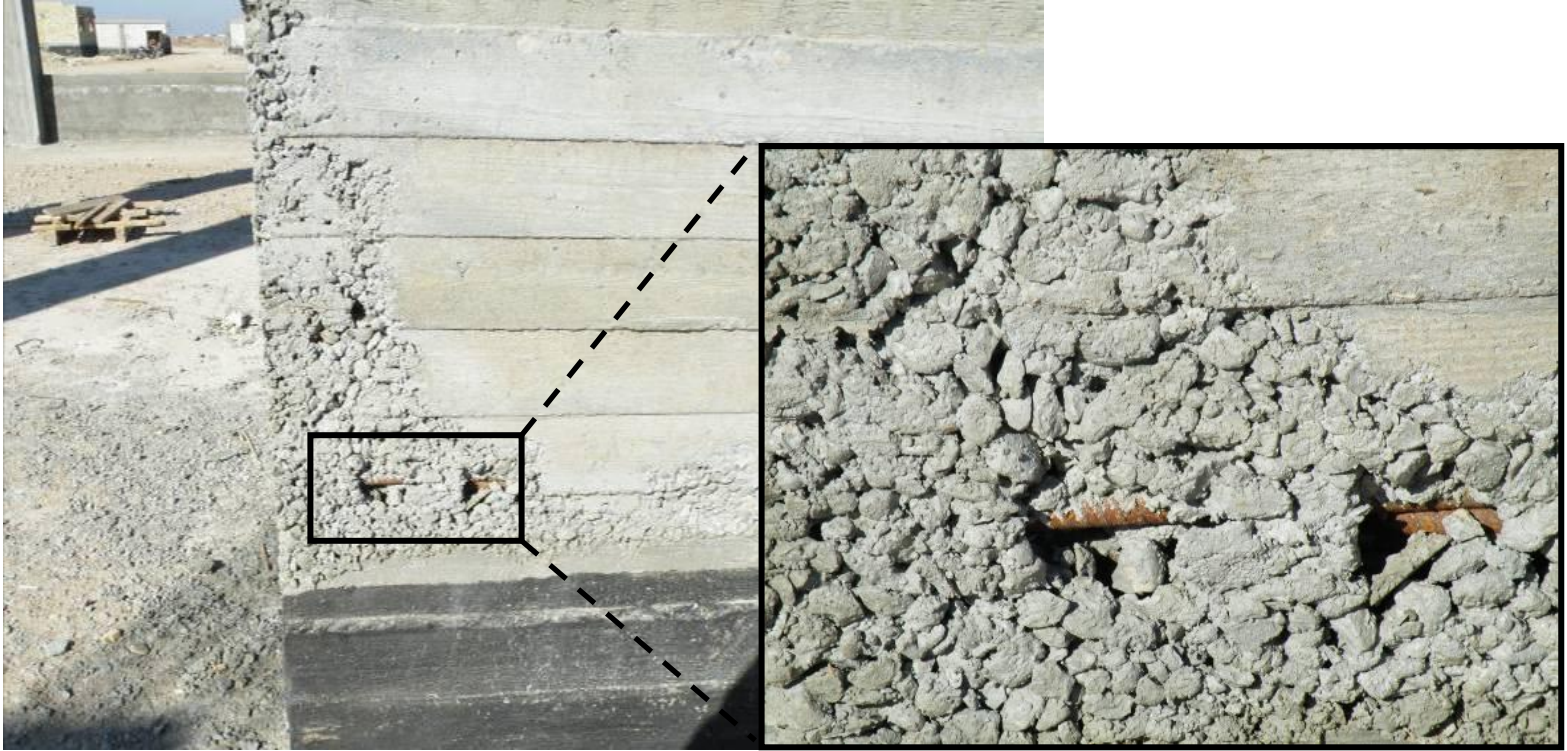
**Site Photo 9. Example of severe concrete honeycombing (including exposed reinforcement bar)**

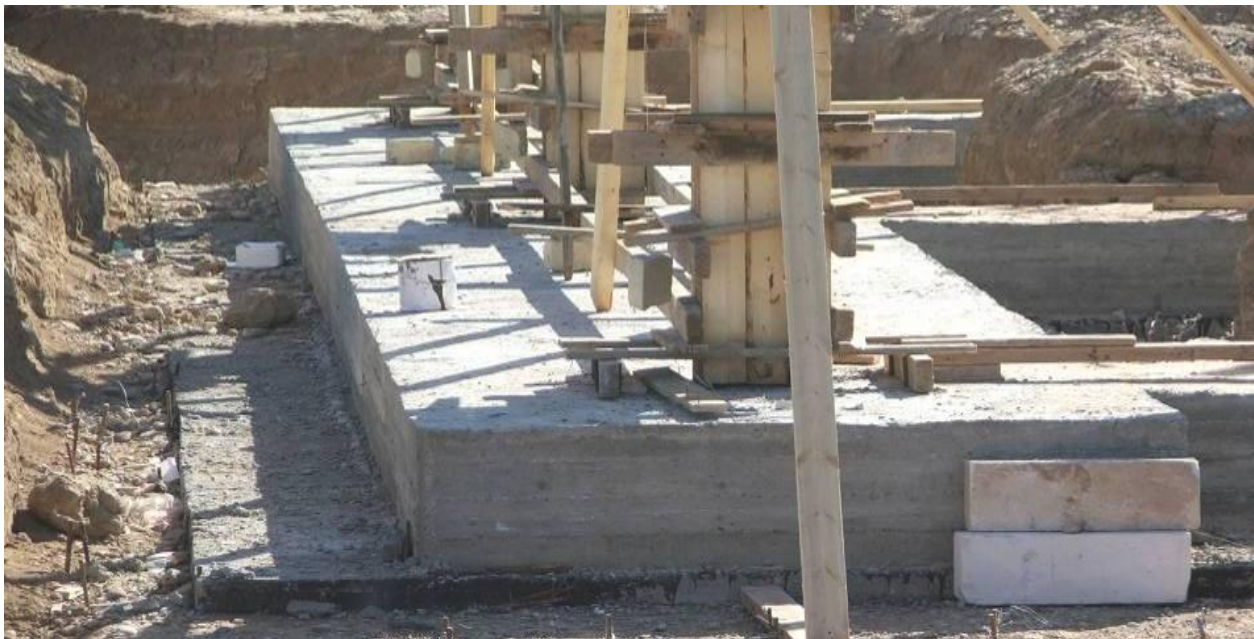
At the time of the site visit, the foundation backfill had already been performed over a significant portion of the project site. Consequently, SIGIR was only able to inspect limited areas of the foundation (Site Photo 11).

**Site Photo 11. Foundation prior to backfill**

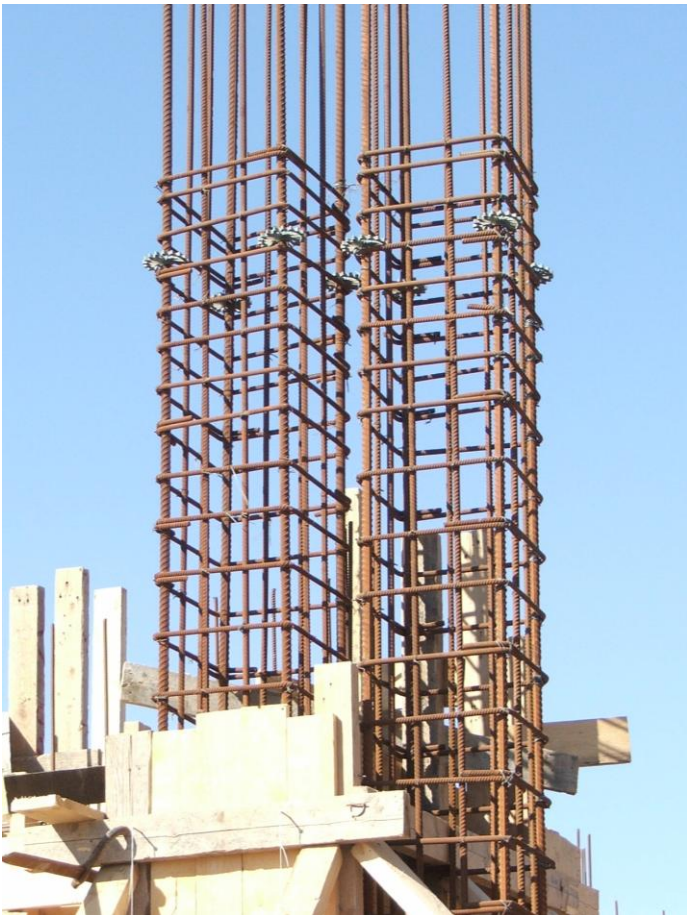
Site Photo 14. Double column forming

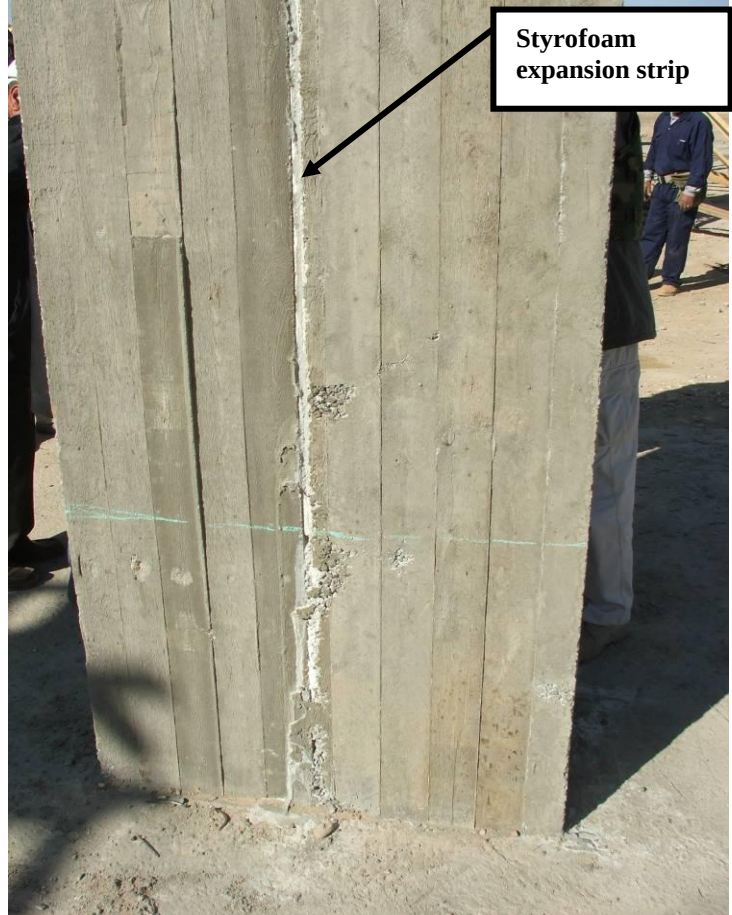
The columns appeared to be constructed from independent concrete pours with Styrofoam expansion strip placed between the columns (Site Photo 15). While not the ideal material to use, Styrofoam will effectively isolate the columns along their length.

Site Photo 15. Example of Styrofoam expansion strip

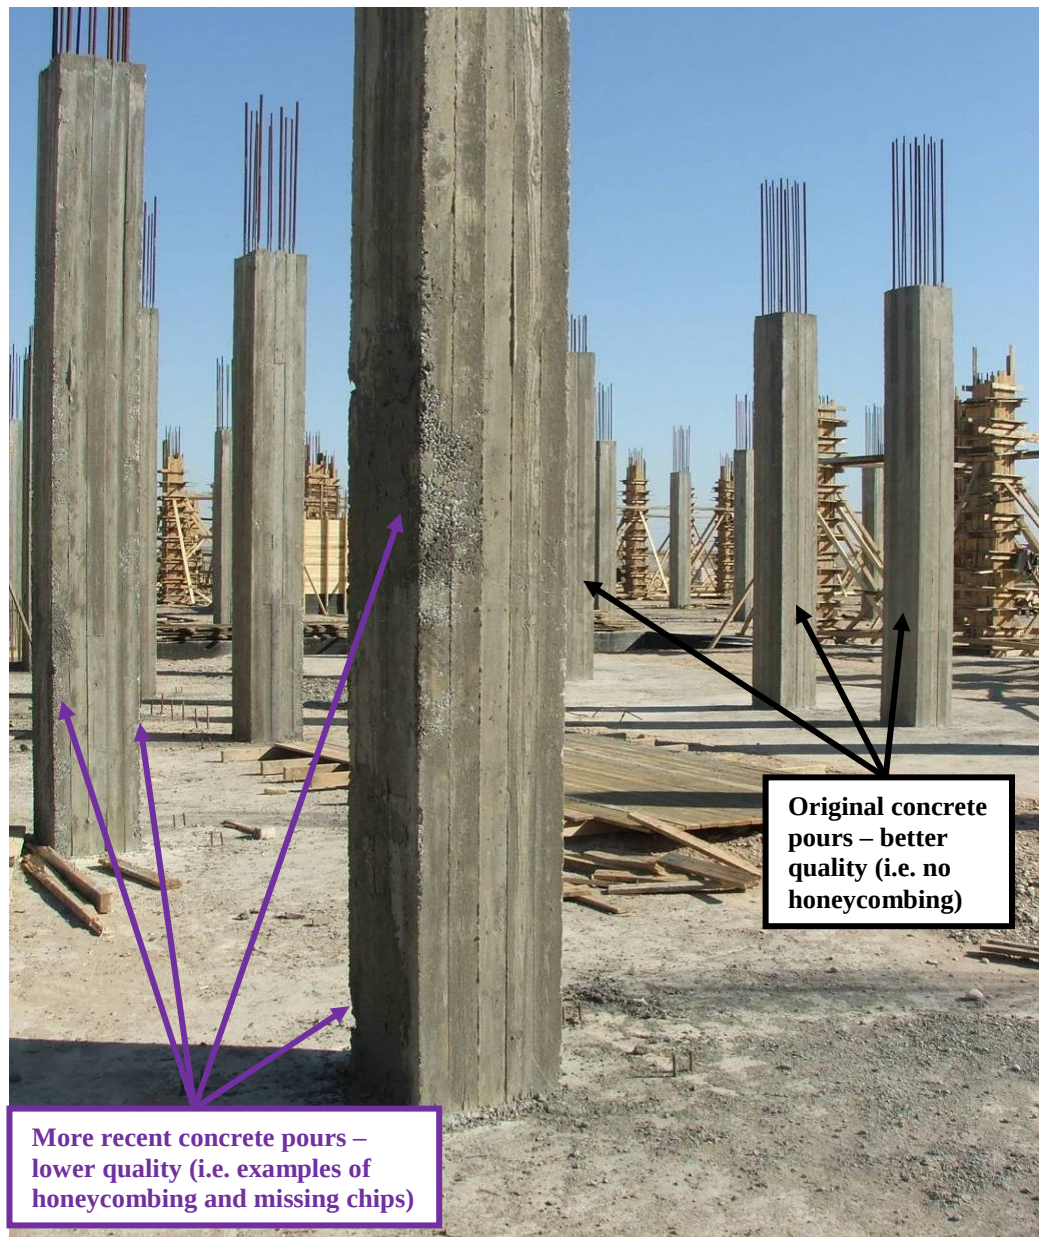
SIGIR noticed that the quality of the more recently constructed structural concrete columns was considerably less than some of the original columns (Site Photo 16). There is the possibility that contractor efforts to expedite the project may have led directly to concrete quality issues. For example, in an effort to increase productivity, the contractor probably pulled the column formwork too quickly and failed to adequately clean it prior to the pouring of the next column. Pulling the formwork before it is completely dry and not adequately cleaning it will significantly affect the quality of the next formwork concrete pours. SIGIR mentioned this to the GRS AAO representatives, who agreed that the more recent concrete quality issues could be due to the contractor being asked to follow a more expedited construction schedule.

Site Photo 16. Example of difference in concrete quality from more recent concrete pours

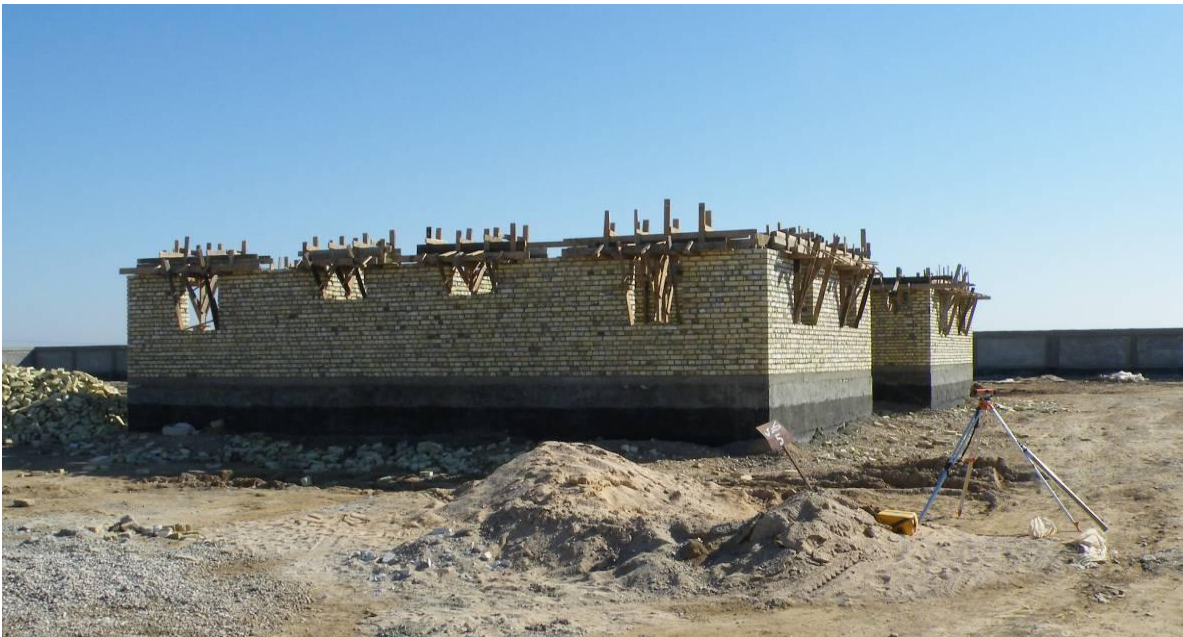
The construction of the brick walls followed local construction techniques and is a two "Wythe English" bond configuration. The bricks are not mortared on perpendicular (vertical sides) nor are they uniform in shape or size (Site Photo 18). While the methods and quality of construction is not comparable to typical European brick masonry, the small size and limited number of stories of this structure should result in relatively low stresses in the brick.

**Site Photo 17. Physician's residence**

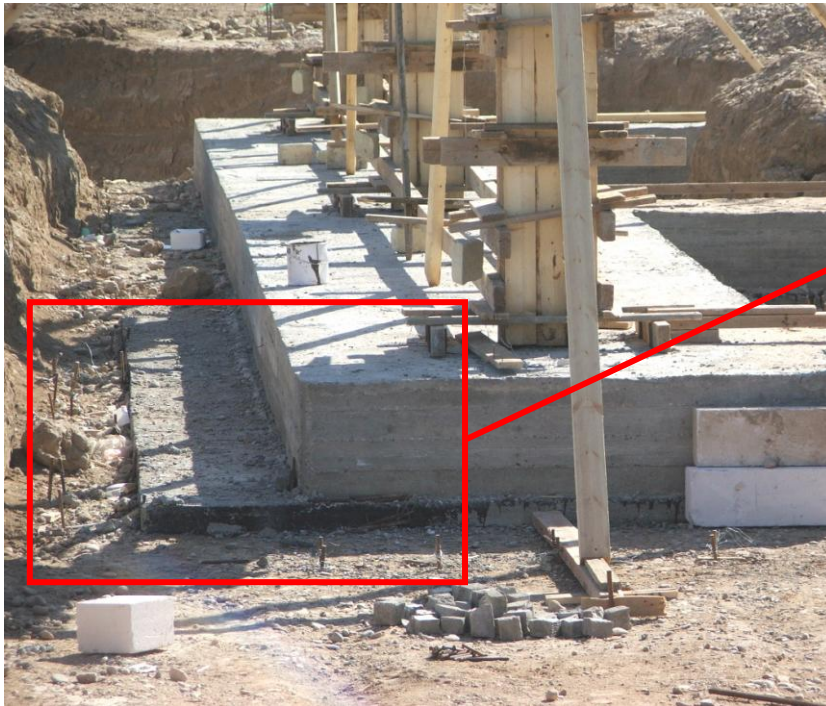
**Site Photo 19. Examples of protruding reinforcement bar**

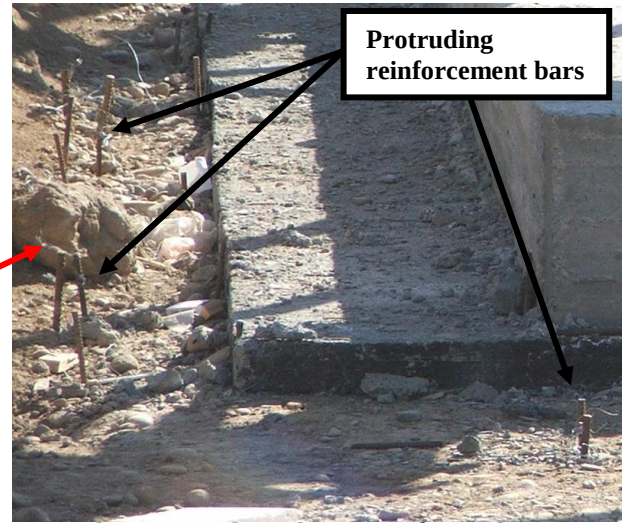
**Site Photo 20. Enlarged portion of Site Photo 19**
