SOME REMARKS on a 100 Tons ACCIDENTAL EXPLOSION in  
TUNNEL SYSTEMS in 1965

Seppo Tuokko

Ministry of Defence, Helsinki Finland

TWENTY-FIFTH DOD EXPLOSIVES SAFETY SEMINAR

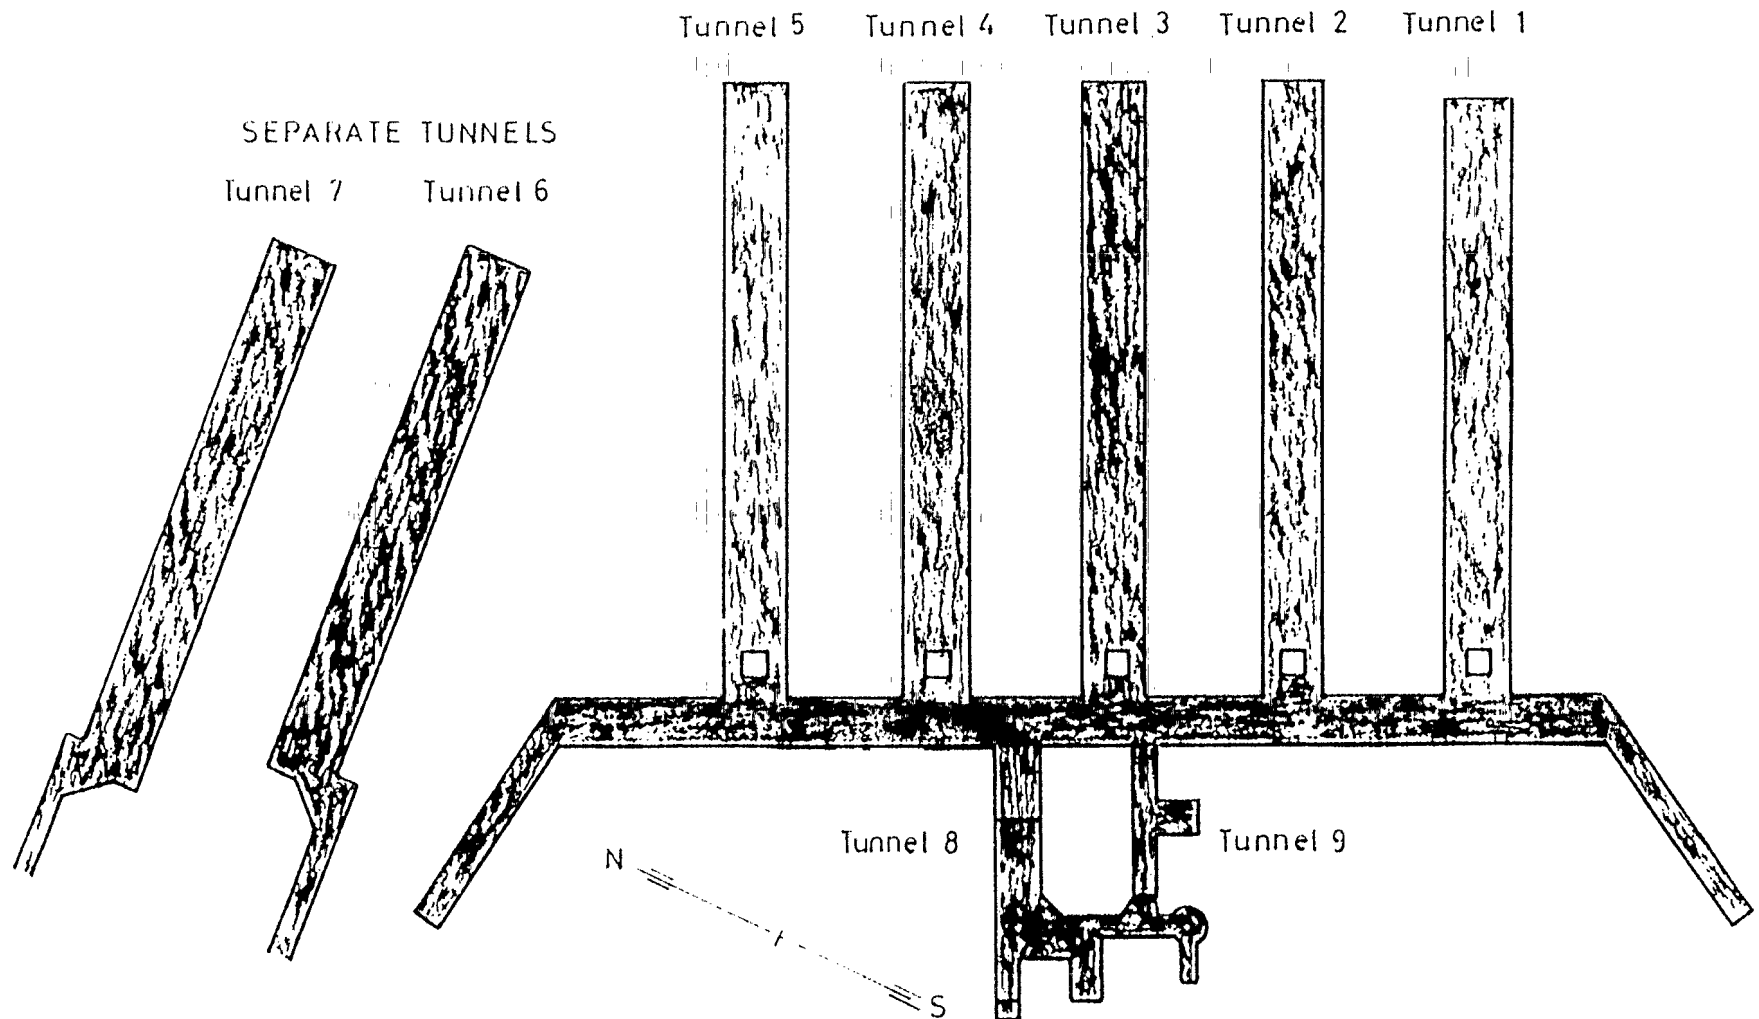
Figure 1

The plan of the underground storage is to be seen in Fig 1. The underground storage was only a part of the whole Depot. On the ground there were many workshops, barracks and different kind of storages.

This Tunnel System was consisted of the (so called) main part, of tunnels 1-5 and of two separate Tunnels numbers 6 and 7. Each one had volyme of 2700 m<sup>3</sup>.

Tunnels 1-5 included mostly ammunition and gunpowder. In tunnel number 6 there was mostly gunpowder (about 220 tons) and in tunnel 7 mostly TNT and RDX (together 310 tons). There were also small storages numbers 8 and 9, including only some hundreds of kilos explosive material.

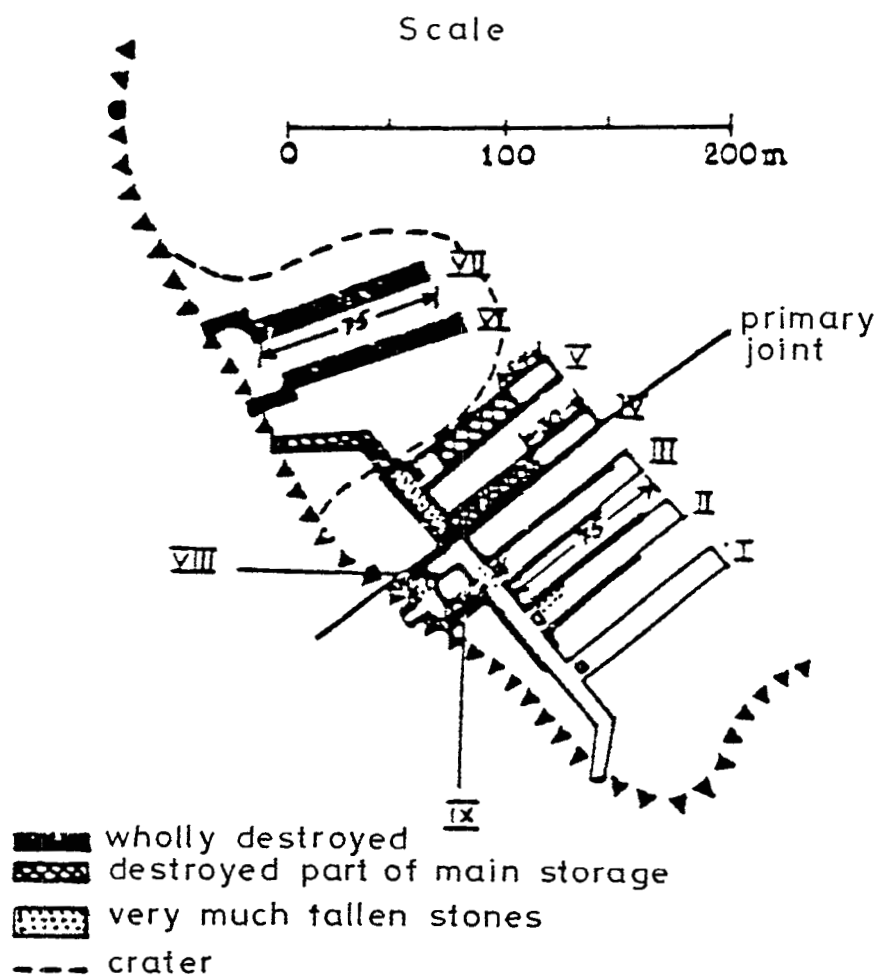
Figure 2 shows the situation in the Tunnels after explosions. Tunnels 6 and 7 are wholly destroyed, there is only a crater. The deepest part of the crater is in the middle between the Tunnels. Figure 3 shows the ground profile before and after the explosion.

Tunnels 4 and 5 are only partly destroyed, the rears are damaged only a little.

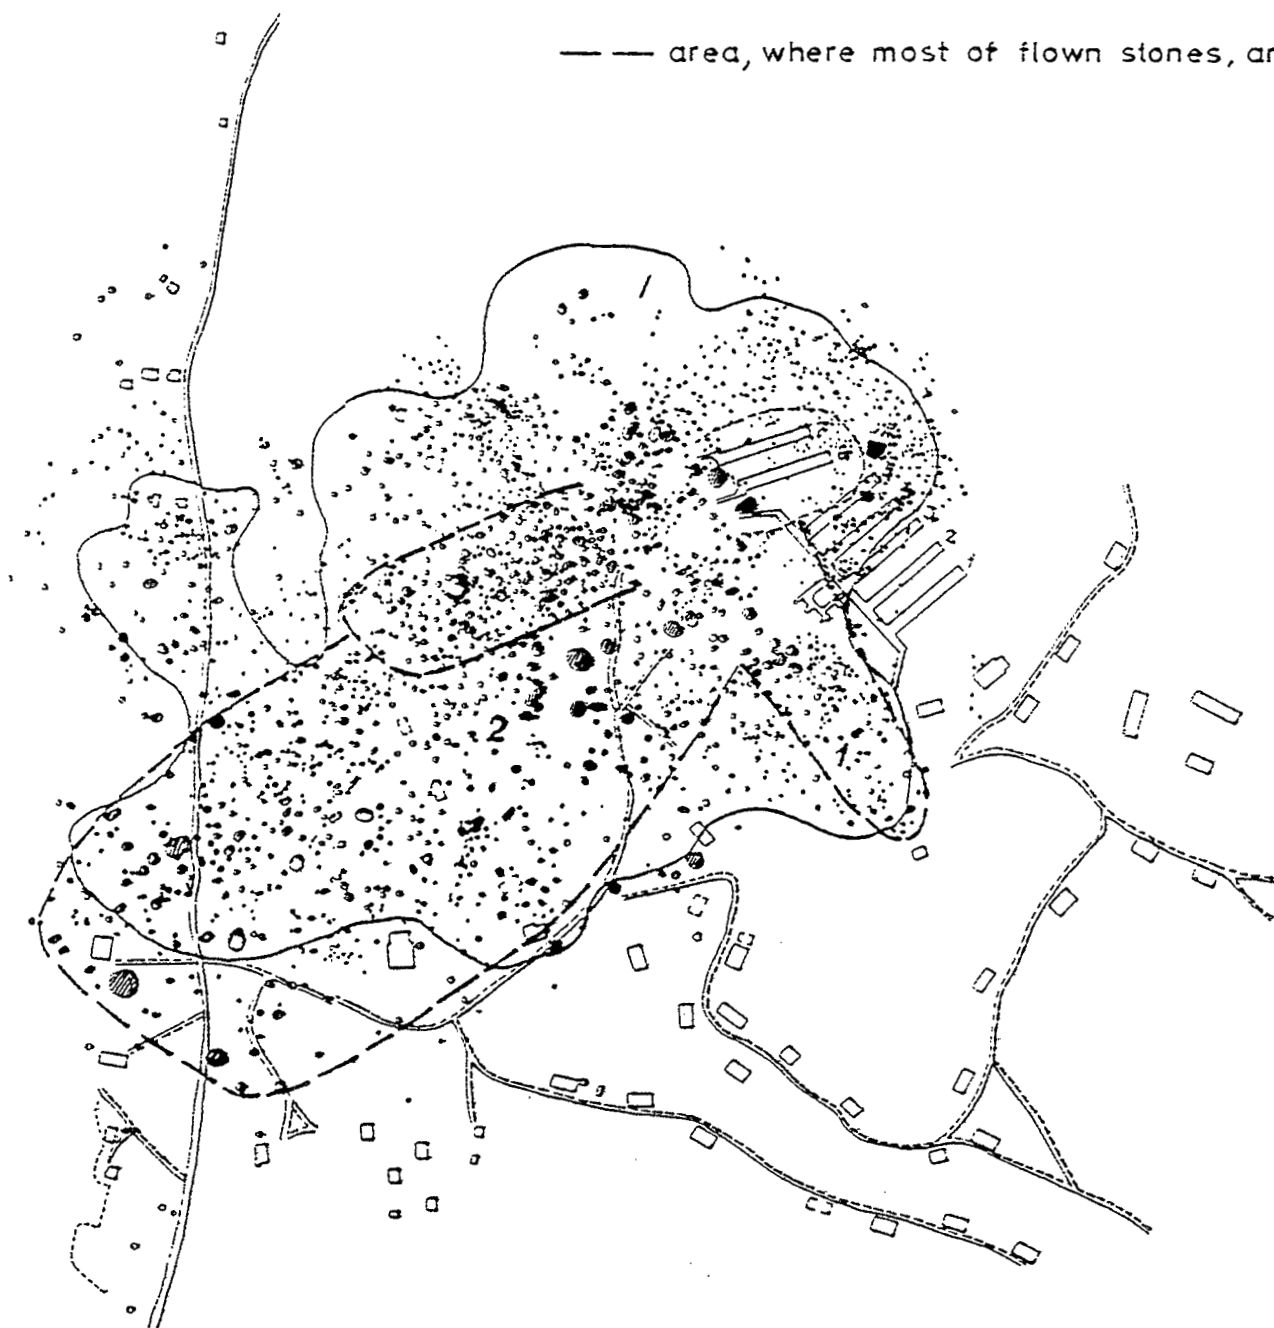
Fig. 4

In Fig 4 there can be seen areas, where most of the flown blocks were found. Typically, they have been directed mostly southwest. Also very many windows were broken, the longest distance was 7 km. There were some astonishing features in the effects, for example a brick chimney is almost undamaged although it is near the opening of the Tunnel System.

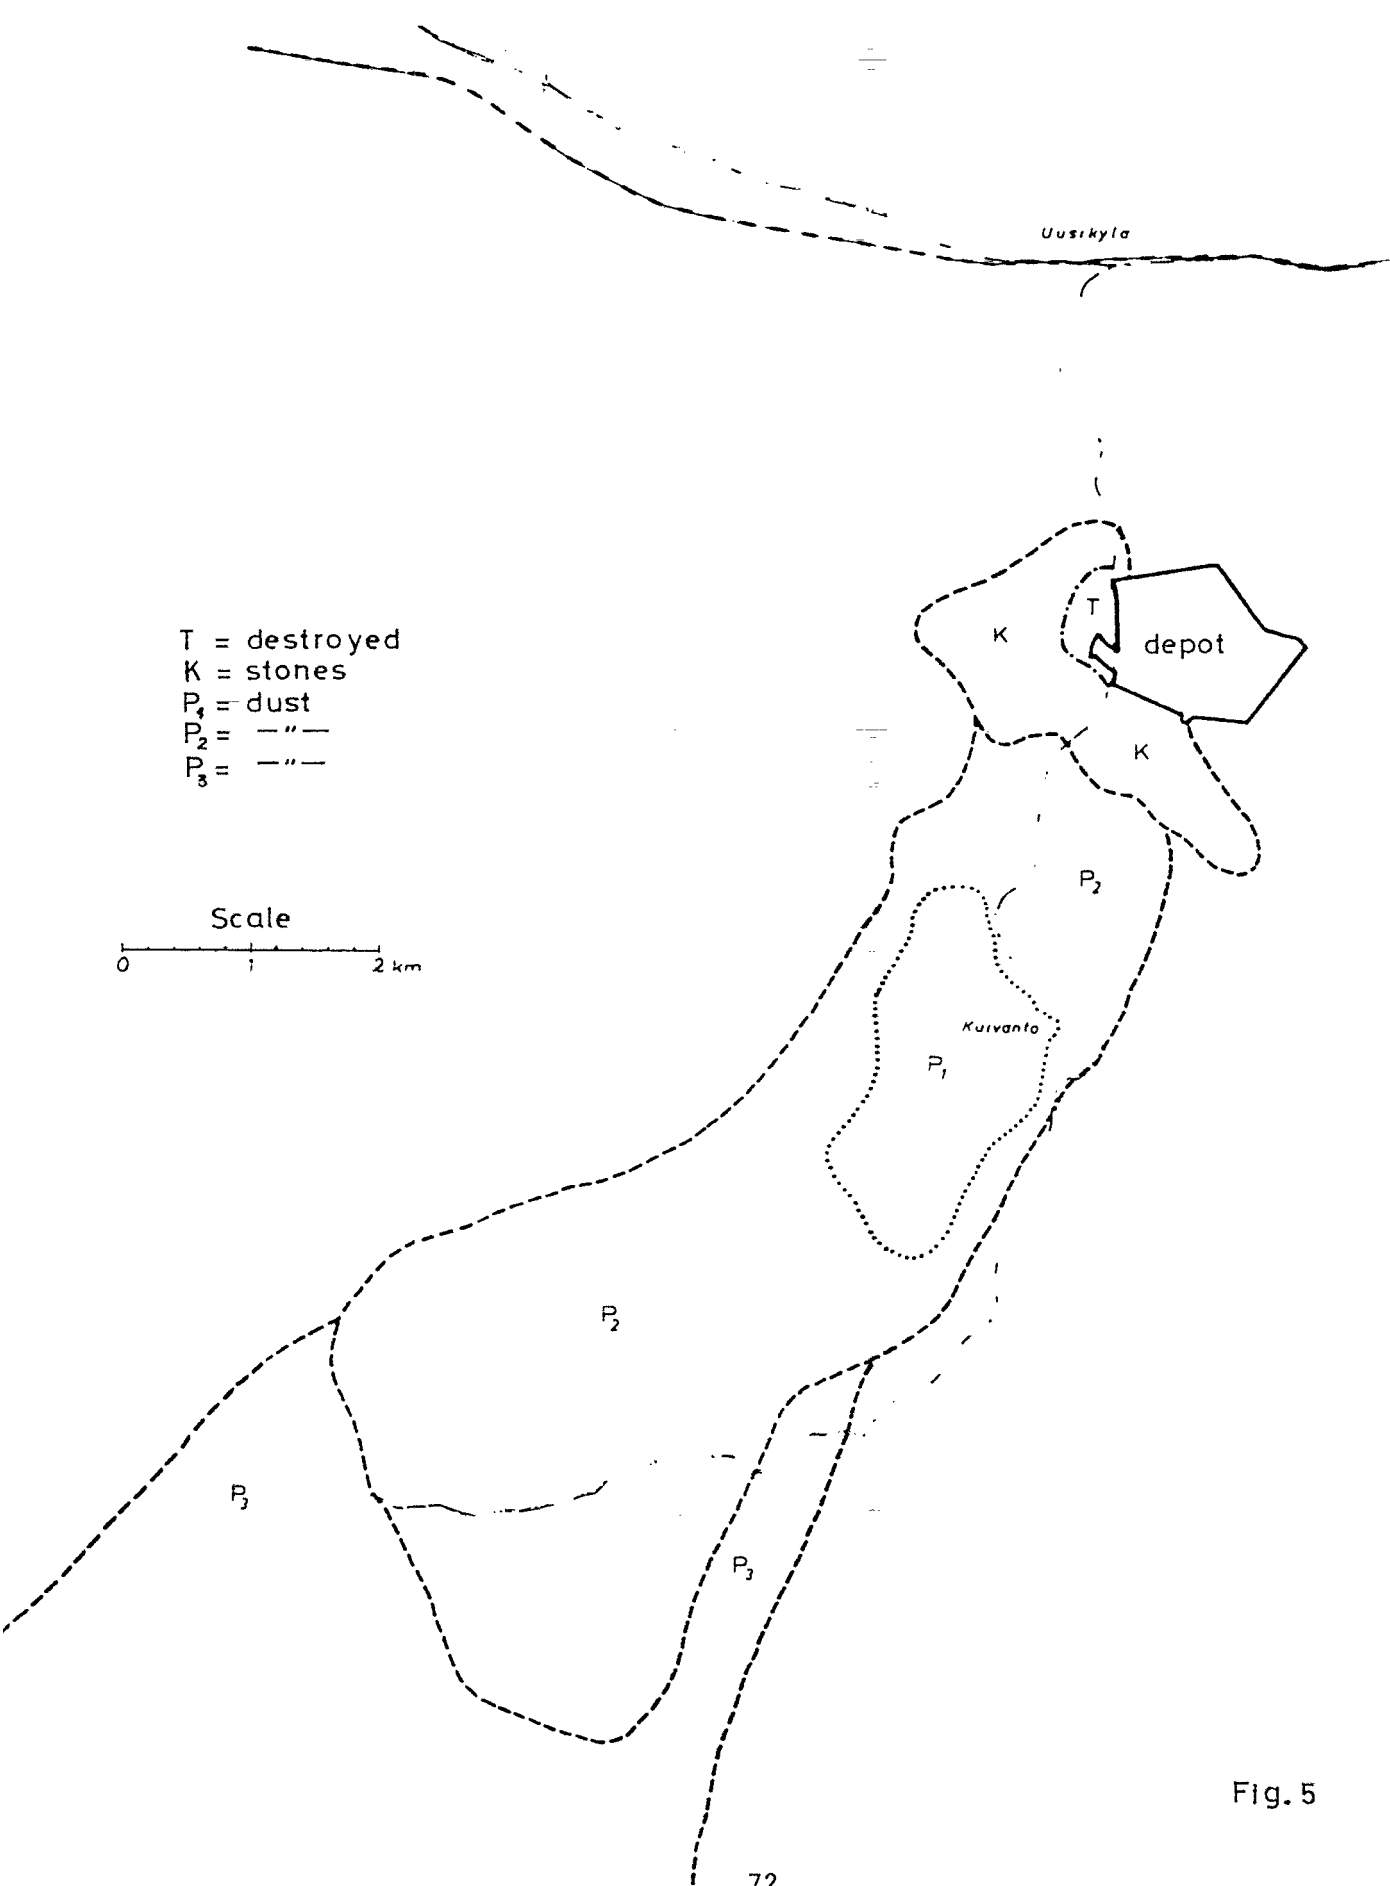
Fig. 5

In the pictures there are shown the effects of the rock shower to the buildings and surroundings. Specially in this accident the effects of flying stones, blocks and dust were typical effects to surroundings. For example there were hay and berries spoiled by dust in large areas (Fig. 5).

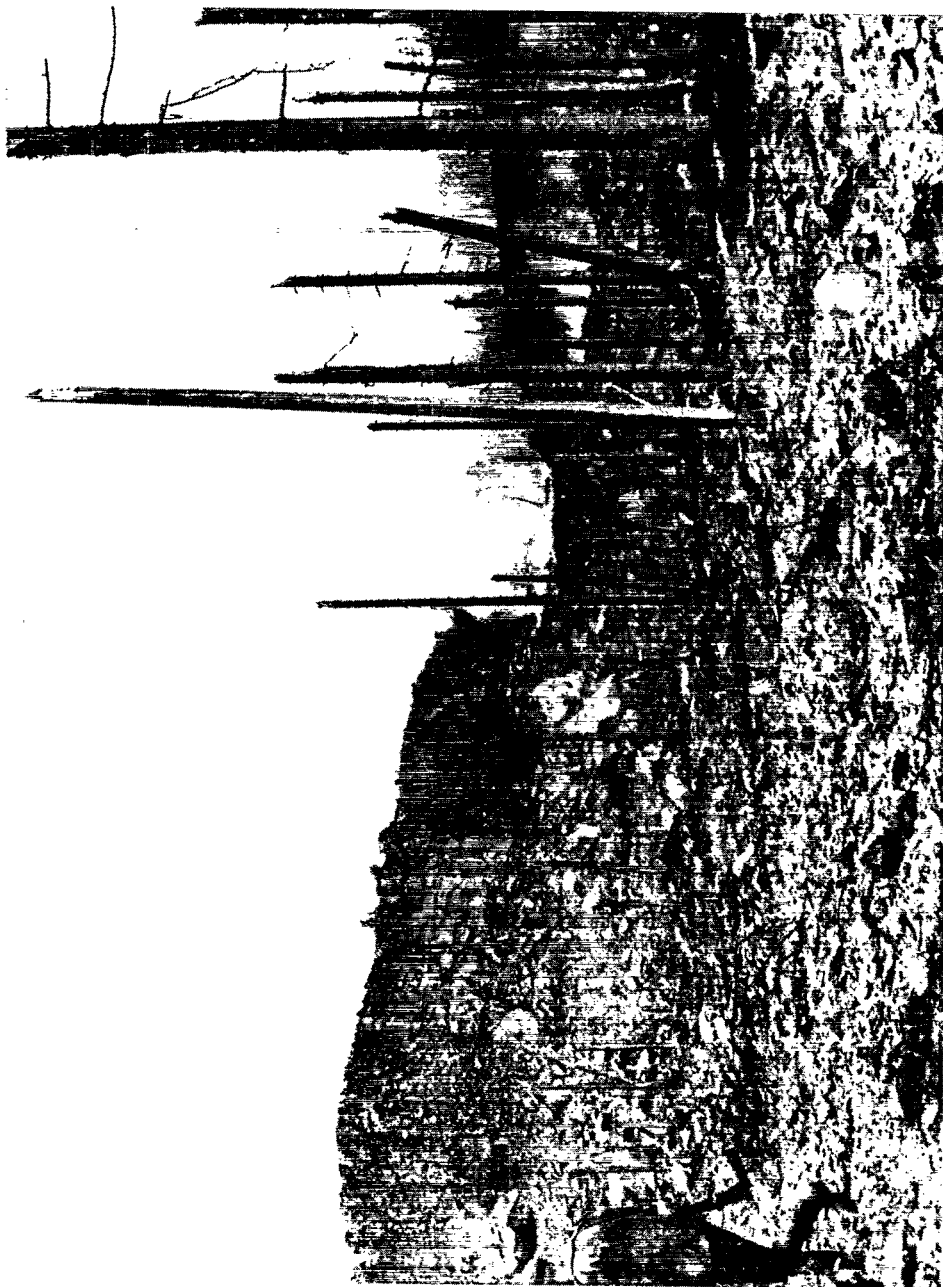
PICTURE 1

Near the crater. Something is still burning.

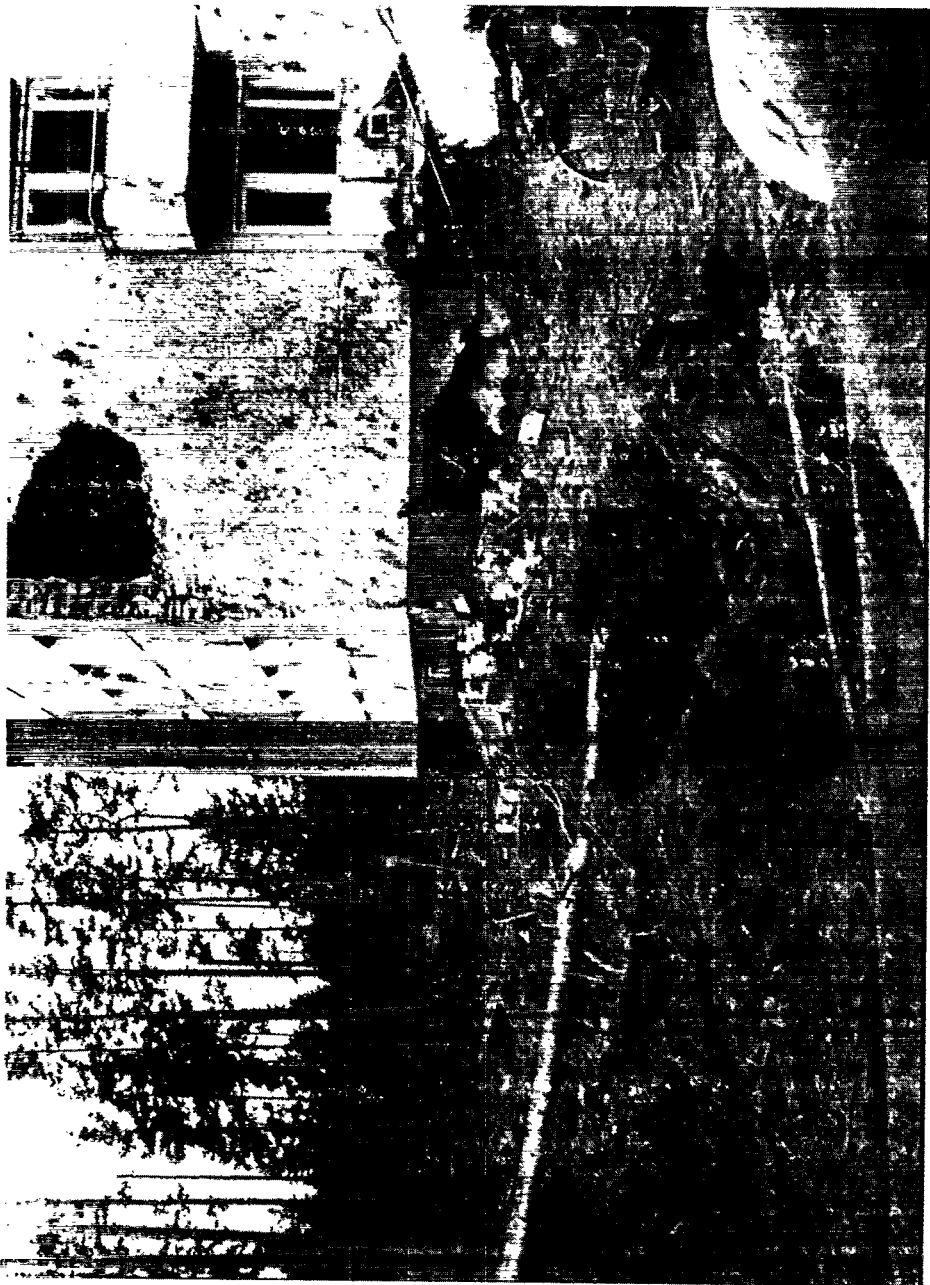
PICTURE 7

The Living house, 650 m from  
the Explosion.
