# **MJU-8 IR FLARE MIX FIRE AT LONGHORN AAP, 28 SEPT 91**

**RALPH A. KNAPE**

**U.S. ARMY ARMAMENT  
MUNITIONS AND CHEMICAL COMMAND**

**25th DEPARTMENT OF DEFENSE  
EXPLOSIVES SAFETY SEMINAR  
18-20 AUGUST 1992**

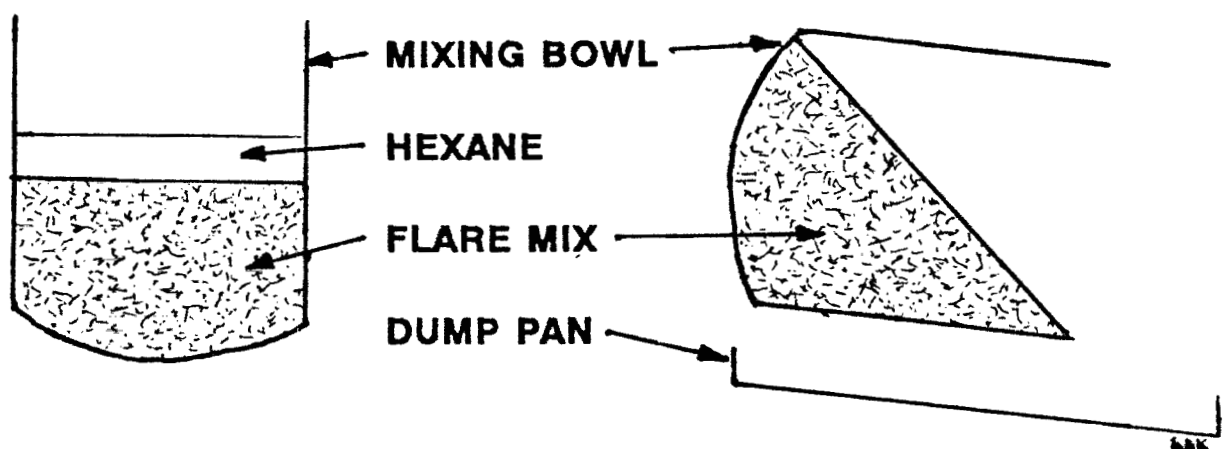
## DIAGRAM 1

Diagram 1 cross-sections the mixing bowl in upright and dump positions. In the first case, the MJU-8 mix is shown covered by a layer of hexane liquid as the mix precipitates out in the absence of agitation. The second illustration shows the mixing bowl as pouring off of hexane liquid is completed. (Actually, the liquid is about 93 percent hexane and 7 percent acetone at the time of dumping.) The second illustration shows the mixing bowl in the position it was in at the time of the incident. The fact that the side of the bowl is turned about five or ten degrees past horizontal is significant.

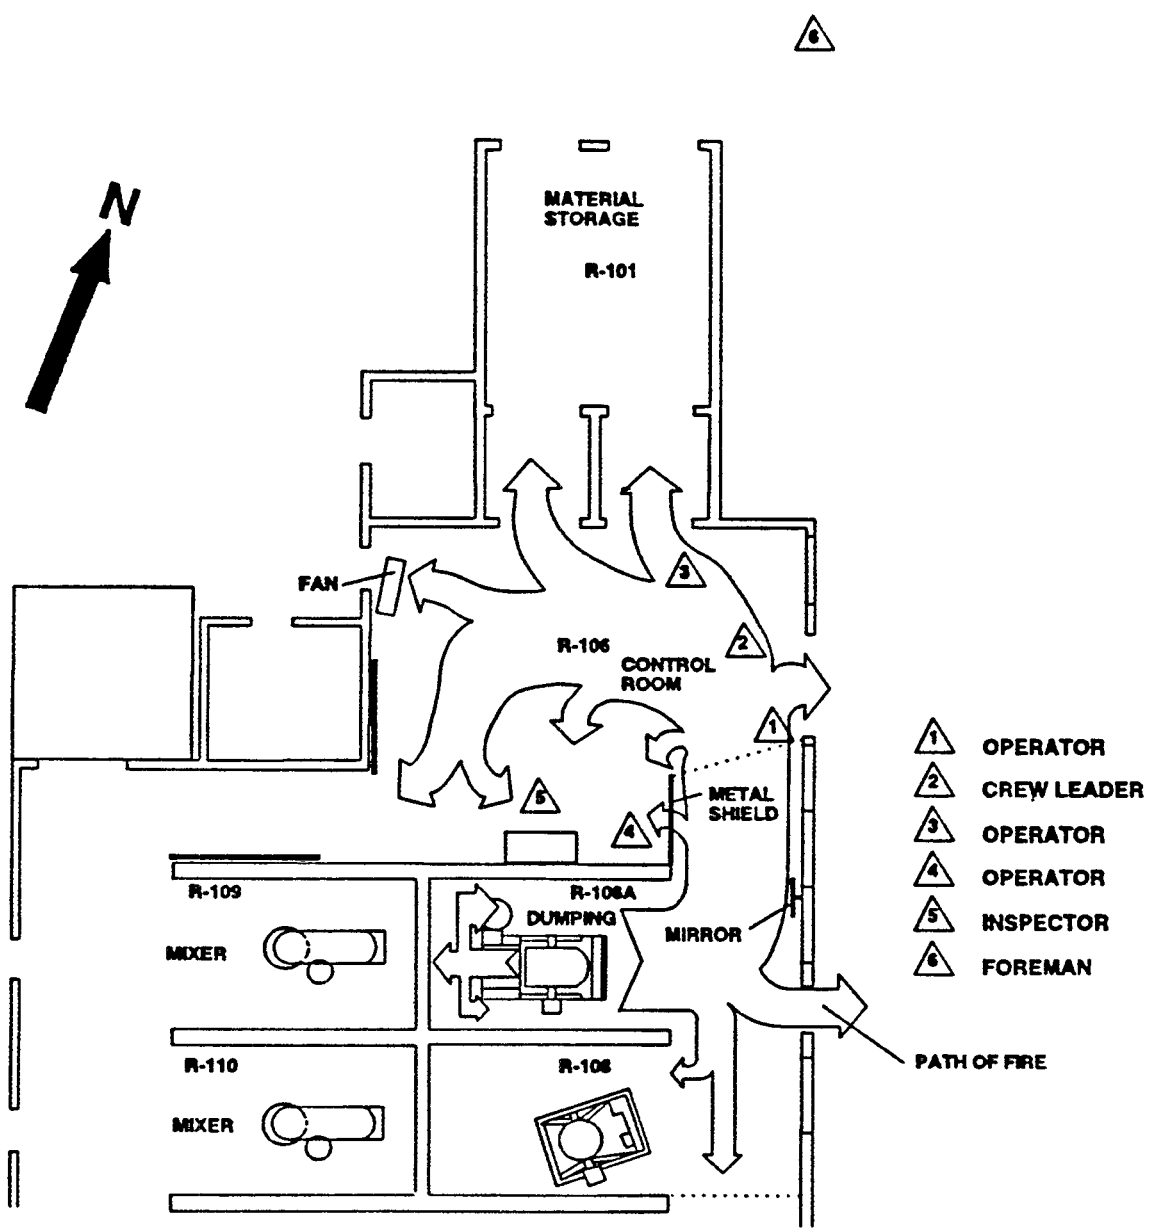
DIAGRAM 2

Investigation after the incident located the point of ignition of the fire as the area of hexane dumping and collection and tracked the path of the fire as it spread. The path and speed of fire spread during the incident was determined by a number of factors, including the presence of hexane vapor, the type and amount of mix in the bowl, the building construction and wind direction. Diagram 2 shows the path of the fire and indicates the location of the personnel in the building at the time of the fire. Evidence in the building indicted that the expanding fireball carried particles of burning mix as it bounced off the dump bay wall and swept out into other building areas. Size of the arrows is used to denote the relative amount of flame and heat as the fireball expanded.

Personnel at locations one through three were near exits and exited immediately as the fire initiated in the dumping bay, before the fireball could spread completely into the control room. Personnel at locations four and five were not in positions to immediately exit and had to fight their way through the fireball and burning mix in the control bay to exit. Both were severely burned and one subsequently died.

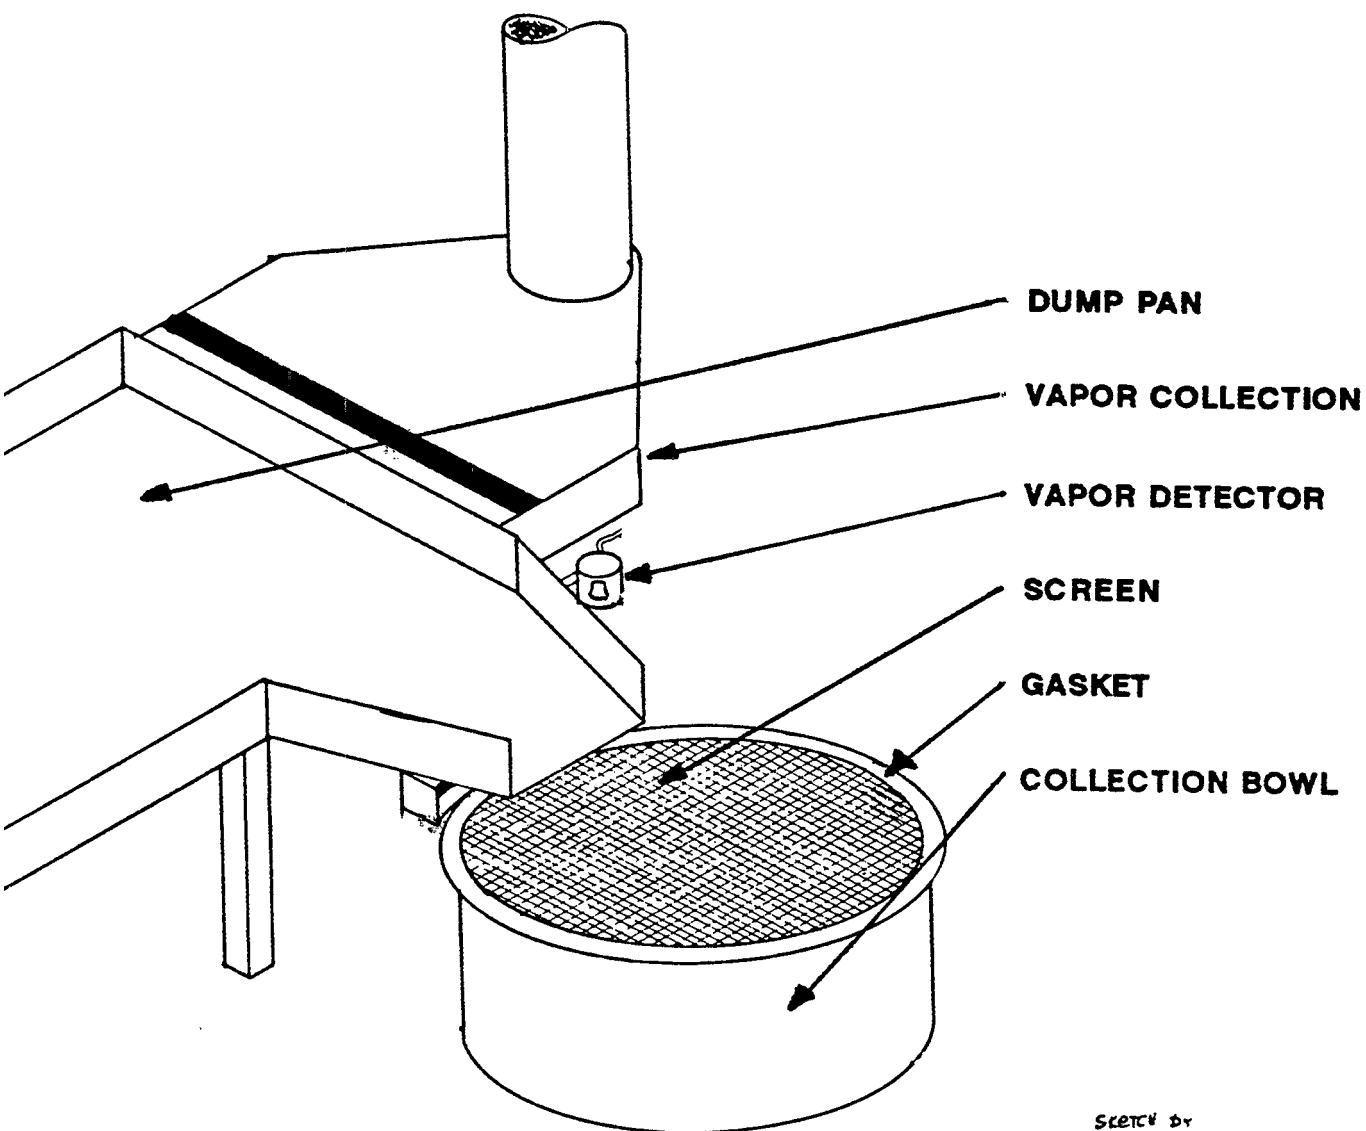
**DIAGRAM 3**

All permanently installed equipment in the dump bay had been bonded and grounded, and had undergone periodic testing. However, the BOI identified a screen that the hexane flowed through which was electrically isolated due to the addition of a nonconductive rubber gasket. The circular metal screen had not been tested when other equipment was tested. It was determined by the BOI that, most likely, a static spark from the screen ignited the surrounding hexane vapor which in turn ignited the MJU-8 mix.

The conclusion reached by the BOI was that the static spark was the root cause in the incident. The day that the incident occurred was the first very low humidity, low temperature day since adding the rubber gasket to the screen, creating a high static environment. A new dump operator, less experienced at the dumping operation was at the controls, possibly causing less smooth flow of hexane compared to operators more practiced at dumping, raising the potential for static generation and discharge. These factors combined to provide the opportunity for the spark. Testing after the incident proved that the dump pan above the screen and the collection bowl below the screen were

grounded, so two possible directions existed for the spark to jump. Both possible locations were known to contain hexane vapor even though both were covered by ventilation systems. A direct trail of hexane/hexane vapor led from the collection bowl through the area of the screen and to the mix in the dumping bowl. The entire hexane collection system quickly became involved and immediately ignited the mix in the mix bowl. Once ignited, the mix burned violently, blowing particles of mix out of the bowl, through the dump bay and into the hallway where those burning particles could be pushed by gas pressure into the control bay to surround the two operators.
