# **THE EXPLOSION OF THE DISPLAY FIREWORKS ASSEMBLY PLANT "MS VUURWERK" ON FEBRUARY 14, CULEMBORG, THE NETHERLANDS**

25th DoD Explosives Safety Seminar  
18-20 August 1992, Anaheim, California

W.P.M. Mercx and H.H. Kodde

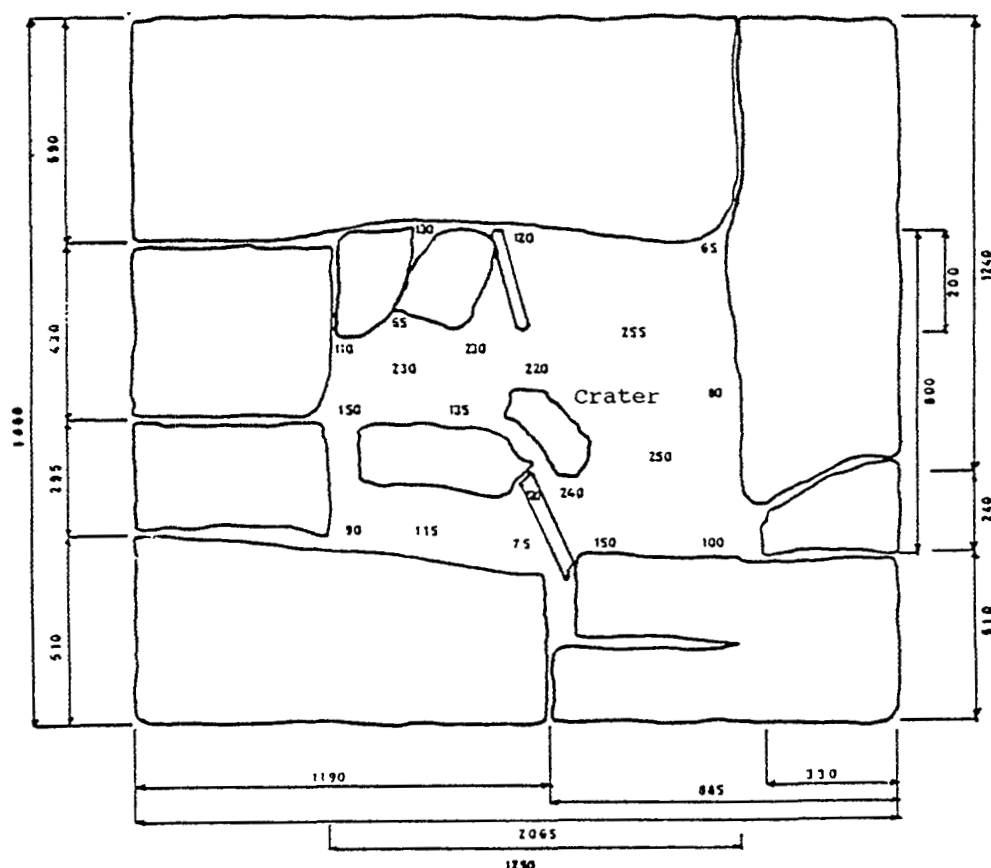
Figure 5 Overview of the crater

It appeared that the new building was completely vanished and that only a large crater was left. The crater dimensions where 10 by 5 meters with a depth of more than two meters (see Figure 5).

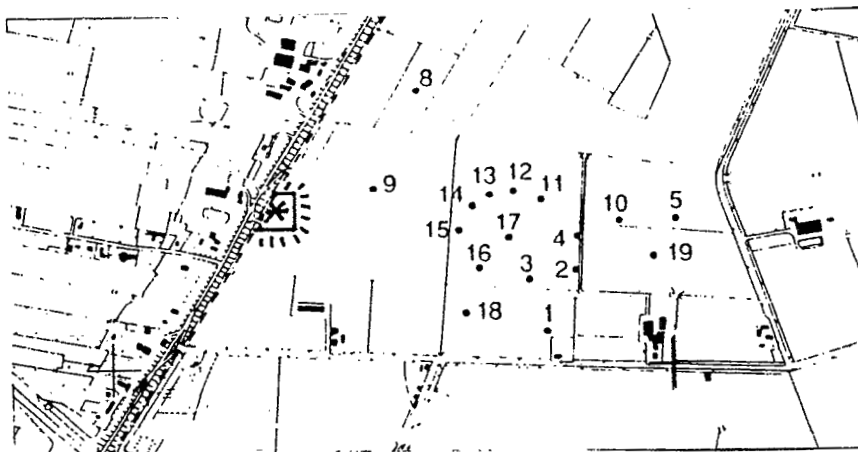
Figure 6 Location of the large steel girder parts

Beside damage caused by the blast there was considerable damage caused by flying debris. The largest range over which debris was thrown was found on the eastern side. The storage rooms were situated on the eastern side of the assembling hall. Up to 650 m east of the plant large pieces of concrete weighting 10 to 20 kg and parts of steel girders (length approx. 4m) were found.

Table 1 gives an overview of the large steel girders that were found and Figure 6 gives the location of these pieces of steel. All IPE's box girders and steel strips were parts of the steel truss of the exploded building.

It is recommended to make an evaluation of the damage caused by the explosion in relation of the criteria of the quantity distances as recommended by the AC/258 storage group. This should be done especially for the fragment and debris criterion for HD 1.1 as large pieces of steel girders were thrown far beyond the 400 m circle.

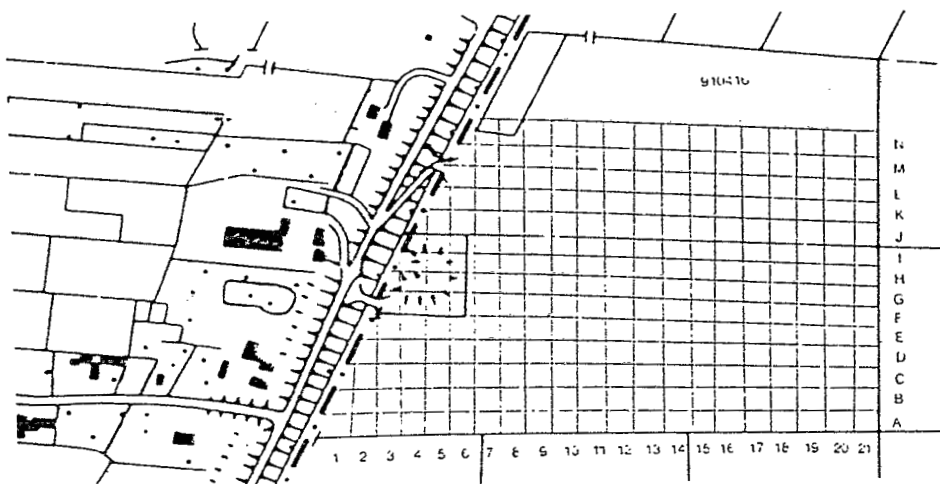
Figure 7 Sections for fragment and debris recovery

Most of the debris consisted of bricks or parts of bricks and concrete pieces with dimensions comparable to bricks. At a distance of 300 to 550 m in eastern direction, the distance between the pieces of debris was about 50 m.

Each section was searched by a team of police and army men and every piece of debris weighting over 0.5 kg was gathered. Table 2 gives the total weight of the debris found in each section.

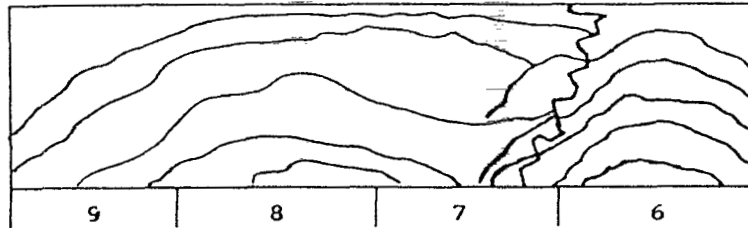
Figure 8 Cracks in concrete floor in front of the storage rooms

The crater consisted of two parts, one part underneath storage room 6 and the other part underneath storage rooms 7, 8 and 9. The concrete floor plates of storage room 7 and 8 were partially shoved over the floor plates of storage room 6.

A reasonable explanation for this is that the explosion probably started in storage room 6, immediately followed by an explosion in storage room 7, 8 and 9. The latter was responsible for shoving the concrete floor plates over each other. This sequence of events is also in agreement with the locations where some of the green plastic fragments were found.

A second fact to support the theory of an initial explosion . immediately followed by a second one, is the crack pattern in the concrete floor plates in front of the storage rooms (see Figure 8).

This pattern showed two circular crack zones, one in front of storage room 6 and one in front of the storage rooms 7, 8 and 9 and a large cross crack perpendicular to the storage rooms. The circular cracks in front of storage room 6 were not interrupted by the cross crack while the circular cracks in front of 7, 8 and 9 were. This indicates that the cracks in front of rooms 7, 8 and 9 were created after the formation of the cracks in front of room 6.
