## **Corrosion-Resistant Materials for Water and Wastewater Treatment Plants at Fort Bragg**

Final Report on Project AR-F-319 for FY05

L.D. Stephenson and Ashok Kumar

June 2007

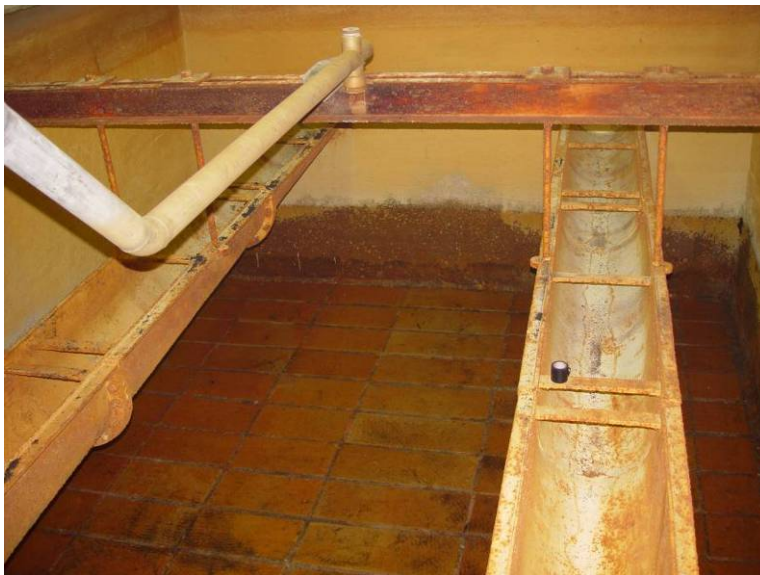
In WTPs, the concrete surfaces of the single and dual water filters deteriorate over time. This deterioration occurs primarily due to chlorine attack on the concrete mortar. This is evidenced by exposed aggregate in the surface of the concrete.

Figure 1a. Concrete surface in single cell water filter before refurbishment.

1. *Refurbish the concrete wall coating in the single filters.* These tasks involved the rehabilitation of the concrete walls in single cell filters No. 1 through 10. All deteriorated concrete and coatings were removed, and the walls were cleaned down to the sound coated concrete surfaces. Mainstay ML-72 Microsilica Restoration Mortar was then applied over those exposed concrete surfaces and troweled smooth (at +/- ½-in. thickness) to restore the concrete walls to their original thickness. The ML-72 mortar was then coated with 20 to 25 mils of Madewell 1103 Epoxy Coal Tar coating and top-coated with 16 mils of Mainstay DS-4 epoxy. Mainstay ML-72 Sprayable Microsilica Cement Mortar is a restoration mortar that forms a

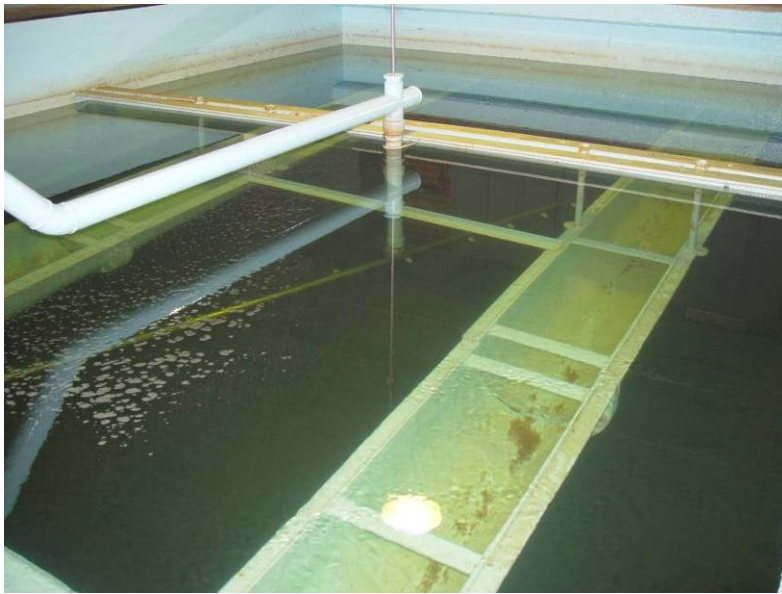
Figure 1b. Concrete surfaces in single cell water filter after refurbishment.

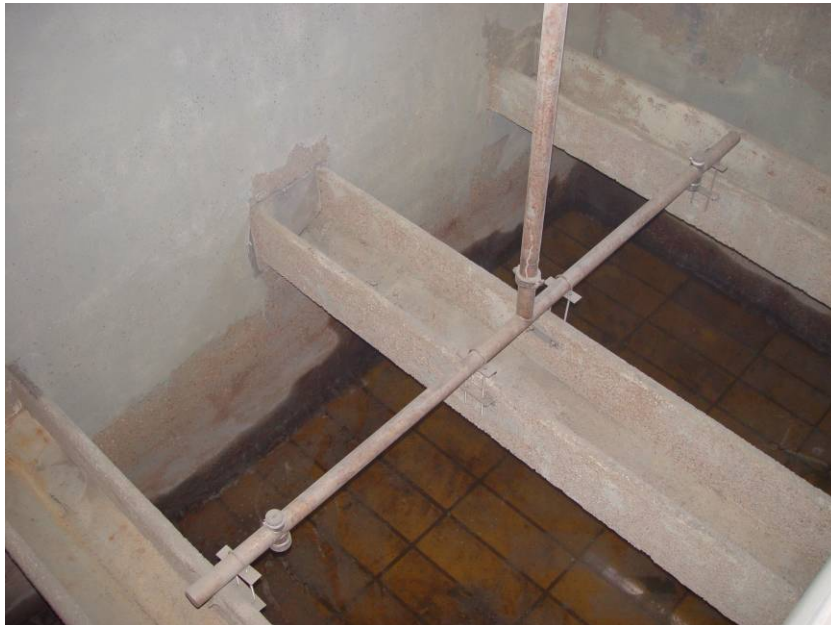
Figure 2a. Concrete surface in dual cell water filter before refurbishment.

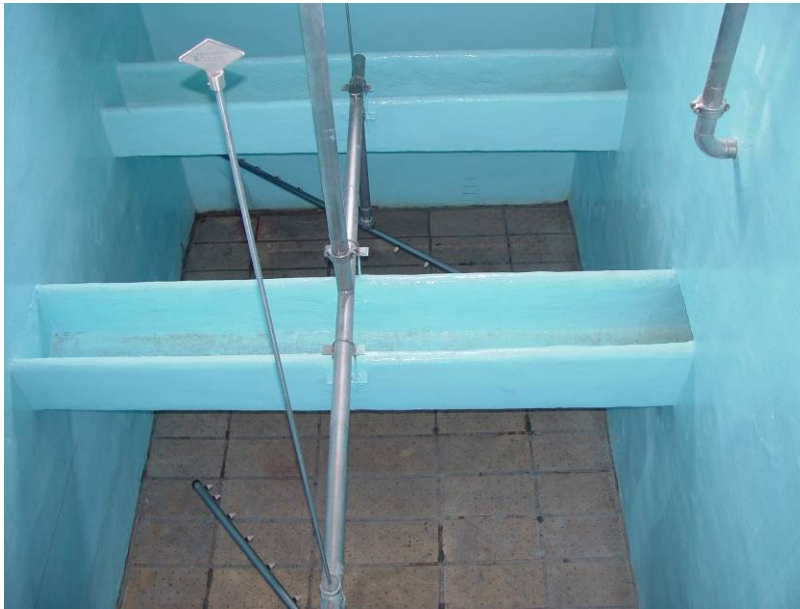
Figure 2b. Concrete surface in dual cell water filter after refurbishment.

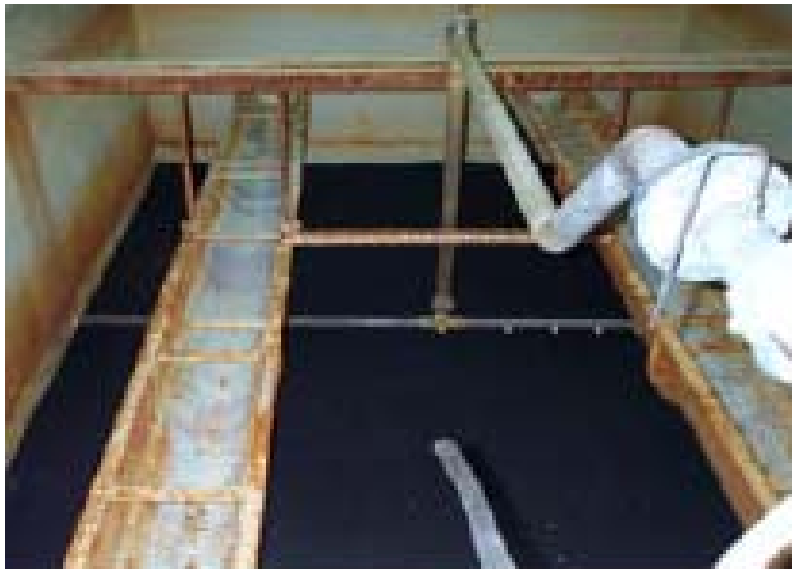
Figure 3a. Metal troughs and wash piping in single filter cells before coating refurbishment.

Before and after photographs are shown as Figure 3a and Figure 3b, respectively in the water treatment plant photographic journal section (Appendix 2). Additional specification information may be found on the PDS for these materials, as given in Appendix 3. Certain unforeseen field conditions ultimately led to premature corrosion in some areas (estimated to be less than 1% of the total trough surface area). The problem areas were all concentrated in tight, difficult to access spots, such as segments of angle iron mounted back-to-back, bearing plates attached directly to (and in in-

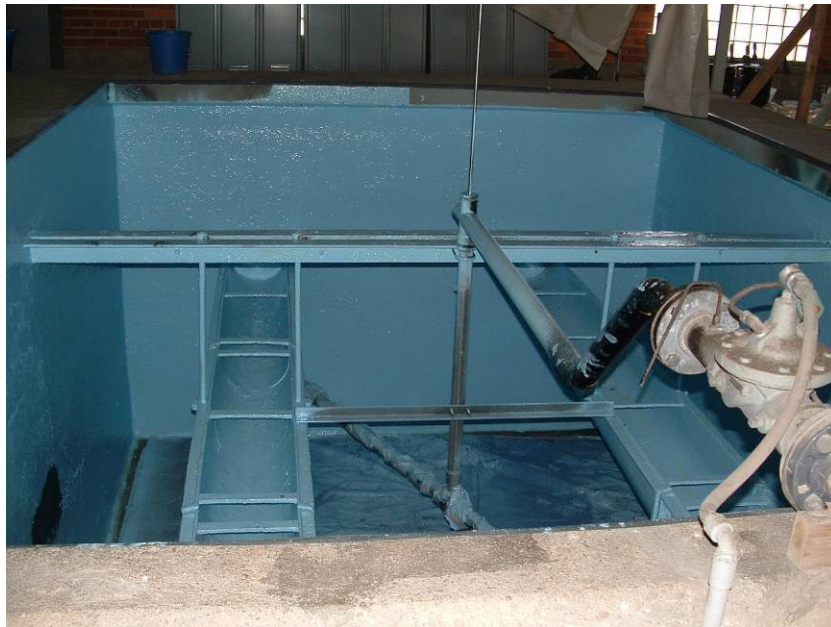
Figure 3b. Metal troughs and wash piping in single filter cells after coating refurbishment.

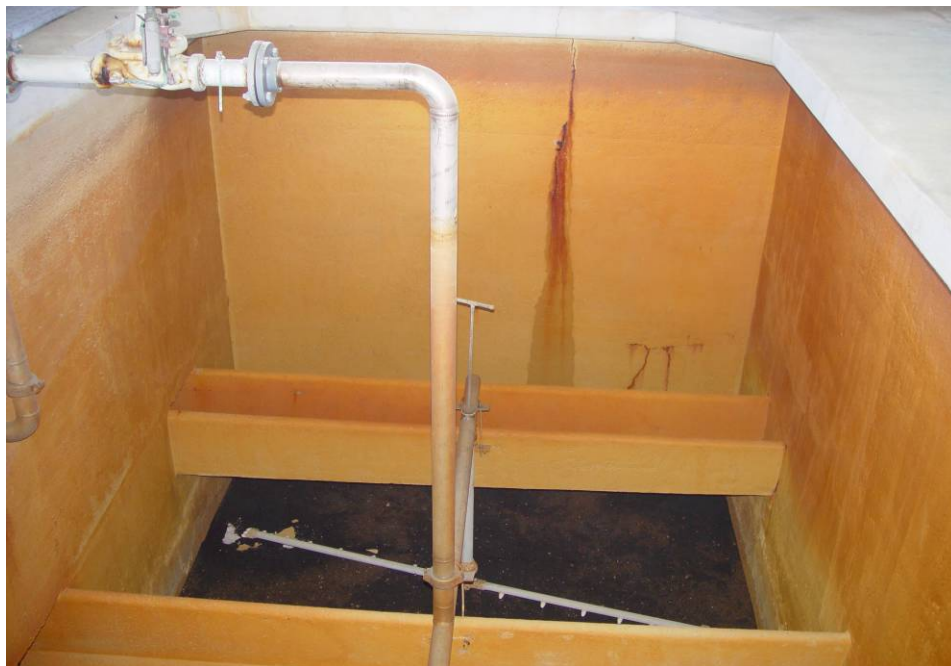
Figure 4a. Newly installed wash piping in dual filter cells before refurbishment.

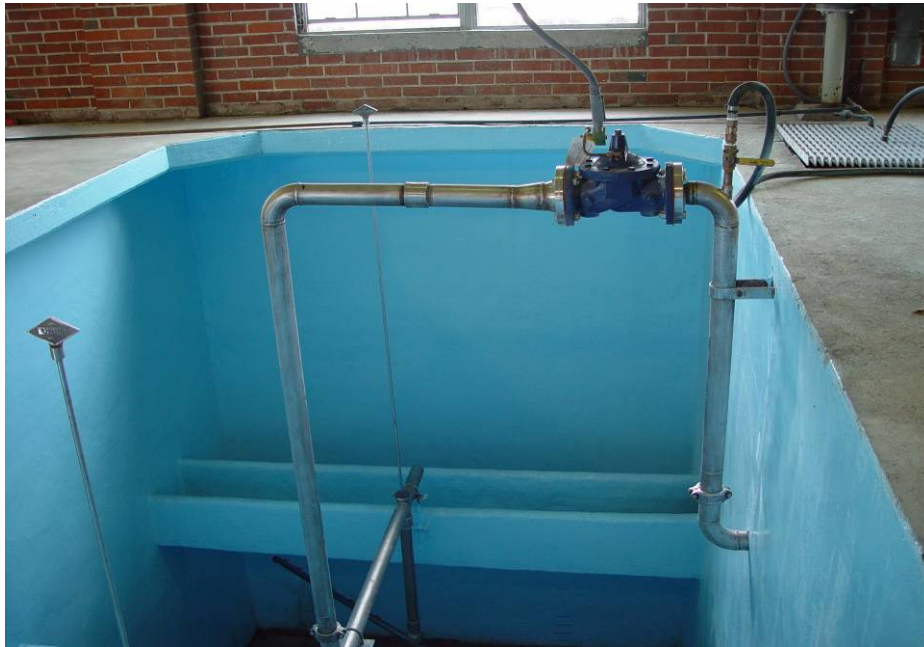
Figure 4b. Newly installed wash piping in dual filter cells after refurbishment.

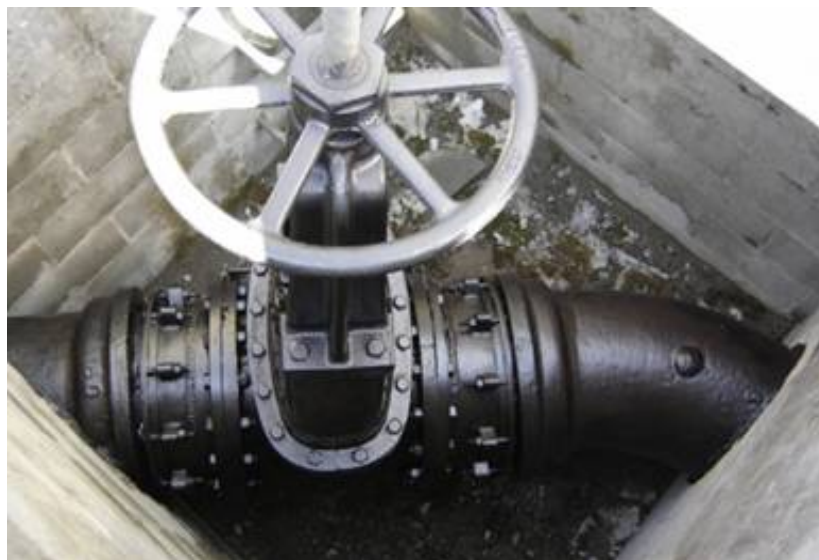
Figure 5. New coating system on one of nineteen underground valve pits.

*5. Refurbish the coating on the piping and valves in below ground pits.* This task involved repairing the coatings on the water pipes and associated valves within 19 underground valve pits in the fresh water plant. The pipes, valves, and fittings were sandblasted to near white metal (SP-10). The contractor then applied 20 to 25 mils of 1103 coal tar epoxy. Figure 5 is a photograph of one of the newly coated valve pits (Appendix 2).

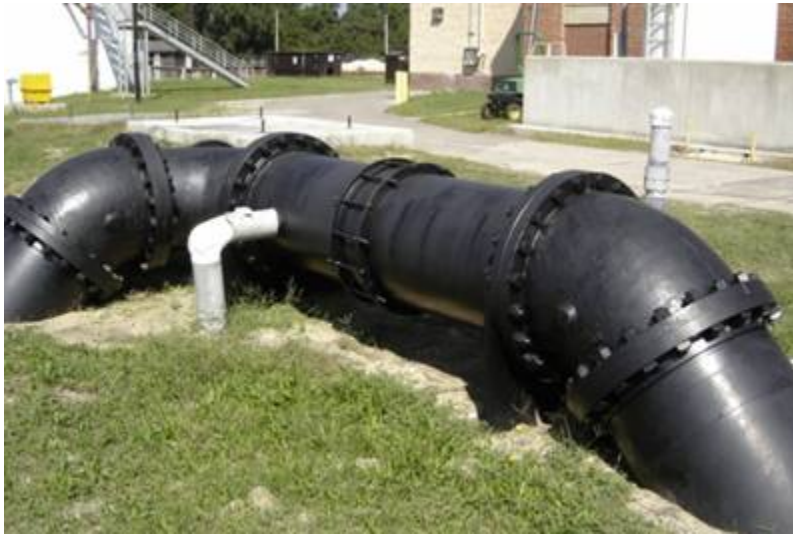
Figure 6. New coating system on above-ground manifold.

6. *Refurbish the coating on large, above ground piping manifold.* This task involved the repair of coatings on the 20-in.  $\phi$  manifold piping behind the filter building in the fresh water plant. The piping was abrasively blasted to near white metal (SSPC-SP 10), and then 20 to 25 mils of Madewell 1103 epoxy were applied. Figure 6 is a photograph of the newly coated piping manifold (Appendix 2).

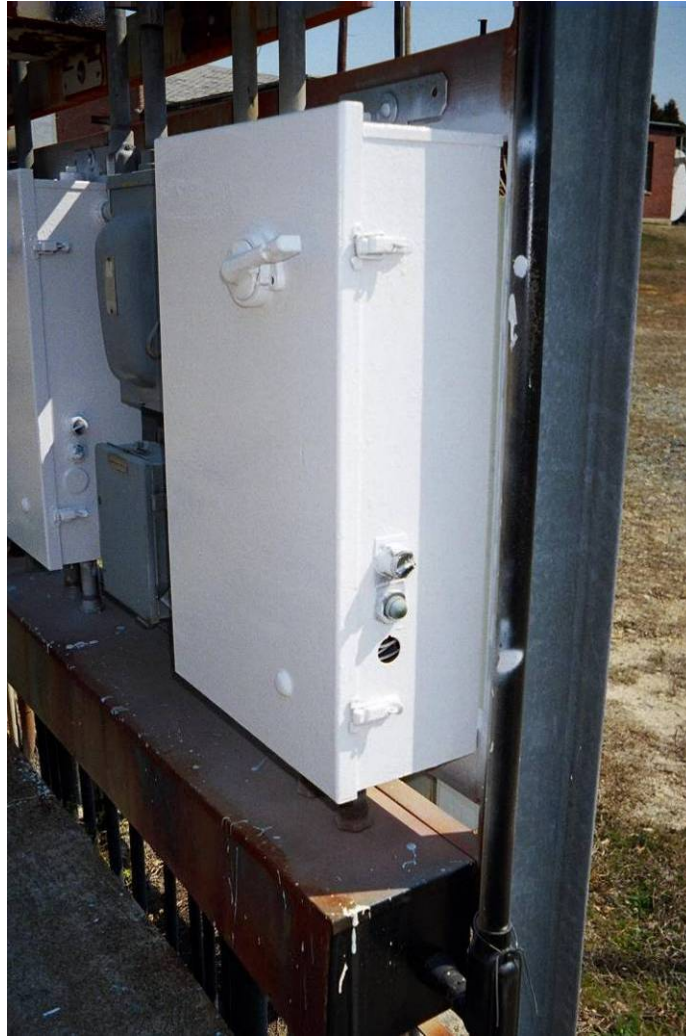
Figure 7. Electrical boxes at water treatment plant after refurbishment.

7. *Refurbish the coating on electrical panel box.* This task involved the repair of two electrical panel boxes in the water plant that service recirculation pumps No. 1 and 2. The boxes were abrasively blasted to near white metal (SSPC-SP 10). Then 10 mils of Madewell 1312S epoxy were applied and top coated with 2 to 3 mils of Madewell 1450 urethane. Madewell® 1312S is a heavy duty, 100% solids two component epoxy coating product. It is used for both new construction and maintenance of steel and concrete surfaces in tanks, sumps, trenches, decks, and pipe interiors and other process equipment and structures in chemical processing, power, refining, mining, pulp/paper and oil refining industries. Madewell 1312S may be used as a topcoat for other Madewell 1312 series coating systems to add color and/or seal the surface.

Madewell 1312S protects surfaces against chemical attack under immersion, spill, and splash conditions and impact and abrasion damage by rough use or heavy traffic. It is normally applied at a nominal thickness of 10 to 25 mils in two coats. Being attractive and easy to clean, its monolithic construction resists moisture, chemical, and bacterial penetration. Its free spreading characteristics, fast set time, and easy cleanup help to minimize labor costs and down time. Additional specifications may be found on the PDS for these materials, as given in Appendix 3. Figure 7 presents a view of a typical electrical panel box after refurbishment in the photographic journal section (Appendix 2).

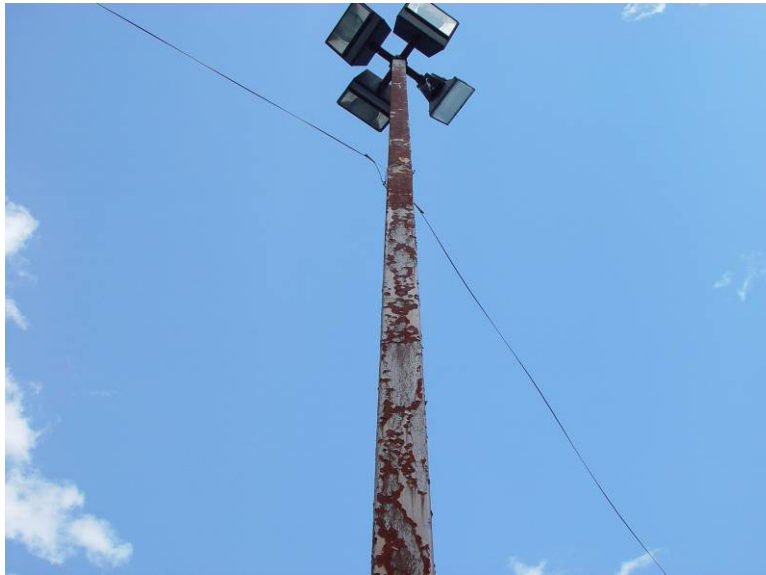
Figure 8a. Typical steel light pole at wastewater treatment plant before refurbishment.

1. *Refurbish the coating on 40-ft tall yard light poles.* This task involved repairs to 17 light posts within the wastewater treatment plant. The contractor wet blasted the square metal posts, including the base plates, to white metal (SSPC-SP 10). A 20 to 25 mil coat of 1103 coal tar epoxy was applied, followed by 2-3 mils of urethane 1450. Before and after photographs are shown as Figures 8a and 8b, respectively, in the wastewater photographic journal section (Appendix 2). Additional specifications may be found on the PDS for these materials, as given in Appendix 3.

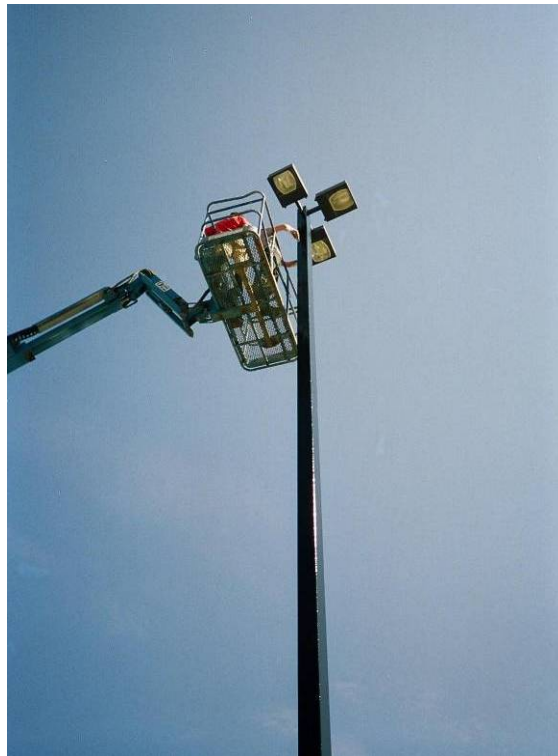
Figure 8b. Typical steel light pole at wastewater treatment plant after refurbishment.

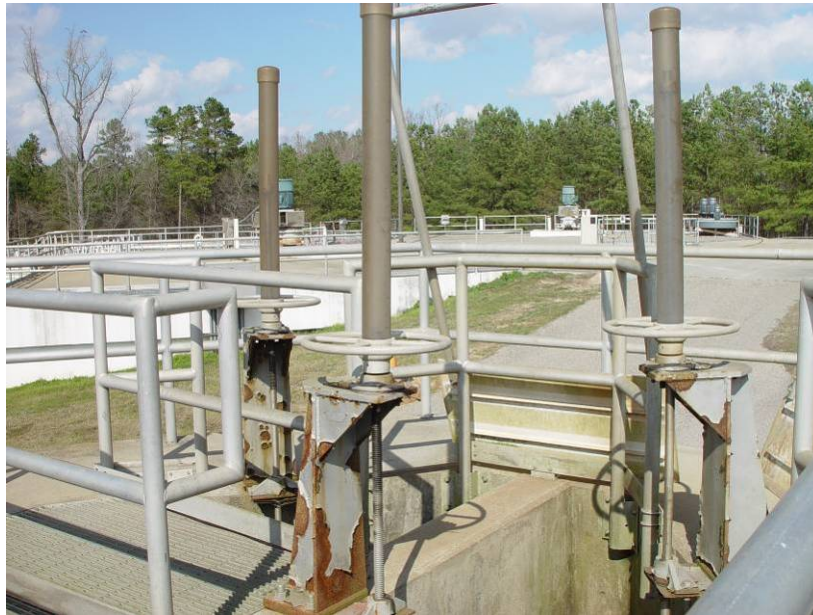
Figure 9a. Hand wheels and operator stands before refurbishment at wastewater treatment plant.

2. *Refurbish the coating on remote valve hand wheels and valve stem operator stands.* This task involved the repair of valve stands and valve wheels within the WWTP, sand blasting and coating 19 valve wheels, and sand blasting and coating 11 valve stem operator stands. The wheels and stands were sand blasted to SSPC-SP 10. Once cleaned, the wheels and stands were coated with at least 20 mils of Madewell 1103 coal tar epoxy and 2 to 3 mils of Madewell 1450 urethane. Before and after photographs are shown as Figures 9a and 9b, respectively, in the wastewater photographic journal section (Appendix 2). PDS for these materials are given in Appendix 3.

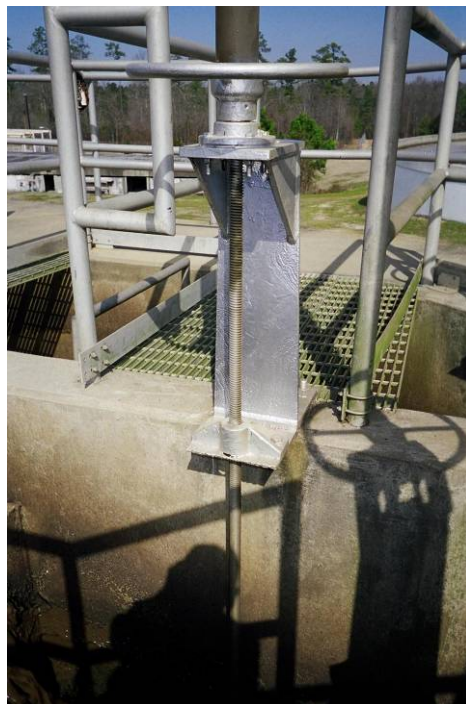
Figure 9b. Hand wheels and operator stands at wastewater treatment plant after refurbishment.

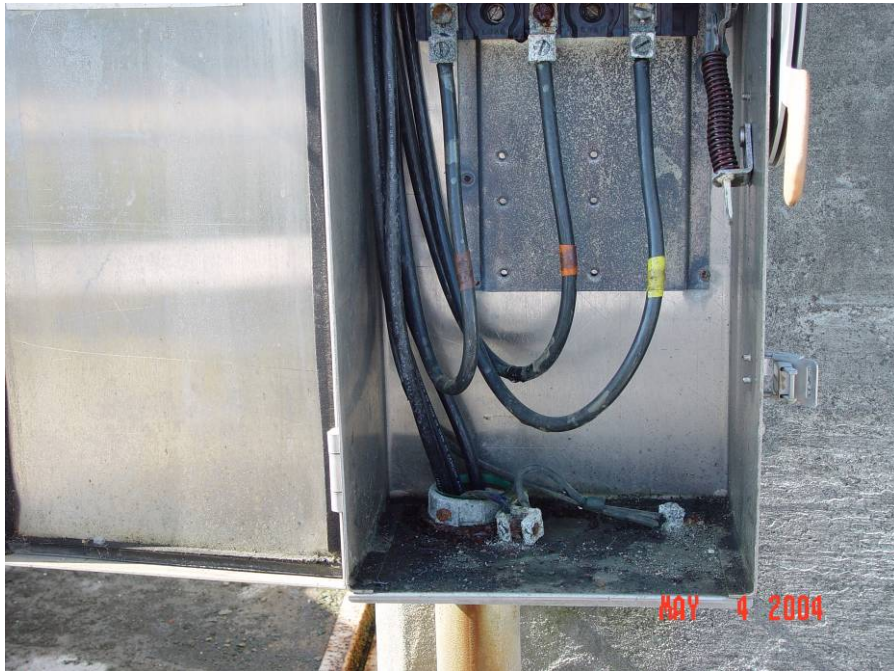
Figure 10a. A typical electrical control box before refurbishment.

3. *Refurbish and seal stainless steel electrical motor control/circuit breaker panel boxes.* This task involved repairs to ten existing electrical disconnect boxes on various pump and mixer motors in the wastewater plant. The boxes are primarily stainless steel, with a mixture of galvanized, polyvinyl chloride (PVC) and PVC-coated flexible conduits. The contractor inspected each box, replaced damaged hinges and hasps, repaired conduit connections, replaced missing or damaged gaskets with corrosion-resistant nitrile gaskets, and sealed the conduits. Before and after photographs are shown as Figure 10a and Figure 10b, respectively, in the wastewater photographic journal section (Appendix 2). Nitrile or buna-N rubber seals are used more than all the other elastomers combined, since nitrile is the most versatile material and is not as likely to fail as do most other rubber gaskets and seals due to the natural breakdown of the elastomeric molecular bond of rubber when stressed (e.g., compressed, elongated). Additional specifications may be found on the PDS for these materials, as given in Appendix 3.

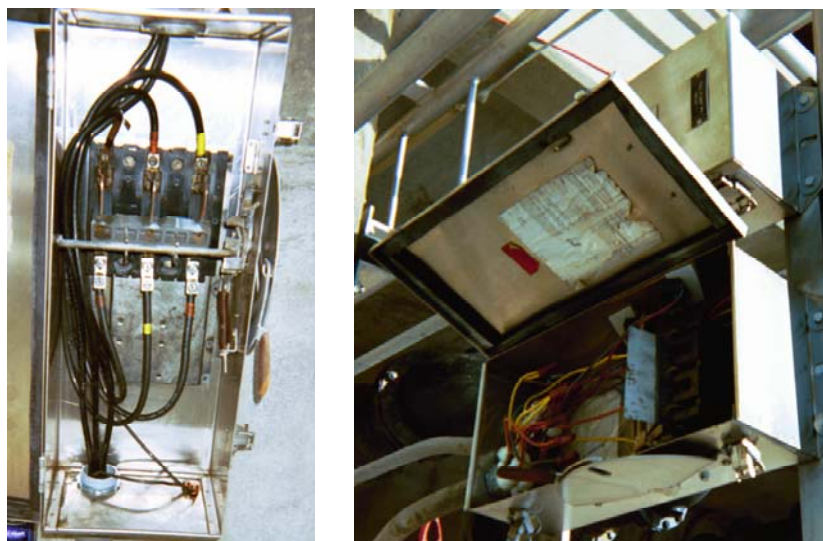
Figure 10b. Electrical control boxes at wastewater treatment plant with nitrile gaskets after refurbishment.

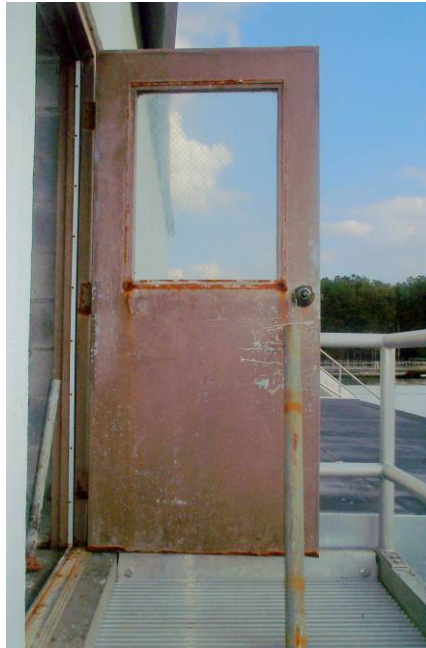
Figure 11a. Typical steel door at chlorine building at wastewater treatment plant before refurbishment.

4. *Replace one single and two double metal doors with FRP doors.* This task involved replacement of five sets of doors on the chlorine injection building (V-3408), within the potable water plant. The original steel doors and frames were removed, and the thresholds cleaned. New fiberglass frames and doors were then installed with stainless steel hardware. The new doors (manufactured by Tiger Doors) were of phenolic honeycomb core construction with exclusive press molding technology, yielding an integrally fused product. They also have a polyurethane skin coating on that provides the same excellent mechanical durability and superior resistance to sunlight, moisture, and chemicals. They carry a lifetime warranty as it specifically relates to delamination or corrosion, excluding third-party damage, vandalism, force majeure events, etc. Before and after photo-

graphs are shown as Figures 11a and 11b, respectively, in the wastewater photographic journal section in Appendix 2. Appendix 3 provides additional specification on the FRP doors. Appendix 4 presents a more detailed report on FRP doors installed at Fort Bragg under this OSD-sponsored project and at Fort Drum, NY, under a previous corrosion control technology demonstration project.

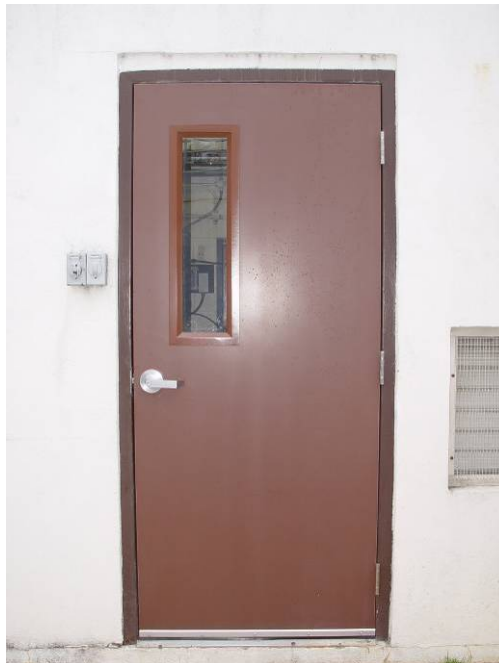
Figure 11b. Typical steel door at chlorine building at wastewater treatment plant after refurbishment.

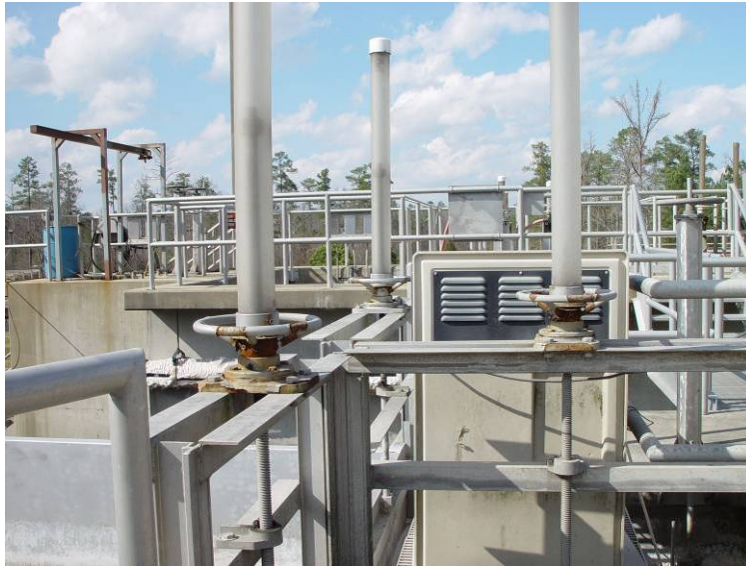
Figure 12a. Severely corroded (un-salvageable) corroded steel hand wheels at WWTP before replacement.

5. *Replace remote valve hand wheels and remote operator stands.* Three hand wheels were unsalvageable and had to be replaced. They were replaced with a corrosion-resistant aluminum alloy B26-525. Before and after photographs are shown as Figures 12a and 12b, respectively, in the wastewater photographic journal section in Appendix 2.

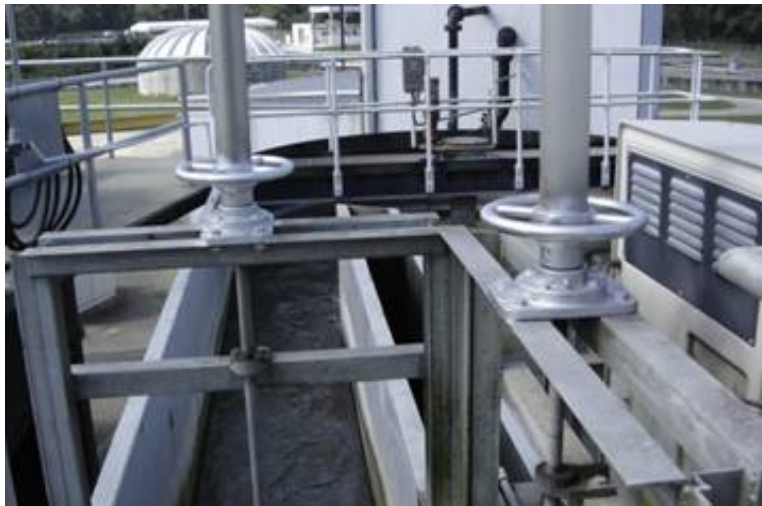
Figure 12b. New hand wheels (aluminum alloy B26-535) at WWTP replacing the corroded steel hand wheels shown in Figure 12a.

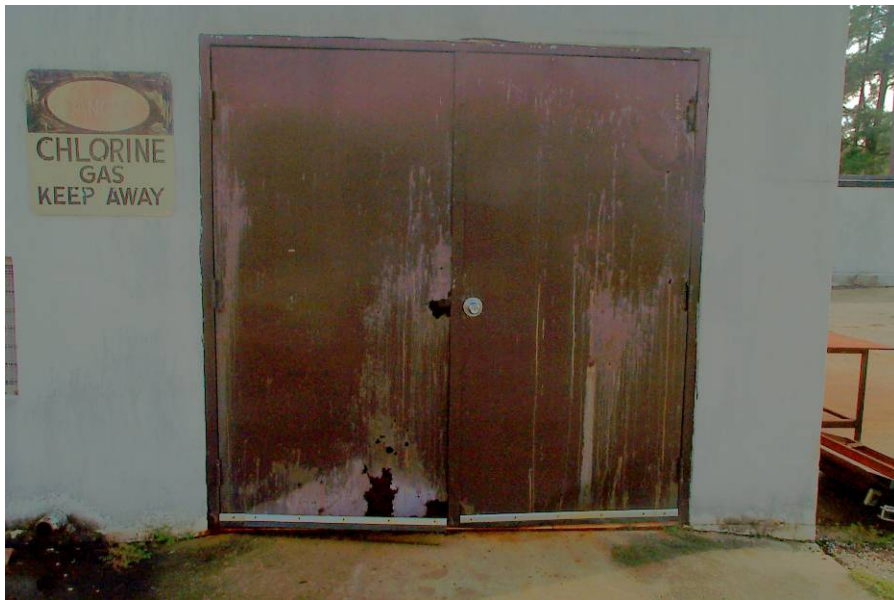
The exterior doors of the water treatment plant at Fort Bragg are shown in Figures 1-4. These photos were taken by R. Heidersbach, Dr. Rust, Inc., during a preliminary inspection of facilities at Fort Bragg in September 2004.

Figure 1. Corroded metallic doorway at the Fort Bragg water treatment plant.

The doors shown in Figures 1–4, and other doors on the same building, were scheduled for replacement with FRP doors, which should be more resistant to corrosion and weather. The lack of sills or other overhangs contributes to the corrosion of these doors, but they have also deteriorated due to the aggressive nature of the chemicals in use at the water treatment plant.

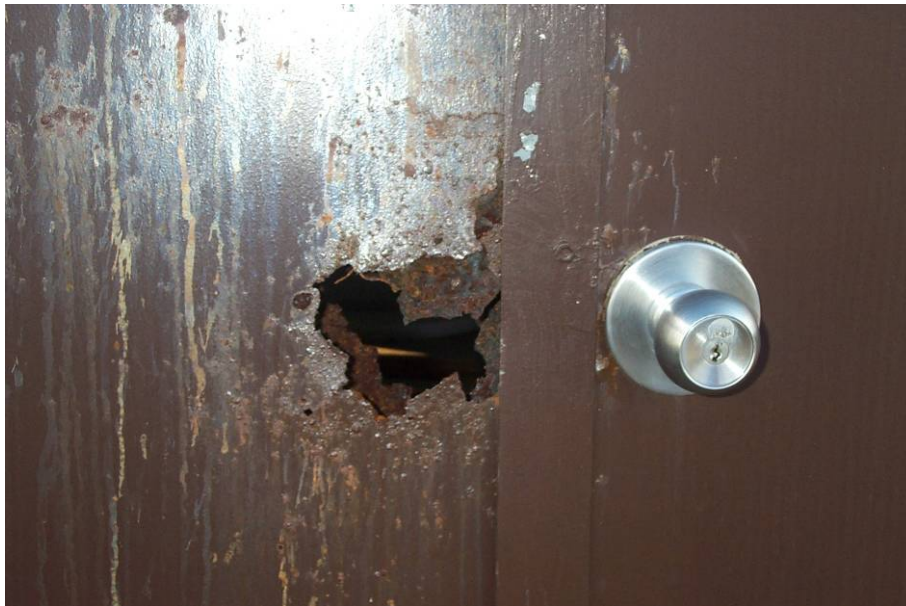
Figure 2. Closeup of corrosion on doors shown in Figure 1.

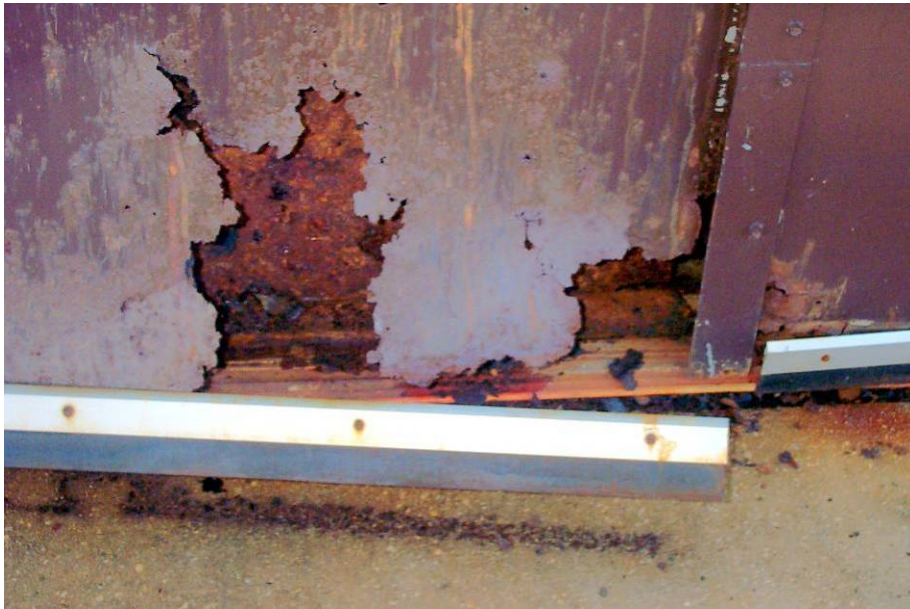
Figure 3. Corrosion of the bottom of the doors shown in Figure 2.

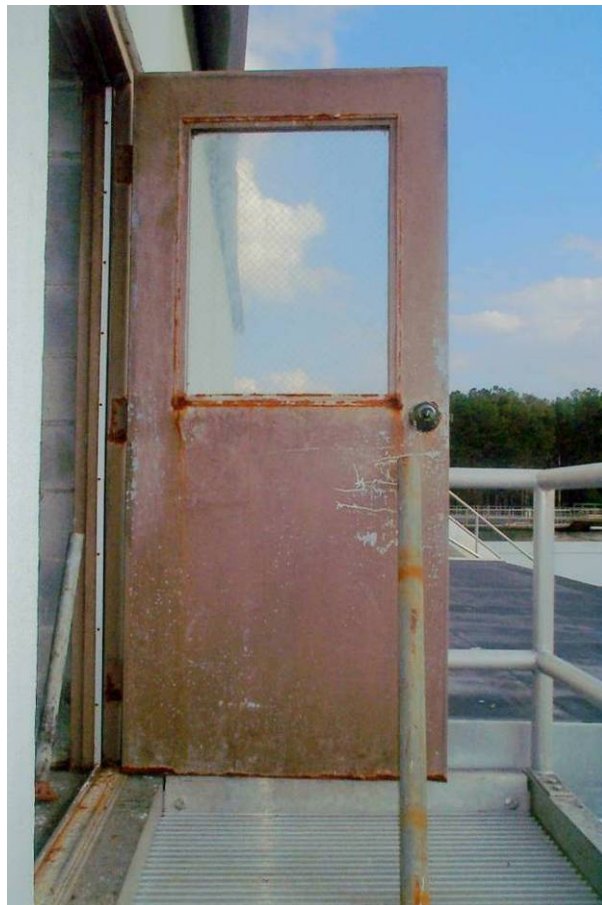
Figure 4. Corroded metallic doorway at the Fort Bragg water treatment plant.

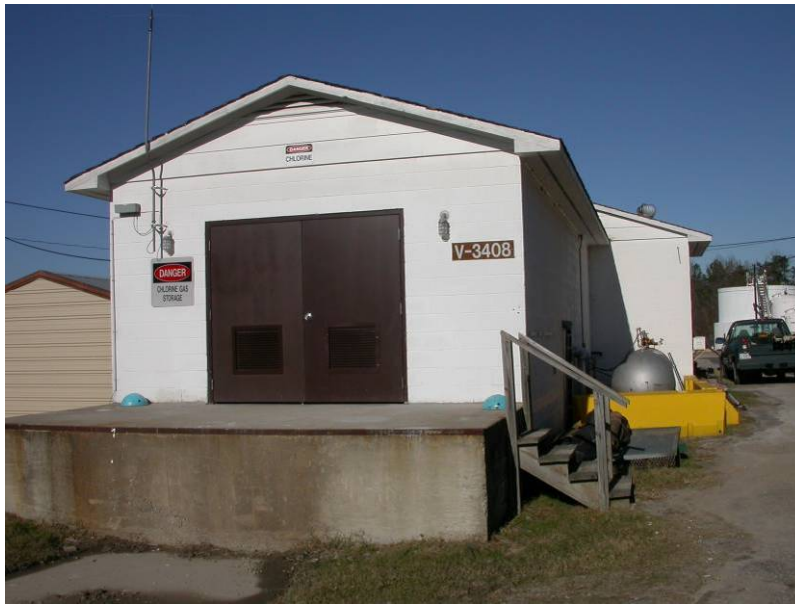
Figure 5. Replacement doors for the doors shown in Figures 1–3 above.

The concrete block surrounding the doorway had also deteriorated and needed to be replaced. The repaired wall and new door sills allowed replacement with standard-sized doors in this location.

The doors of the water treatment plant were replaced by a contractor in November 2005. Figure 5 shows the new doors that replaced the doors shown in Figures 1 through 3.

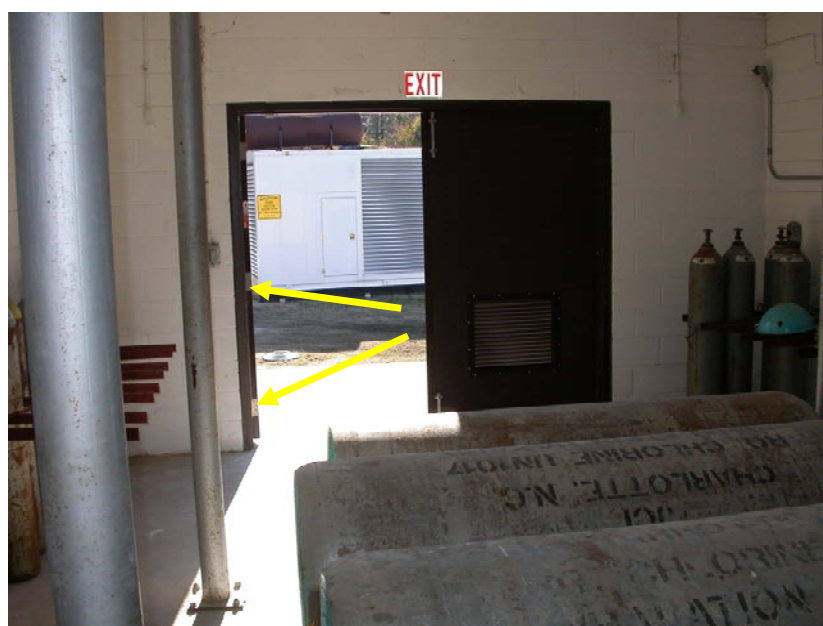
Figure 7. Interior view looking out at door shown in Figure 6. Arrows point to stainless steel hardware necessary because of corrosive conditions at this location. Note the chemical gas cylinders in the foreground.

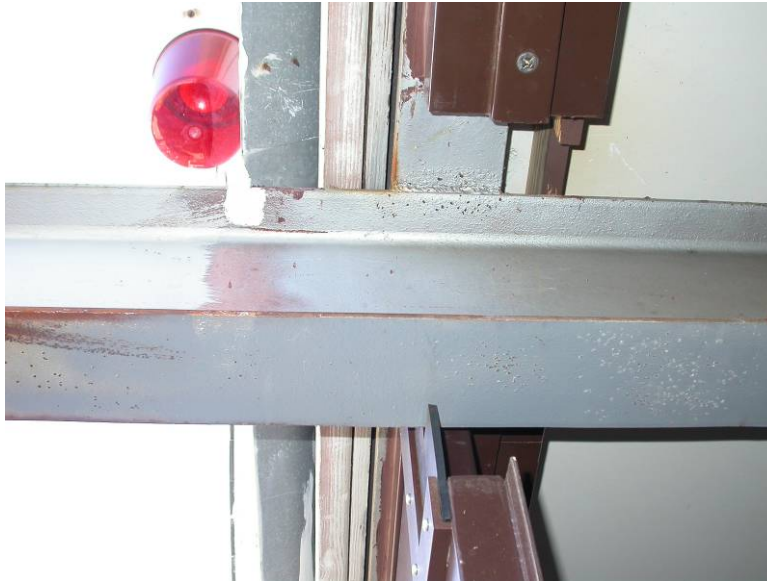
system. The carbon steel overhead rail for this system was not replaced, although it was repainted at the time the new doors were installed.

Figure 8. Overhead track used for moving cylinders into the room shown in Figure 6.

Figures 8 and 9 show the overhead FRP door sill that was cut to accommodate the steel rail. Stainless steel screws were used to attach the FRP sill to the masonry building.

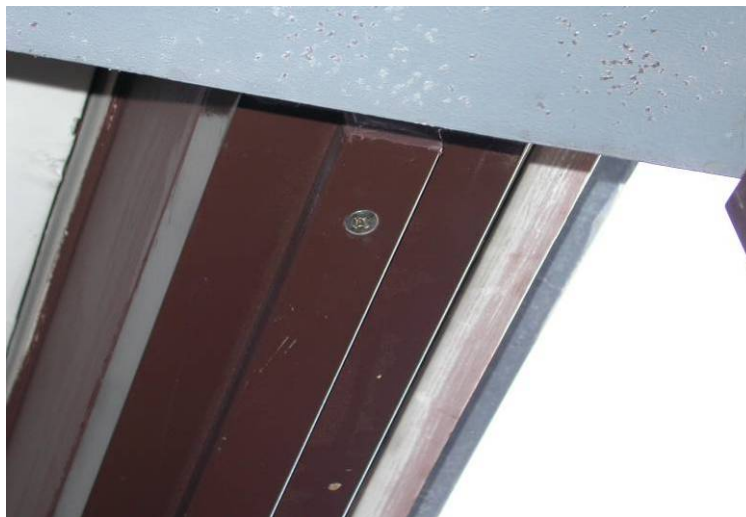
Figure 9. Overhead door sill cut to allow equipment loading track shown in Figure 8.

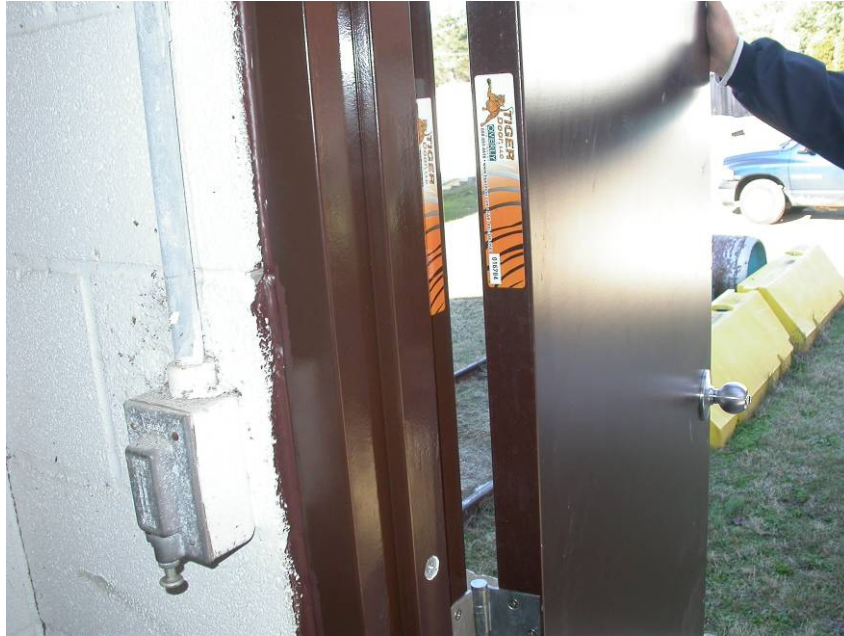
Deterioration of the door jamb necessitated new FRP door jambs that were installed around the doorway. Figures 10 and 11 show details on the left

Figure 10. Special door jamb fabricated for the FRP doors shown in Figs. 5–7.

side of the doorway shown in Figure 7. Because of the corrosive conditions in this location, it was necessary to utilize stainless steel screws, hinges, and other hardware for this entire installation.

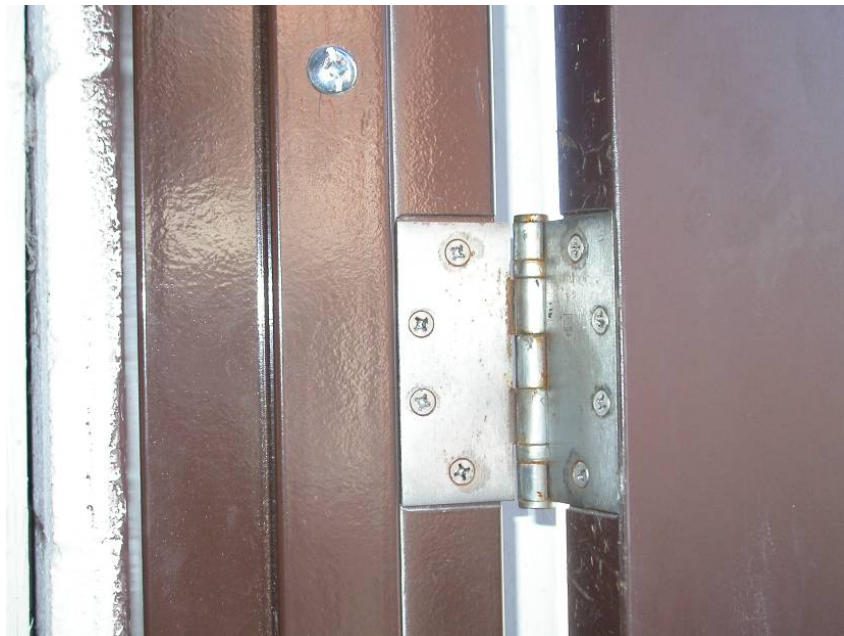
Figure 11. Stainless steel hinges for doors shown in Figs. 6–10.

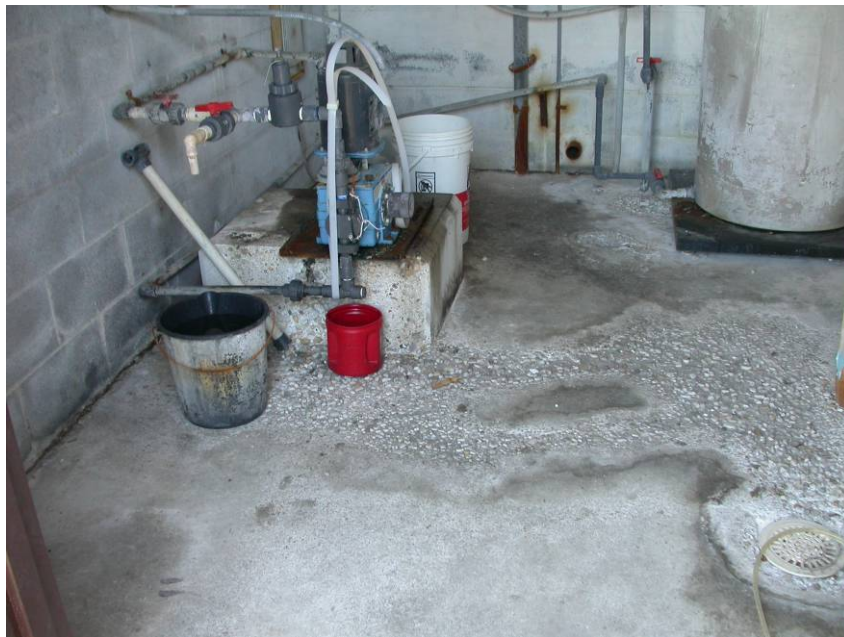
Some of the chemicals shown in the room discussed in Figures 6–11 are mixed and used in the room behind the door shown in Figure 12. The corrosive acids used in water treatment have etched the concrete floor of this room. The floor etching due to chemical spills is apparent in Figure 13.

Figure 13. Interior of room behind door shown in Figure 7. Note the etching of the concrete floor due to spills of acid onto the floor.

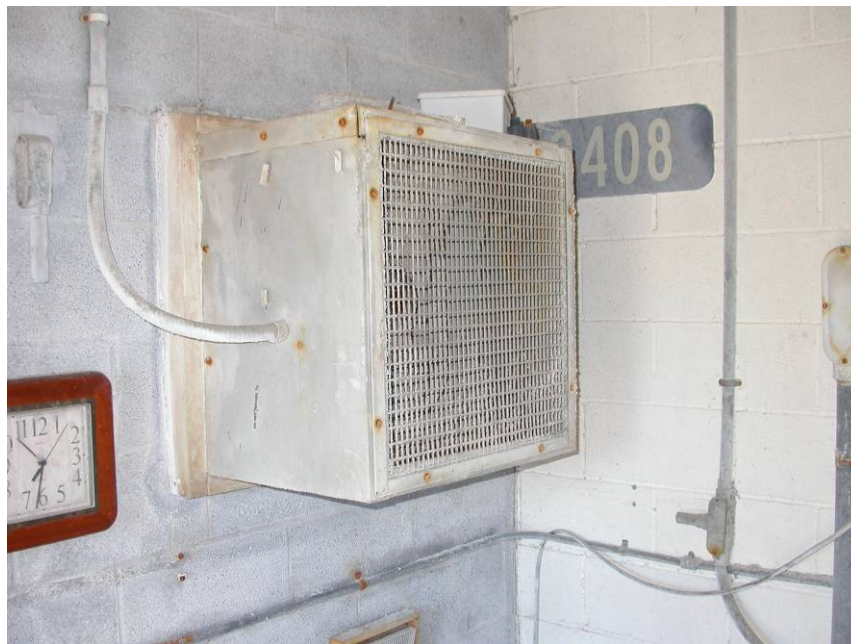
Acid fumes have also caused corrosion of the wall mounted air conditioner in this room, as shown in Figure 14.

Figure 14. Wall mounted air conditioner on the wall above the equipment shown in Figure 13.

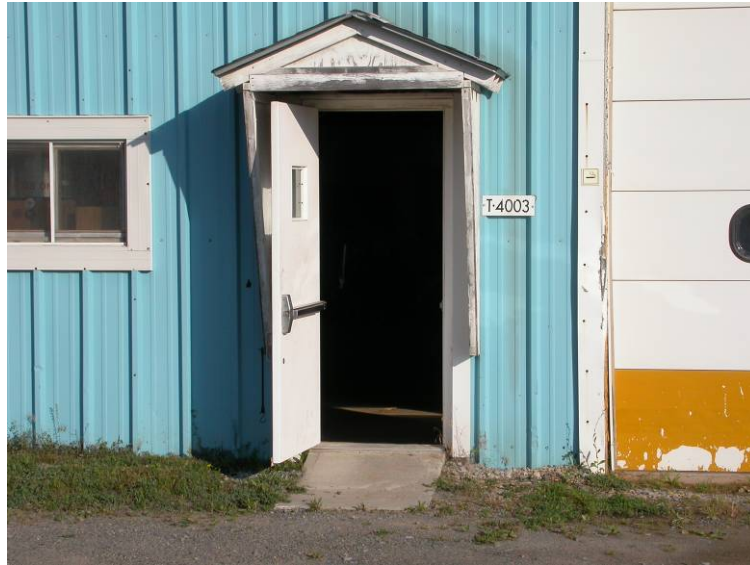
During a parallel project at Fort Drum, New York, several FRP doors that were approximately two years old were examined. Figures 16 and 17 show one of these doors. The panic bar on the door is pulling away from the door, as shown in Figure 17. The solution to this problem is to attach a stainless steel backer plate to the outside of the door and bolt the metal on both sides together.

Figure 16. A two-year old FRP pedestrian door at Fort Drum, New York

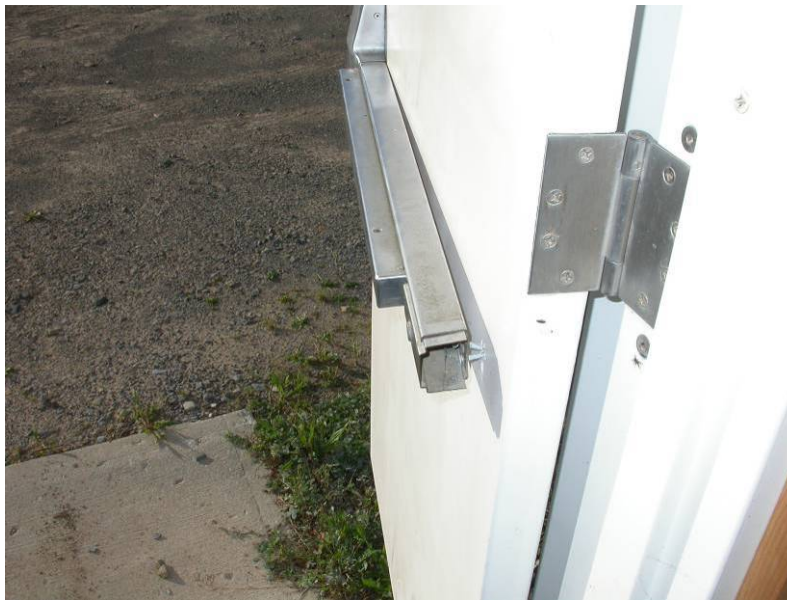
Figure 17. Screws attaching the panic bar to the door shown in Figure 16 showing that the door has bent and pulled the screws from the door.

The problem shown in Figure 17 is not a corrosion problem, but it does indicate a problem associated with the use of composite doors. They can be more flexible than the steel doors they replace, and stripping screws from the hardware is more likely on composite doors than with solid wooden doors or with most steel doors.
