**ABATTOIR (SLAUGHTERHOUSE) IN
QALADZE
SULAYMANIYAH, IRAQ**

**SIGIR PA-09-179
OCTOBER 16, 2009**

SUBJECT: Report on the Abattoir (Slaughterhouse) in Qaladze, Sulaymaniyah
Province, Iraq (SIGIR Report Number PA-09-179)

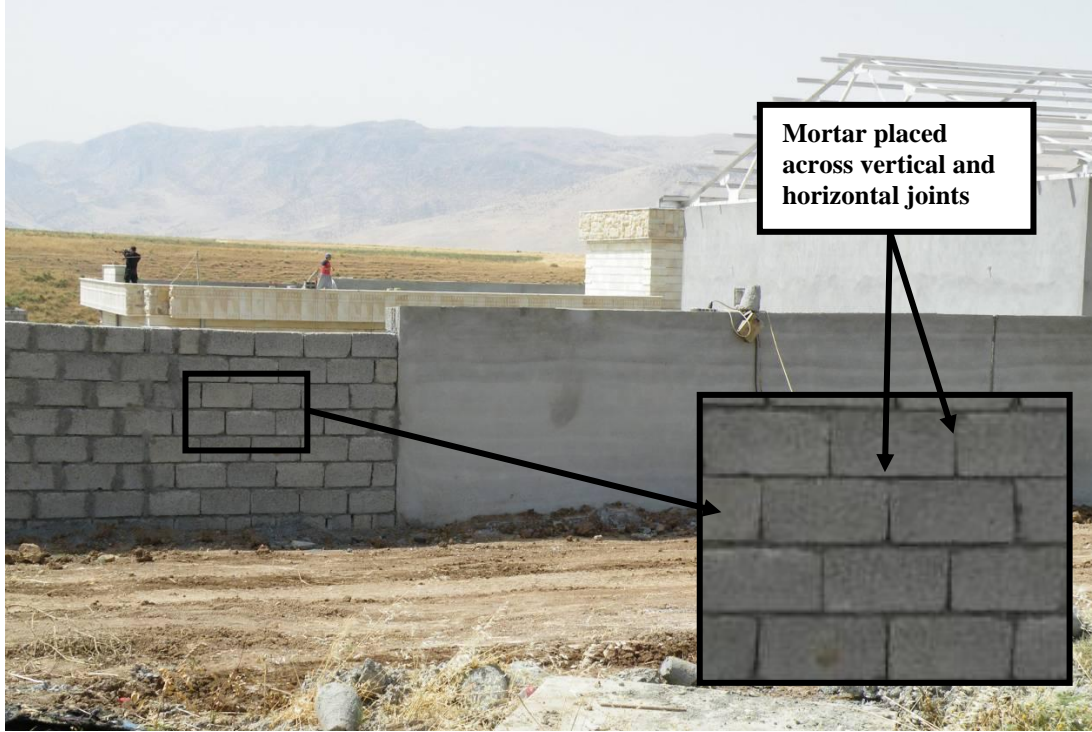
SIGIR inspected the partially completed security fence (Site Photo 5). The contractor had performed the required excavation work of backfilling and compaction prior to construction. The above-ground portion of the wall consisted of hollow concrete blocks with a cement plaster finish. The contractor fully bedded the joints between the concrete blocks for additional strength⁹. To complete the fence, the contractor must finish the cement plaster finish and install a metal door at the main gate.

Site Photo 5. Partially completed security fence surrounding the abattoir

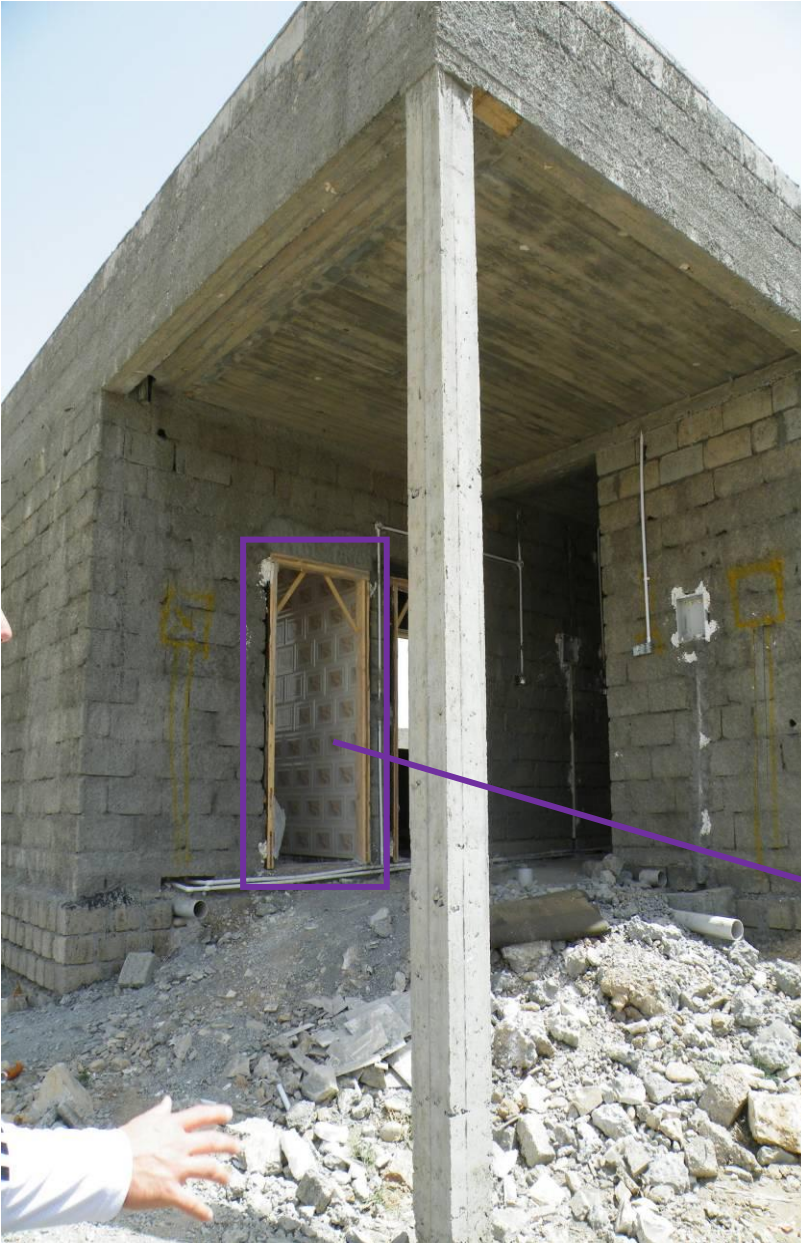
SIGIR inspected both partially constructed guard houses (Site Photo 7). The concrete floor slabs and block walls had been completed; preliminary rough-in plumbing and electrical wiring had been started but not yet fully completed (Site Photo 8). SIGIR observed that the contractor used glazed ceramic tiles on the guard house walls (Site Photo 9), which provided a maintenance-free, nice aesthetic touch to the room.

Site Photo 7. Concrete floor and roof slabs poured for the guard house

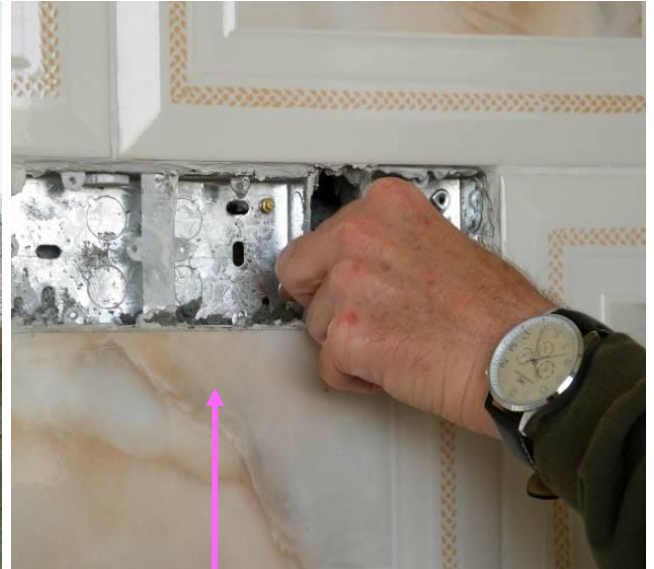
Site Photo 8. Preliminary electrical wiring

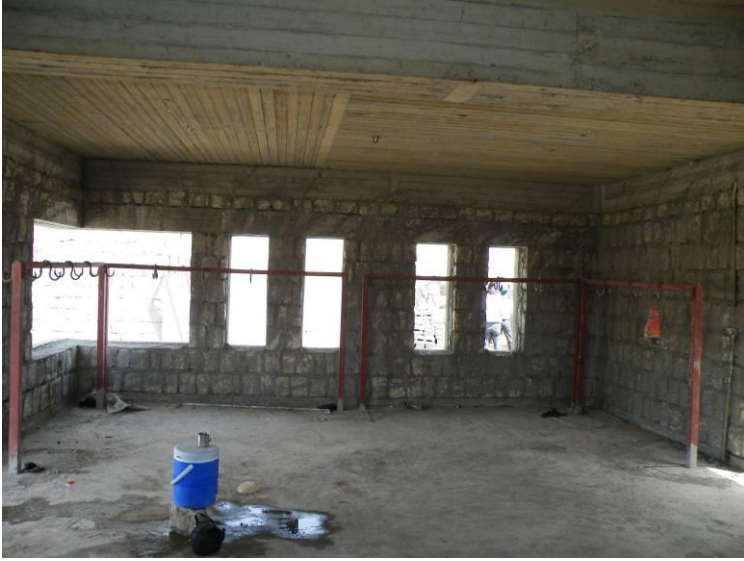
The contractor designed a 10 x 7 meter (m) single room for the winter hall. SIGIR inspected the partially completed winter hall (Site Photo 12). The contractor had poured the concrete floor and ceiling slabs and placed the concrete block walls. SIGIR observed good-quality concrete pours, which resulted in very little noticeable honeycombing or segregation. In addition, to provide additional support for the walls, the contractor buttered¹⁰ the joints between concrete blocks.

Site Photo 12. Interior view of winter hall

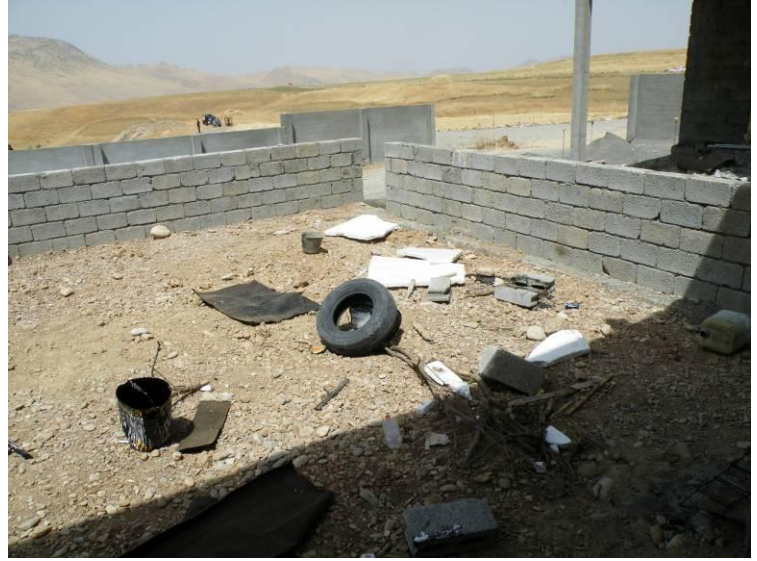
SIGIR inspected the outside summer hall, which the contractor designed as an enclosed area approximately 10.4m x 7m (Site Photo 13). The animal retaining wall was constructed of concrete blocks and appeared to be approximately 1m high. The summer hall provided some shade for the animals and also an open area to roam freely.

Site Photo 13. Exterior view of summer hall

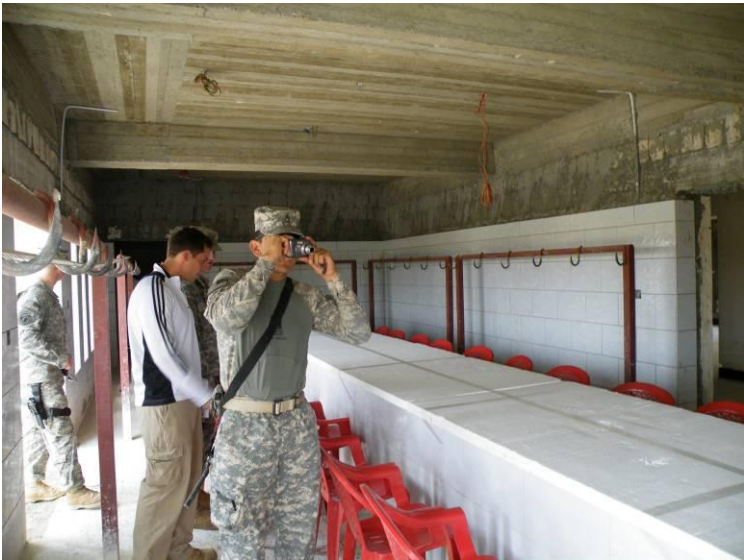
Site Photo 14. View of partially completed meat-testing hall

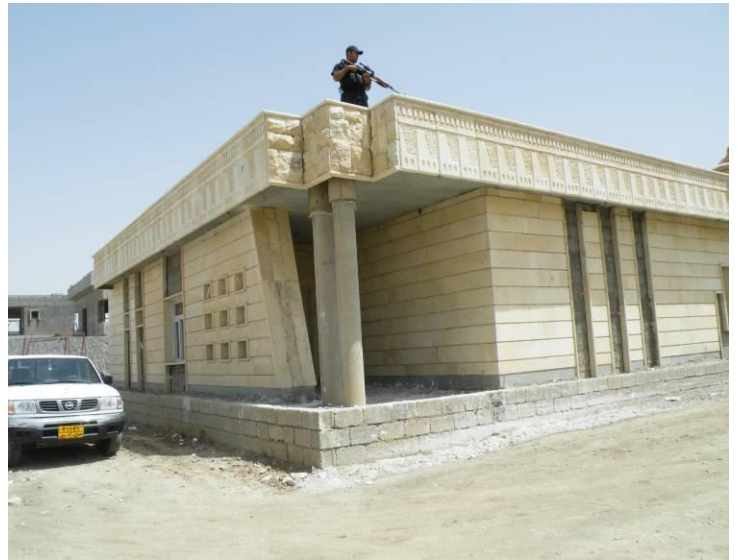
SIGIR observed good-quality concrete pours, which resulted in very little noticeable honeycombing or segregation. In addition, SIGIR noticed that the contractor used an elaborate and creative design for the exterior of this facility, using columns, unique geometric shapes, and stone-masonry facades (Site Photo 15). The facility has a distinctive exterior look.

Site Photo 15. Exterior view of meat-processing facility

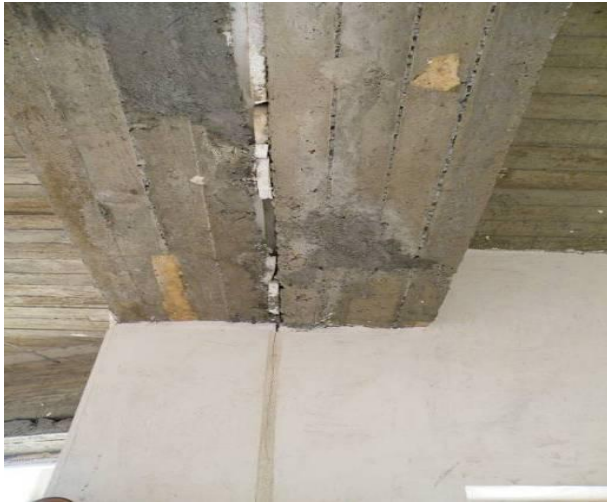
First, the facility's expansion joint system, which is to protect the structure from thermal variations, was incomplete. The expansion joint was correctly designed/placed for the ceiling beams, columns, walls, and roof slab; however, the joint was incorrectly finished and/or not finished at all for the floor and parapet (Site Photos 16-19). An expansion joint was designed and constructed for the wall columns; however, instead of placing the proper expansion joint material inside the joint, the contractor plastered inside it instead. The absence of an expansion joint for the parapet has resulted in a vertical crack. SIGIR found no expansion joint system for the facility's exterior walls. Considering that these walls are exposed to excessive heat in the summer and snow in the winter, a well-designed expansion joint system was warranted. Additionally, sealed joints prevent moisture, dust/dirt particles, and crawling insects from entering the living spaces. Consequently, an expansion joint system promotes structural safety for the building and also provides a better living environment for the occupants.

Site Photo 16. Correctly designed/placed ceiling beam expansion joints

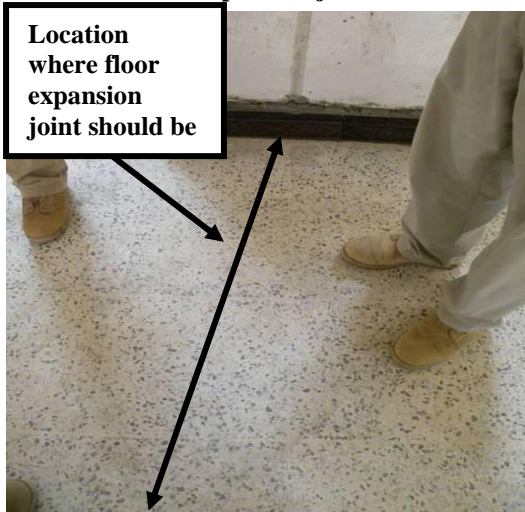
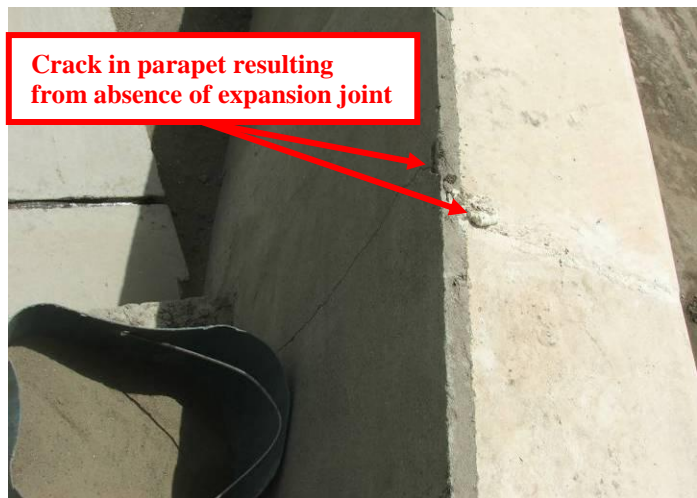
Site Photos 18 and 19. Absence of expansion joint for the floor (left) and parapet (right)

During the site visit, SIGIR identified these deficiencies to the KRO representatives. They readily agreed to the need for internal and external expansion joints and discussed the issue directly with the contractor's on-site representative. The contractor's representative agreed to provide a corrective action plan for the expansion joints to the KRO representatives.

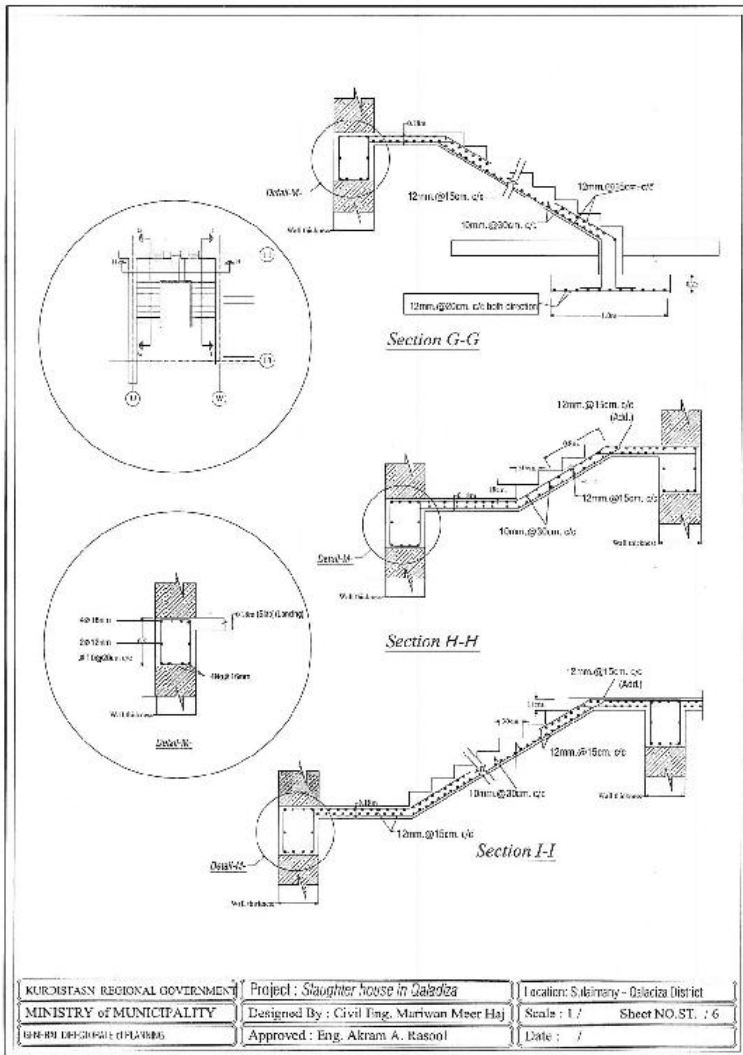
Second, SIGIR identified a tripping hazard inside the facility (Site Photo 20). The risers for a reinforced concrete stair unit are inconsistent and not within the dimensional range specified by the building code and detail shown on the design submittal (Figure 2). Specifically, the first step is only 7 centimeters high, instead of the required 17 centimeters. The site condition of the stair unit does not reflect the original design drawing. In order to provide a safe working environment, this tripping hazard needs to be corrected.

Figure 2. Design submittal for concrete stair unit (Courtesy of USACE KRO)

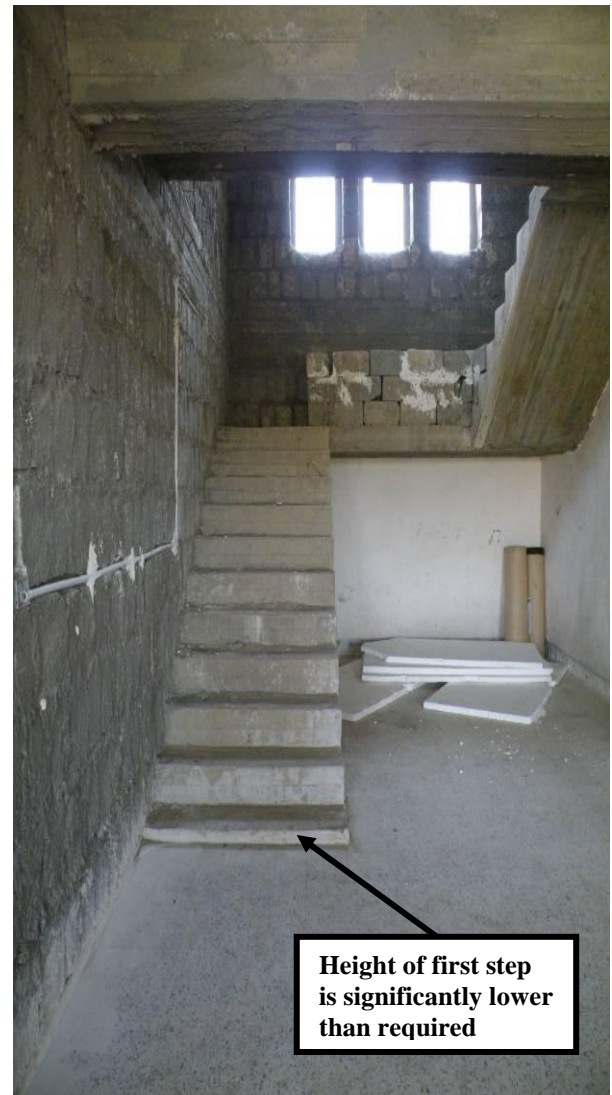
Site Photo 20. Bottom step poses tripping hazard

With regard to the tripping hazard, KRO representatives stated that a quality assurance (QA) daily report had previously identified this problem and that the KRO QA representative was working with the contractor on a corrective action plan.

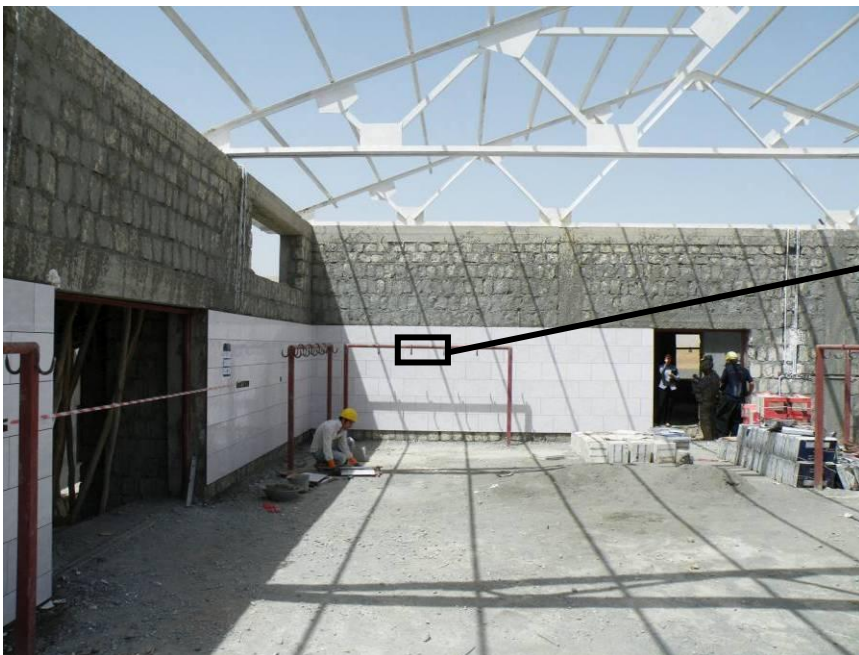
Finally, SIGIR noticed exposed meat-product support hooks throughout the entire abattoir—in the slaughterhouse, winter hall, and administration and meat processing facility (Site Photo 21). The very sharp tip of the exposed meat hook is approximately 5'7" above the ground (Site Photo 22). A typical construction area contains many tripping hazards, such as bags of materials, loose parts, and uneven flooring. It is a distinct possibility that a worker or visitor to the site may trip and fall into the meat hook. The meat hooks are essential to the production process for the facility; however, they also pose an extreme hazard for the workers.

Site Photo 21. Exposed meat support hooks located throughout facility

SIGIR pointed out this potential safety hazard to the KRO representatives, who agreed with the assessment and stated they would look into corrective action, such as covering the pointed ends with a suitable length of ½-inch diameter polyvinyl chloride pipe.

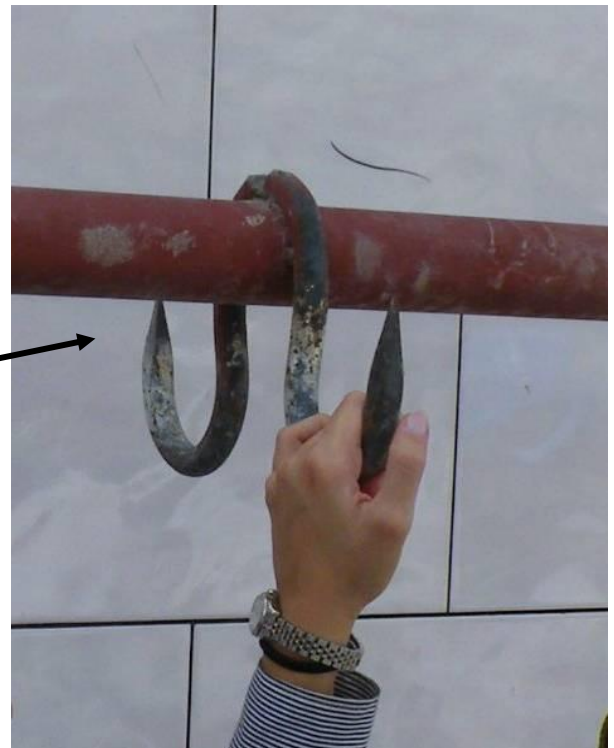
Site Photo 22. Close-up of exposed meat hook
