**RABEAA POINT OF ENTRY
SCREENING FACILITY
RABEAA, IRAQ**

**SIGIR PA-09-173
JANUARY 11, 2010**

Summary of Report: PA-09-173

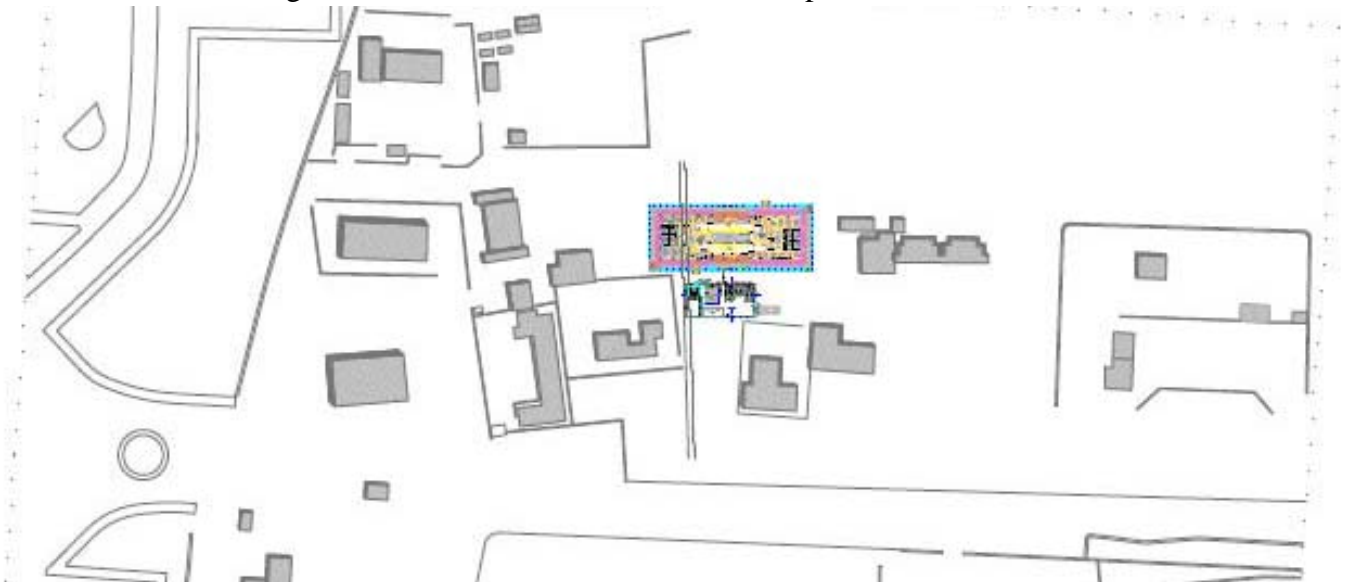
Figure 1. Civil site plan (Courtesy of USACE)

The civil design package included more architectural plans than civil drawings and the actual civil site plan (Figure 1) lacked details on topography, roadways, parking, and other typical site plan requirements. A primary concern was the lack of any drainage plan in the civil site plan. The contractor noted in the geotechnical report that drainage could contribute to future foundation problems.

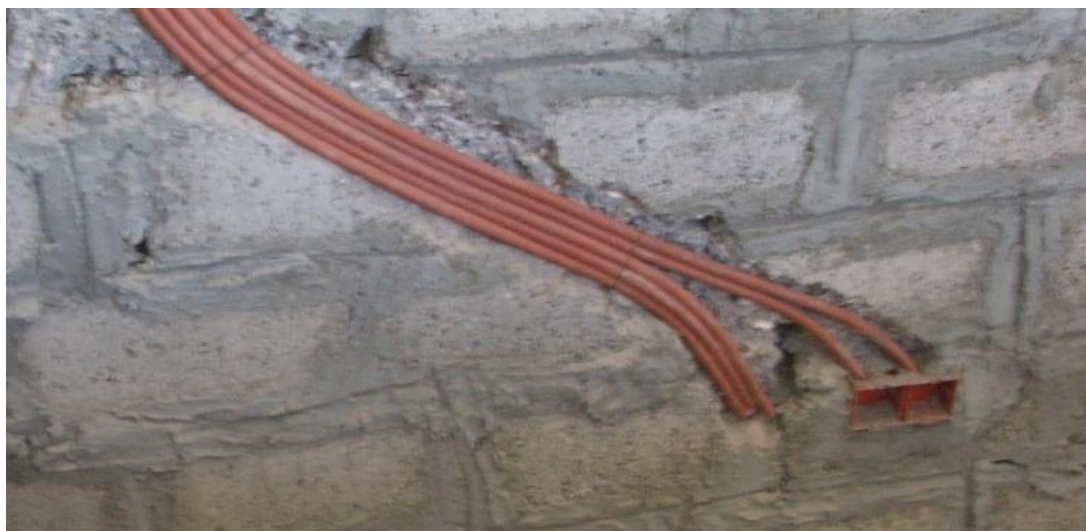
The conduit for future electrical wiring was embedded in the interior masonry walls (Site Photo 5). The SOW, Section 26.2.1 required that all building electrical lines were to be "surface mounted in conduit vice embedded." In addition, the conduit used did not match the COR approved product submittal.

Site Photo 5. Electrical conduit embedded in interior wall

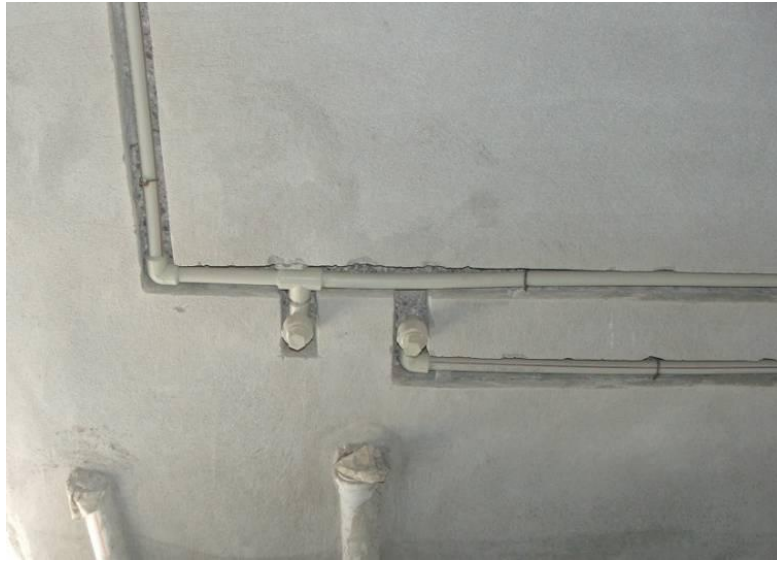
SOW, Section 22.5.3 required the contractor to use "schedule 40 galvanized steel pipes" and the water lines were to be surface mounted. The COR approved the use of a Turkish made product, pilsatherm (plastic) pipe, in a product data submittal. SIGIR noted that the COR approved a different water pipe product even though the pilsatherm pipe data submittal was unclear whether it met the International Plumbing Code standards as required by the SOW, Section 21.1.1. Also, the COR did not provide a contract price adjustment that should have been calculated when approving cheaper products and installation methods. At the time of the site visit, SIGIR noted that the potable water

lines were embedded in the masonry walls and were constructed using polypropylene (plastic) pipe (Site Photo 6).

Site Photo 6. "Pilsatherm" water pipes embedded along exterior wall

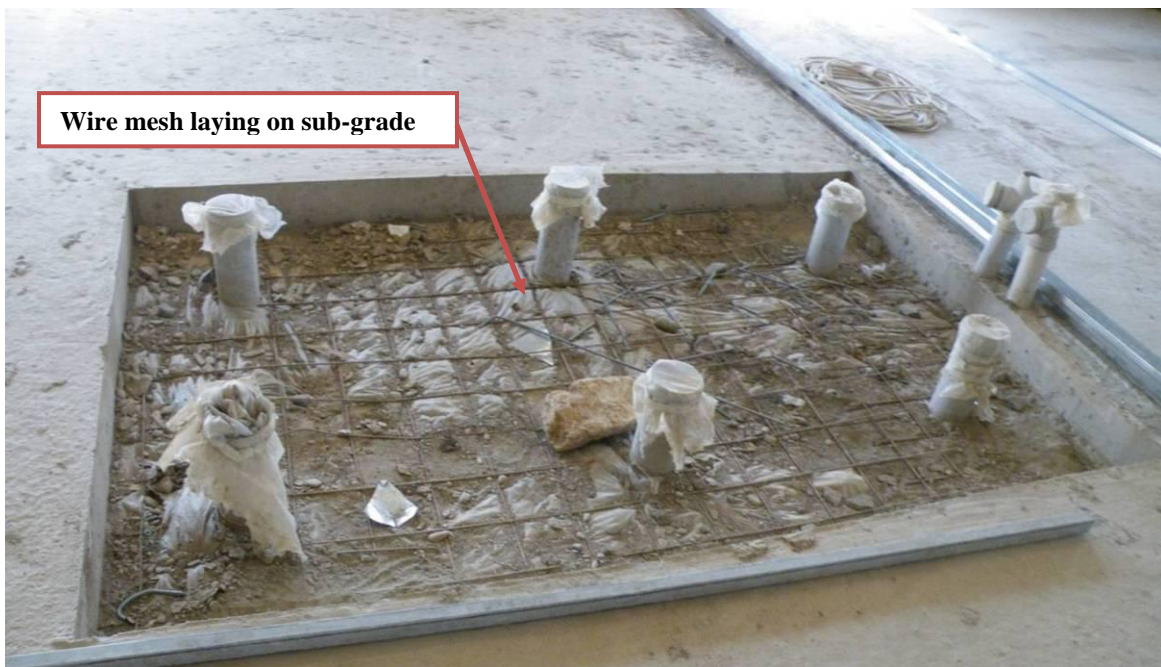
The SOW, Section 22.7.1 and 22.8.1 stated that the contractor was to provide sewer piping of "ductile steel with a minimum 100 millimeter (mm) diameter." In the product data submittal documents provided by GRN, the COR approved the use of the Turkish pilsa (type of plastic) 9001 series pipe. Although SIGIR would not recommend the use of ductile steel pipe, the COR did not provide a contract price adjustment when approving the pilsa 9001 series pipe for the contractor to use. Also, the pilsa pipe data submittal provided by GRN was unclear as to whether the pilsa 9001 series pipe met the International Plumbing Code. At the time of the site assessment, the contractor installed the sanitary sewer piping under the concrete floor slab with polyvinyl chloride (plastic) pipe (Site Photo 7).

Wire mesh laying on sub-grade

Site Photo 7. "Pilsa 9001" sewer pipes under floor slab

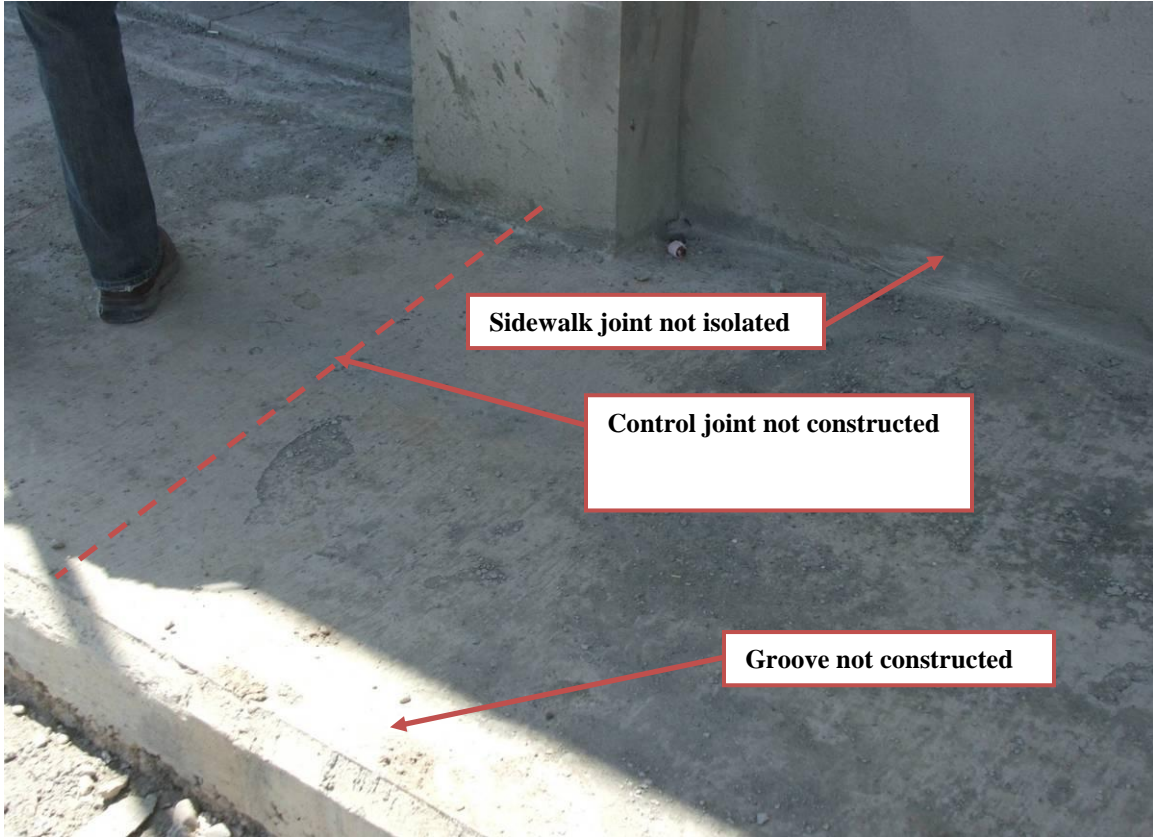
At the time of the site assessment, the exterior sidewalk was partially constructed; the construction was determined to be lacking an isolation joint next to the building, control joints, and a 200mm groove (Site Photo 9). Both the isolation joint and the groove were included in the 100% drawings submitted for approval (Figure 5). The control joints (contraction joints) were required every 1.2 meters (m) per a special note on the plans.

Site Photo 9. Construction of exterior sidewalk

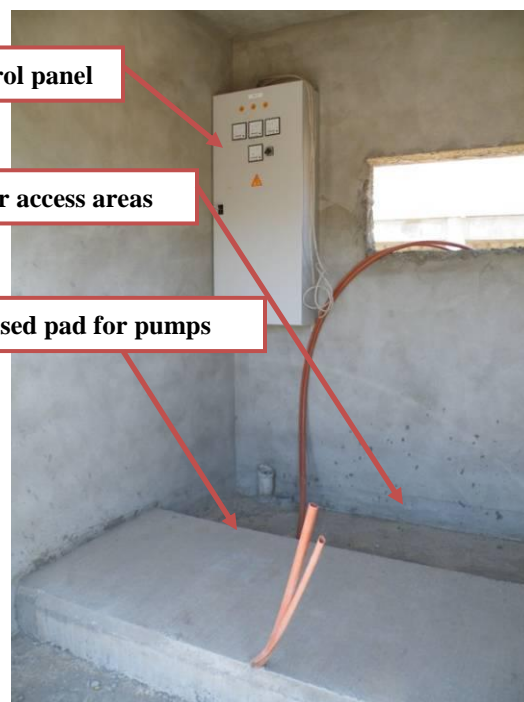
Although the construction of the water pump house was partially completed, SIGIR noted that the construction of the raised concrete pump pad was not constructed in accordance with the drawings (Figure 6 and Site Photo 10). Specifically, the raised floor as submitted on the plans was a 1.8m square raised concrete pad. The actual construction of the raised concrete pad was not configured in a square and did not allow for access against one exterior wall. Once the booster pumps are placed on the concrete pad, the access to the electrical control panel could be impeded. The original design allowed for unimpeded access all around the raised pump pad.

Site Photo 10. 100% Water pump room - actual construction

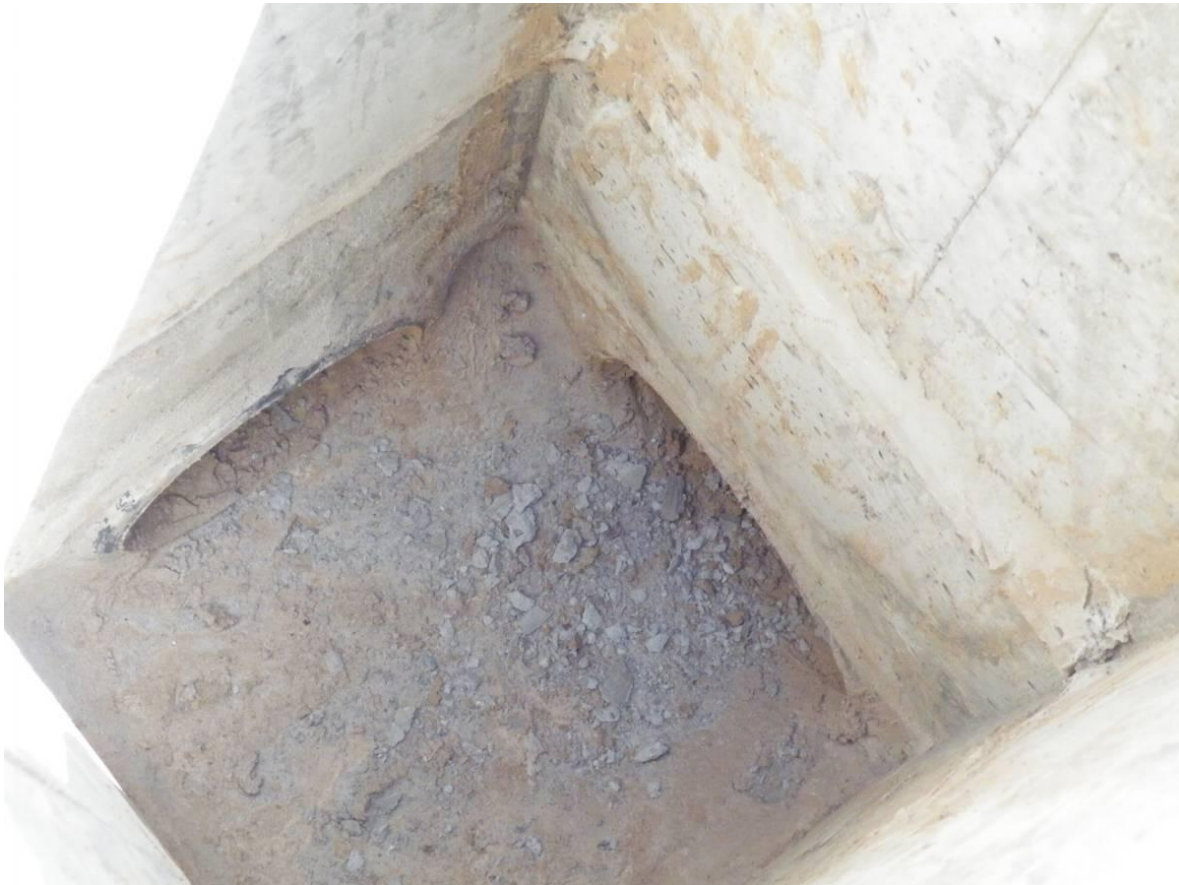
The sanitary sewer manhole contained debris in the bottom of the manhole and the sewer line. Also, the manhole lacked any access steps (Site Photo 11).

Site Photo 11. Sanitary sewer manhole with debris and no access steps

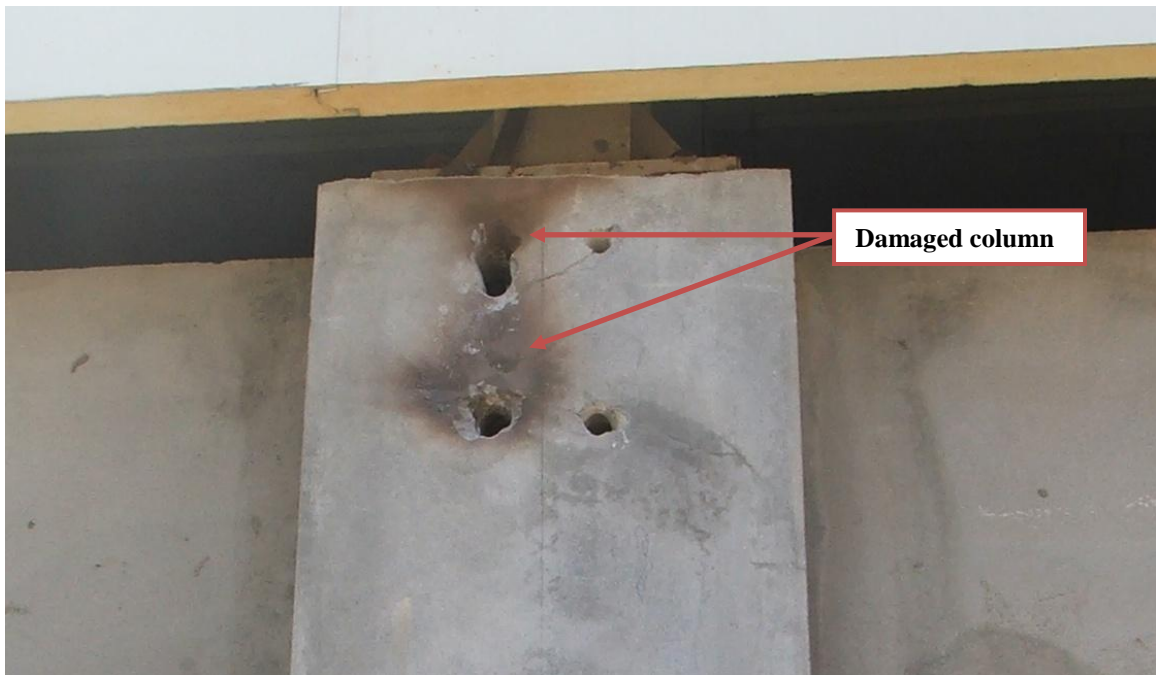
SIGIR determined that the construction of the perimeter awning was defective and required repair. The anchor bolts that attached the steel structural shade to the building columns were not embedded in the columns correctly and caused damage to the column (Site Photo 12). Also, SIGIR noted that the contractor hit steel reinforcement while drilling holes for the anchor bolts, which caused damage to the columns (Site Photo 13). If the anchor bolts were embedded in the columns before pouring the columns, the need for drilling holes would have been unnecessary. SIGIR found no evidence that epoxy or expanding fasteners were used to ensure that the anchor bolts were securely fixed into the columns. The anchor bolts should be load tested prior to the structural members being erected.

Site Photo 13. Column damage from drilling holes for anchor bolts

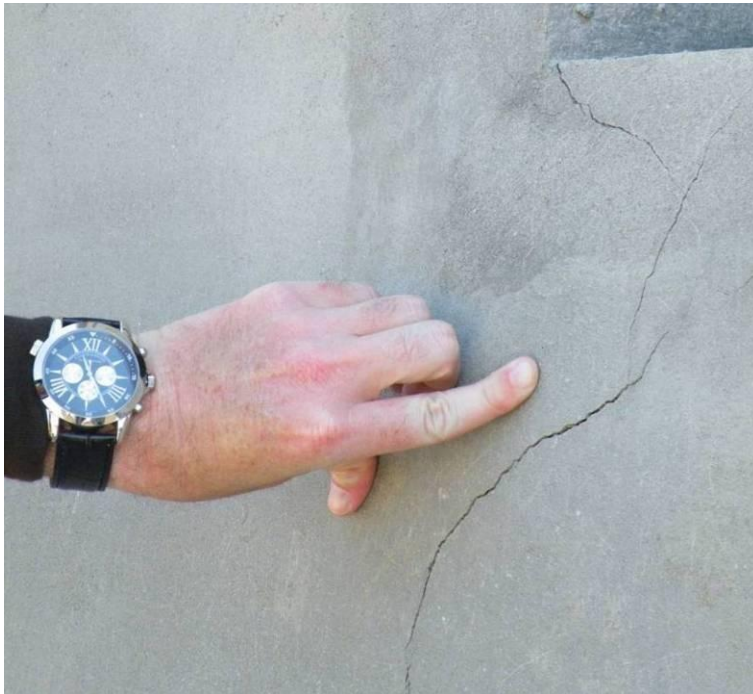
SIGIR observed that the west end of the building contained significant cracking of the mortar surface coating of masonry block and concrete columns (Site Photo 14). The damage appeared limited to the west end of the building. However, SIGIR was unable to determine why the damage occurred, and informed the GRN Mosul Area Office representative that the cracking could be due to shrinkage.

Site Photo 14. Cracking of the surface coating on the block walls and columns

14, page 17 of the report. Had the crack been a structural default the crack would have been more vertical or horizontal.

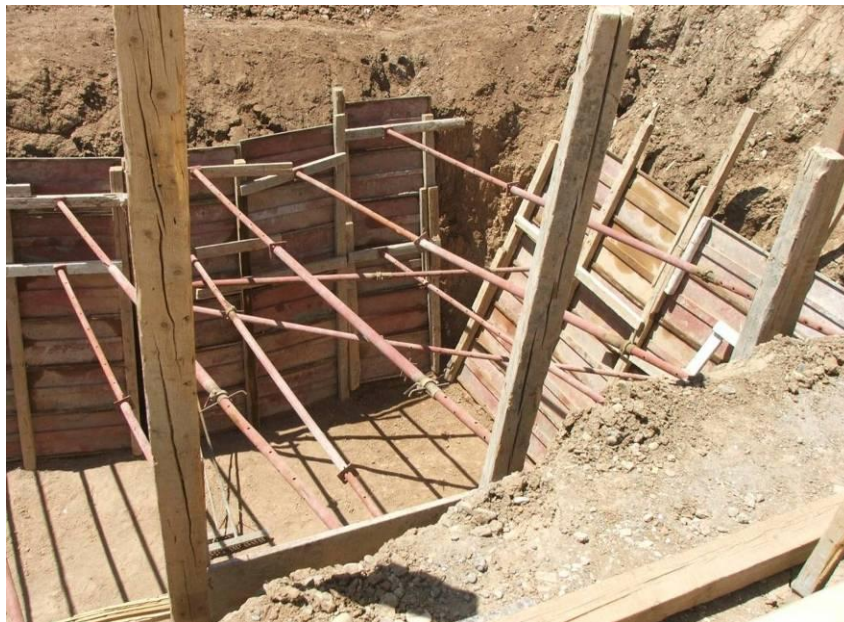
Further, SIGIR noted that the construction site continues to have on-going safety issues. According to GRN Mosul Area Office representatives, a “Stop Work Order” was issued on 17 March 2009, when an employee fell to his death while not following proper safety procedures. The “Stop Work Order” was on-going at the time of the site assessment and a review of the safety plans and on-site safety procedures was being conducted. SIGIR observed that the project site was unsafe due to the open excavations for the sanitary sewer lines and septic tank. The trench excavations either lacked shoring completely or were improperly braced (Site Photo 15).

Site Photo 15. Improperly braced shoring for septic tank construction.
